Thorrington Reserve – Pump Shed
PRK 1762 BLDG 001
Detailed Engineering Evaluation
Qualitative Report
Version FINAL

Christchurch City Council

Date
21 May 2013

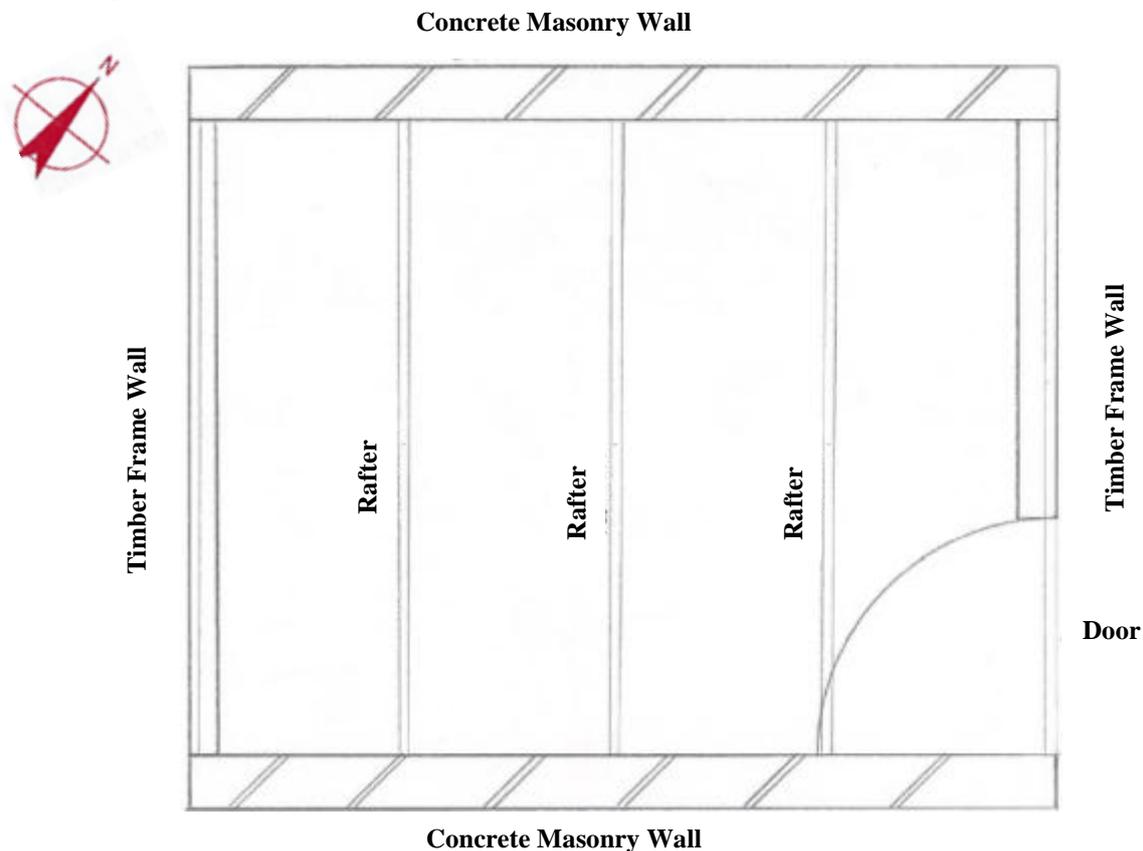
Figure 2 Plan Sketch Showing Key Structural Elements

Gravity loads are transferred from the roof cladding to the timber rafters. The rafters transfer loads to the supporting concrete masonry walls. Loads are transferred down through the masonry walls to the floor slab thickenings and through to the ground below. Internal gravity loads are transferred directly down through the floor slab to the ground below.

Lateral loads in the along direction are resisted primarily by the concrete masonry walls with secondary lateral load resistance provided by the roof structure. Lateral loads acting in the across direction are resisted by the timber framed external walls.

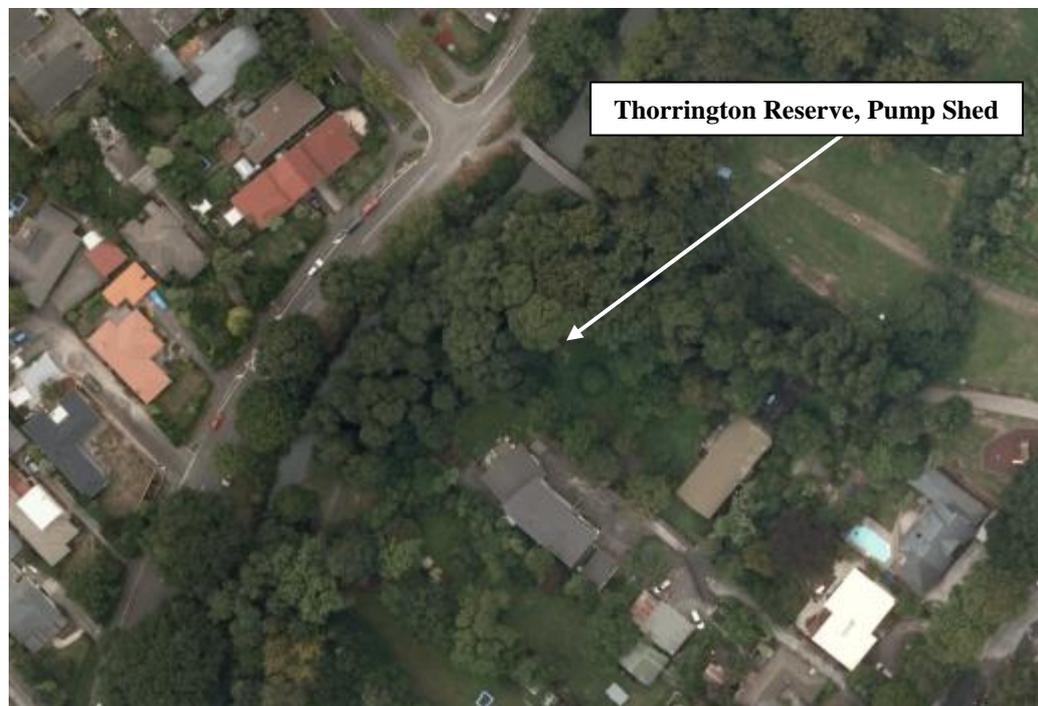
Figure 3 Post February 2011 Earthquake Aerial Photography ⁴

The site has been categorised as “N/A – Non-Residential”. However, neighbouring residential properties are indicated as being within the TC3 (blue) zone³. This means that moderate to significant land damage from liquefaction is possible in future significant earthquakes.

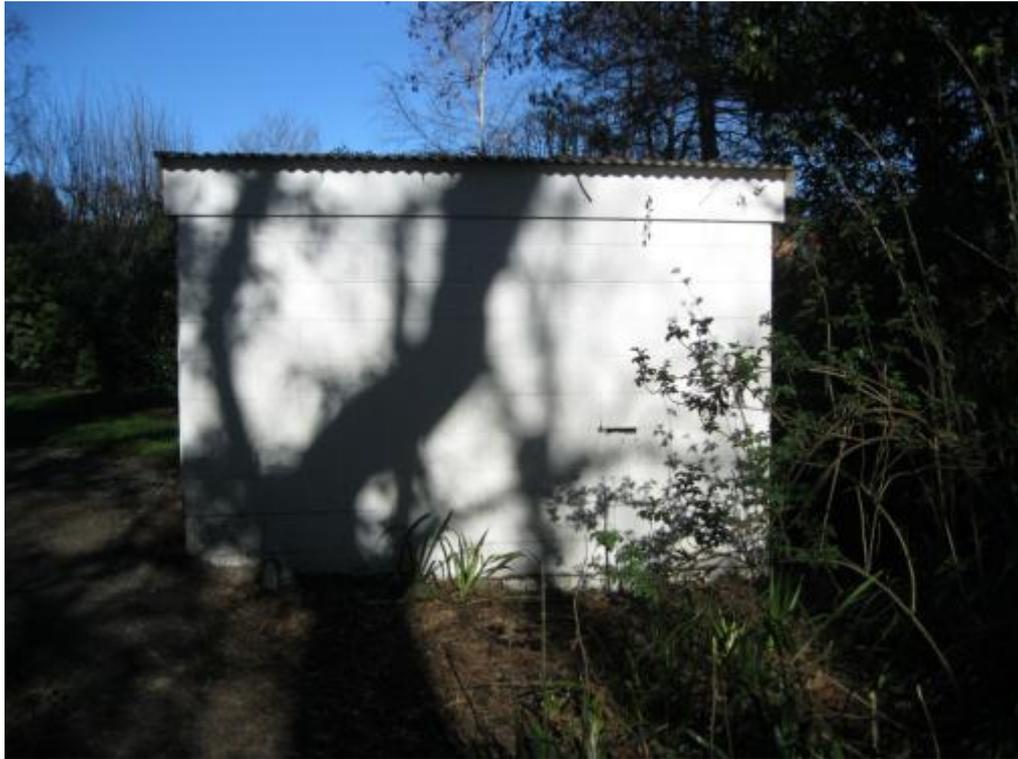
Photograph 1 North elevation.

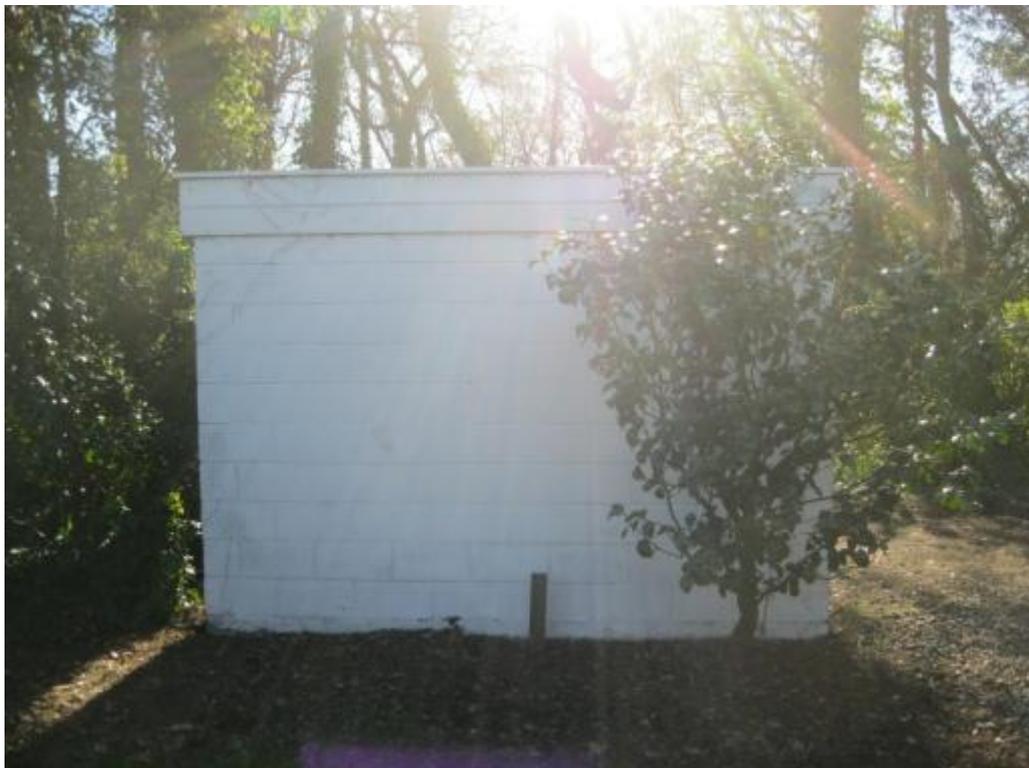
Photograph 2 View of the pump shed from the south.

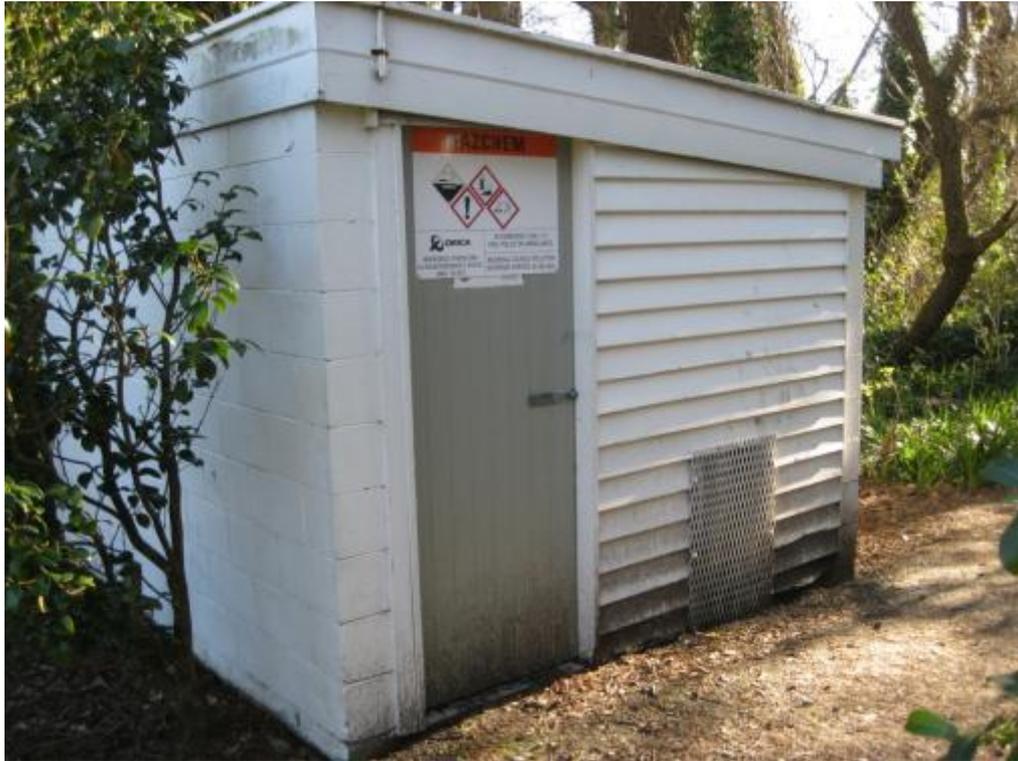
Photograph 3 View of the pump shed from the east.

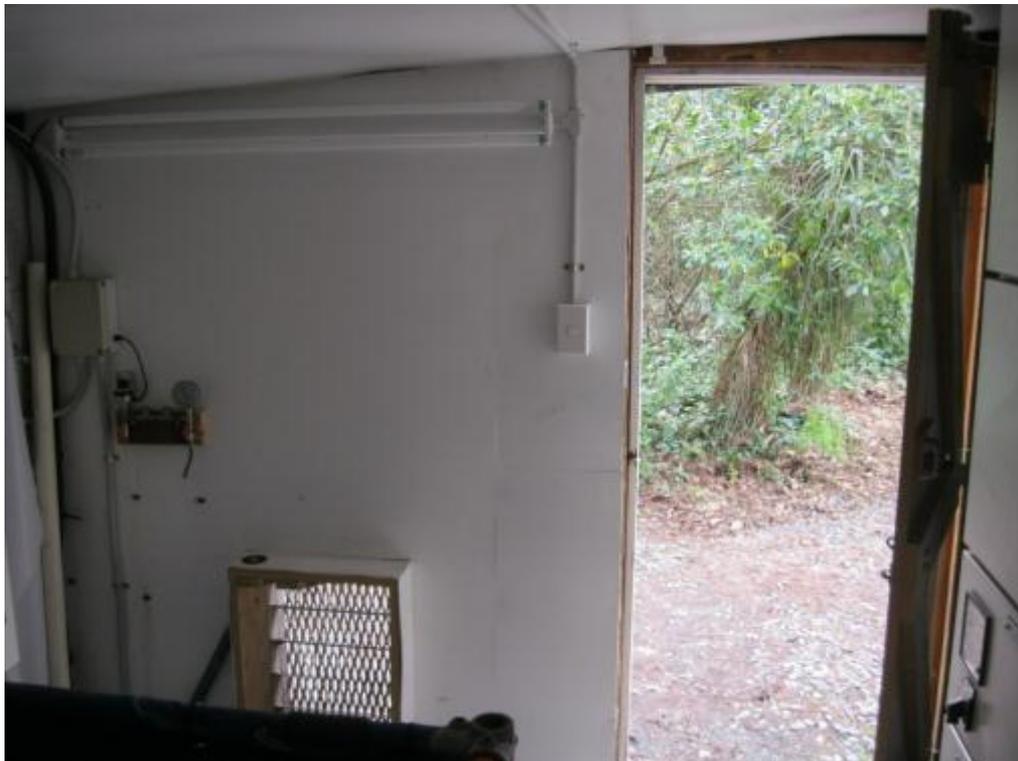
Photograph 4 Internal view of timber frames wall showing fibreboard ceiling and wall lining.
