Tommy Taylor Courts
BU 1048-001 EQ2
Detailed Engineering Evaluation
Quantitative Assessment Report
7 Cecil Place, Waltham, Christchurch
Christchurch City Council

**Quantitative Assessment Report
7 Cecil Place, Waltham, Christchurch
Christchurch City Council**

Date: December 2012
Reference: 6-QUCCC.86
Status: Final V2

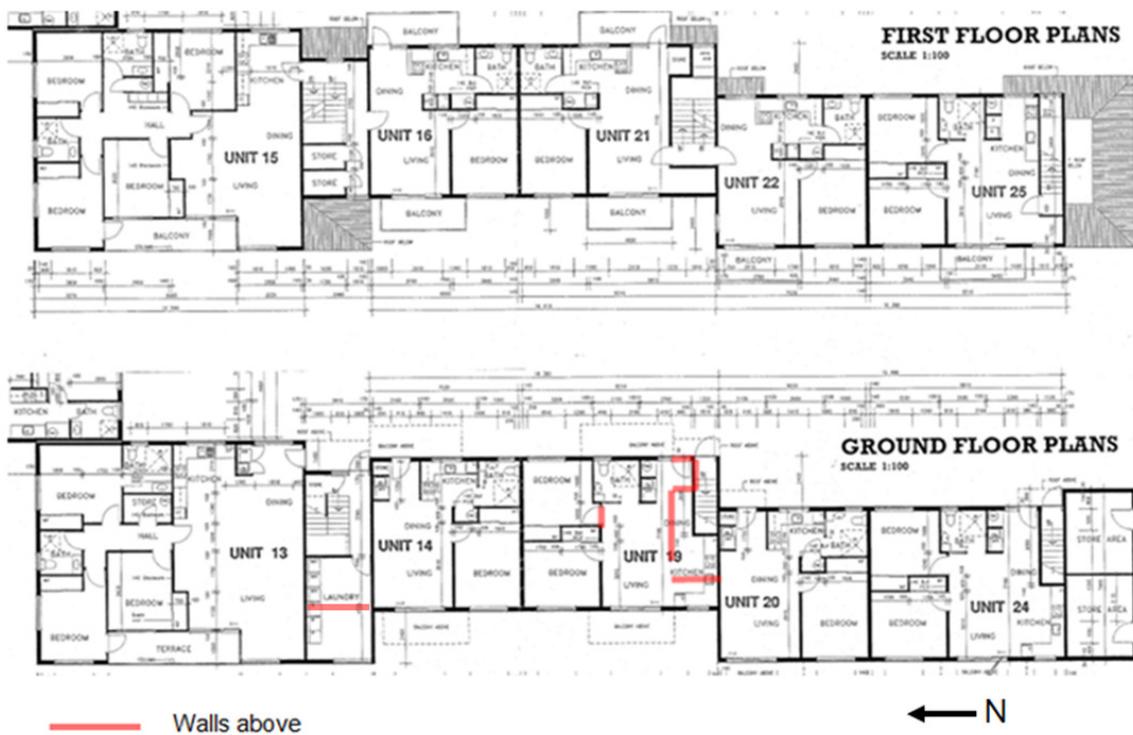
Figure 3 – Locations of discontinuous walls in west wing

- b) Discontinuous walls: There are several reinforced masonry walls at the west wing that are not continuous to the foundation. Seismic overturning forces in these walls impose additional loads and can overwhelm supporting elements. The following points summarise where these discontinuous walls occur (refer to figure 3):

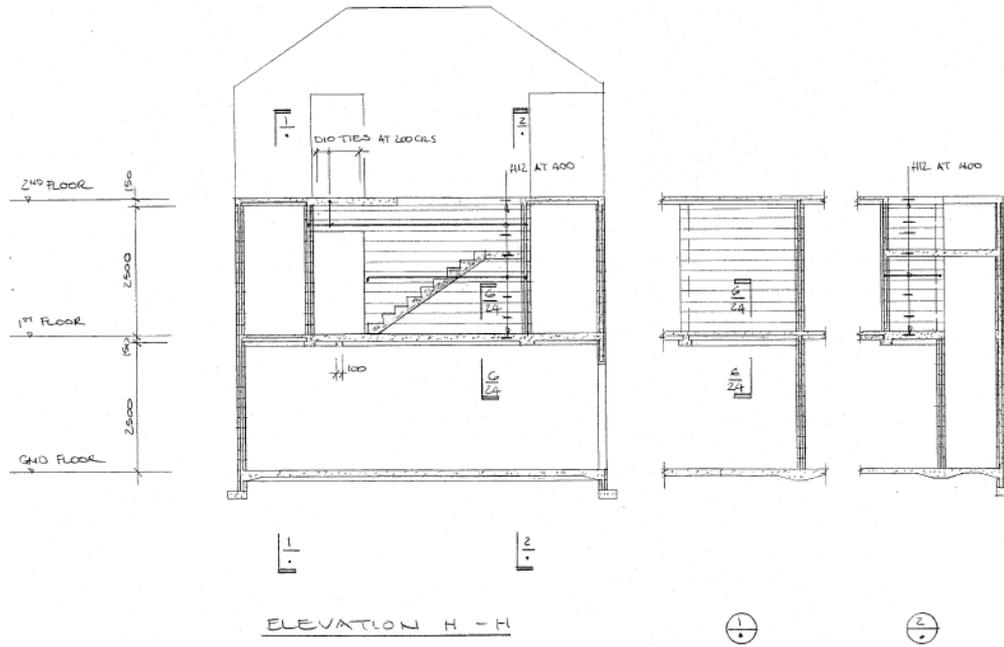
Figure 4 – Elevation of discontinuous wall between unit 21 and the stair

- i. The concrete block bearing wall at the 1st floor between unit 21 and the stairwell is not continuous to the foundation. Instead, it is supported by a concrete beam at 1st floor and perpendicular concrete block walls. The limiting component is the concrete block header above the entry door at the 1st storey and the 1st floor concrete beam (see figure 4).

Discontinuous shear wall between unit 21 and stairway.	The concrete block wall between unit 21 and the stairway is not continuous to the foundation; instead, it relies on a concrete beam at the 1 st floor and perpendicular concrete block walls for vertical support. The limiting element in this load path is the concrete block header above the entry door at the first storey. The failure mode is in flexure. Since the wall provides gravity support for 1 st and 2 nd floor slabs, failure of these elements could lead to local loss of gravity support. Note that the 1 st floor beam is notched at the doorway. See Figure 4.	Yes	40%
Discontinuous shear wall above entry to unit 19.	Wall pier above the entry door into unit 19 is discontinuous at the ground floor. The wall pier and the 1st floor beam are supported on the block header above the window/door into the unit. The failure mode is flexure in the header.	Yes	50%

- Perform remedial strengthening to support discontinuous shear walls in the west wing. We recommend that these local areas of concern be addressed promptly. This work will all occur in unit 19 at the ground floor.
- Develop a strengthening works scheme to increase the seismic capacity of the building to at least 67%NBS; this will need to consider compliance with accessibility and fire requirements.
- Engage a quantity surveyor to determine the costs for strengthening the building.
- The site needs a full geotechnical assessment to determine the potential for further liquefaction and if ground improvements are needed.
- These buildings are not considered earthquake prone and may be occupied per the 2004 Building Act.

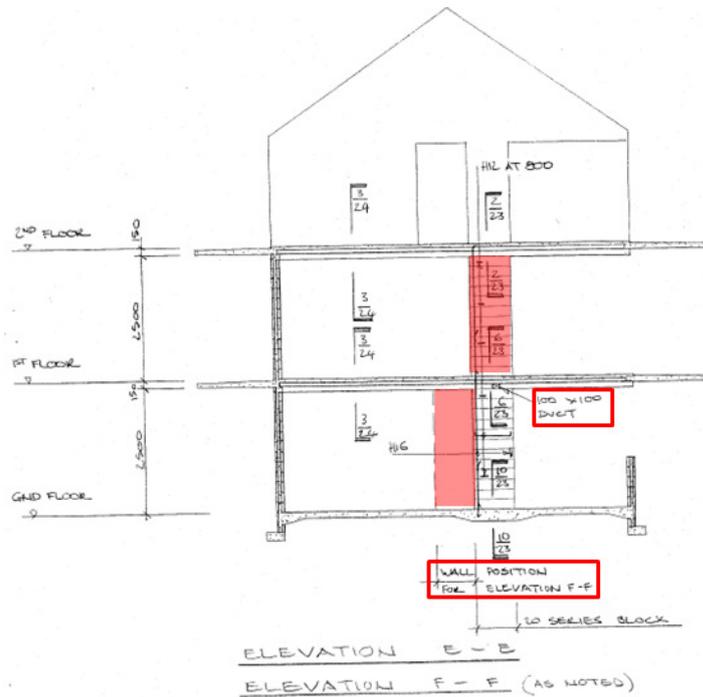
Figure 5 – Elevation of slender wall in unit 21 and 19

- ii. The slender wall pier at the 1st level between the dining area and the kitchen of unit 21 is offset from the wall pier at the ground floor below in unit 19. The

- wall above is supported on the 1st floor concrete beam. The drawings also indicate a notch in the bottom of this beam which exacerbates this condition (see figure 5).
- iii. The wall pier at the 1st level above the entry door into unit 19 is also discontinuous at the ground floor. The wall pier and the 1st floor beam are supported on the block header above the window/door into the unit (see figure 6).
 - iv. The exterior wall at the 1st floor between at the store room between units 15 and 16 (above the laundry room) is discontinuous.

Discontinuous slender wall pier in unit 21	The slender wall pier between the dining area and the kitchen in unit 21 is not continuous to the foundation. The wall pier below along the same line in unit 19 is offset to the west. The pier above is supported on a 250mm by 250mm concrete beam on the 1 st floor. The drawings also show a notch in the bottom of this beam. The complex load path is loaded to its full capacity by gravity only loads. In theory, the first story wall will not resist lateral seismic loads because it is free to rotate about its support at the bottom west corner. See Figure 5.	Yes	See discussion
Discontinuous shear wall at store room between units 15 and 16	The exterior wall pier at the 1st floor at the store room between units 15 and 16 (above the laundry room) is discontinuous and is supported by transverse walls along each side of the laundry room at the ground floor. A window opening occurs at this wall and the failure mode is shear in the spandrels above and below this window.	Yes	34%

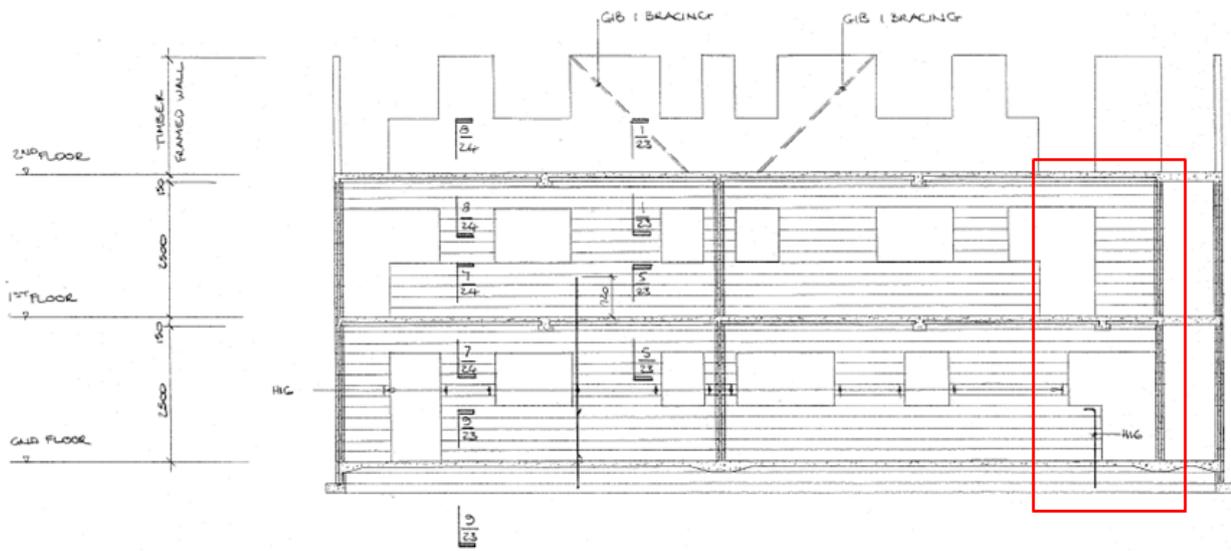
Figure 6 – East elevation showing discontinuous shear wall above entry to unit 19

The discontinuous wall pier above the entry to unit 19 bears on the door header at unit 19. See Figure 6. This condition should be addressed for long term use of the building.

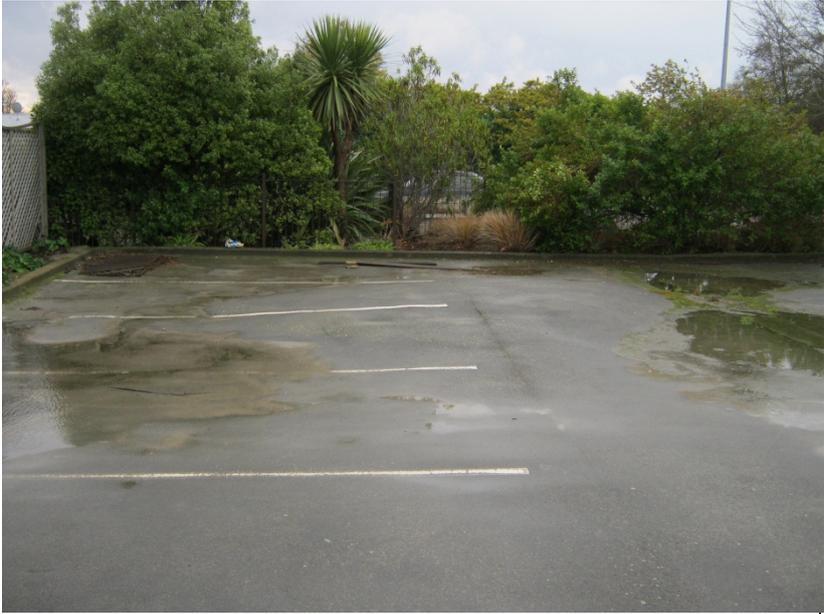
- a) Significant liquefaction has occurred throughout the site as evident in the ground displacement in the carpark as well as the north wing.
- b) The floor level survey indicates the slope in the ground floor slab in the west wing is up to 40mm over 4.5m which is considered excessive.

<p>3.</p>	<p>Vertical ground displacement at parking lot area to the east of north wing</p>

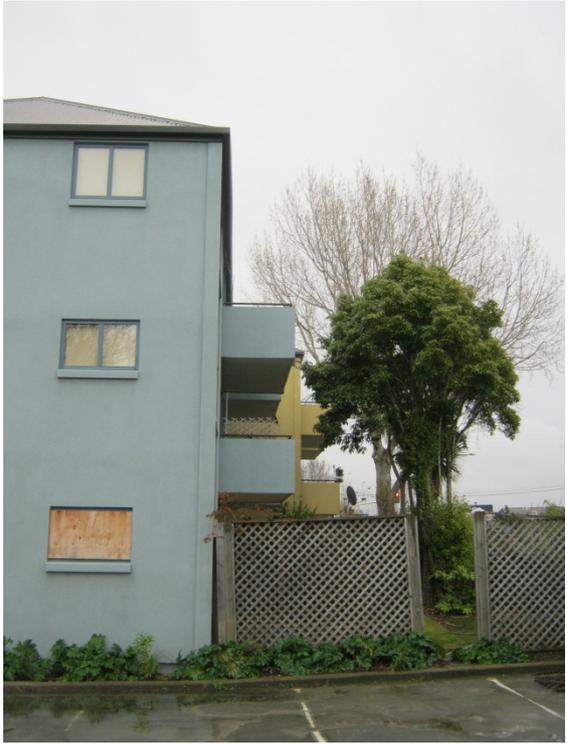
- c) The north wing has tilted approximately 100mm towards the north leaving a separation at the intersections between the two wings. The tilt created a large gap in the exterior sheathing along the full height of the building.

<p>4.</p>	<p>Tilting of north wing</p>

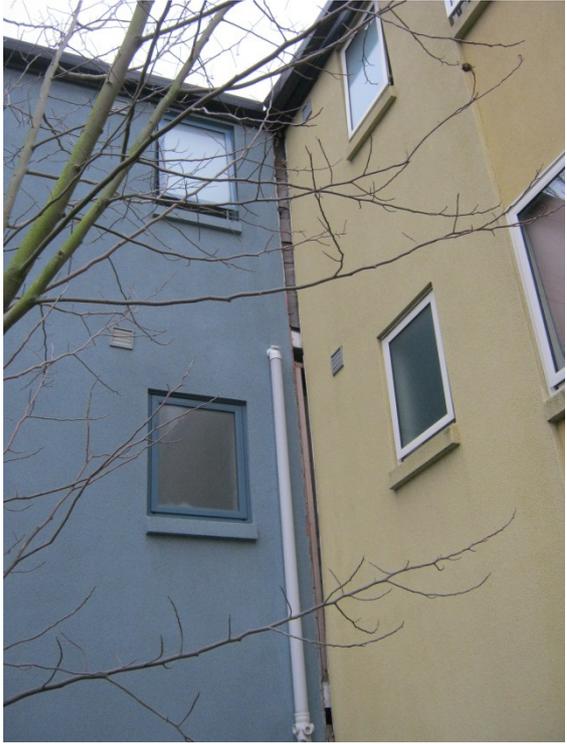
- The north wing has tilted approximately 100mm towards the north leaving a separation at the intersections between the two wings. The tilt created a large gap in the exterior sheathing along the full height of the building (photo 5).
- Minor cracking of exterior finishes typically around window or door openings (photos 10, 16 to 19).
- A vertical crack of the block wall was observed in the storage room at the southern end of the west wing (photo 9).
- Vertical cracks were observed at the junction between the balcony side wall and the building exterior walls (photo 20)

<p>5.</p>	<p>Separation of north wing and west wing</p>

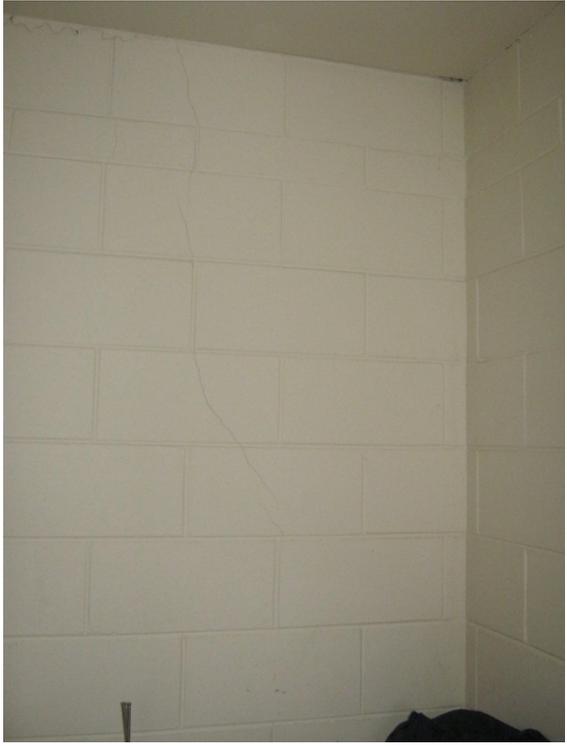
- d) Some minor cracking of exterior finishes typically around window or door openings.
- e) Vertical crack of the block wall was observed in the storage room at the southern end of the west wing.

<p>9.</p>	<p>Vertical crack in the masonry wall inside the storage room at the southern end of the west wing</p>

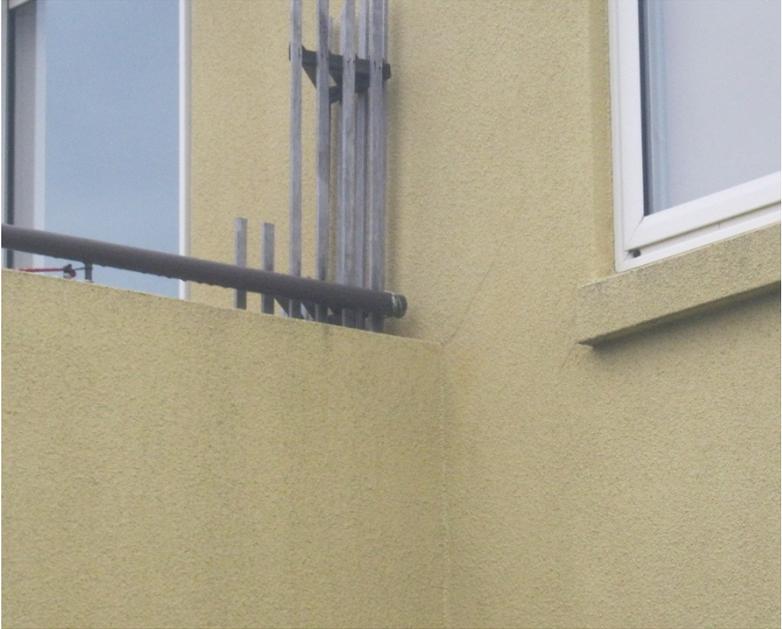
<p>10.</p>	<p>Crack in the exterior finish where it joins the balcony</p>

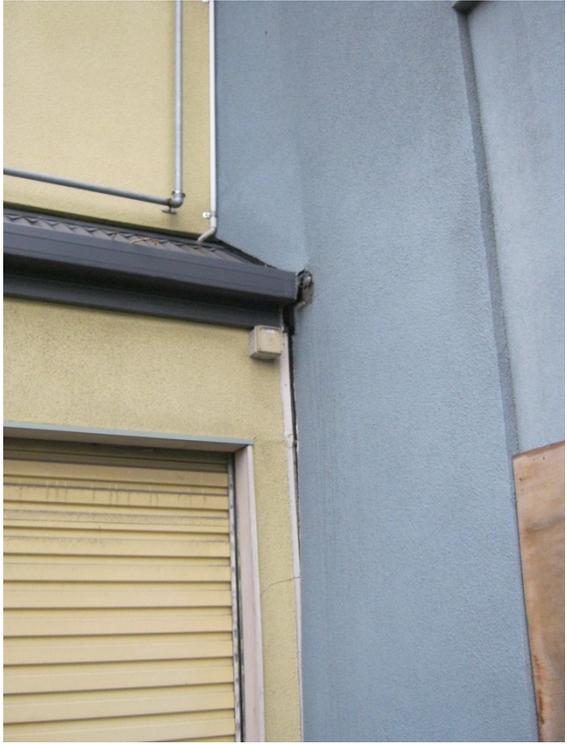
<p>11.</p>	<p>Separation of north and west wing as seen from the southern junction</p>

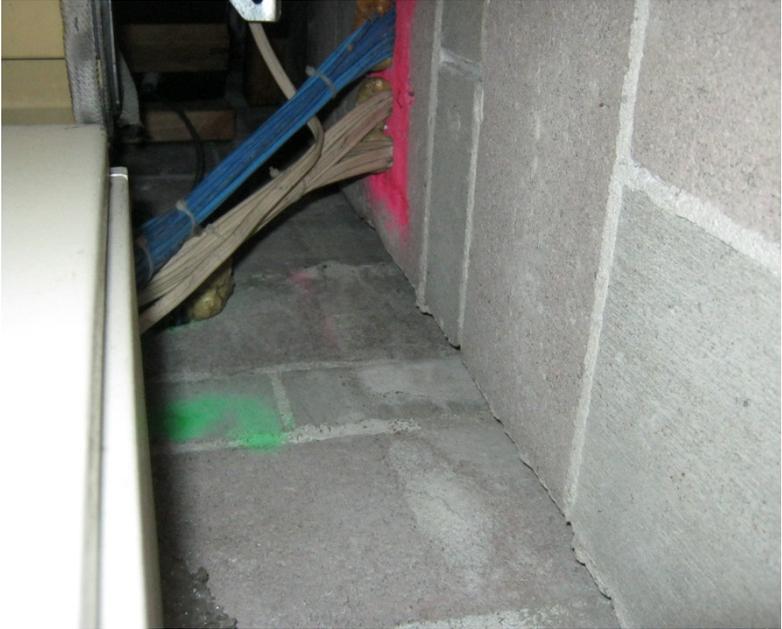
A photograph showing the exterior of a building. On the left is a yellow wall with a roller door. To the right is a grey wall. A dark horizontal beam or gutter runs across the top of the yellow wall, meeting the grey wall. A vertical pipe is visible on the yellow wall above the door.
<p>12.</p>	<p>Gap between north and west wing masonry walls</p>

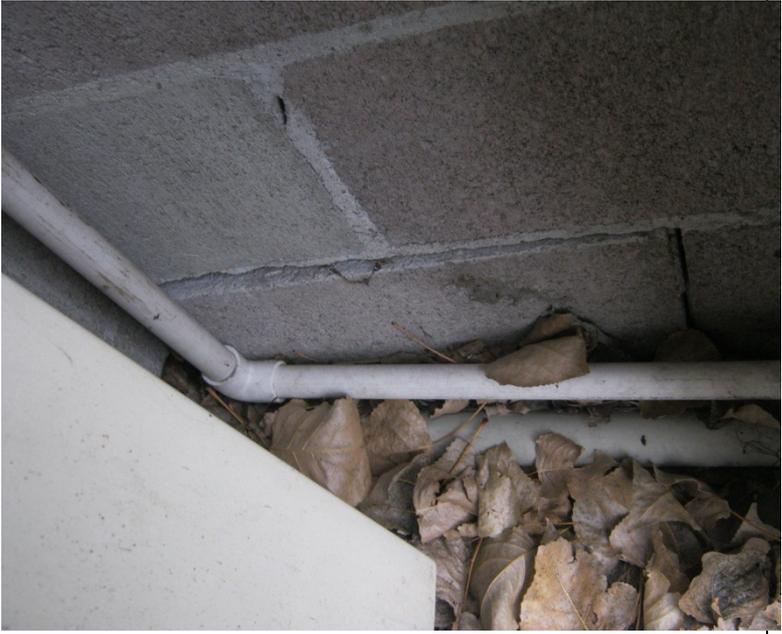
<p>13.</p>	<p>Masonry unit face shell separated at base of wall</p>

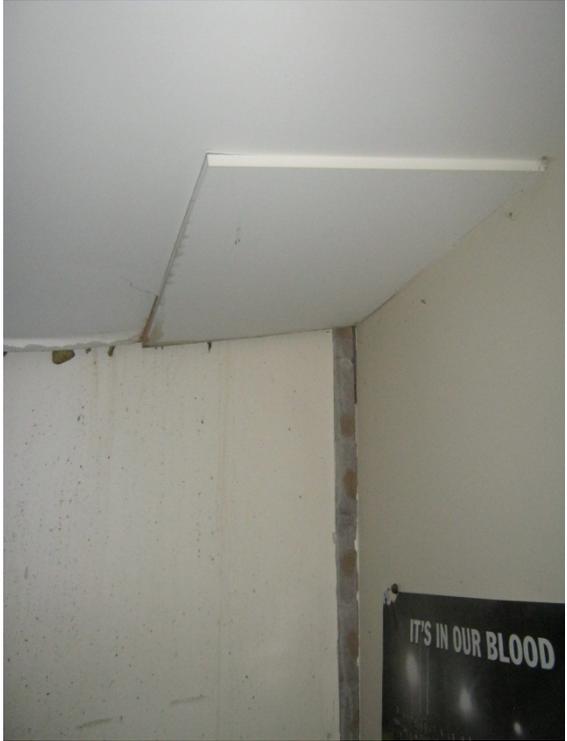
- Minor cracks to the interior linings were observed around corners of window or door openings (photos 23 to 26).
- The ceiling has partially dropped in unit 13 at the junction between the north wing and the west wing (photo 14). Daylight can be seen from interior of unit 13 where the north and west wing have been separated.
- A minor crack was observed below one of the precast concrete stairs (photo 22).

<p>14.</p>	<p>Separation of west and north wing as seen within unit 13</p>

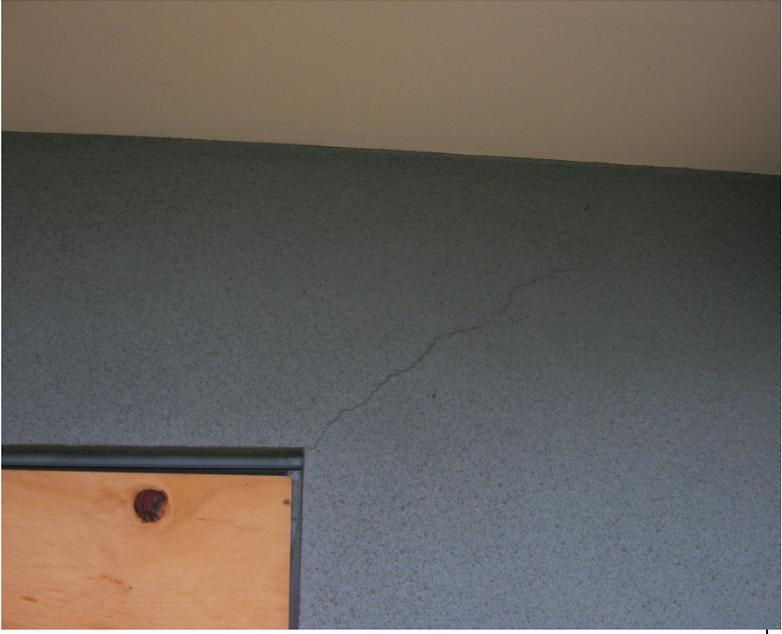
<p>16.</p>	<p>Cracks in finishes near corner of window opening</p>

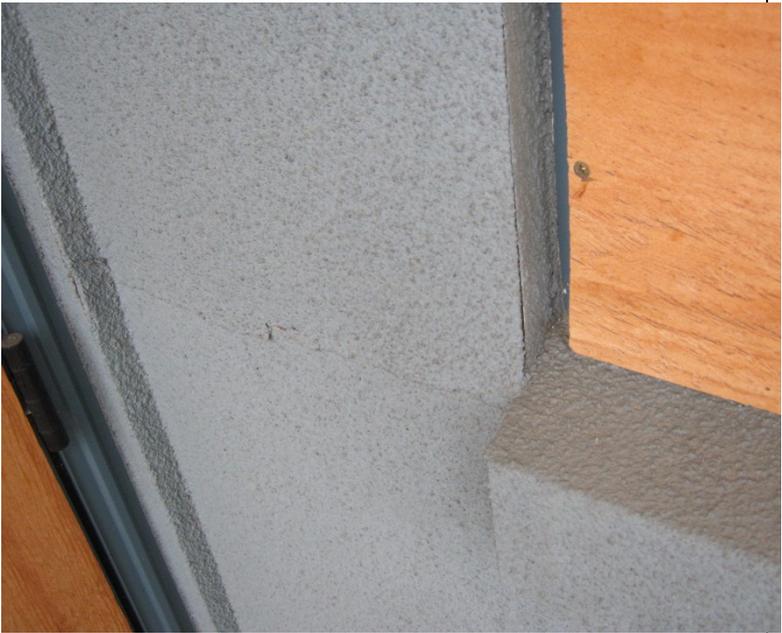
A photograph showing a crack in a grey, textured finish. The crack starts near the top right corner of a window opening and extends horizontally towards the left. A wooden panel is visible at the bottom left of the window frame.
<p>17.</p>	<p>Horizontal crack of exterior finishes adjacent to window opening indicating flexural yielding in wall pier</p>

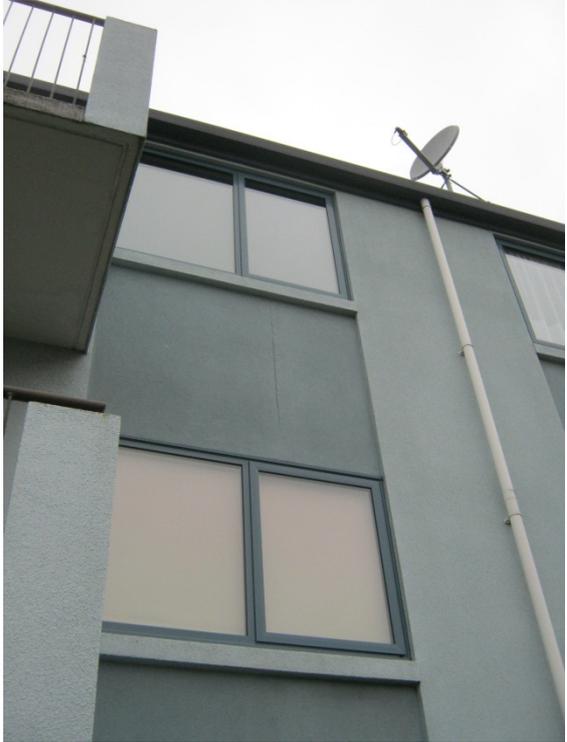
<p>18.</p>	<p>Vertical crack in the wall finish below a window opening</p>

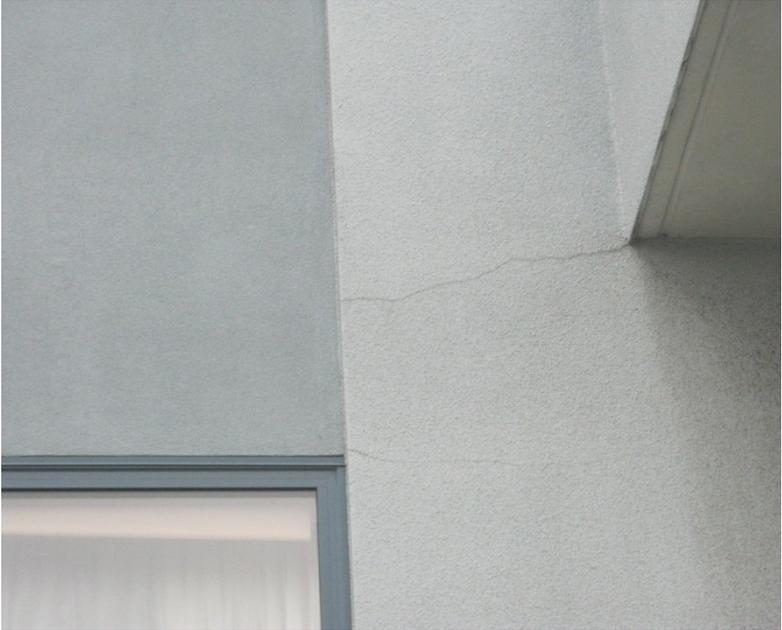
A photograph showing a vertical crack in the light-colored wall finish. The crack runs downwards from just below a window opening. The window has a dark frame and is partially obscured by a balcony railing on the left. A satellite dish is mounted on the roof above the window, and a white downspout is visible on the right side of the wall.
<p>19.</p>	<p>Horizontal crack in the wall below balcony</p>

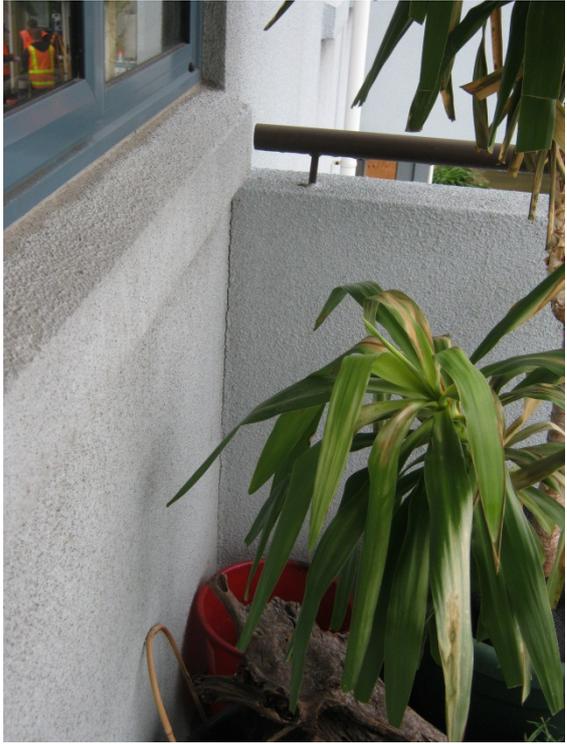
- f) Vertical cracks were observed at the junction between the balcony side wall and the building exterior walls.
- g) Minor cracks to the interior linings were around corners of window or door openings.

<p>20.</p>	<p>Gap between masonry wall and balcony in west wing</p>

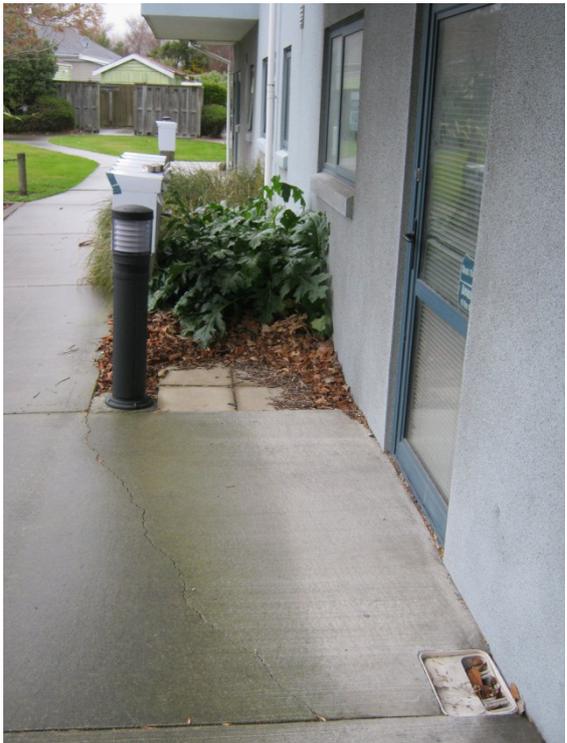
A photograph showing a close-up of a light-colored masonry wall and a balcony. A gap is visible between the wall and the balcony structure. A potted plant with long green leaves is in the foreground, and a window with a blue frame is visible above the wall.
<p>21.</p>	<p>Cracks in the entrance slab of west wing due to settlement</p>

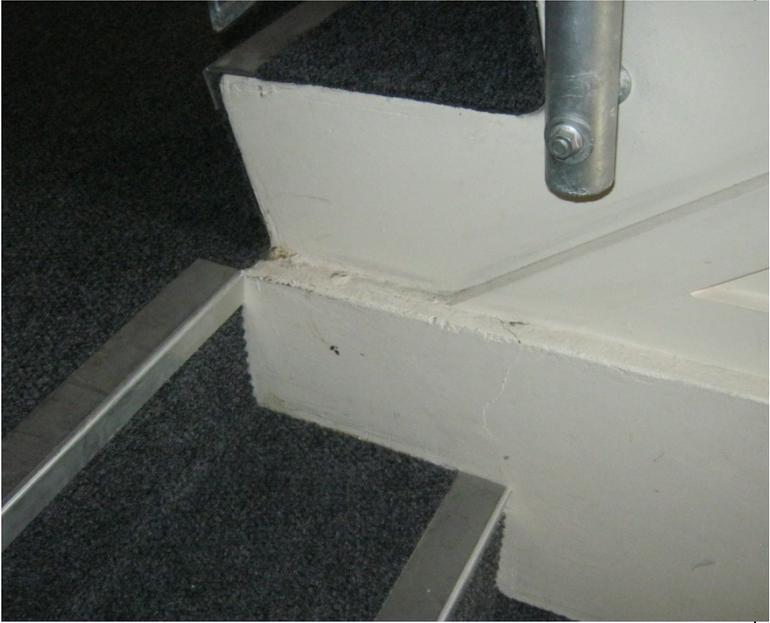
- i) A minor crack was observed below one of the precast concrete stair.

<p>22.</p>	<p>Crack in the precast stairs in west wing</p>

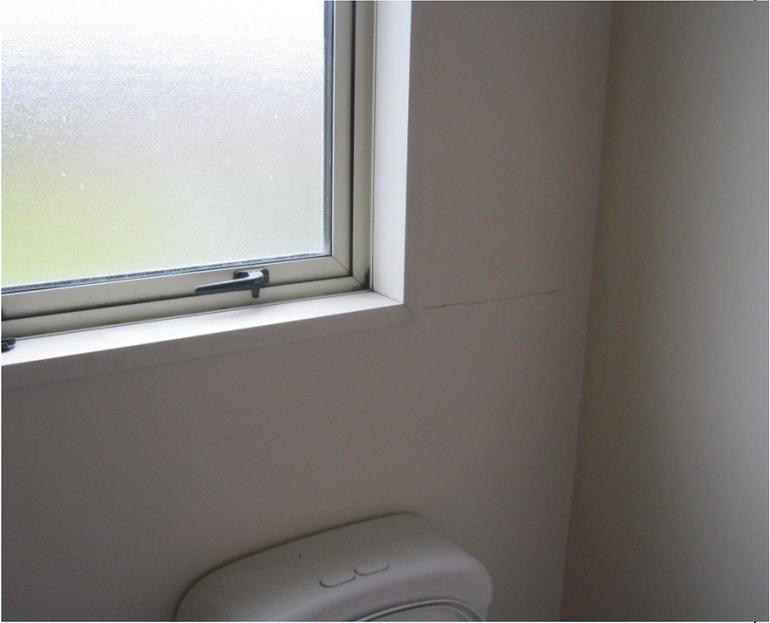
A close-up photograph of a precast concrete stair tread. A dark, jagged crack runs horizontally across the surface of the concrete, just below the carpeted edge. A metal handrail bracket is visible on the right side of the tread.
<p>23.</p>	<p>Typical horizontal crack in the wall near an opening</p>

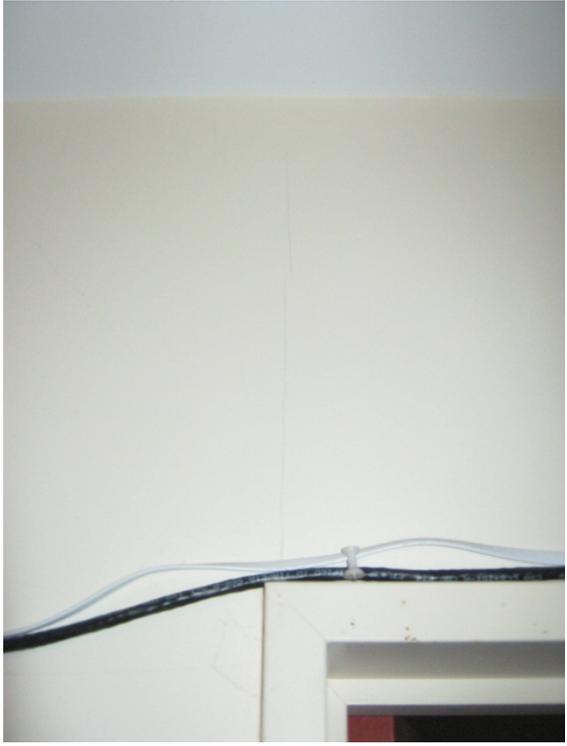
<p>24.</p>	<p>Vertical crack in the wall finishes over an opening in west wing</p>

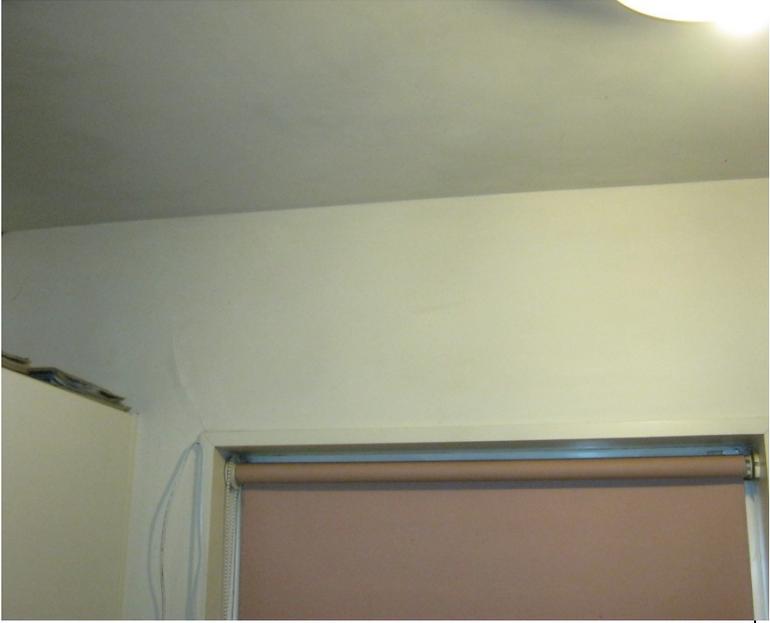
<p>25.</p>	<p>Typical crack in finishes over an opening</p>

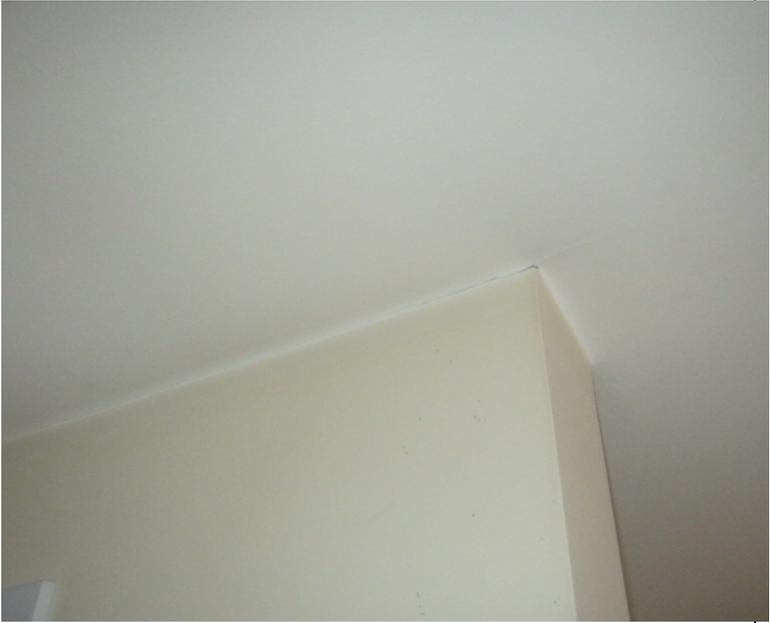
<p>26.</p>	<p>Separation between timber framed wall and roof ceiling in west wing</p>

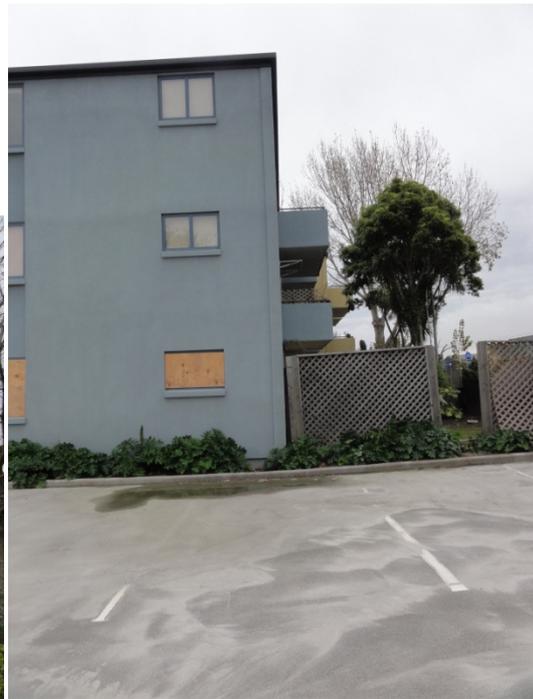
View of East- West Wing tilting north.

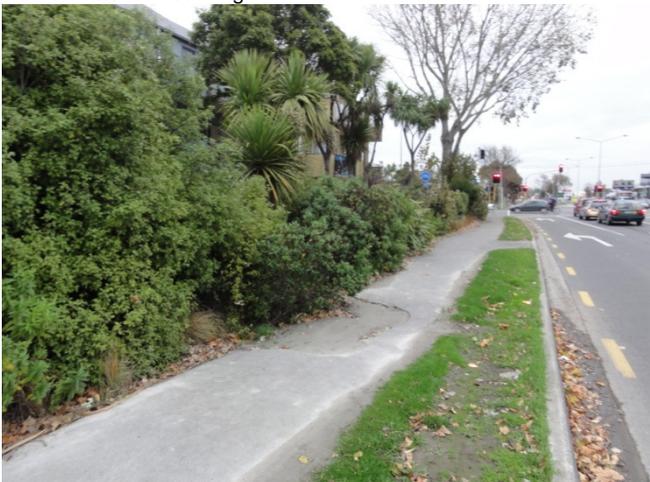
Liquefaction damage to footpath

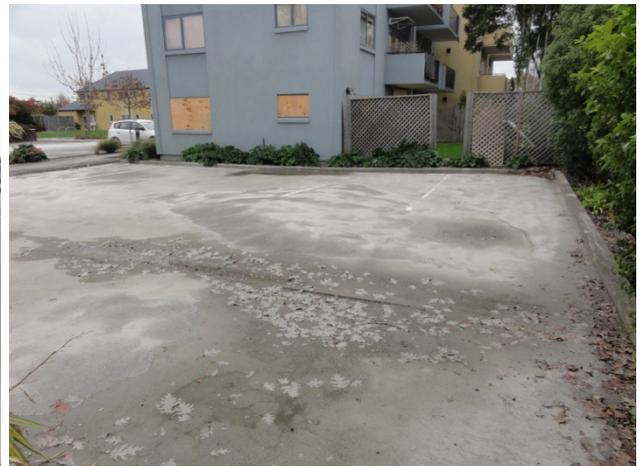
Heave of asphalt in Carpark

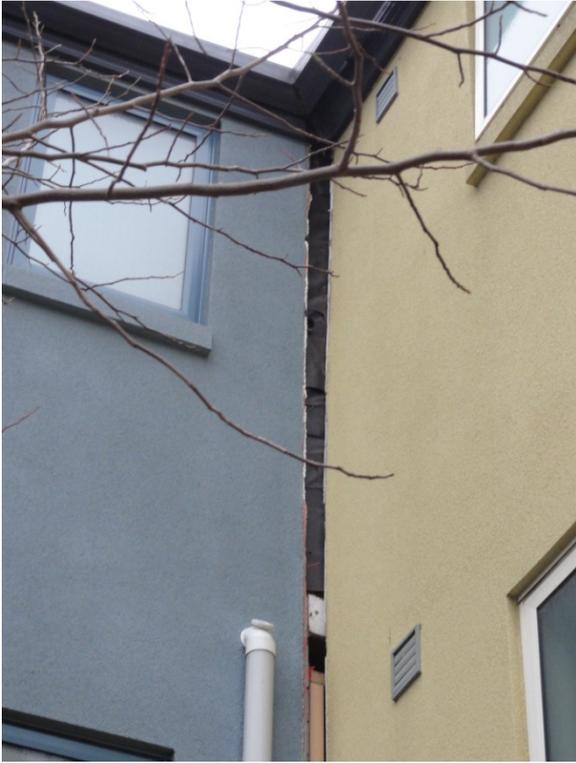
150mm gap at the junction of the two wings

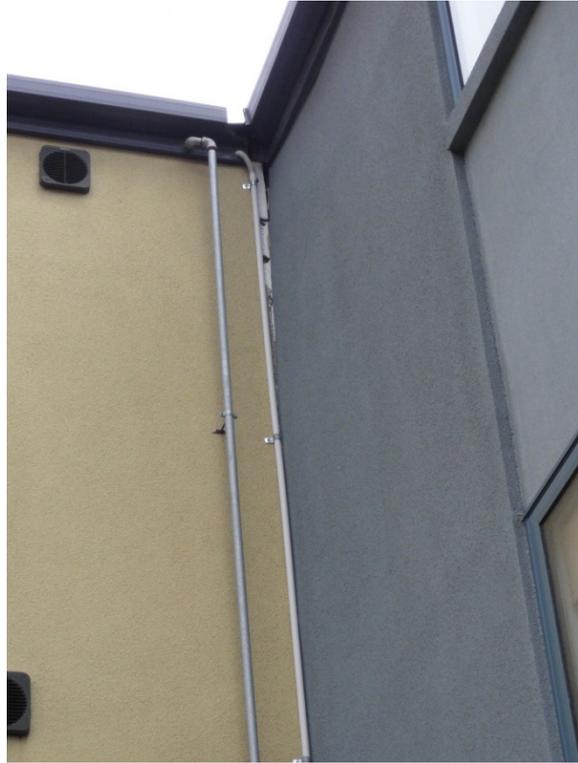
Smaller gap on northern elevation.
