CHRISTCHURCH CITY COUNCIL
PRK_2347_BLDG_007 EQ2
Travis Wetland Cottage
280 Beach Road, Burwood

**QUALITATIVE ASSESSMENT REPORT
FINAL**

- Rev B
- 25 March 2013

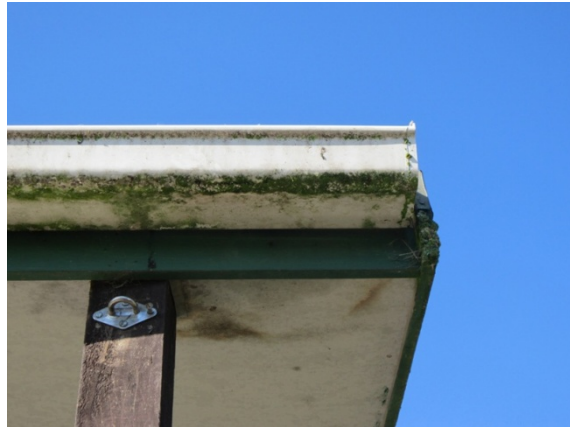
- 1) Gaps opening up between plasterboard cladding panels on the walls and ceiling.
- 2) Impact damage to the profiled metal wall cladding on the north side. This is not considered to be earthquake-related damage.
- 3) Water damage on the underside of the gutter. This is not considered to be earthquake-related damage.

Photo 5: Water damage to underside of gutter (typical)

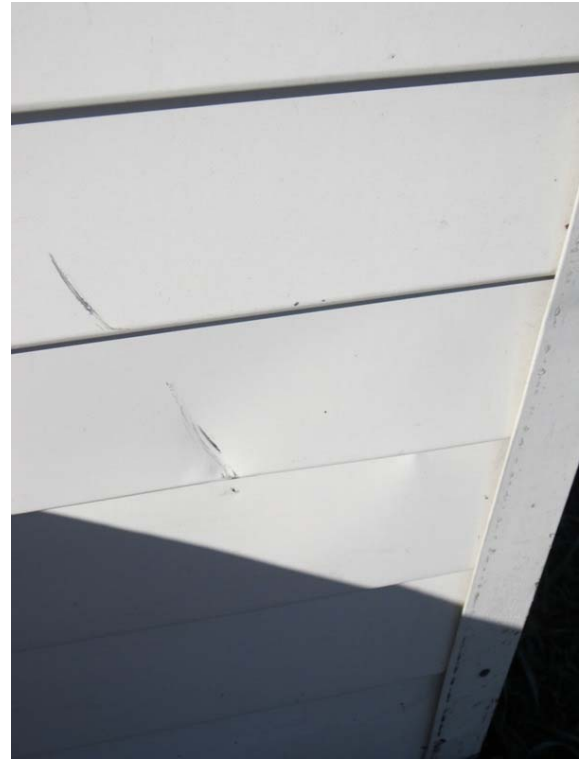
Photo 6: Impact damage to external profiled metal wall cladding

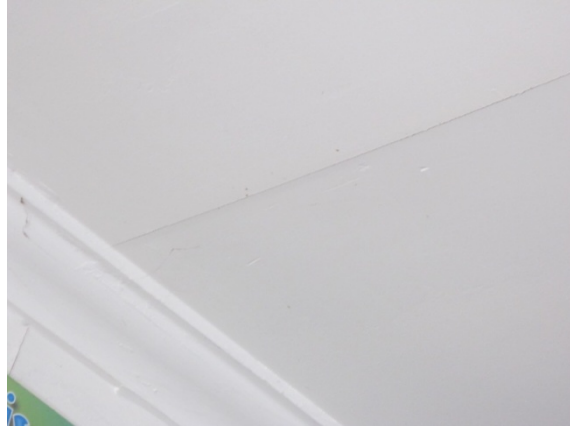
Photo 9: Gaps opening up between plasterboard ceiling cladding panels

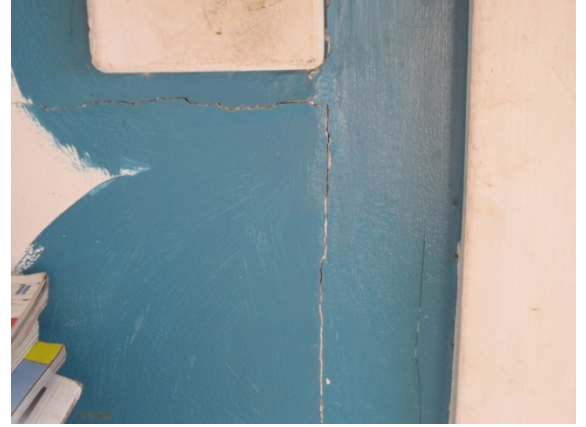
Photo 10: Gaps opening up between plasterboard wall cladding panels

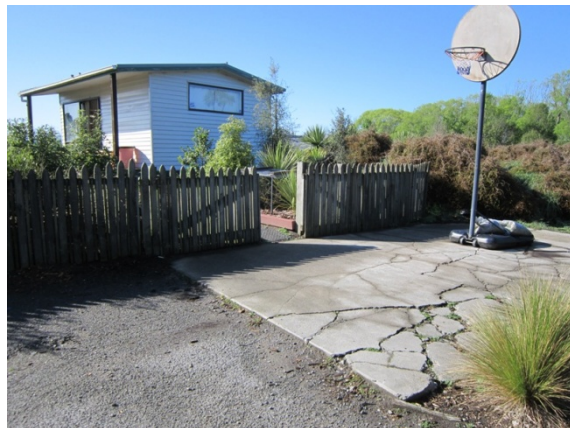
Photo 11: Heavily cracked concrete slab west of the building

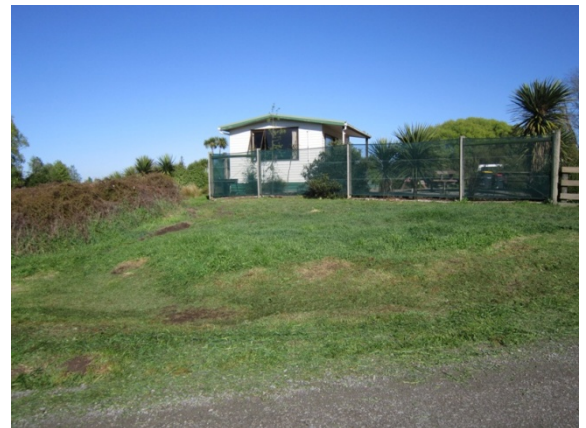
Photo 12: Sloping ground around building

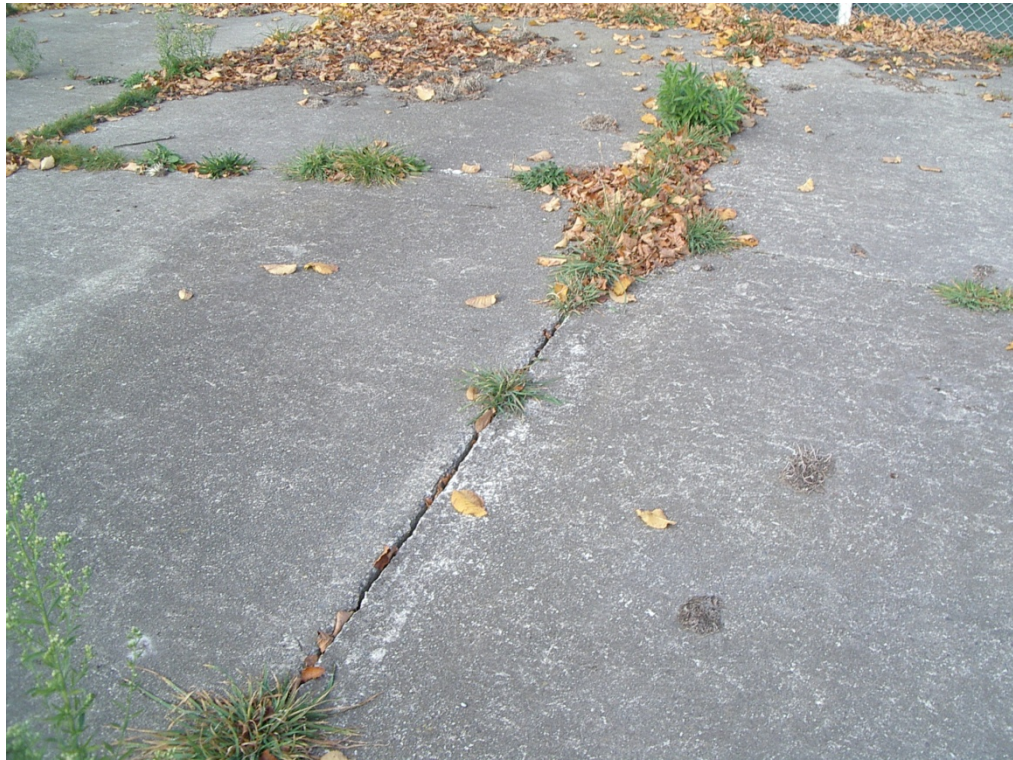
■ **Figure 16 - Noted damage to the concrete paving**

The performance to date suggests that in general the existing foundations are adequate for their current purpose. However some damage to the concrete slab supporting the barn structure was noted. From the site walkover it was noted that the shallow piled foundations in general performed better than the slab foundations.

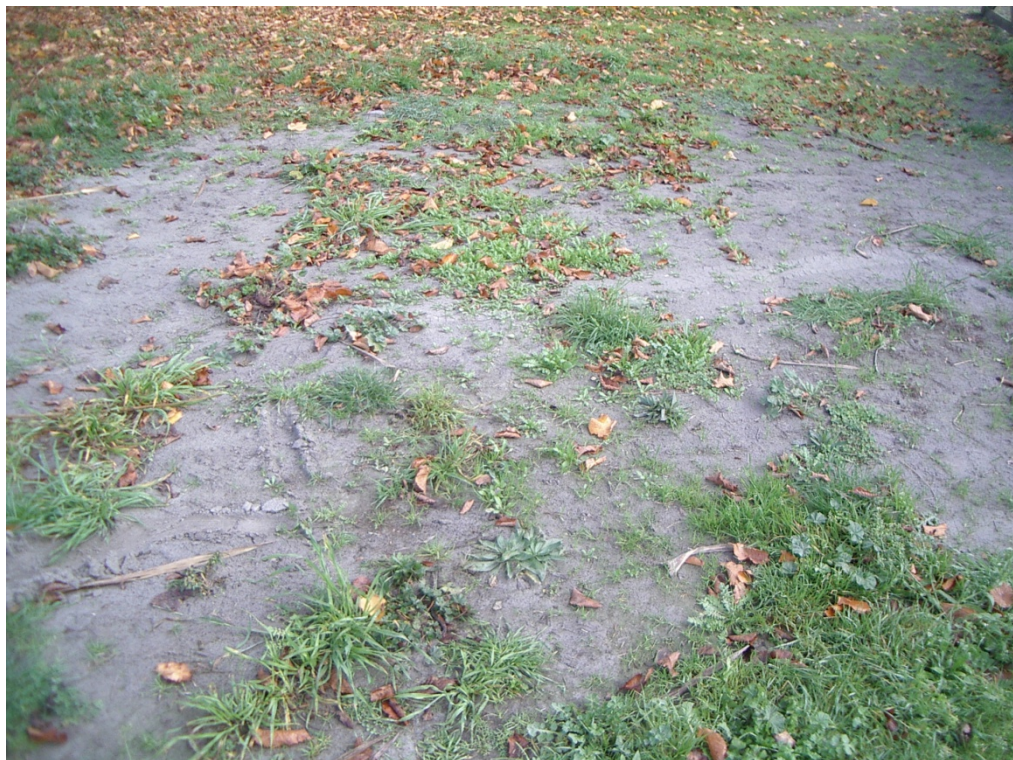
■ **Figure 17 - Ejected sand**
