CHRISTCHURCH CITY COUNCIL  
PRK\_2347\_BLDG\_006 EQ2  
Travis Wetland Plant Nurseries  
280 Beach Road, Burwood

QUALITATIVE ASSESSMENT REPORT  
FINAL

- Rev B
- 23 May 2013

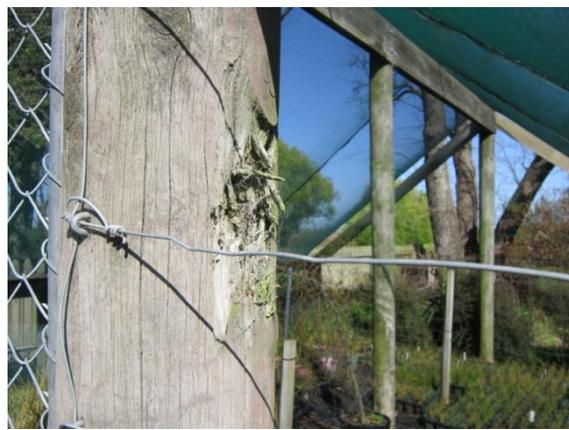
- 1) No earthquake-related damage was observed during our site inspection.
- 2) Splitting in timber elements along the grain. This is not believed to be earthquake damage.
- 3) Impact damage on a timber column on the east side of the south plant nursery.

Photo 9: Impact damage on timber pole on east side of south plant nursery

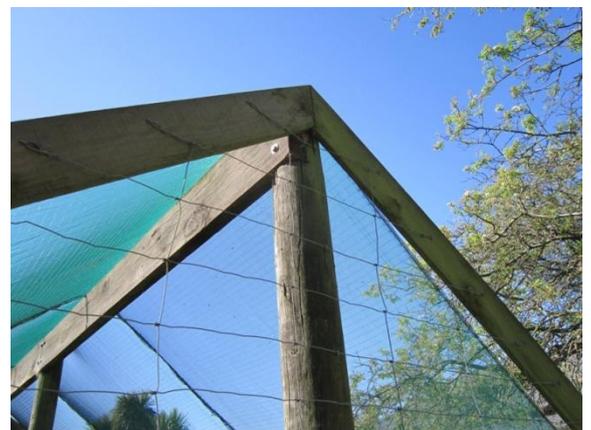
Photo 10: Connection of timber elements at apex on end timber frame

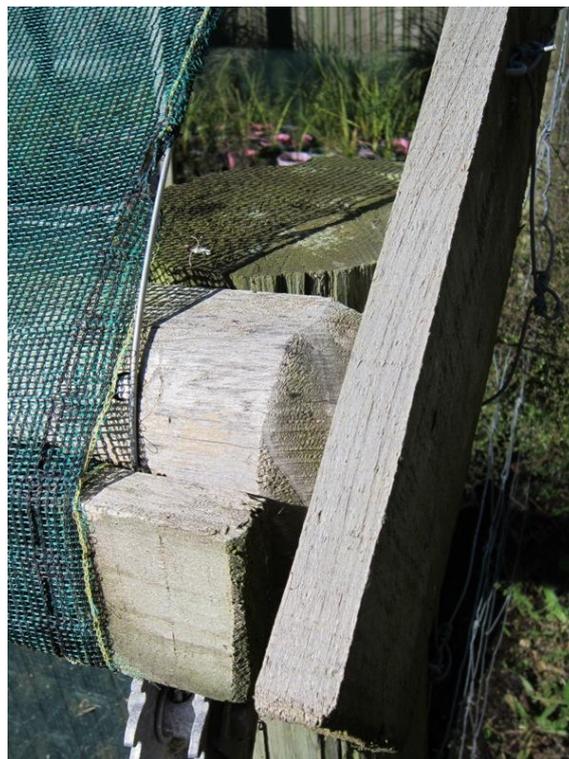
Photo 11: Connection between end timber frame rafter, timber pole and longitudinal beam

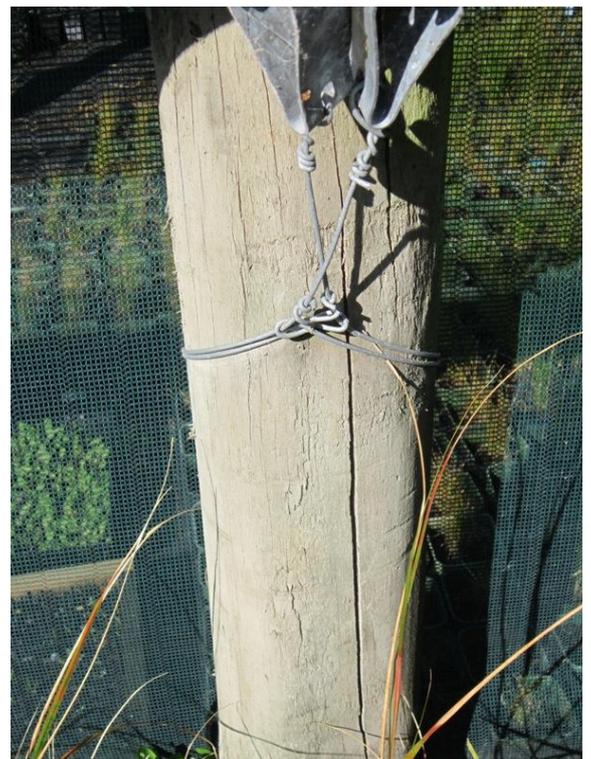
Photo 12: Splitting of timber element along the grain (typical)

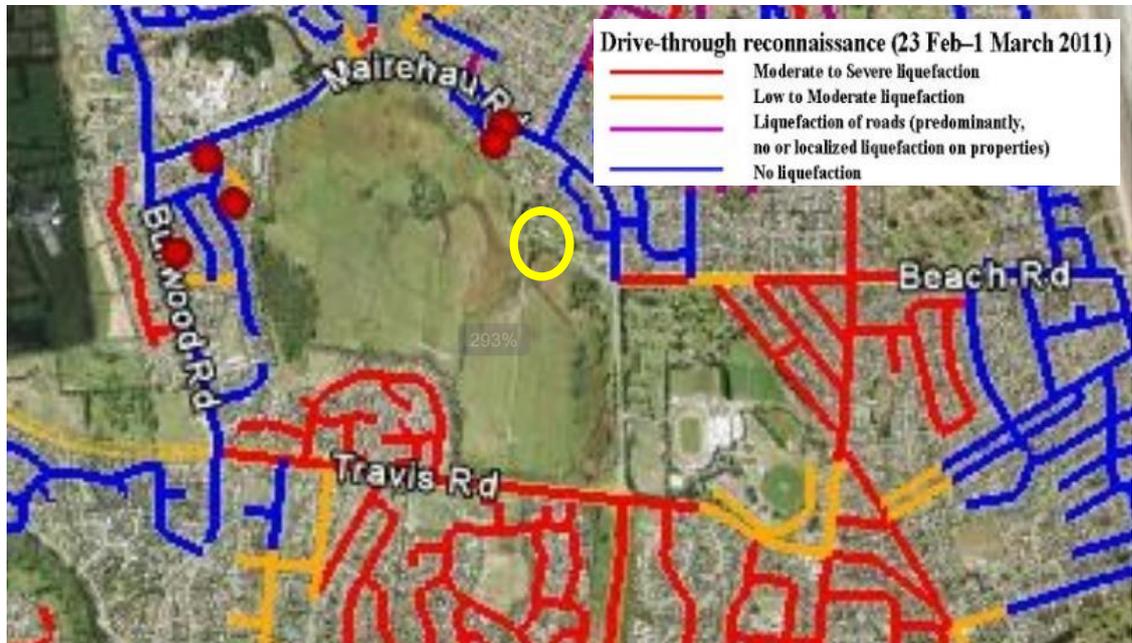
■ **Figure 4 – Liquefaction map (Cubrinovski & Taylor, 2011). Site marked in yellow.**

Following the 22 February 2011 event drive through reconnaissance was undertaken from 23 February until 1 March by M Cubrinovski and M Taylor of Canterbury University. Their findings show no liquefaction on Mairehau Road and Medina Crescent to the north east and moderate to severe liquefaction on Beach Road to the east.

However, as the drive through reconnaissance did not continue to the immediate location of the site and as the site is inferred to be underlain by a different geological formation, the level of liquefaction noted above may not be relevant for the site itself.

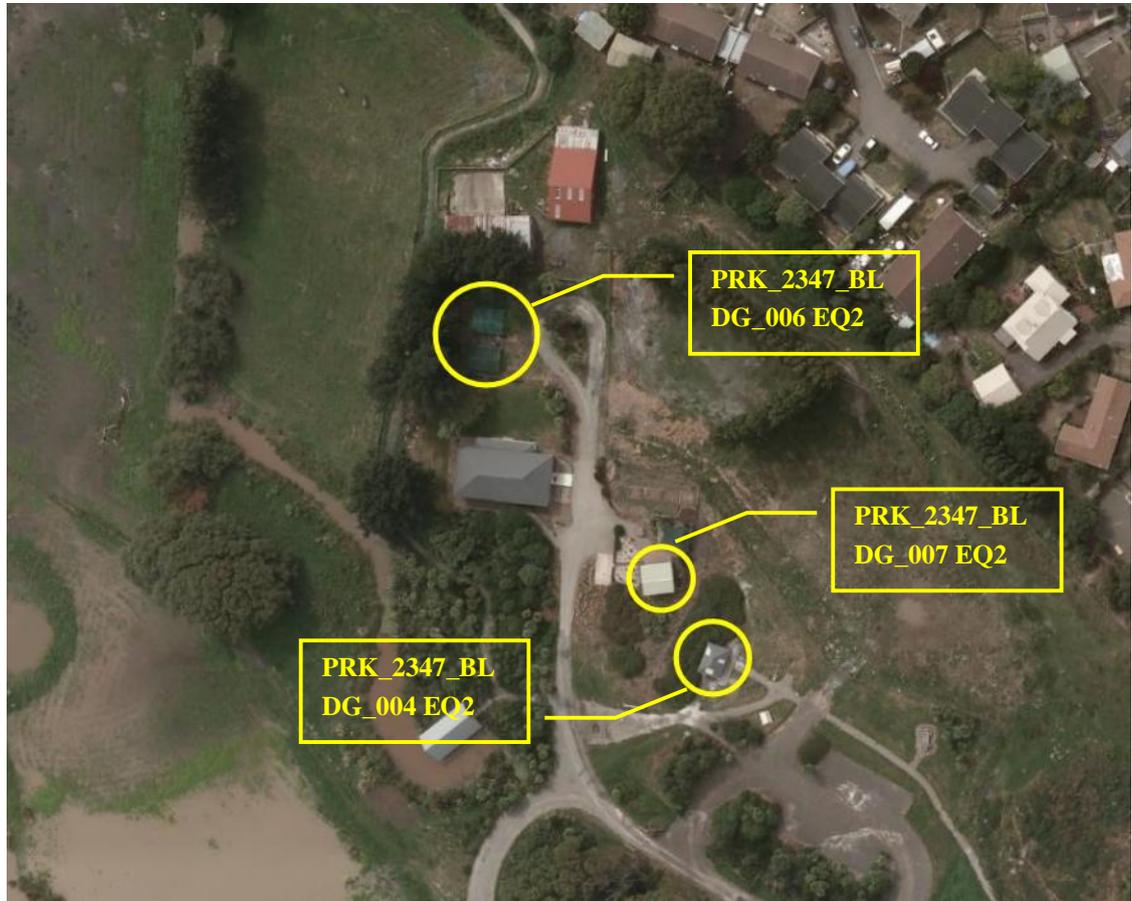
■ **Figure 5 – Aerial photography from 24 Feb 2011 (<http://viewers.geospatial.govt.nz/>)**

A reasonably significant amount of liquefied ejecta could be seen on Beach Road and in land areas around the structures. Due to the presence of the lake to the west, it is expected that ground water level would be shallow beneath the site. This may explain the level of liquefaction noted. From the aerial photograph, no clear evidence of tension cracks or lateral movement towards the lake could be seen.

Additionally, from high level view of the structures there appears to be no catastrophic damage of the surrounding structures as a result of the seismic shaking and land damage caused by the earthquake event.

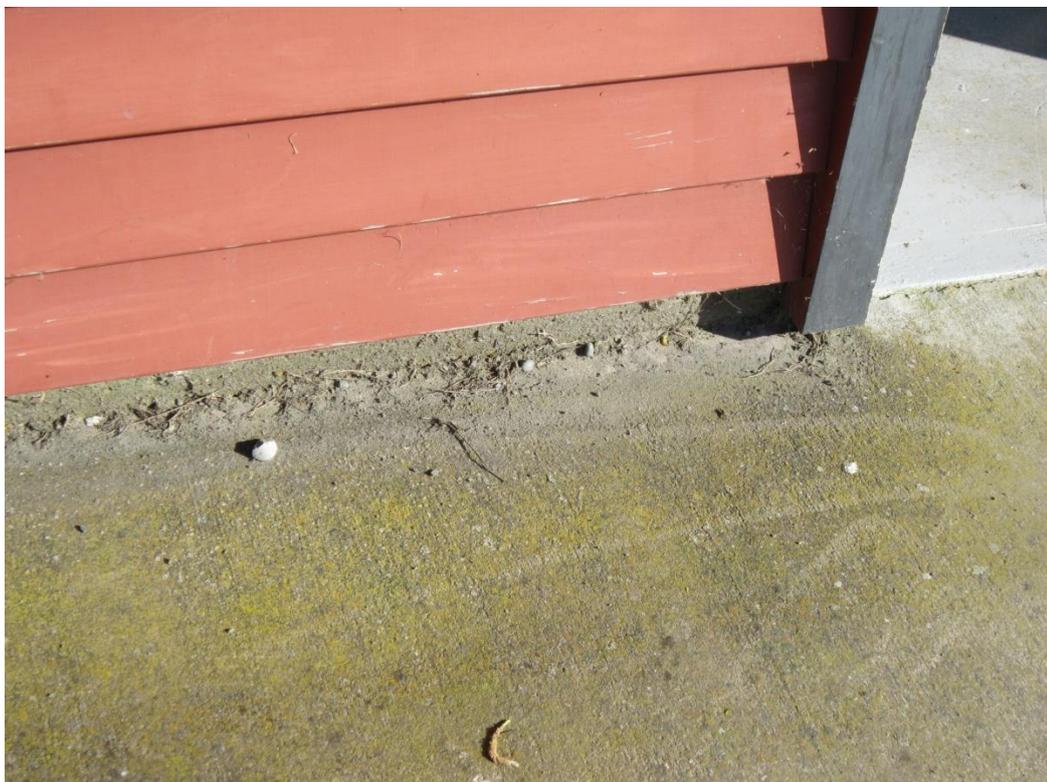
■ **Figure 9 - Remaining silt ejecta from the earthquake event**

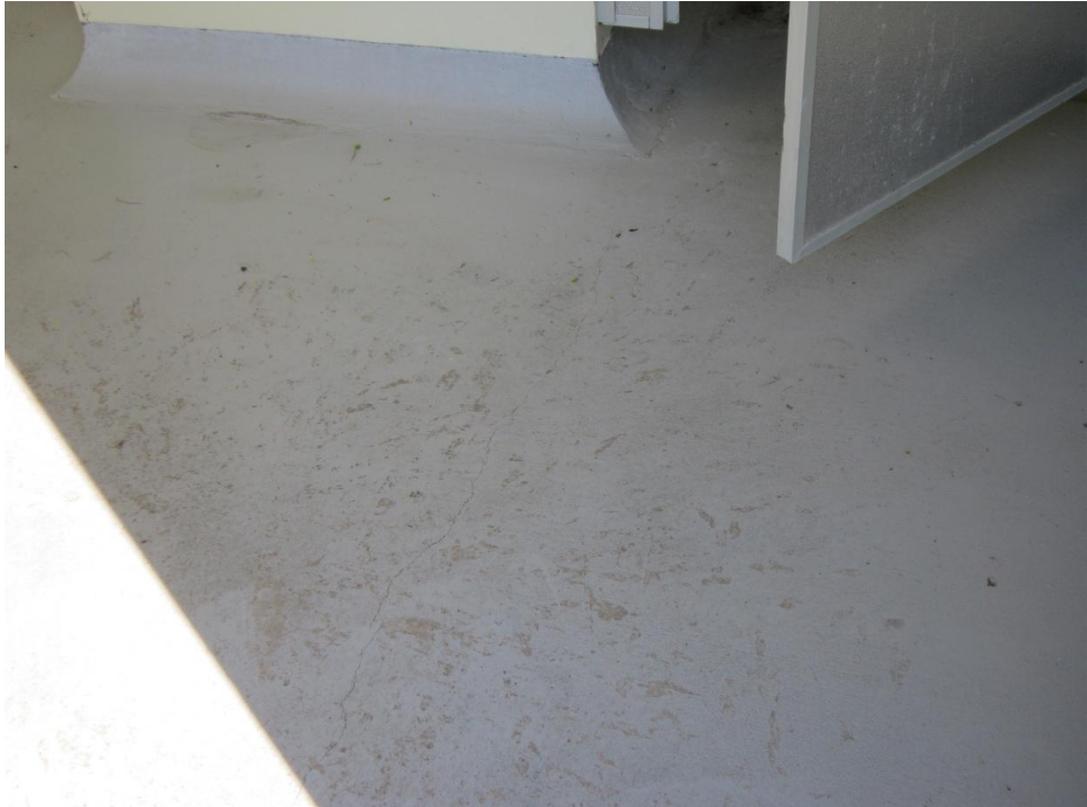
Additionally, hair line cracks were in the floor slab and some separation of the outside pavement slabs was noted. No significant evidence of settlement due to liquefaction was noted. Therefore, the above separation and settlement may have been caused by ground shaking.

■ **Figure 10 - Hair line cracks in the floor slab**

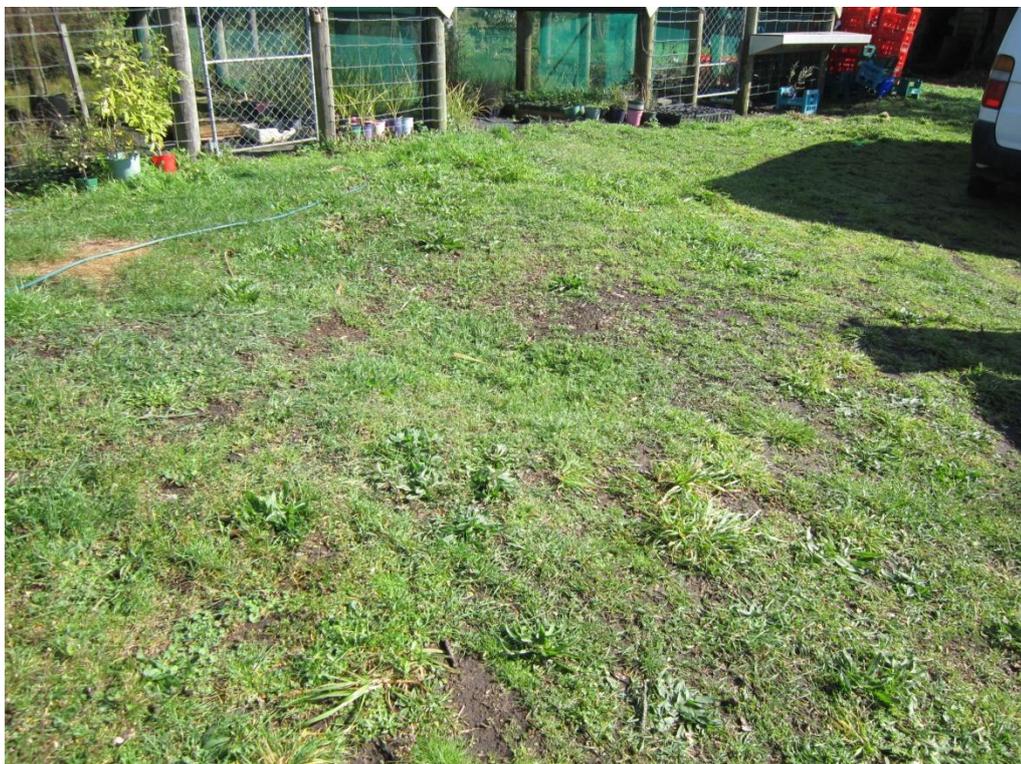
Undulating ground was noted around the structure. However, this topography is expected to have existed before the earthquake. Some loose silt and sand material at ground surface was noted, which may be remnant ejecta from the earthquake event. However, other than for this no other significant land damage was noted during the site walkover.

■ **Figure 12 - Patches of remnant silt ejecta**

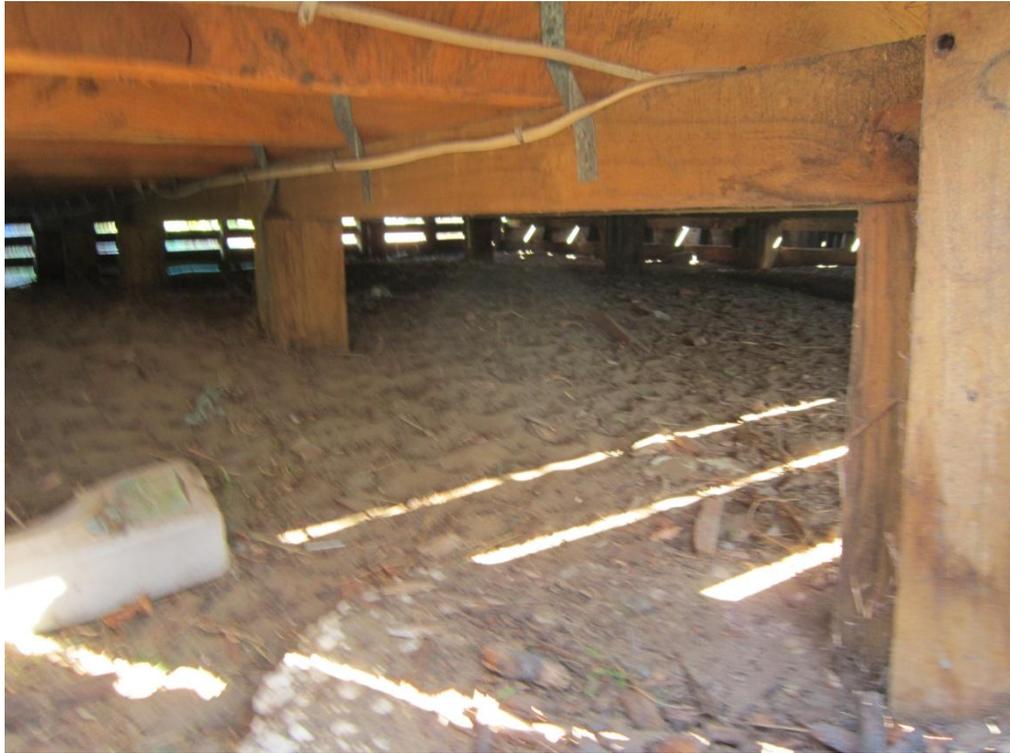
The building is a timber construction, with timber piled foundations, with a metal roof, with the canopy supported on timber posts. The timber piles appear to be encased in a concrete block below ground level. The embedment depth of the piles is not known. The adjacent ground was noted to be slightly sloping toward the toilet structure.

■ **Figure 14 - Observed foundation for the building**

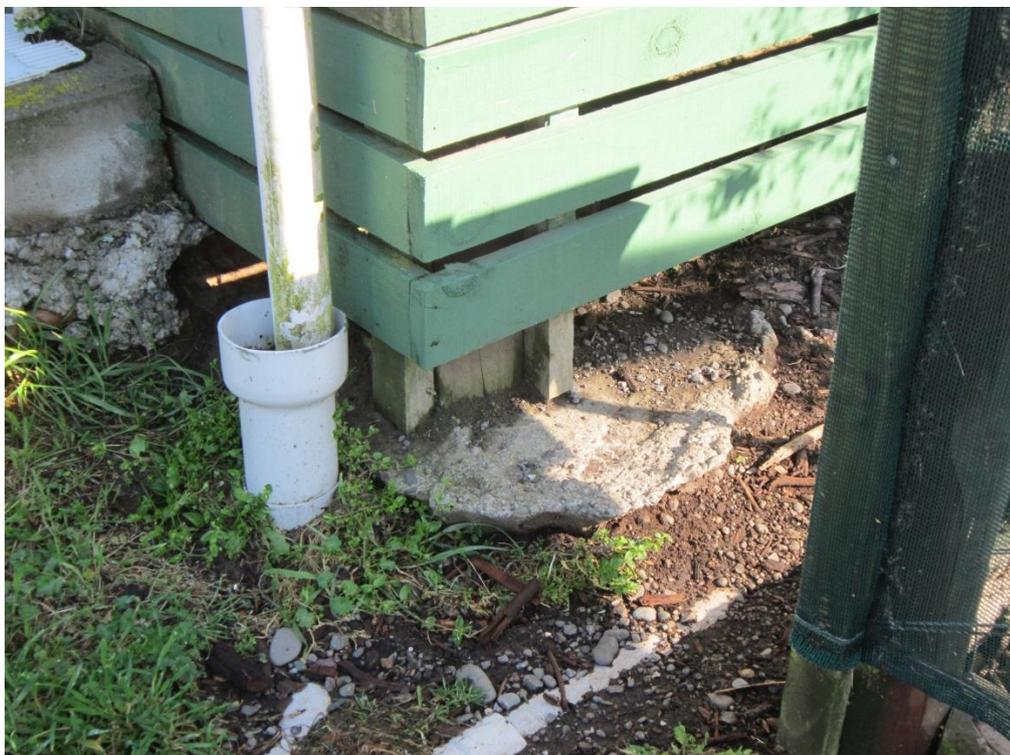
Some separation of the concrete block encasing the piles and adjacent ground was noted. This may indicate some differential settlement between adjacent ground and the respective posts. Significant amount of cracking (up to 10 mm wide) was also observed in the concrete slab west of the structure. However, the level and nature of this damage indicates that it is likely to have been a result of vehicle or other repeated loading on the unreinforced concrete slab rather than damage caused by the earthquake event.

■ **Figure 15 - Concrete encased piles some separation between the block and adjacent ground**

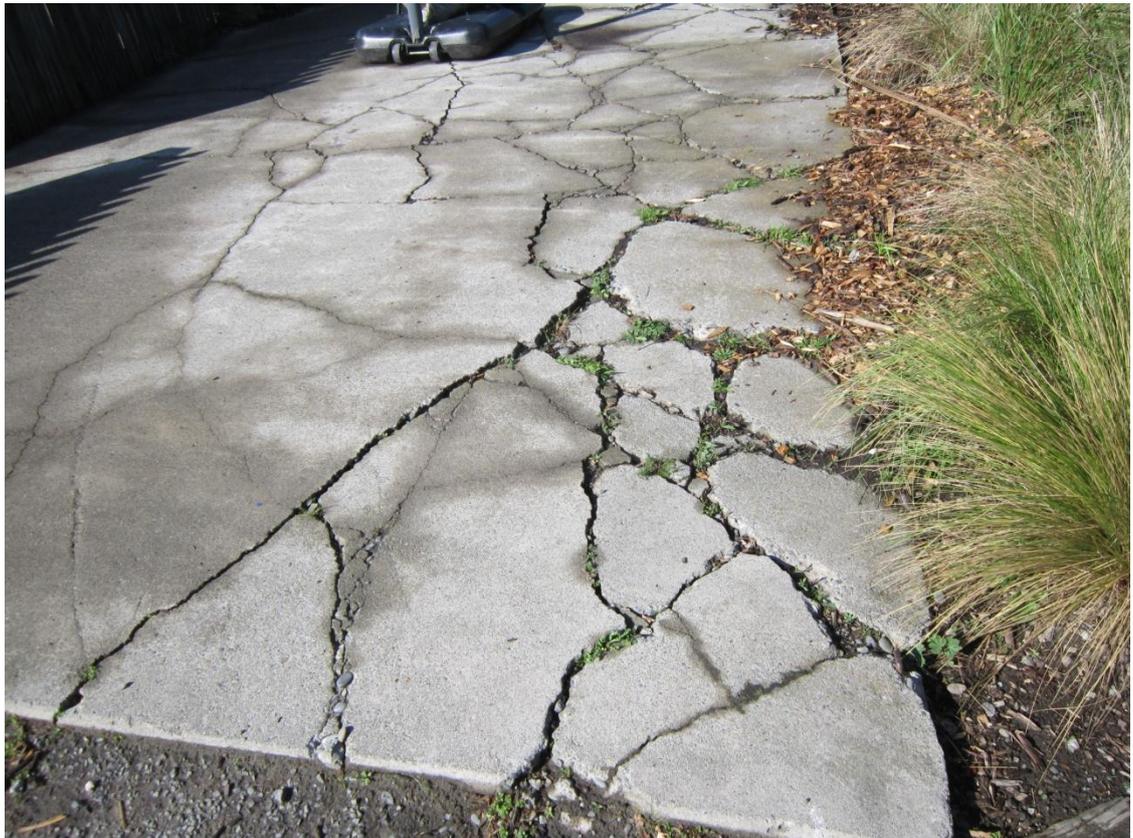
■ **Figure 16 - Significant cracking of the slab west of the building**
