Tulett Park Shed
PRK 0394 BLDG 002 EQ2
Detailed Engineering Evaluation
Quantitative Assessment Report

Tulett Park Shed

Quantitative Assessment Report

Date: 5 February 2013
Reference: 6-QUCC1.71
Status: Final

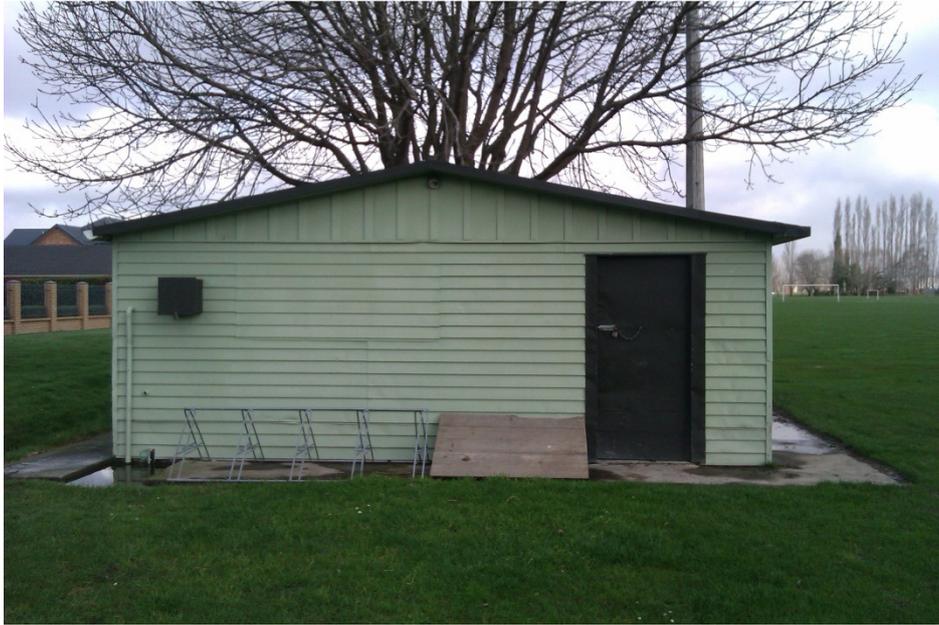
Photo 1: View of the front of the building

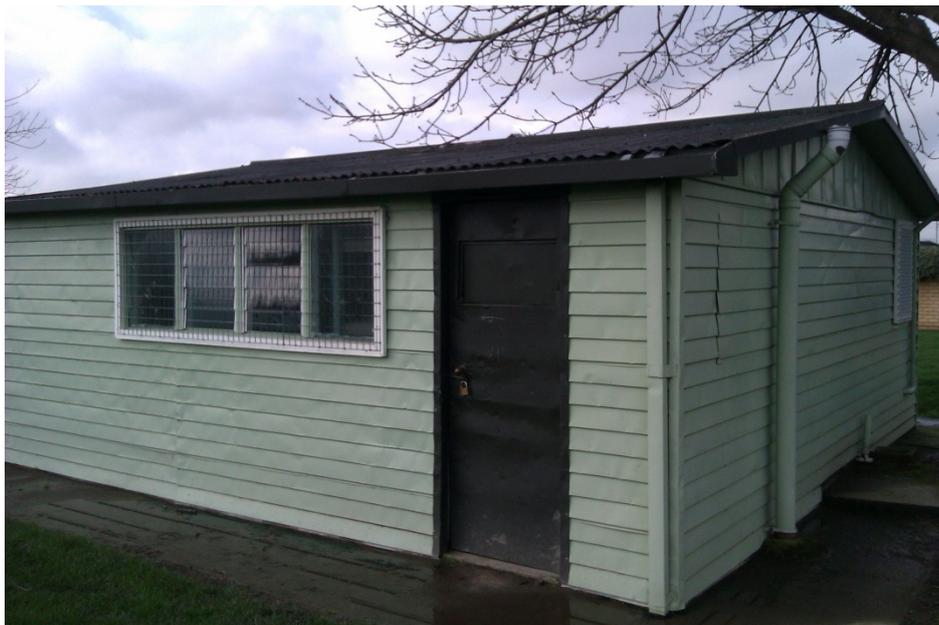
Photo 2: View of the side and rear

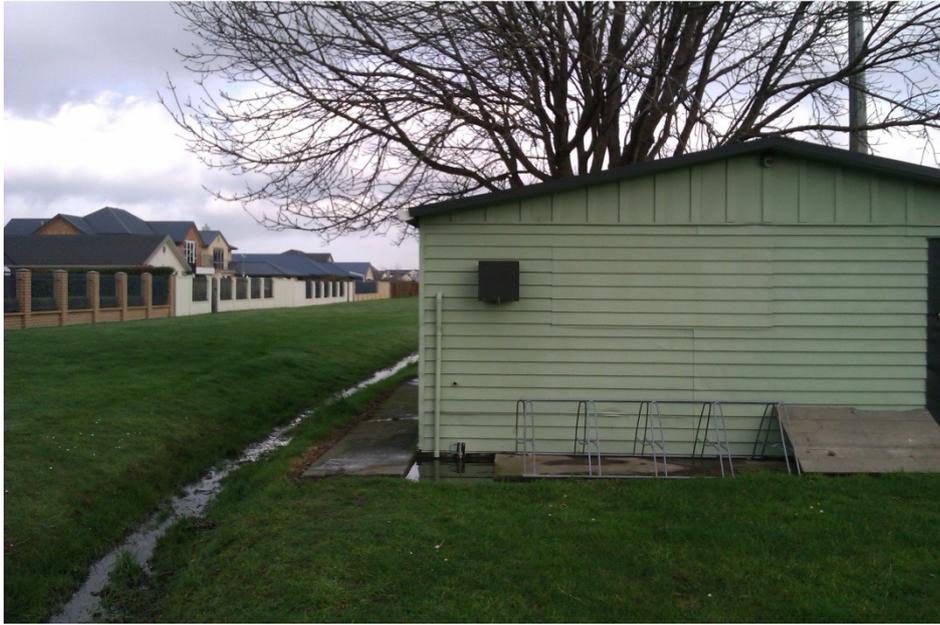
Photo 3: View of the front and drainage ditch

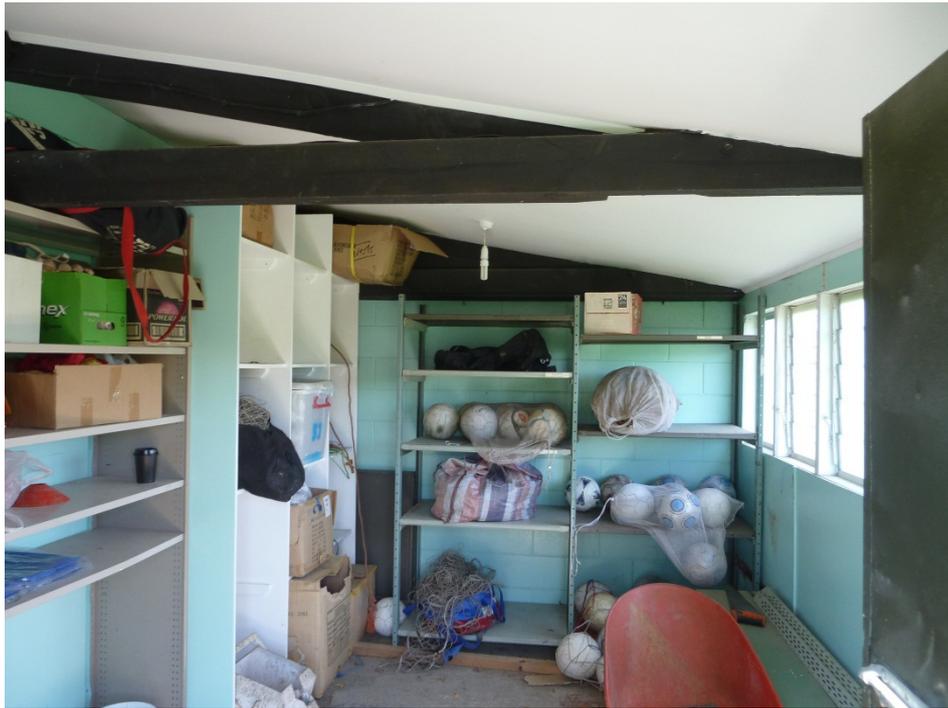
Photo 4: Internal View

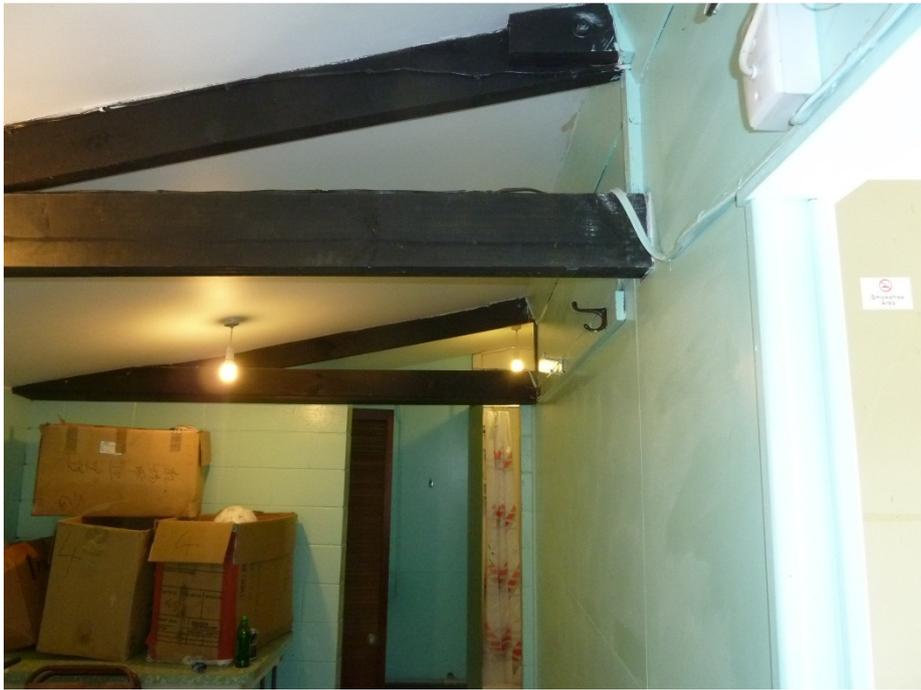
Photo 5: Internal View
