Upper Riccarton Library  
Quantitative Engineering  
Evaluation

Functional Location ID: BU 3036-001 EQ2

Address: 71 Main South Road

**Date:** 9 April 2014

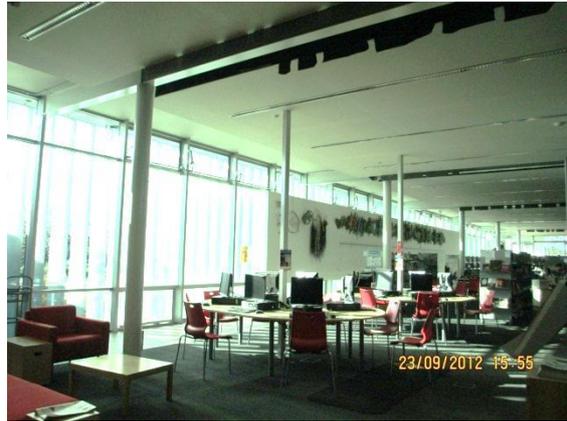
Internal view of the central part of the building (Steel portal frames from Grid 2 to 9 between Grid E to H – see Floor Plan).

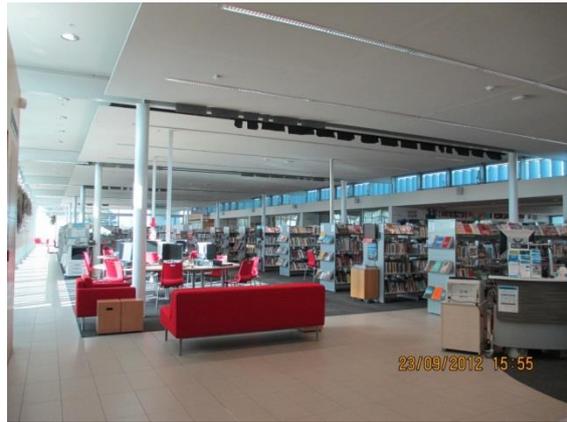
Internal view of the precast concrete tilt up wall panels in the southern end of the building.

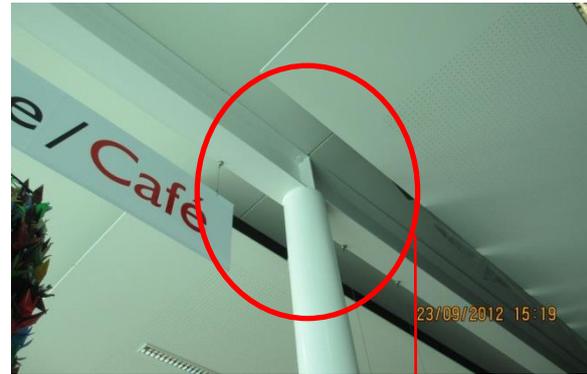
This welded plate and bolts has been added to the secondary frame in the longitudinal direction.

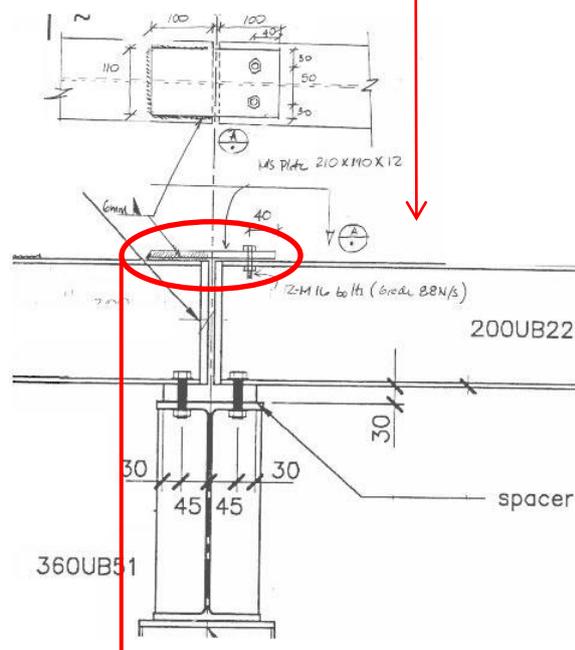
Note: This connection detail is vital in establishing the lateral restraint in the longitudinal direction of the building.

This welded plate and bolts have been added to the structure enabling the frame in the longitudinal direction to act as a moment resisting frame.

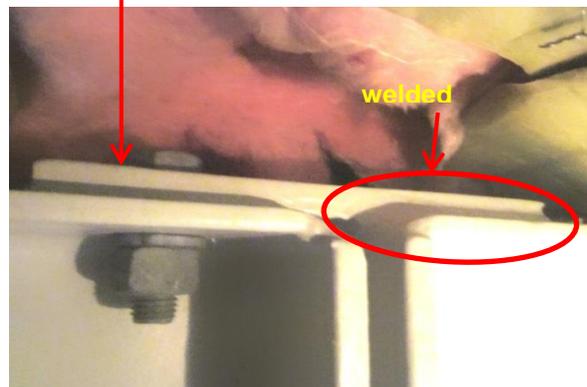
Plates, timber blockings, screws and bolts have been added to the steel moment resisting frame in both directions (see Appendix B – Calculation Sheet 1 for the location of these plates).

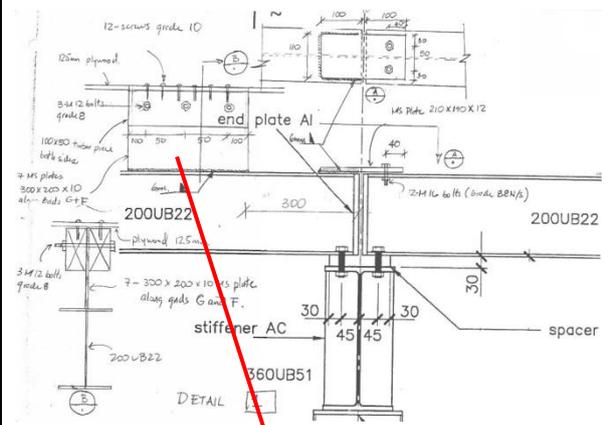
This plate is along Grid 4 and close to the left of Grid F. Due to space limitations and numerous obstructions, we are unable to take photos of the bolts but we can confirm that there are bolts and timber blocking on the top part of this plate.

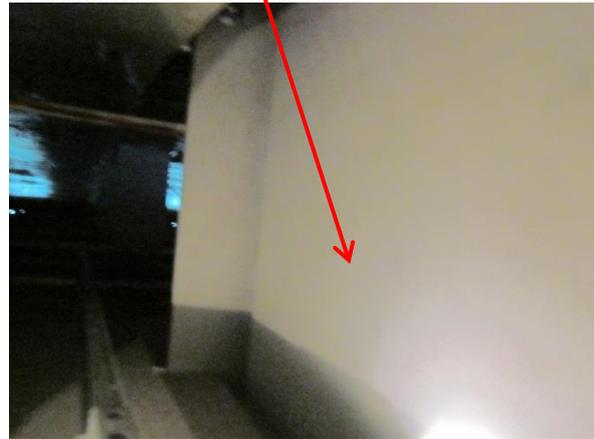
This plate has been added to the main moment resisting frame in the transverse direction.

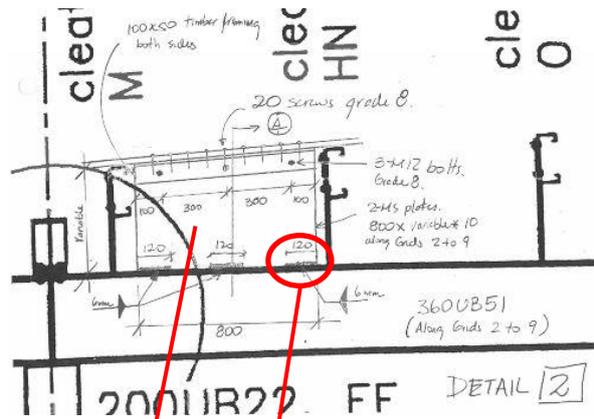
This plate is along Grid F and closer to right of Grid 4.

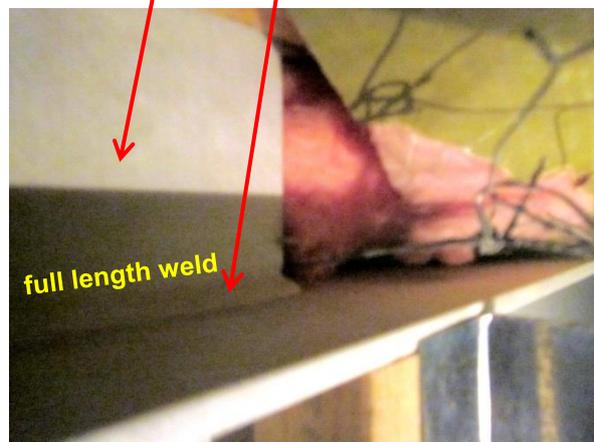
Note: Weld is applied to full length of the plate not hit-miss as drawn.

Southern cantilevered end of the transverse moment resisting frame.

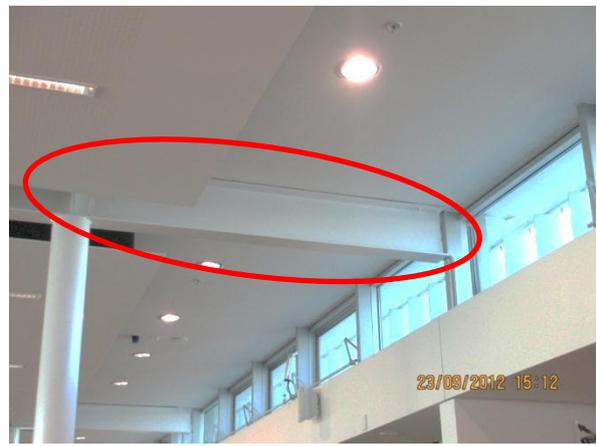
Internal view along Grid D (see Floor Plan)

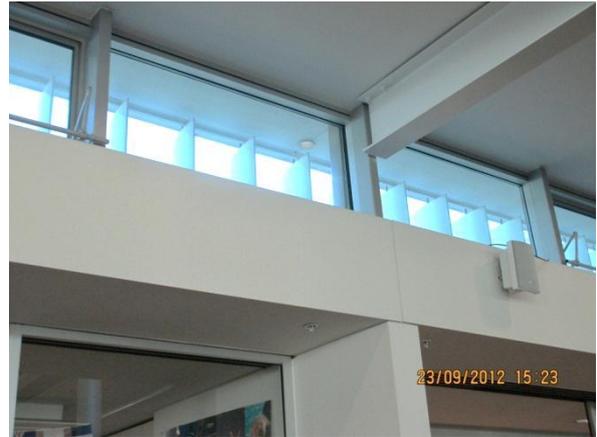
Typical RHS (as shown in the previous photo) in the southern end of the building is not connected to the precast wall.

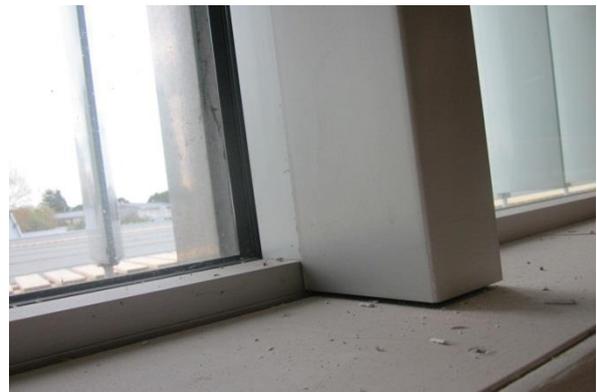
Precast wall in the southern end of the building.

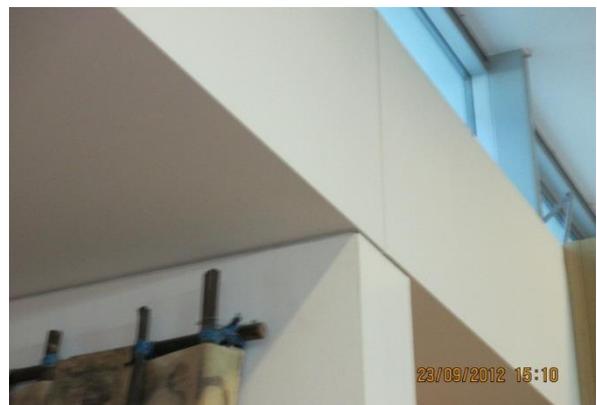
Typical connection details between the precast wall in the transverse direction and 250PFC running in the longitudinal direction.

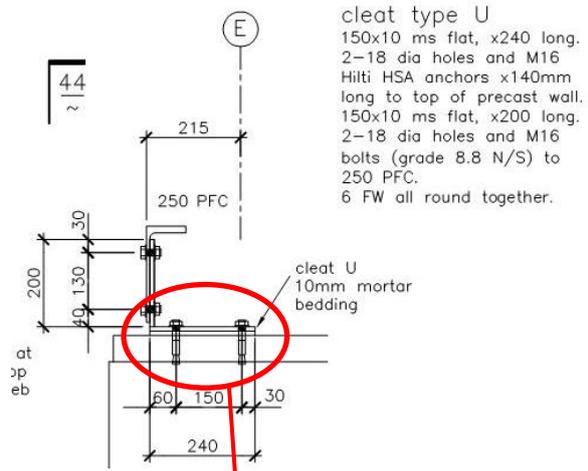
This is the plate and bolts on top of the precast wall (as shown above).

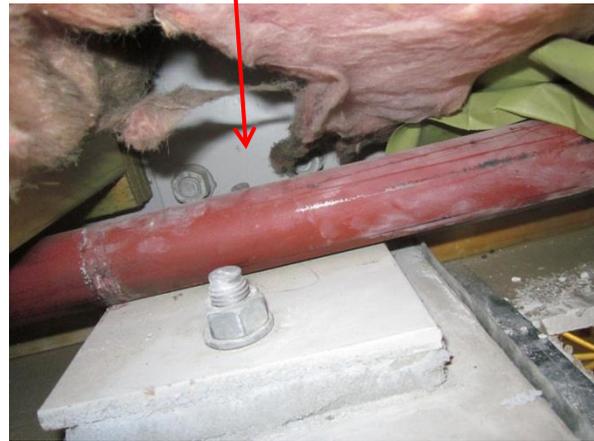
Top connection view of the precast concrete tilt up wall panel (Panel P2R along Grid 7 – see Appendix B page 1).

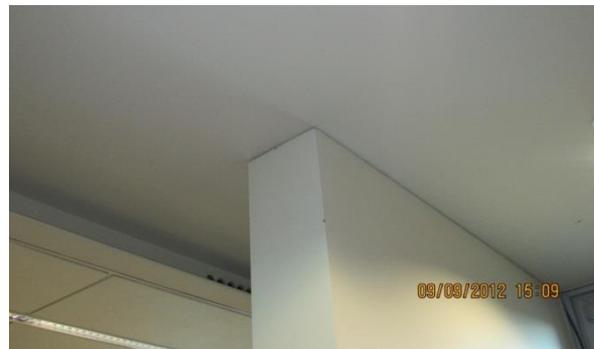
Internal view of precast wall P7.
