Veronica Place Housing Complex PRO 0317

**Detailed Engineering Evaluation
Quantitative Assessment Report**

Veronica Place Housing Complex Quantitative Assessment Report

Date: March 2014
Reference: 6-QC411.00
Status: Final

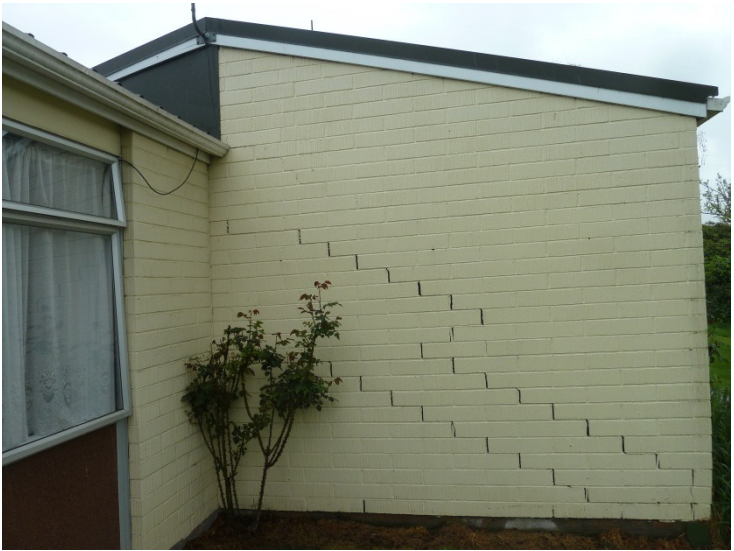
Stepped cracking in the brick veneer exterior cladding mortar joints was observed on some units. Unit 6 has suffered the highest level of damage to its brick veneer (photos 7 and 8).

7.	Significant stepped cracking of brick veneer on Unit 6

- Strengthening options be developed to increase the seismic capacity of all blocks to at least 67%NBS.
- Veneer at height (gable ends) have the veneer ties checked.
- The damaged fire wall and associated cladding on Unit 6 be repaired or rebuilt.
- Cosmetic repairs be undertaken as required.

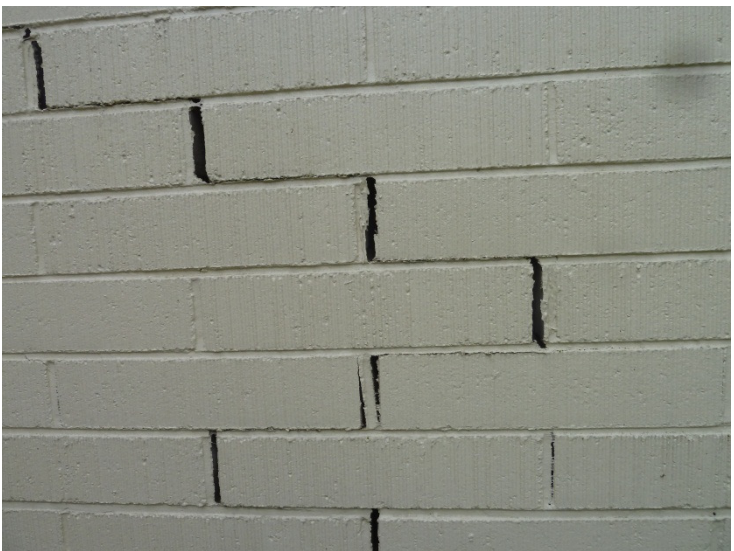
8.	Unit 6 cladding damage

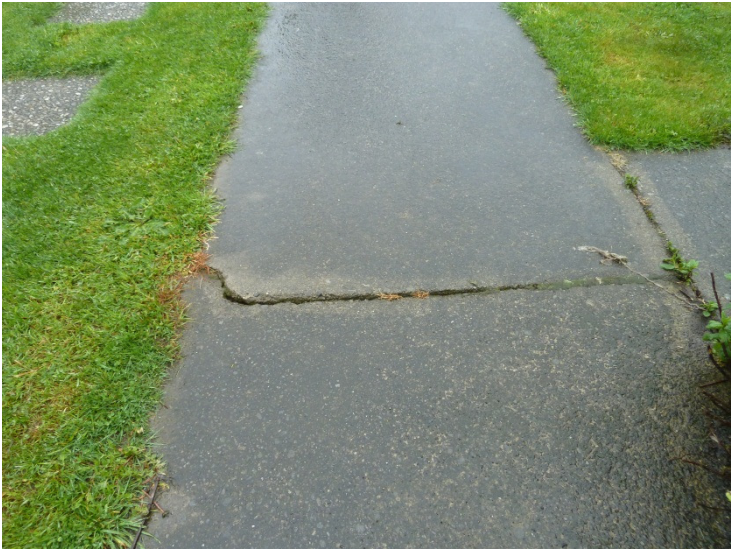
9.	Typical damage to external footpaths

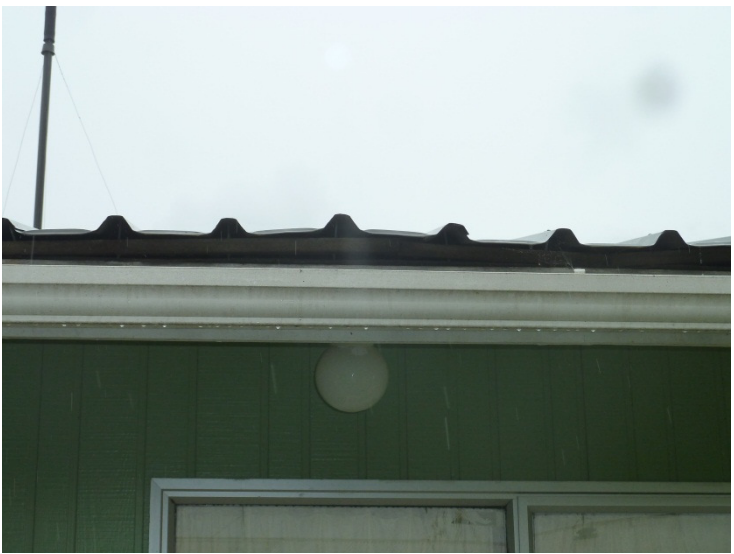
It was noted onsite that some of the metal roofing appears to have lifted on some units where the fixings have become loose (photo 10).

10.	Existing metal roofing has lifted or gutters have dropped on some units.

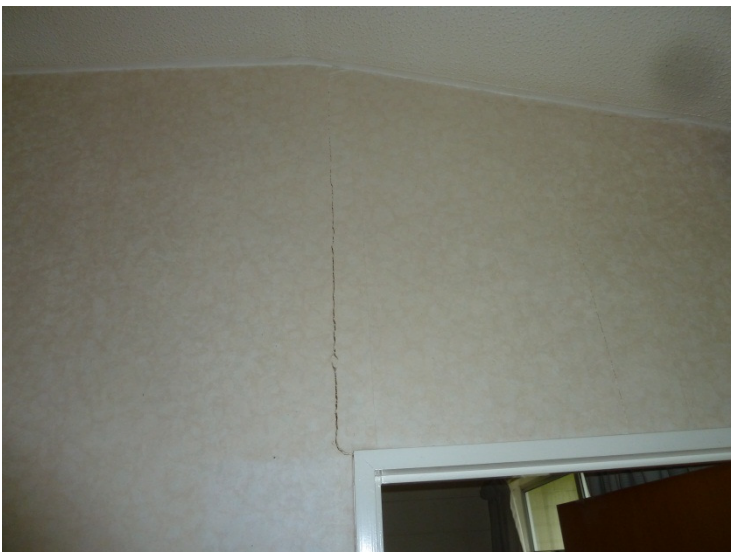
Minimal cracking of plasterboard ceiling diaphragms and wall linings was observed in the units (photo 11). This form of damage is common throughout the units.

11.	Typical cracking of gib wall linings.

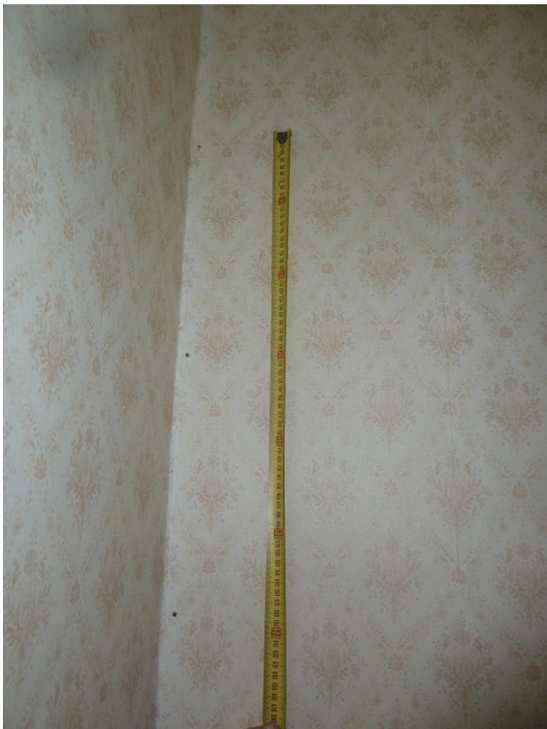
12.	Internal lining bracing fixings – approx 300mm.

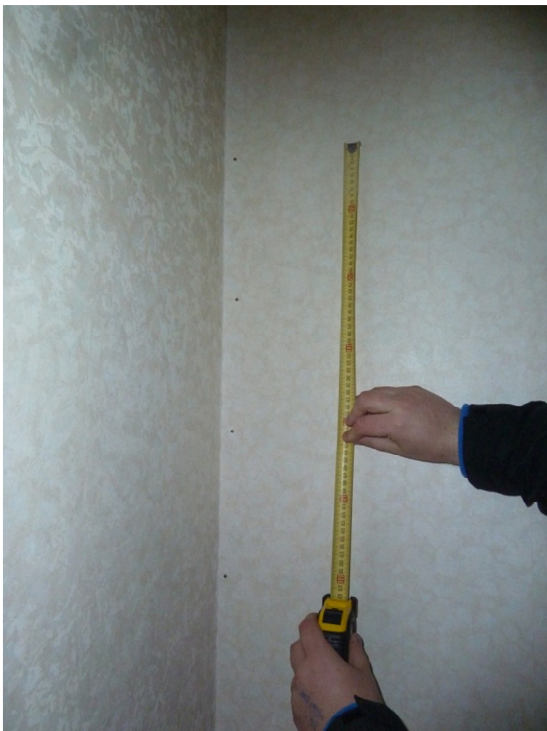
13.	Internal lining bracing fixings – approx 200mm.

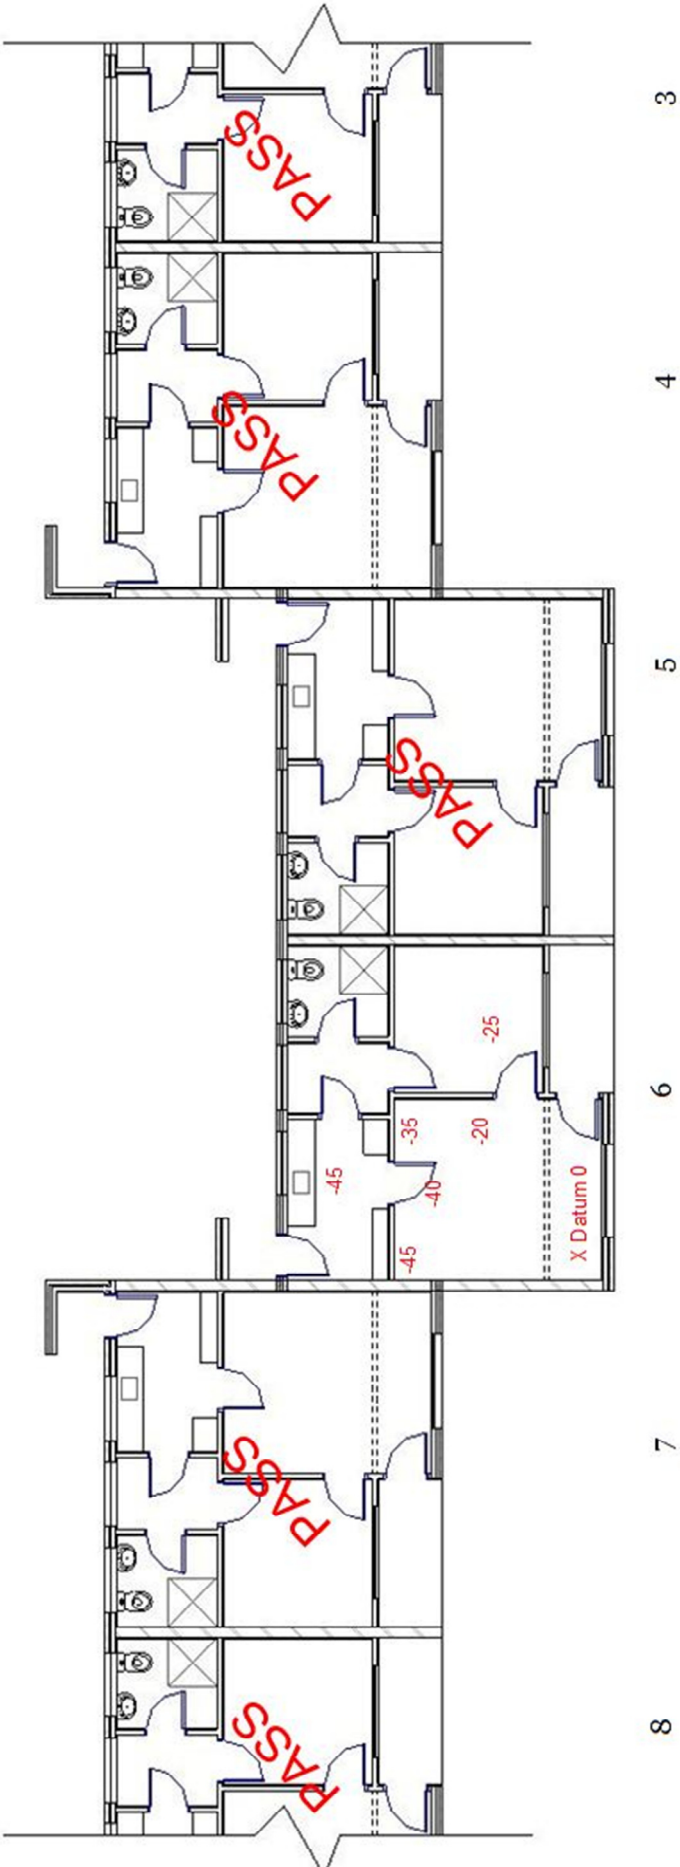
Appendix B – Level Survey

A full level survey was not deemed to be necessary at Veronica Place as it is located in a TC2 zone. Properties in TC2 zones suffered moderate damage due to liquefaction and/or settlement. In lieu of a full level survey, a laser level was placed in each unit so that differentials in vertical levels could be measured at the extreme ends of the unit. These values could then be used to determine the floor slope of the entire unit. For this site, the floor slopes in 1 of the 36 units on site were greater than the 5mm/m limitation imposed by the MBIE guidelines [6].
