Victoria Park – Toilets (Disabled)
Qualitative Engineering Evaluation

Reference: 228908

Functional Location ID: PRK 1829 BLDG 009 EQ2

Date: 22 November 2012

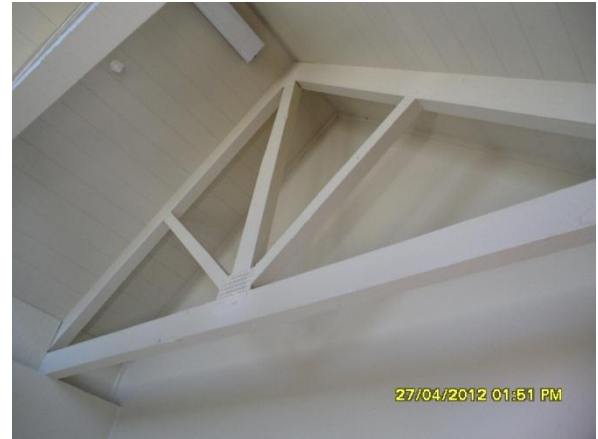
Typical interval view.
