Victoria Park – Rangers Office  
Qualitative Engineering Evaluation

**Reference:** 230675  
**Prepared for:**  
Christchurch City Council

Functional Location ID: PRK 1829 BLDG 003 EQ2

**Date:** 3 August 2012

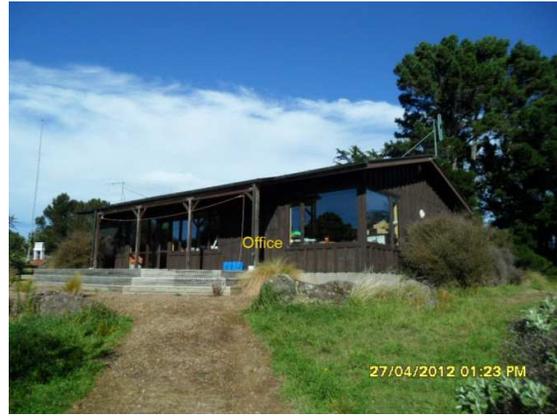
North view of the building.

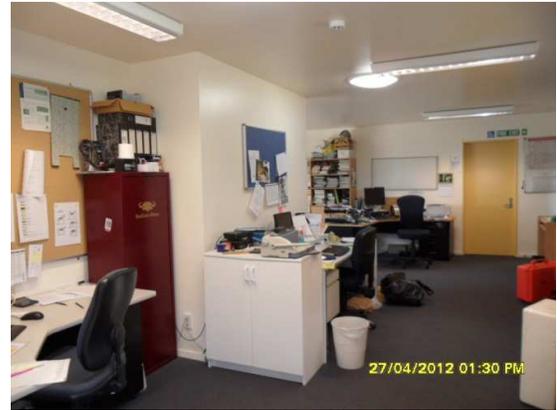
Internal view of the building towards the southeast.

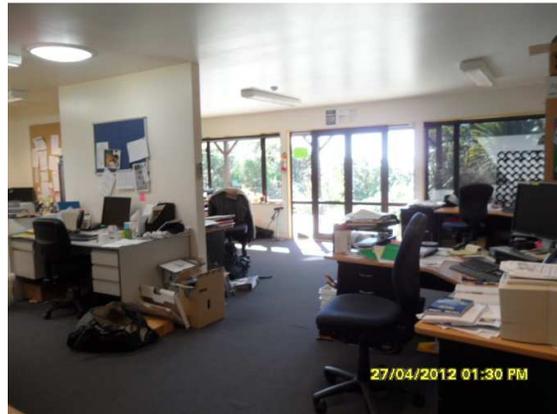
Internal view of the building towards the northeast.

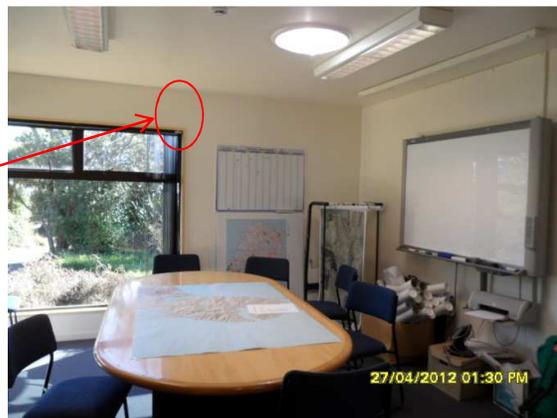
Damage to the wall linings is a common occurrence in this type of construction and occurs as plasterboard is relatively brittle causing cracks to develop with a limited amount of movement. The damage is relatively minor and has not reduced the seismic capacity sufficiently to warrant building closure.

View of the meeting room.

Minor cracking to plasterboard

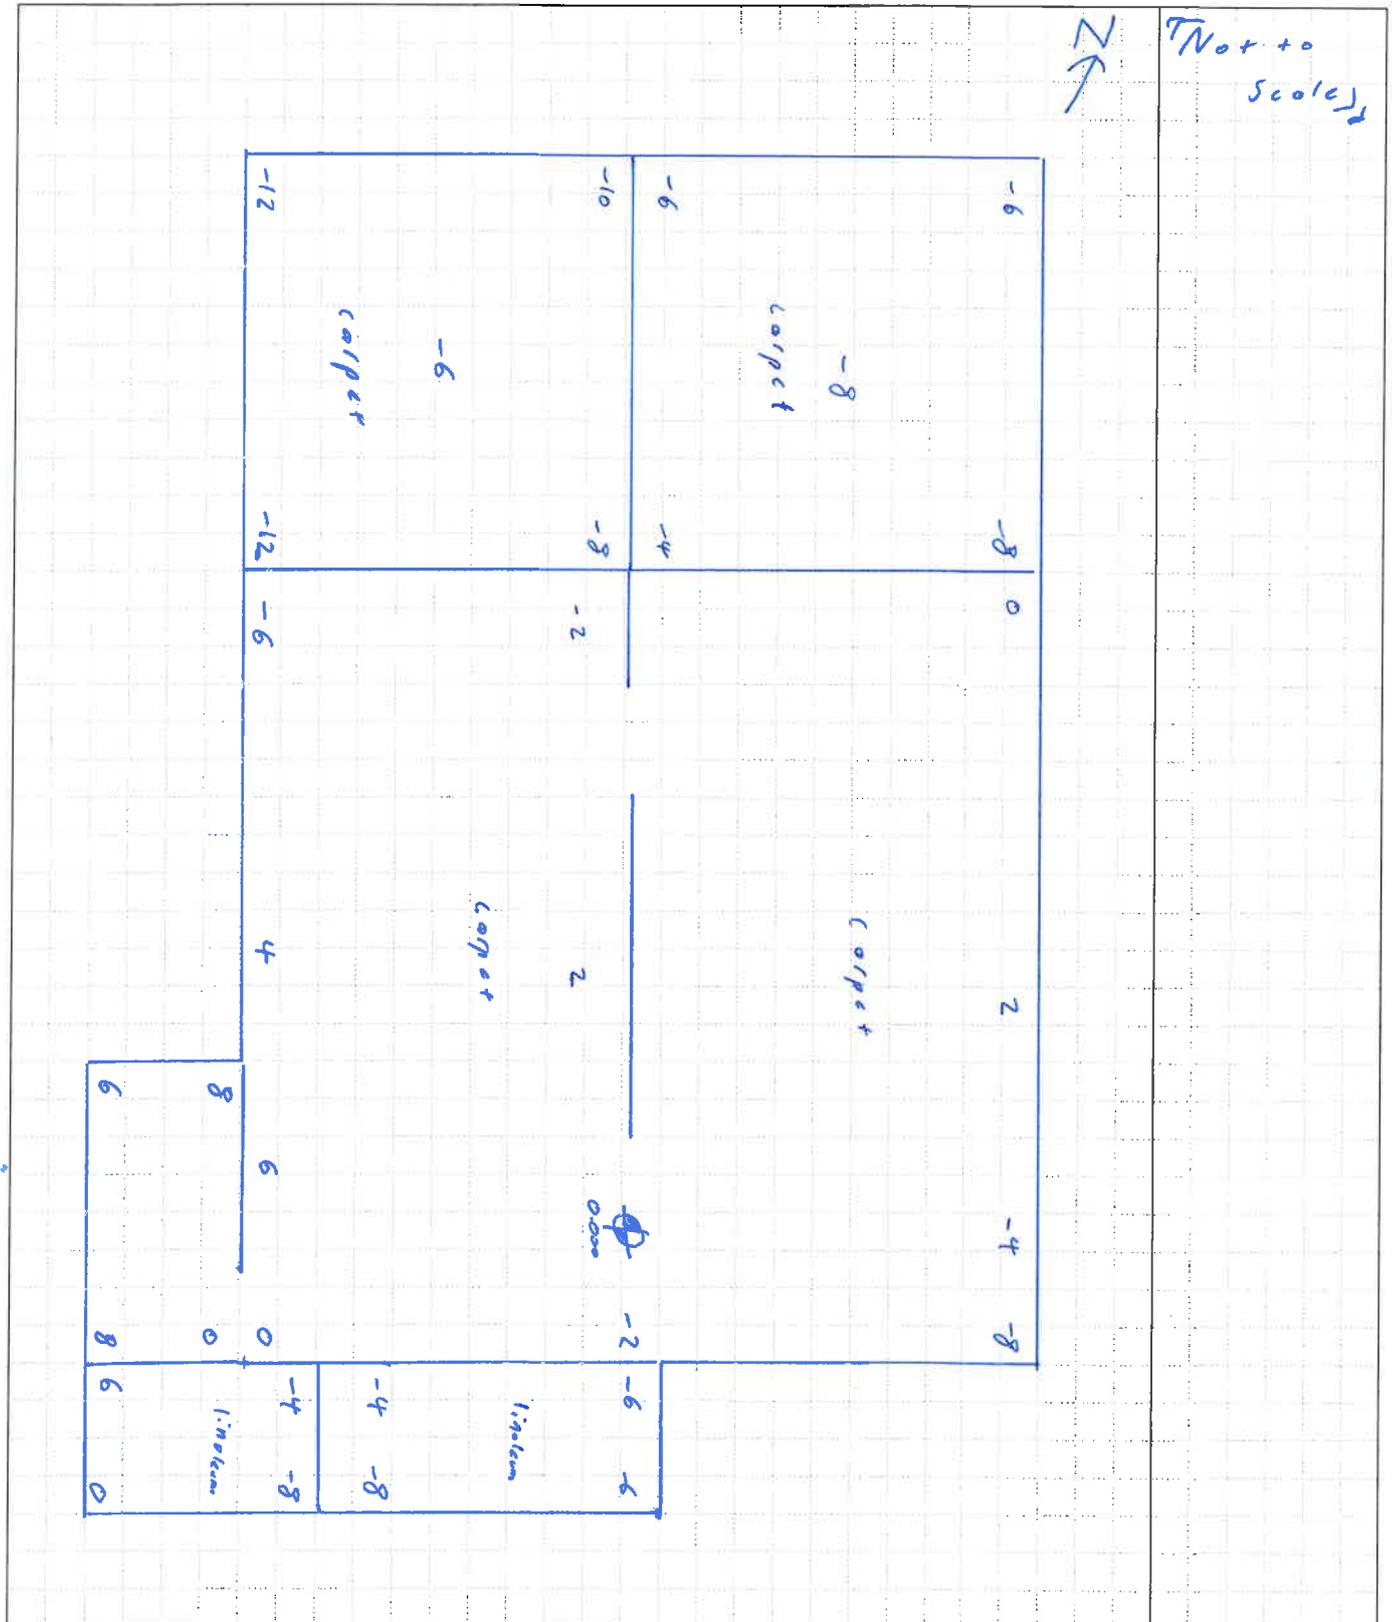
Client: CCC	Date: 30/05/12
Project/Job: Victoria Park Old Ranger Office	Job No: 228666
Subject: Level Survey	Sheet No: 1 By: PL

A floor level survey was undertaken to establish the level of unevenness across the floors. The results of the survey are presented on the attached sketch in Appendix A. All of the levels were taken on top of the existing floor coverings which may have introduced some margin of error.

The floor levels for the Victoria Park – Rangers Office were found to be within the recommended tolerances.
