Victoria Park – Shearing Shed
Qualitative Engineering Evaluation

Reference: 228667

Prepared for:
Christchurch City
Council

Date: 2 July 2013

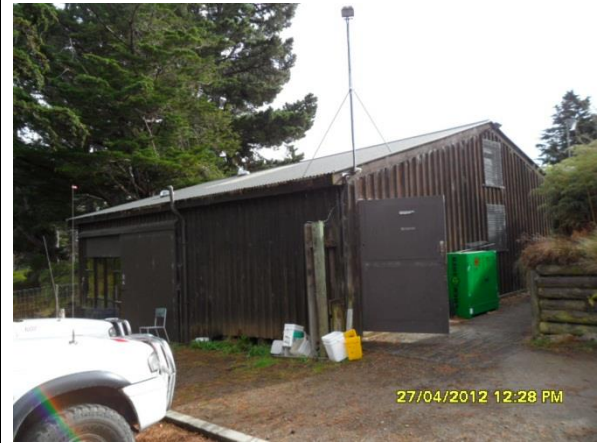
Northeast view of the building.
