Waimairi Cemetery
Toilets/Shed/Office
PRK 0291 BLDG 001 EQ2
Detailed Engineering Evaluation
Quantitative Report
Version FINAL

195a Grahams Road, Burnside

Christchurch City Council

Date
19 March 2013

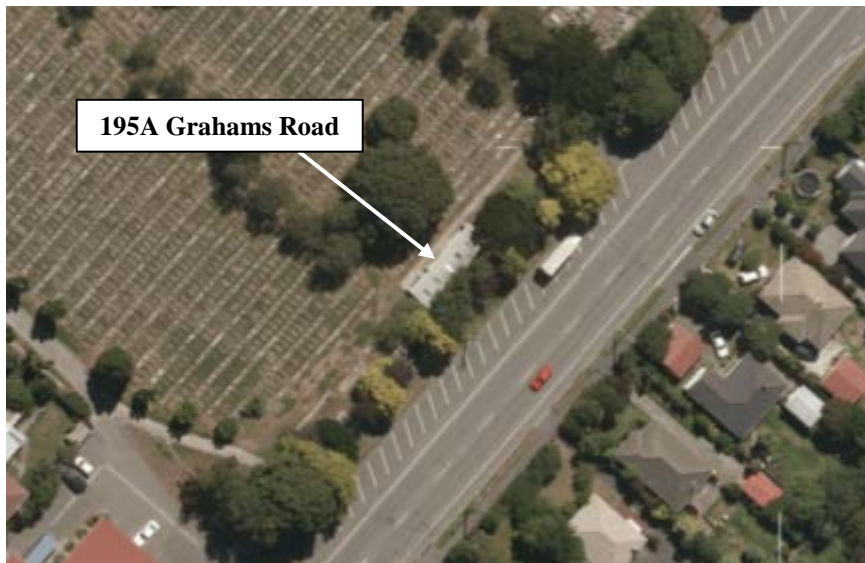
Figure 4 Post February 2011 Earthquake Aerial Photography²

Aerial photography taken following the 22 February 2011 earthquake shows no signs of liquefaction outside the building footprint or adjacent to the site, as shown in Figure 4.

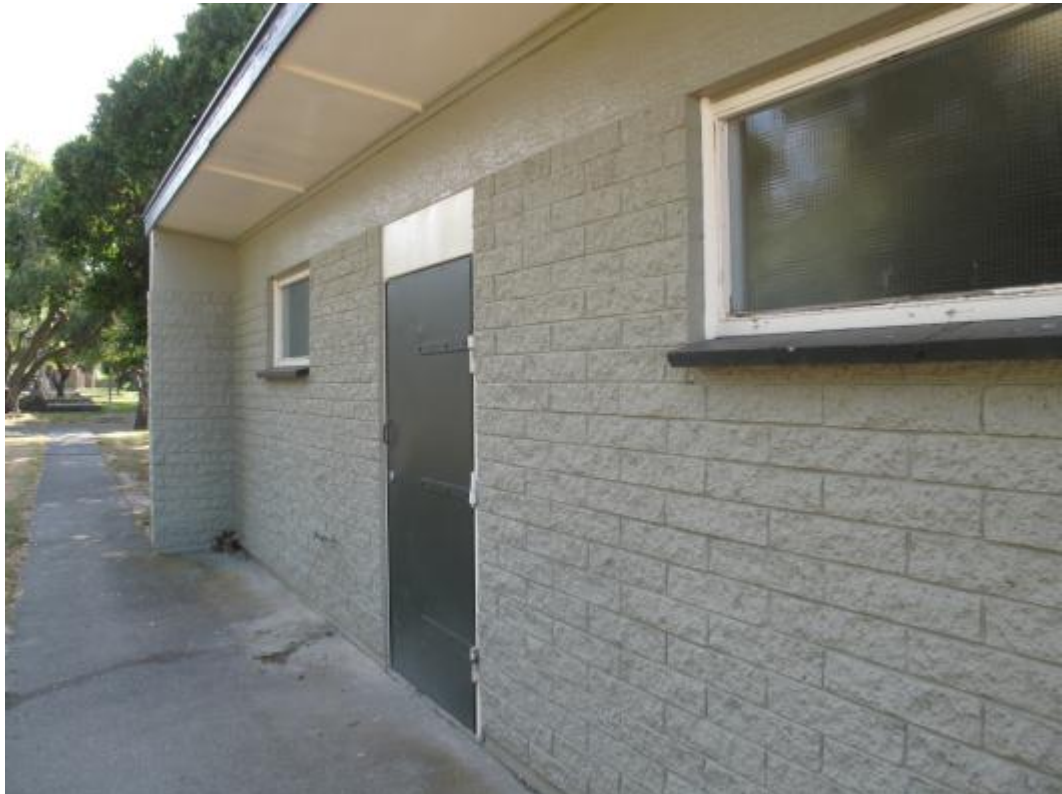
Photograph 3 Brick veneer on the exterior concrete masonry walls

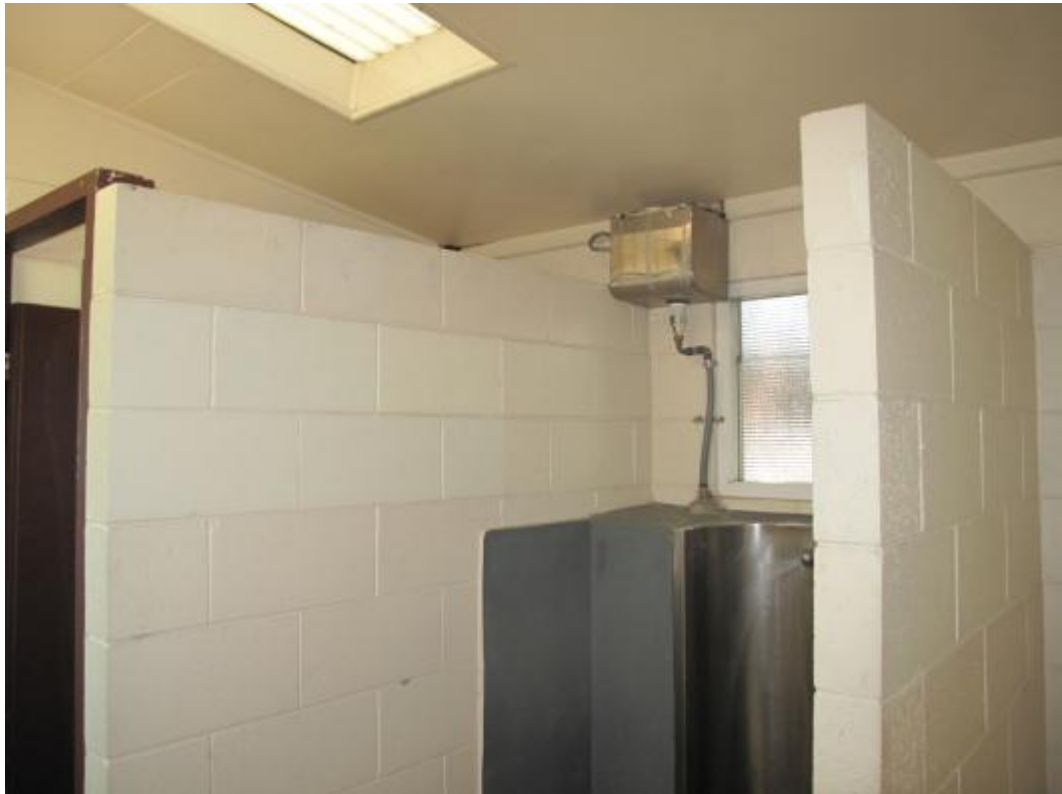
Unrestrained partial height walls form the toilet cubicles in the original building. These walls consist of 100mm thick unreinforced concrete masonry.

Photograph 5 **Unrestrained partial height concrete masonry walls**

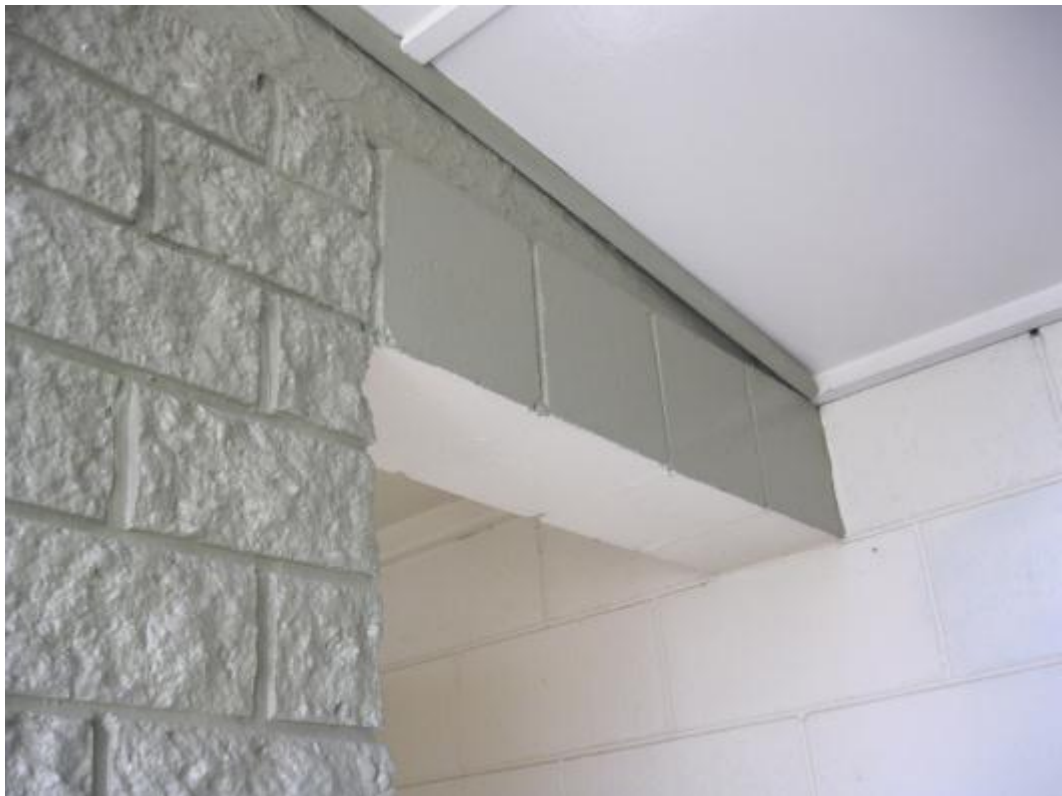
Photograph 6 **Concrete masonry lintel beam**

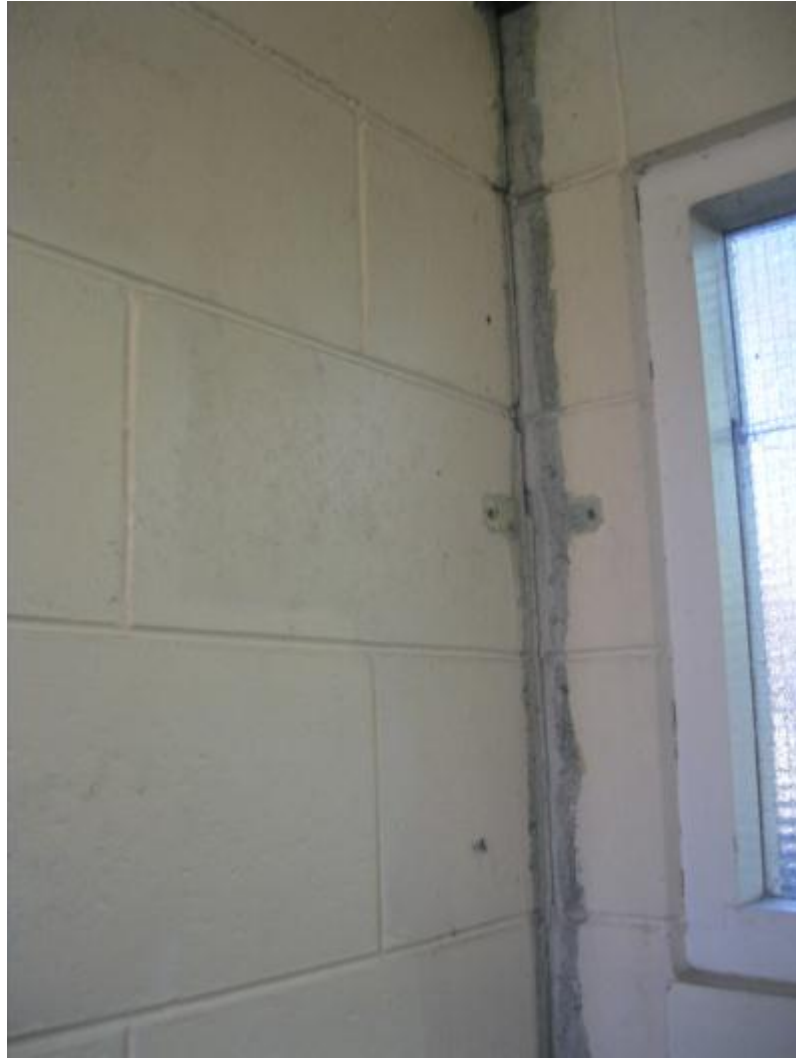
An existing crack at the intersection between a transverse concrete masonry wall and a longitudinal concrete masonry wall was observed in the original section of the building (shown in Photograph 7). The damage observed is unlikely to be a result of recent seismic activity.

Photograph 7 Existing cracking at connection between a transverse wall and a longitudinal wall
