Waimairi Community Centre
BU 0259-001 EQ2
Detailed Engineering Evaluation
Quantitative Report
Version FINAL

166 Waimairi Road, Christchurch

Prepared By
Jay Zeus B. Rivera

Date
31/10/12

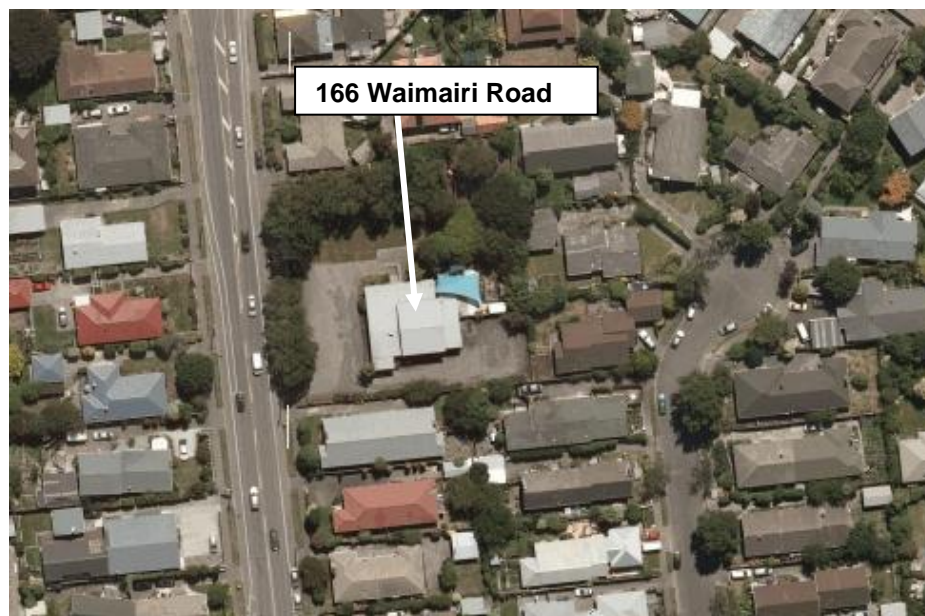
Figure 3 Post February 2011 Earthquake Aerial Photography ²

Aerial photography taken following the 22 February 2011 earthquake (Figure 3) shows no signs of liquefaction outside the building footprint or adjacent to the site and the site inspection commented that there was no noticeable ground damage

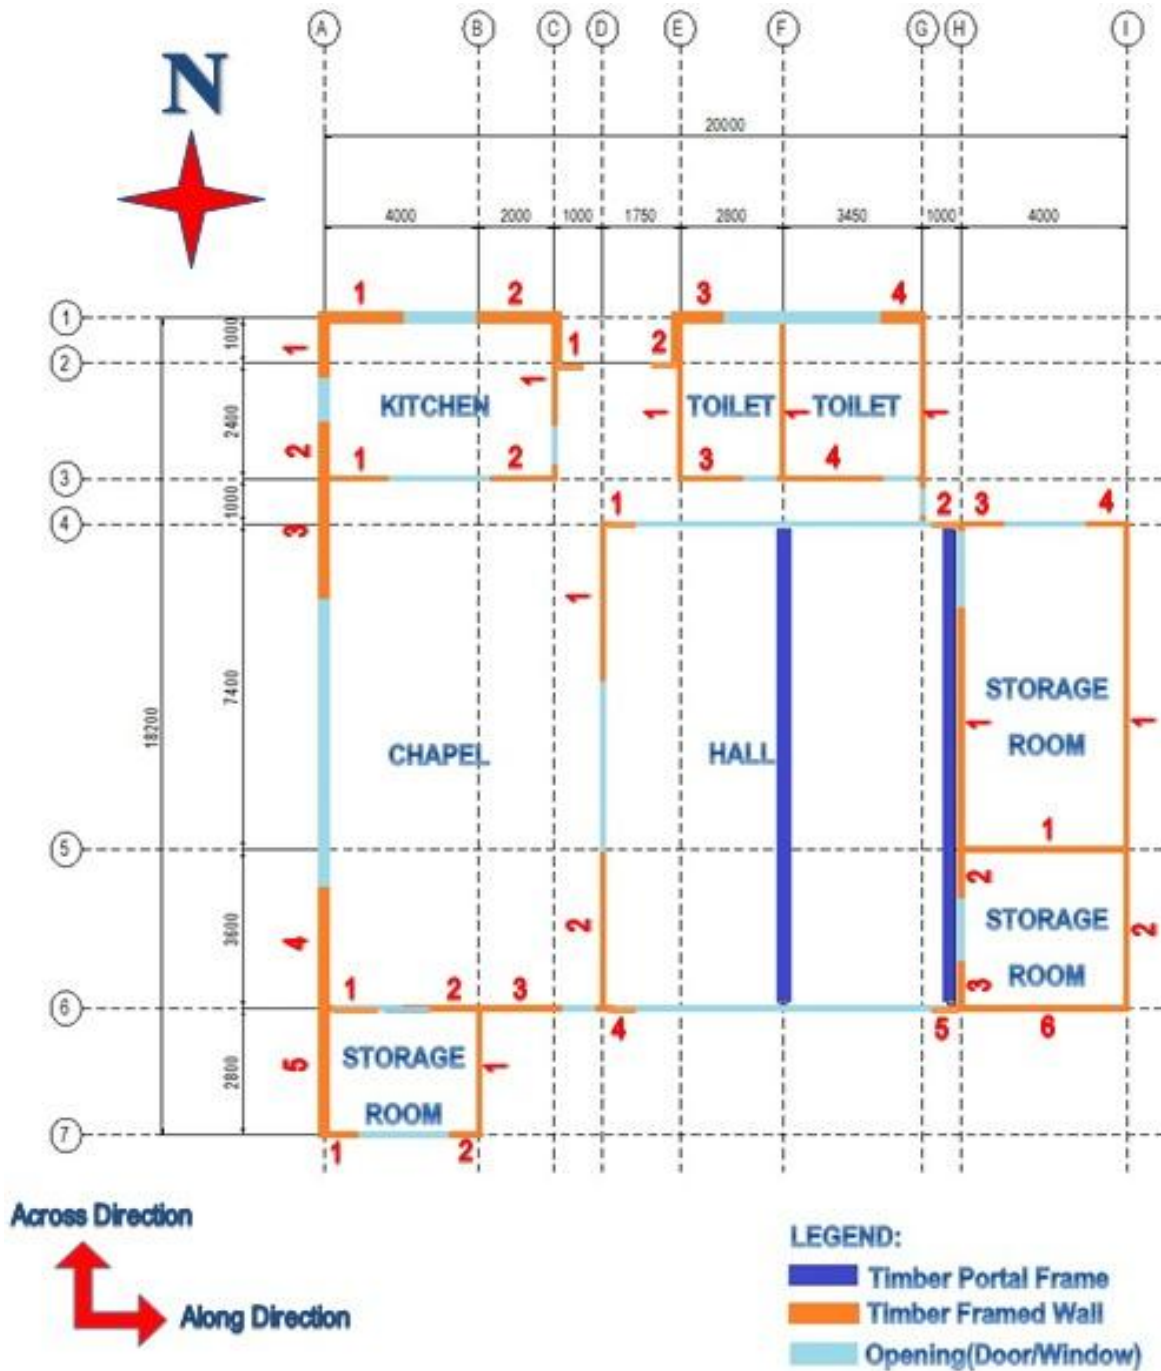
Figure 4 Plan sketch showing numbering sequence for bracing elements

Relative to the overall bracing system capacity, analysis on each bracing line element was also carried out. Calculations showed that the critical bracing line element in the “Along” direction is located at Gridline 5/H to I. This bracing line achieved a score of 51% NBS. Bracing line along Gridline 1/A to B achieved a score of 54%. Therefore, the said wall bracing lines fall in the “Earthquake Risk” category.

Based on this result, analysis for each bracing line element found out that the most vulnerable elements are the wall bracing lines along Gridline 5/H to I and Gridline 6/A to B. these line elements achieved scores of less than 67% NBS.

- ▶ Develop a scheme for strengthening the structure up to 100% NBS or to at least 67% NBS for all wall bracing elements particularly those that are listed in Table 5.
- ▶ Retain the green placard in place until such time that this recommendation have been satisfied.

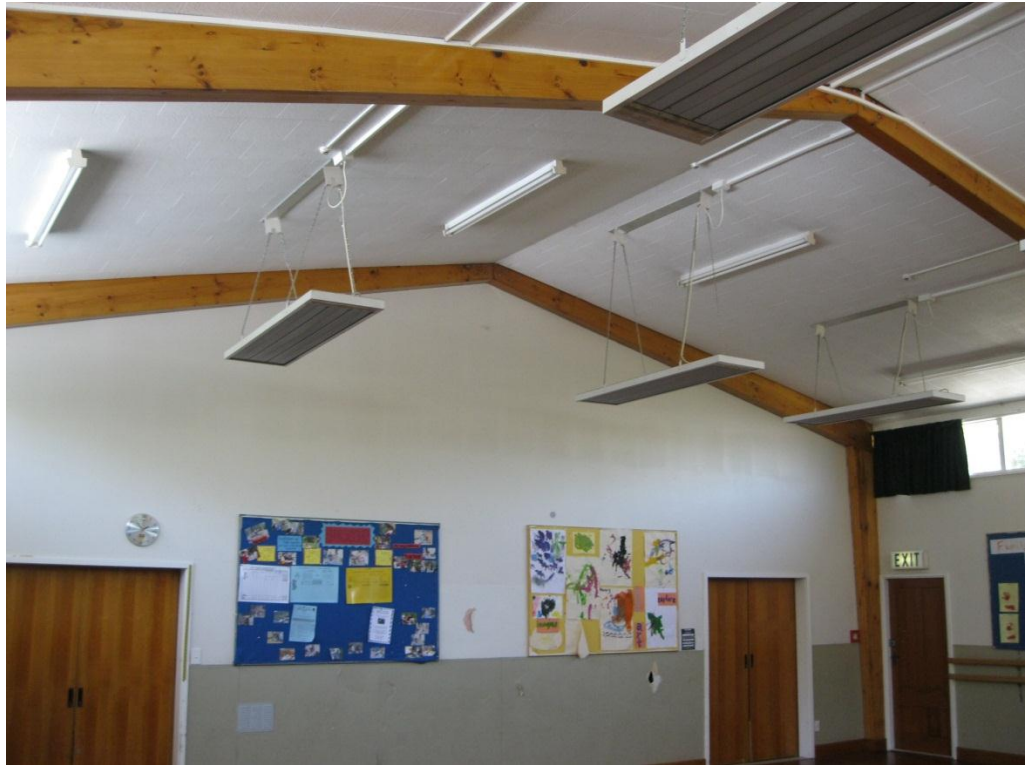
- ▶ There are 50mm x 100mm diagonal timber roof bracing reflected in the drawings issued on 1968. This could be an additional lateral resistance for the structure but it was found during site inspection that the ceiling is directly attached to the underside of the purlins exposing the rafters of the timber portal frame without the roof bracing. Photograph 5 and 6 of Appendix B shows a partial view of the hall area.

Photograph 5: Glulam timber portal frame.

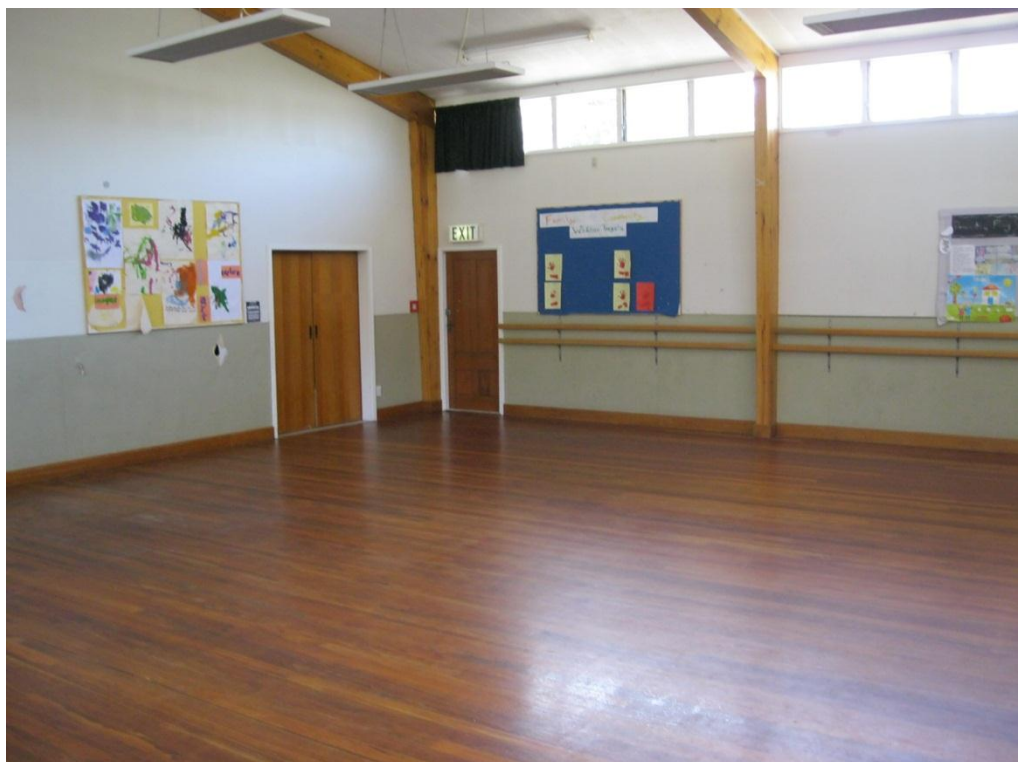
Photograph 6: Suspended timber flooring with internal plasterboard wall linings.

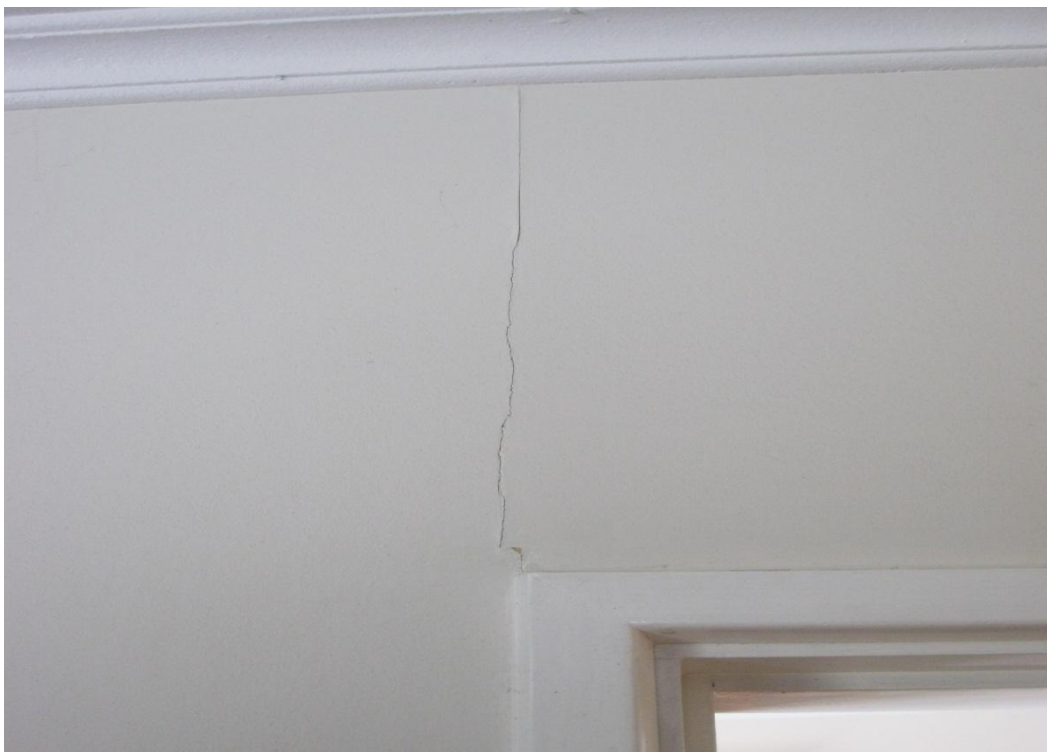
- ▶ Minor cracks to internal wall linings as can be seen in Photograph 7 and 8, Appendix B of this report.
- ▶ Minor cracks to the perimeter strip footing at several locations around the building. This can be seen on Photograph 9, Appendix B of this report.
- ▶ Minor cracks to the external brick veneer as can be seen in Photograph 10, Appendix B of this report.

Minor cracking to internal wall linings was noted.

Photograph 7: Minor cracks on timber framed walls at toilet.

1. The client may choose to consider strengthening the building to at least 67% NBS. Any strengthening to this level is likely to involve moderate cost since few elements fall below 67% NBS minimum requirement.
2. Repair all minor cracks that are found in the structure, as specified in the qualitative report summary and as shown on Photographs 7 to 10 of Appendix B of this report. This is to eliminate the doubts of the community that the structure is weakened by the previous earthquake.

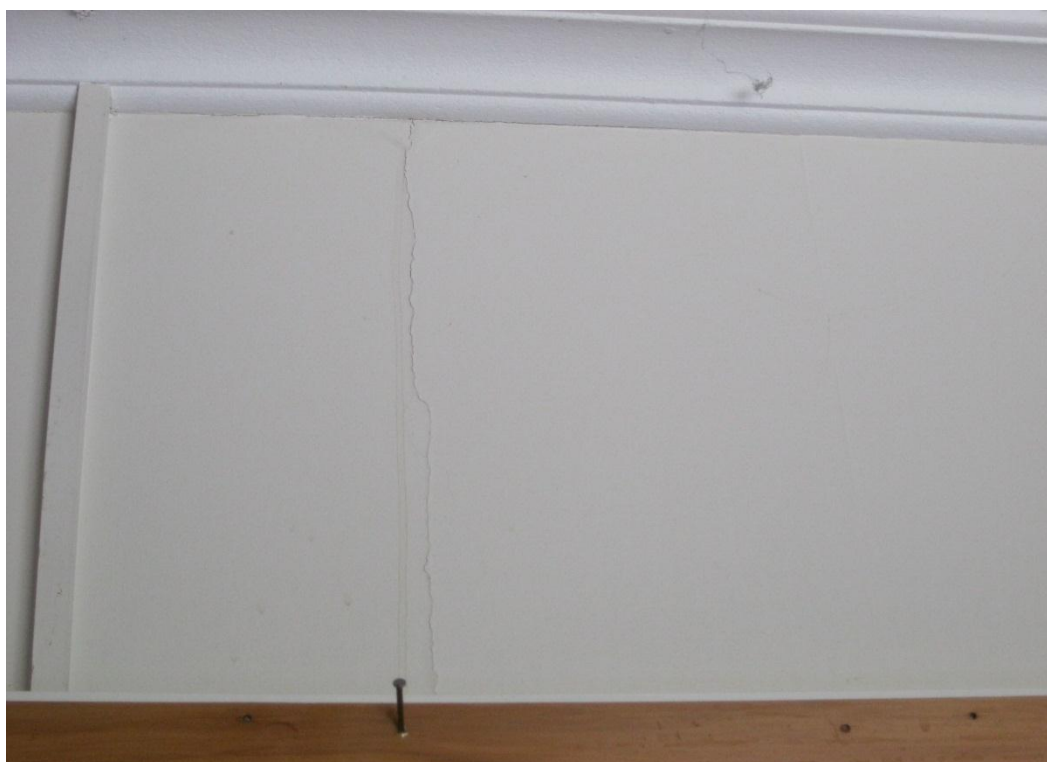
Photograph 8: Minor cracks on timber framed walls at chapel.

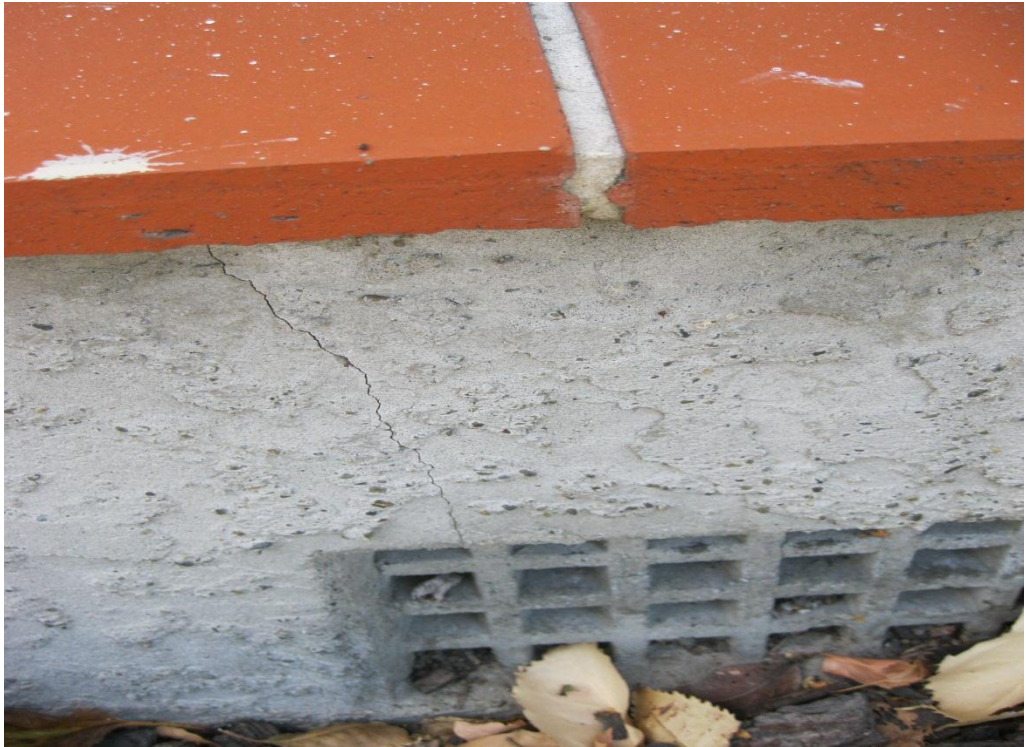
Minor cracking to the perimeter strip footing was observed, as seen in Photograph 9 in Appendix B.

Photograph 9: Slight cracking to the perimeter strip footing.

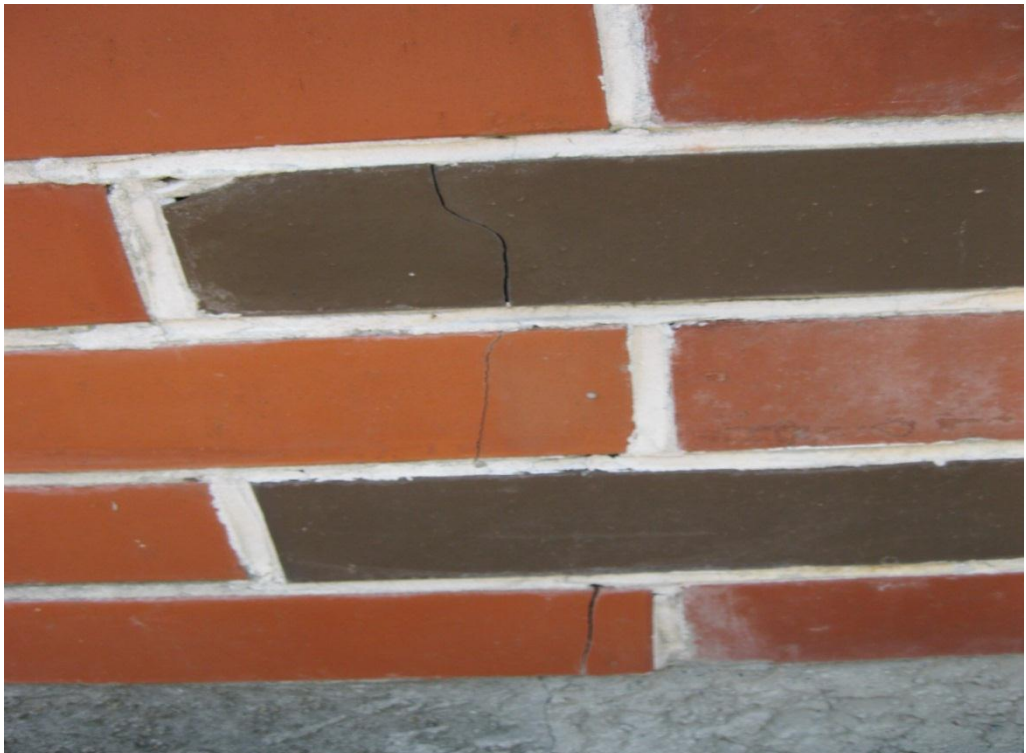
Minor cracks were noted to the external brick veneer. These cracks can be seen in Photograph 10 in Appendix B.

Photograph 10: Minor cracking of the external brick veneer.
