Waltham Community Cottage
BU 2385-001 EQ2
Detailed Engineering Evaluation
Quantitative Report
Christchurch City Council

Detailed Engineering Evaluation Quantitative Report

Date: September 2012
Reference: 6-QUCCC.58
Status: Final

201 Hastings Street East, Waltham, Christchurch

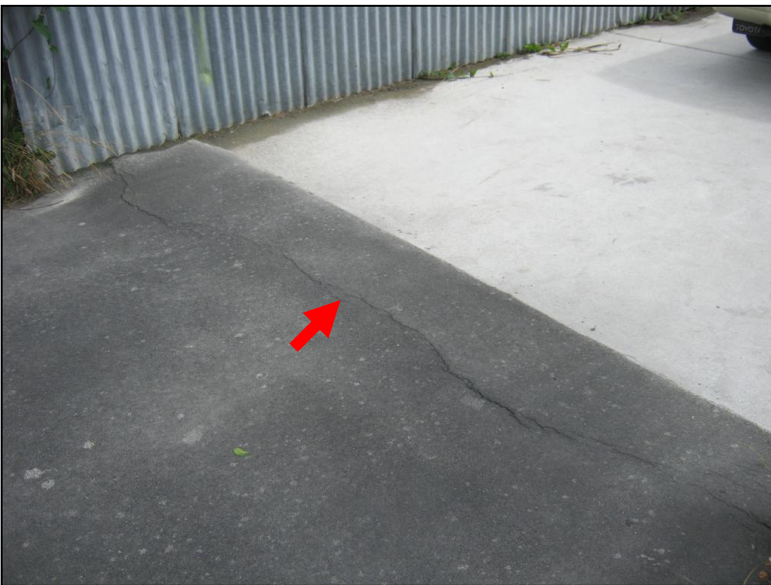
A minor crack (<2mm) was evident in the asphalt that leads from the footpath to the concrete driveway on the property, resulting in minor heave of approximately 10mm. Refer to Photo 4. The crack is likely to be a result of the asphalt and concrete slab pounding against each other during earthquake shaking.

Photo 4: Crack (2mm) in asphalt in driveway resulting in minor heave (10mm).

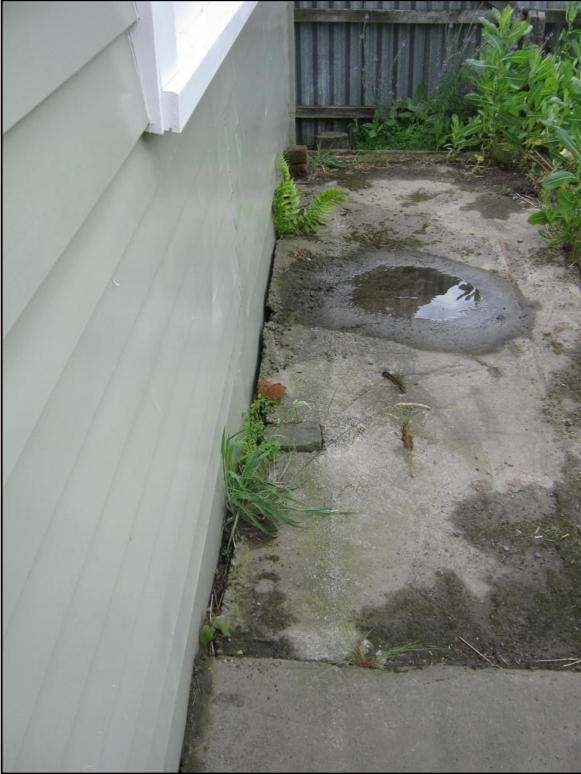
An open crack (20mm) is identified on the attached Site Walkover Plan between a concreted area of the cottage and the south-eastern wall. Upon close inspection it is unlikely that this damage was due to earthquake shaking and may have existed since construction of the ramp. The timber panels of the wall do not appear to be damaged. Refer to Photo 5.

Photo 5: Crack between south-west wall and concrete path (prior earthquake?).

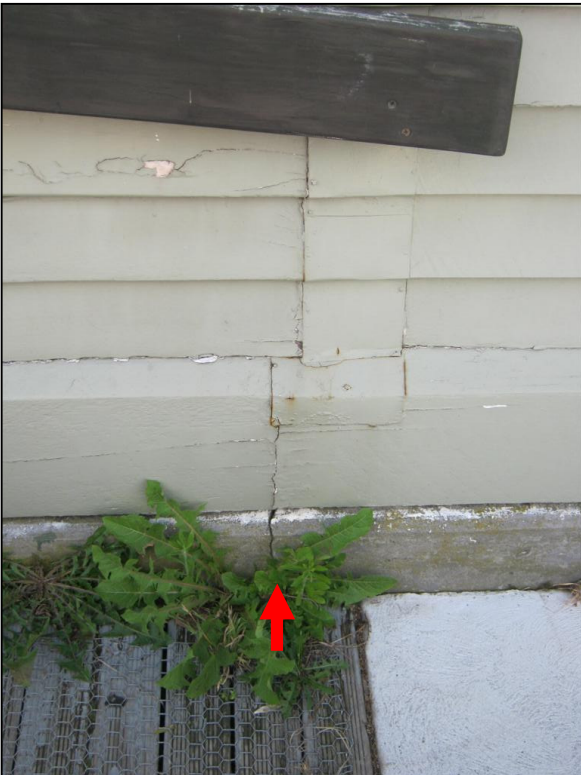
Minor cracking is evident in the concrete foundation of the cottage. Refer to Photos 6, 7 and 8. Three vertical cracks were identified in the perimeter foundation. No vertical displacement was observed during the inspection that would indicate differential settlement.

Photo 6: Crack in foundation, north-west side.

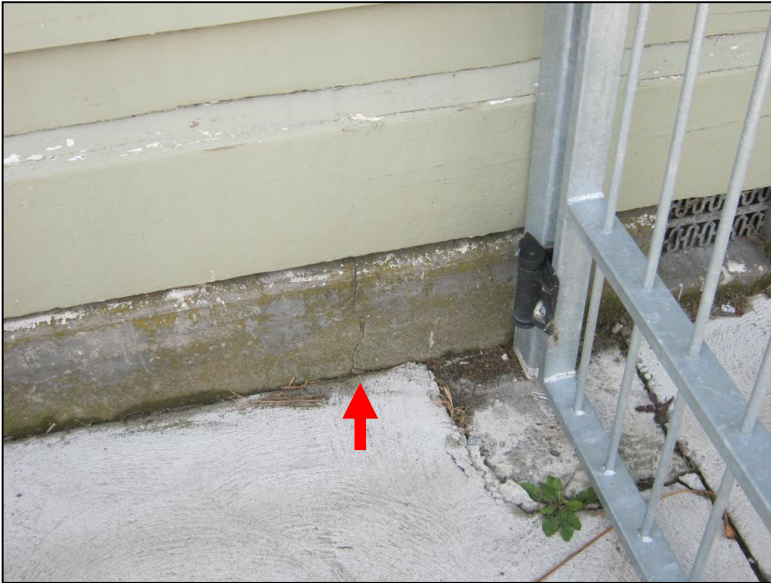
Photo 7: Crack in foundation, north-west side.

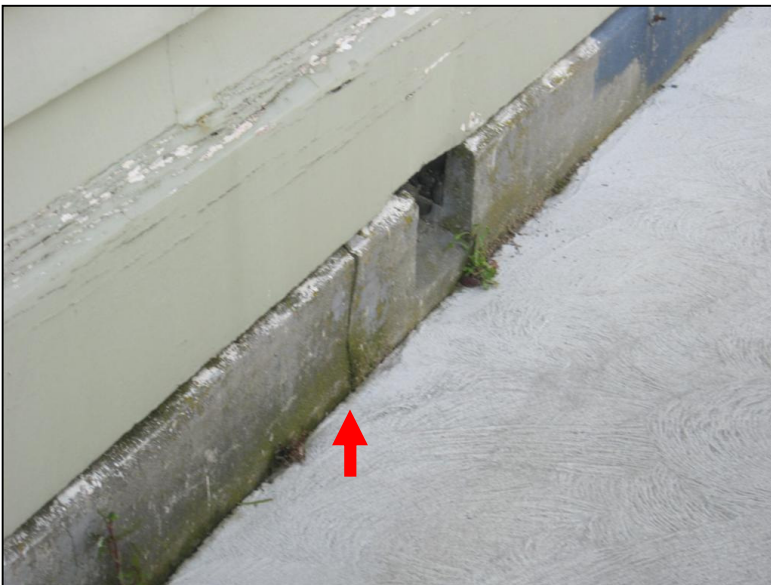
Photo 8: Crack in foundation, north-west side.

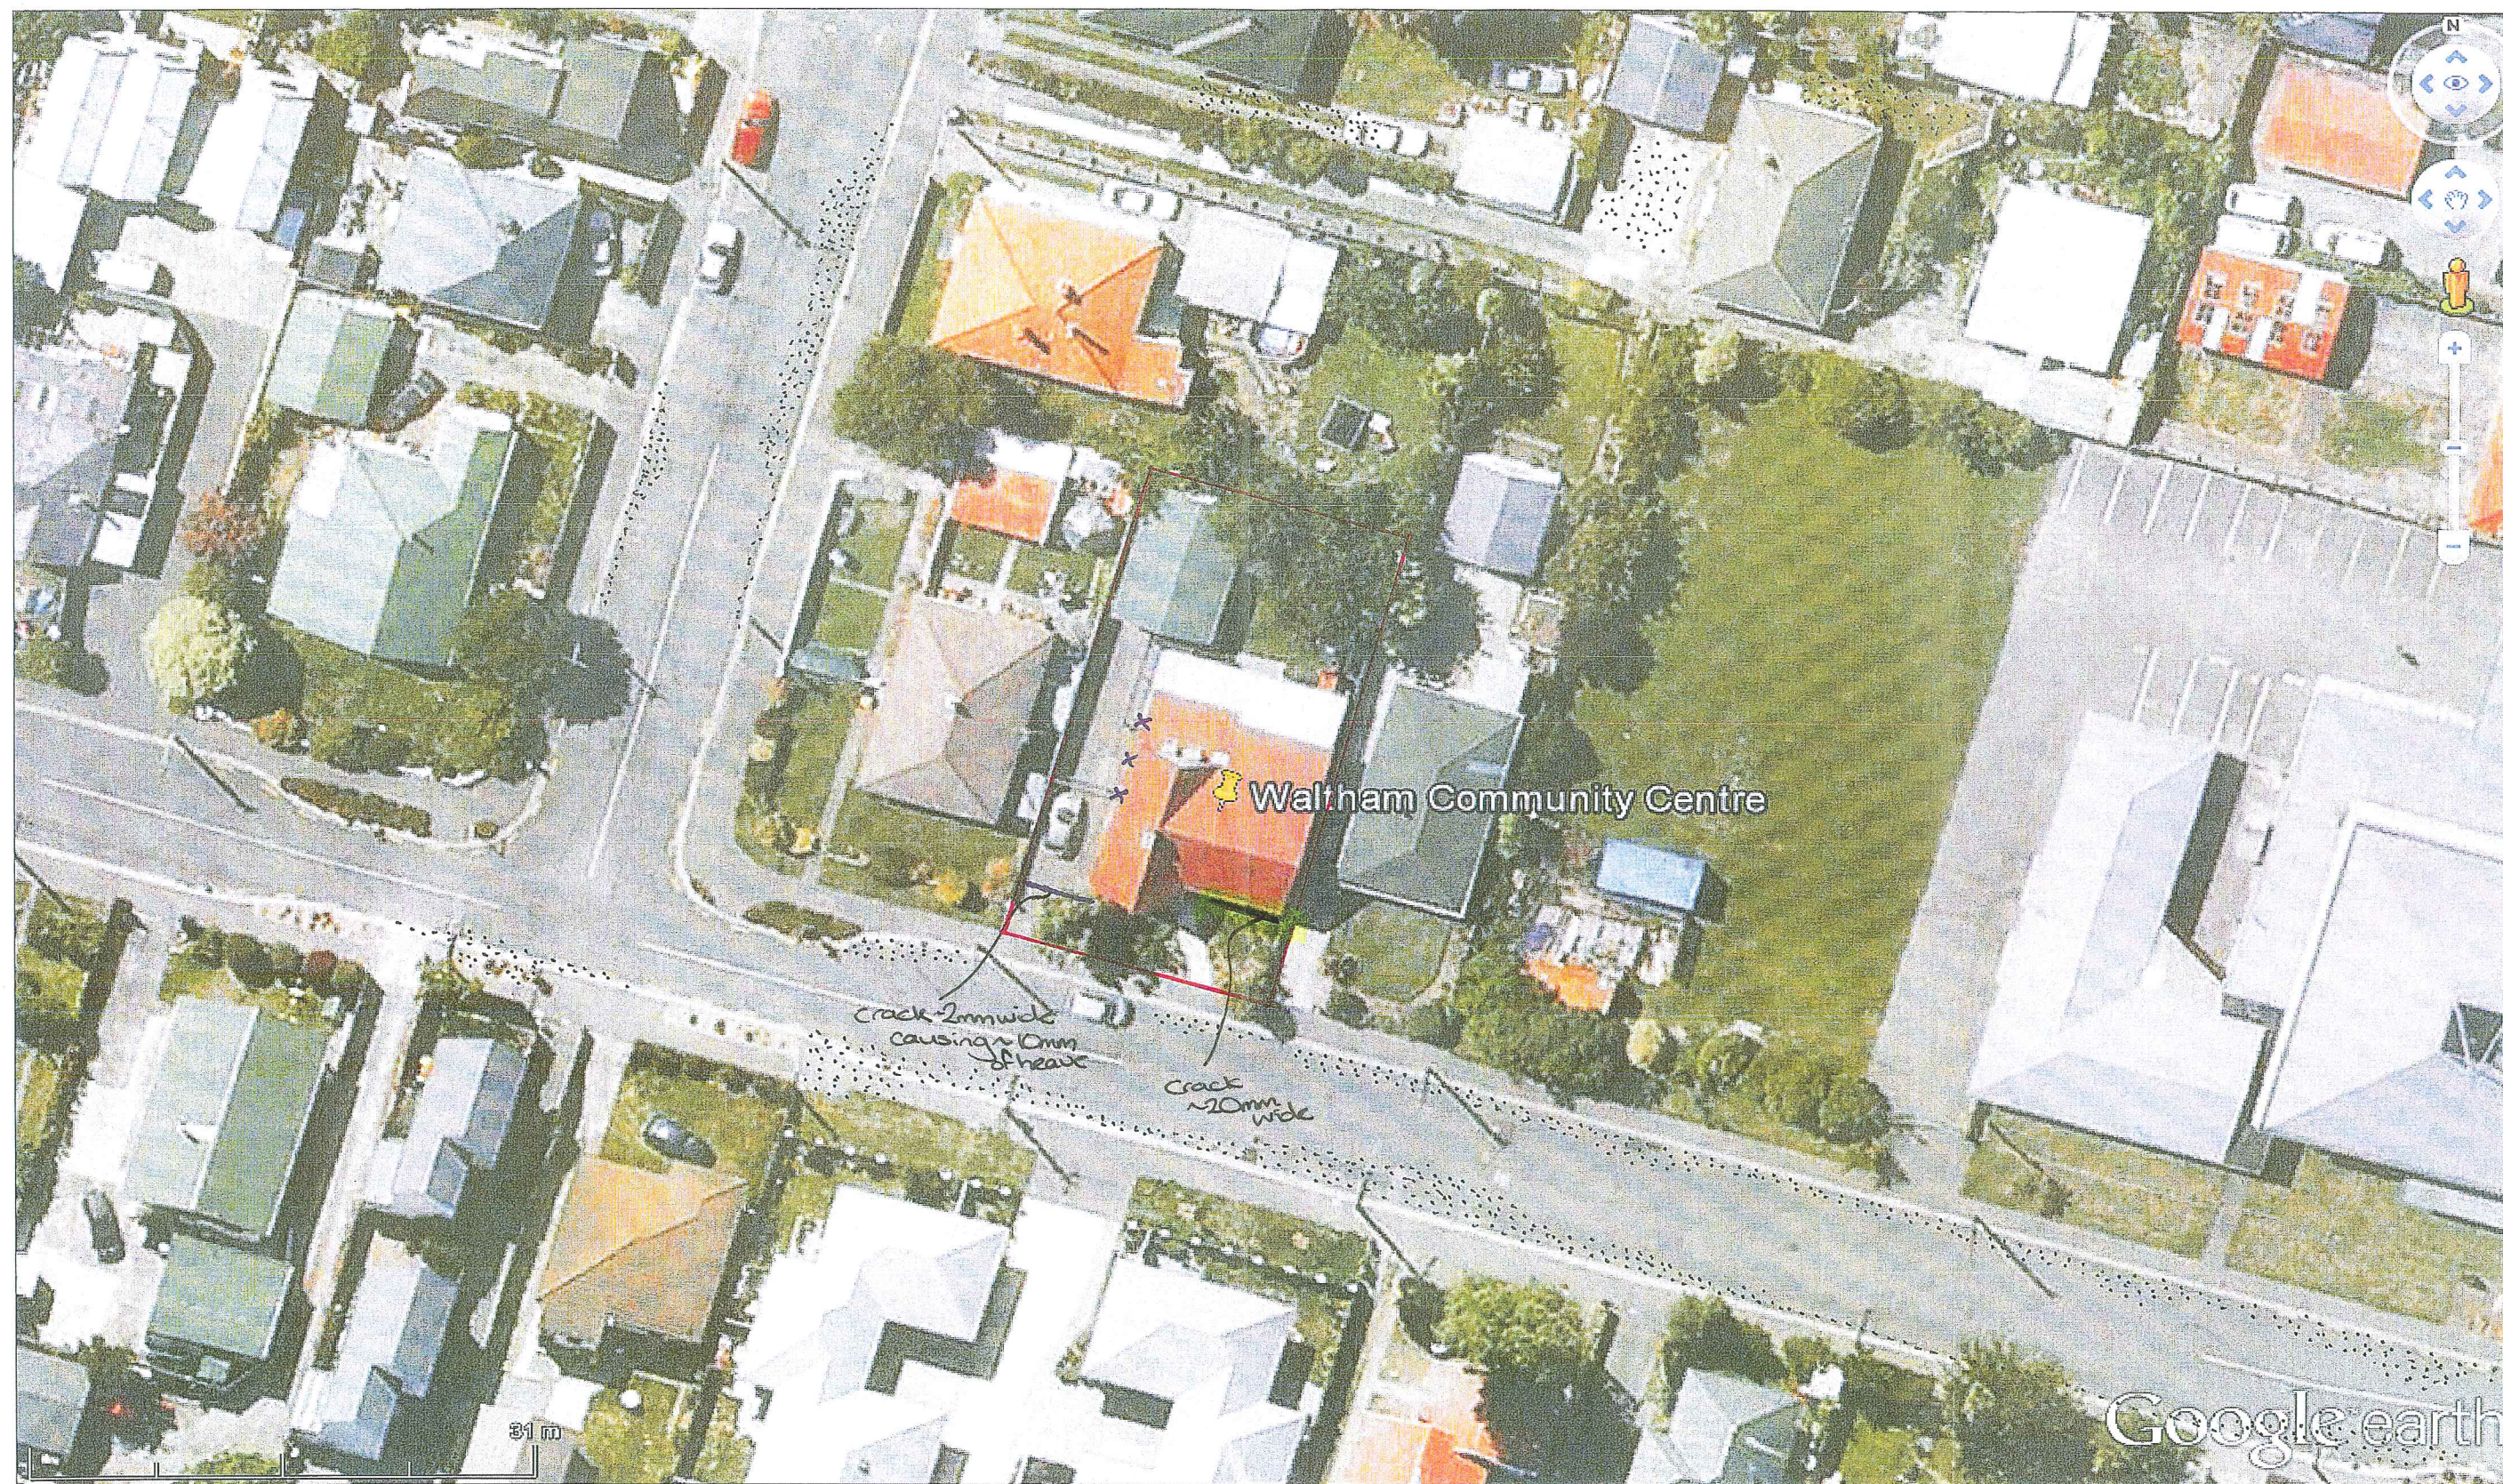
X : Location of cracks in the foundation.
 — : Cracks.
 :: : Liquefaction 22nd February 2011.
