Waltham Courts Housing Complex PRO 1049

**Detailed Engineering Evaluation
Quantitative Assessment Report**

Waltham Courts Housing Complex Quantitative Assessment Report

Date: March 2014
Reference: 6-QC414.00
Status: Final

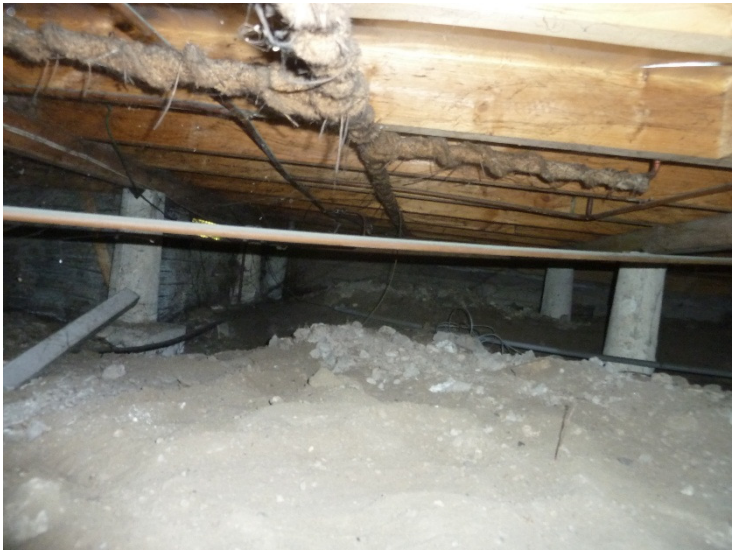
Minor to moderate damage was observed to the primary lateral resistance structure in the form of cracking to plasterboard wall linings (photos 14 and 15) and ceiling diaphragms (photo 19). There is no evidence of sub floor bracing.

7.	Typical floor void

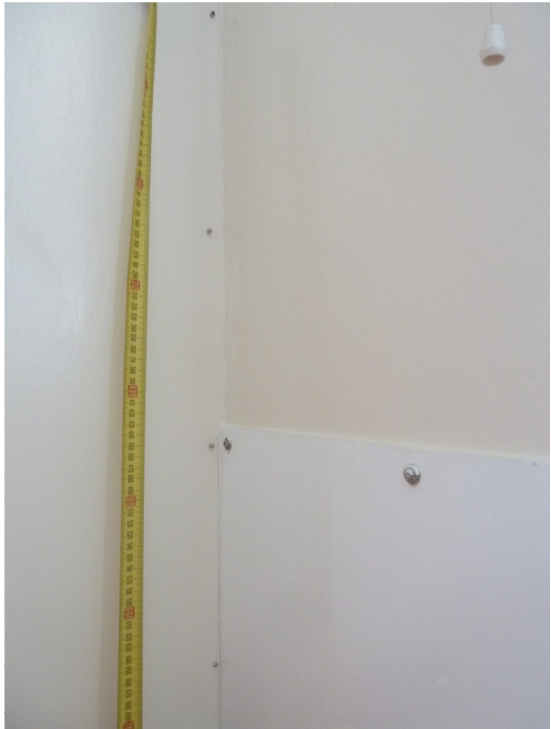
The internal lining nail spacings were measured on site to vary between 200 - 350mm.

12.	Nail spacings (200 – 300 mm)

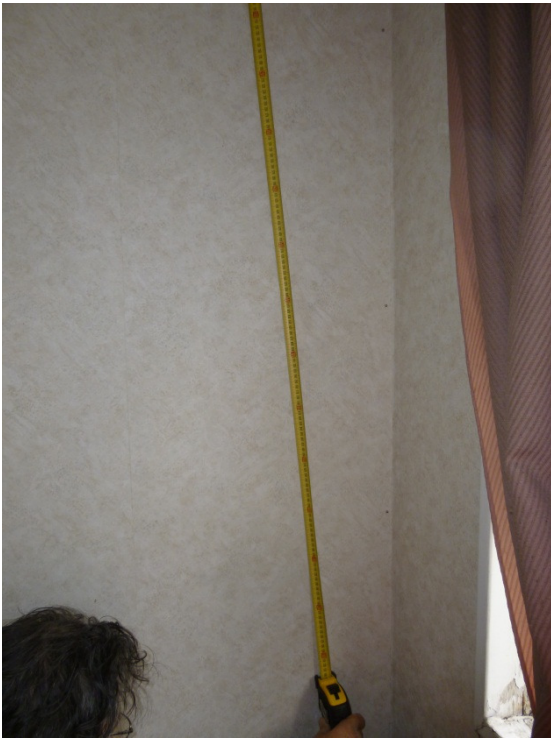
13.	Nail spacings (500 – 600 mm)

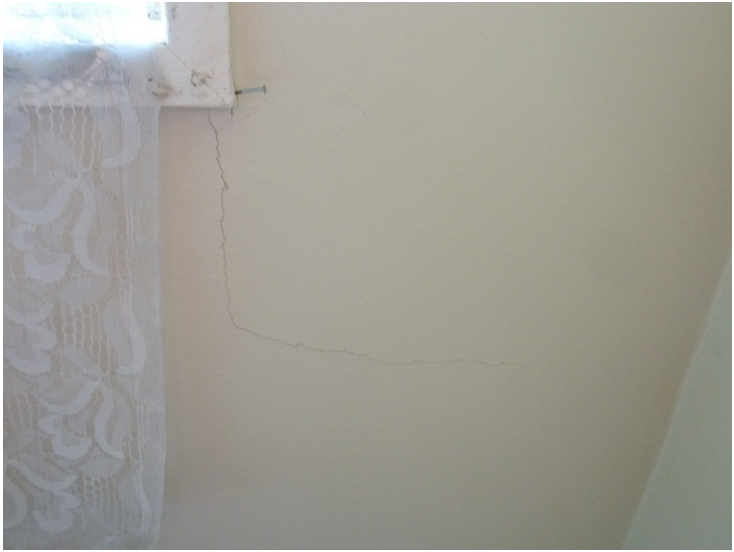
14.	Typical cracking from corners of windows and doors

- Cosmetic repairs be undertaken as required, including replacing and repairing damaged linings.
- Sub floor bracing be installed to increase the capacity of this element to at least 67% NBS. This should include securing the bearers to the piles.
- Repair sunken pile on Unit 14 and investigate source of failure (adjacent stormwater drain).
- Water-tightness of roof structure be investigated.

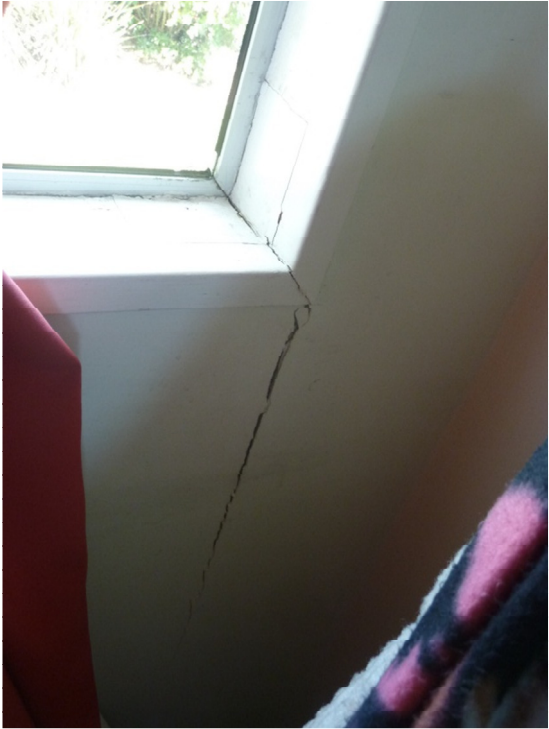
15.	Typical cracking observed around windows and doors

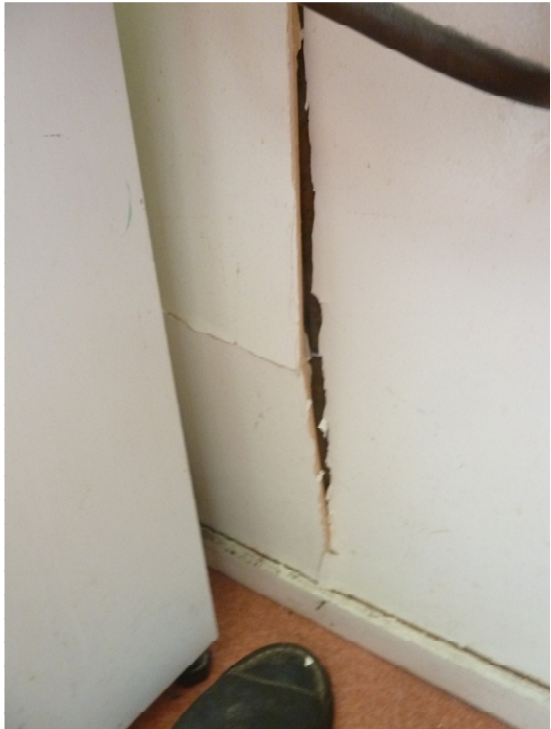
Minor to moderate damage was observed to non-structural elements. Severe cracking to wall linings was observed from the window in the laundry of unit 22 (photo 16). Many doors were observed to be out of alignment (photo 18) and would not shut properly. Cracking was also observed in most units where interior wall and ceiling linings have separated, particularly in corners. Water damage was observed to the ceiling diaphragms in a number of units (photo 20). This damage suggests that the waterproofing of the roof structure may be compromised. This damage is deemed minor and does not affect the seismic capacity of the lateral-resistance structure.

16.	Damage to particle board wall linings in laundry Unit 22

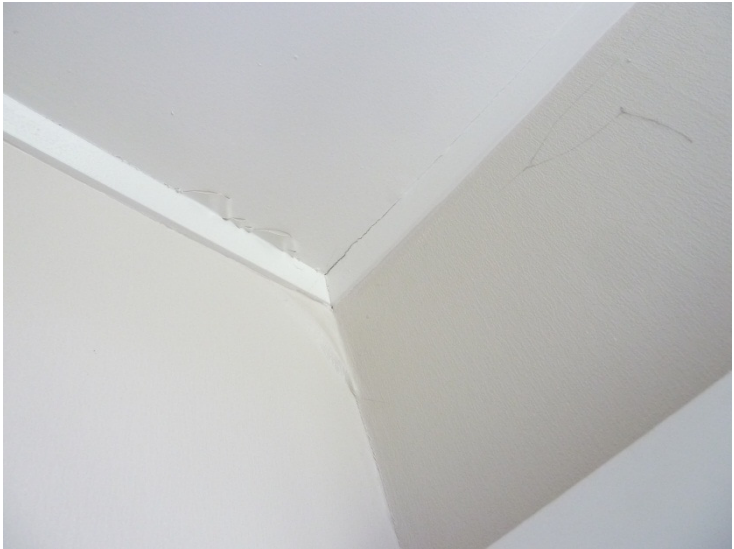
17.	Typical cracking at corners between wall and ceiling linings

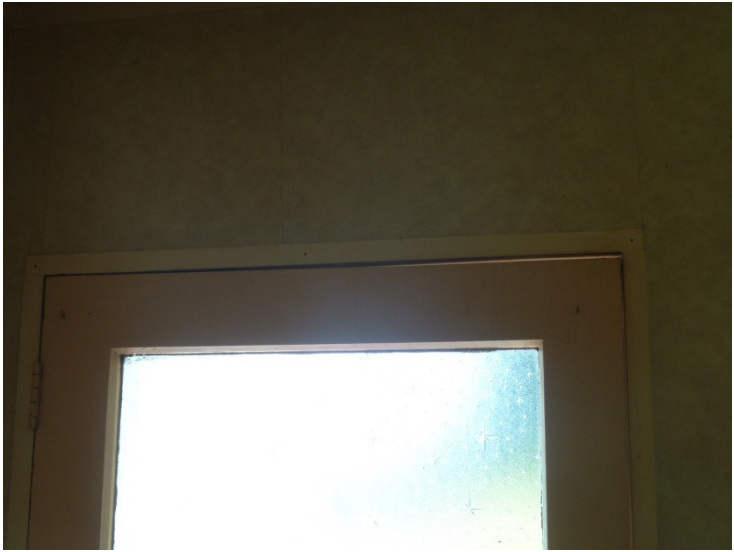
18.	Doors out of alignment

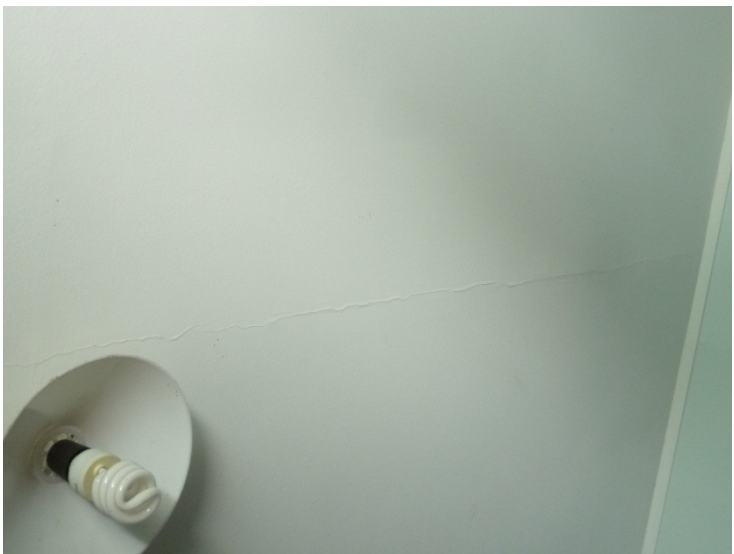
19.	Typical damage to ceiling diaphragms

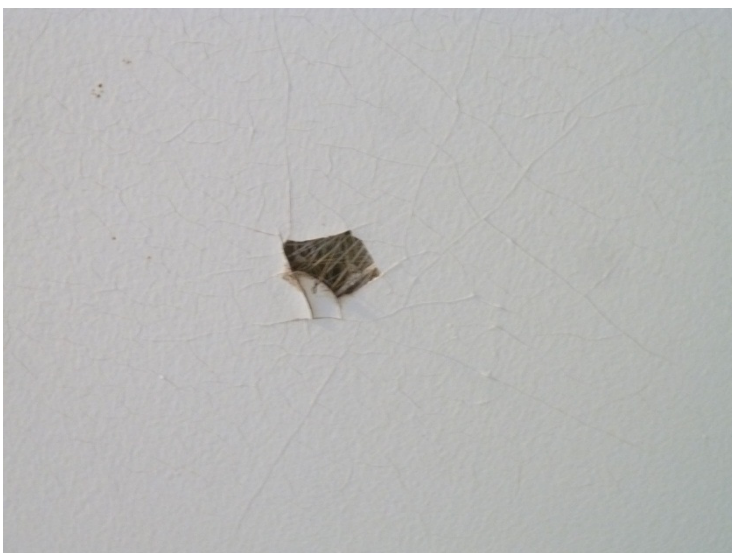
- The super structures of the residential units have capacities of 100% NBS, as limited by the in-plane capacity of the bracing walls. They are deemed to be a 'low risk' in a design seismic event according to NZSEE guidelines. Their level of risk is less than 1 times that of a new building (Figure 1).
- The sub floor bracing in the residential units is 20-30% NBS as there is little evidence of adequate bracing and no evidence of a connection between the piles and the bearers. This failure mode is not a critical structural weakness as it will not cause a brittle failure. In the event of a significant seismic event, the units could come off their piles but the structures would not collapse. On this basis, the units still remain fit to occupy.
- Water damage to the ceilings indicates that the water-tightness of the roof may be compromised.

20.	Typical ceiling damage observed in most units (likely the result of water damage)

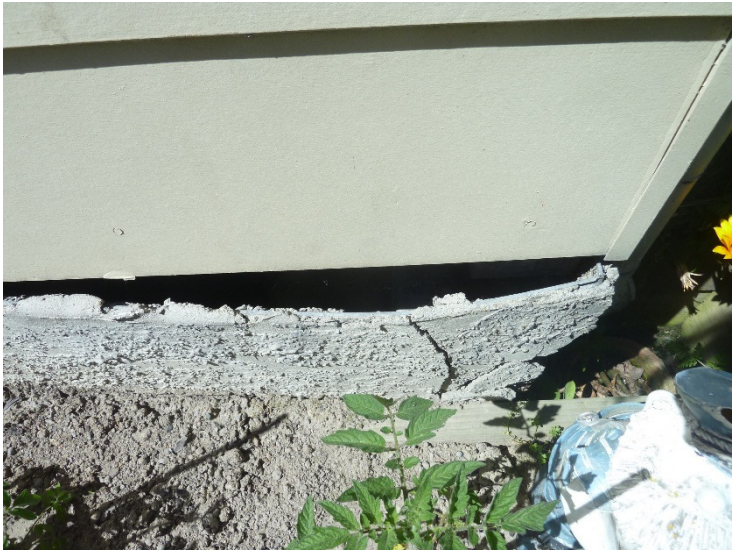
A 140mm separation was observed between the timber floor bearer and the corner concrete pile of Unit 14 (photo 23). The render on mesh 'perimeter wall' has also sunk significantly along with the stormwater drain which drains directly below the corner pile (photos 21 and 22). The evidence on site shows that the settlement is likely due to a leak or inadequate path for water from this drain.

21.	Damage to sunken render and pile on the corner of Unit 14

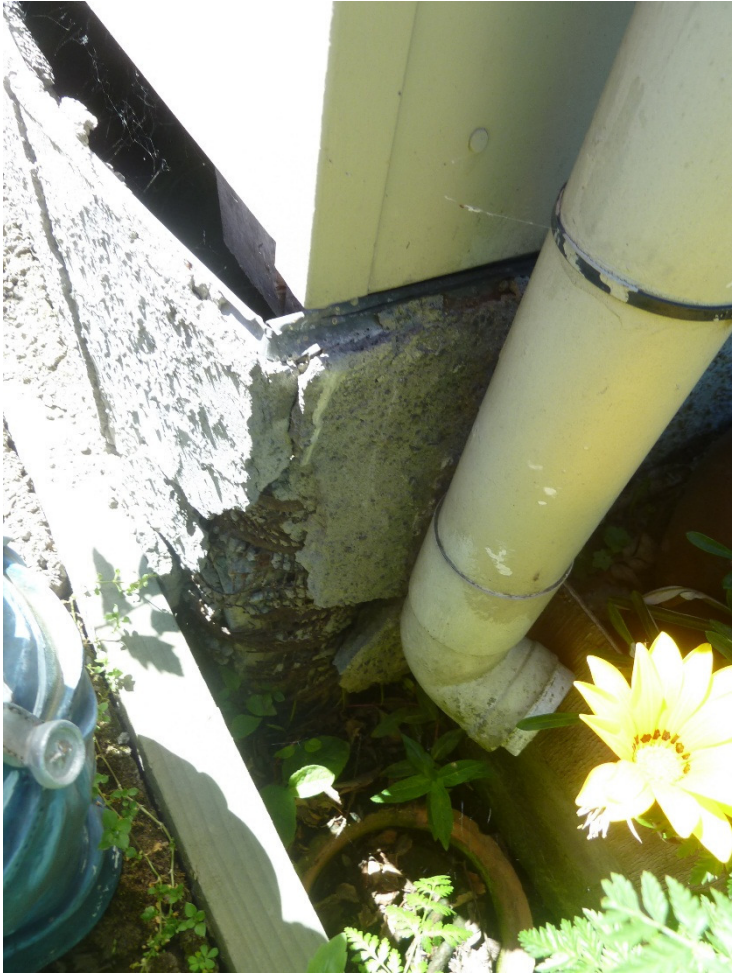
22.	Damage to sunken render and pile on the corner of Unit 14

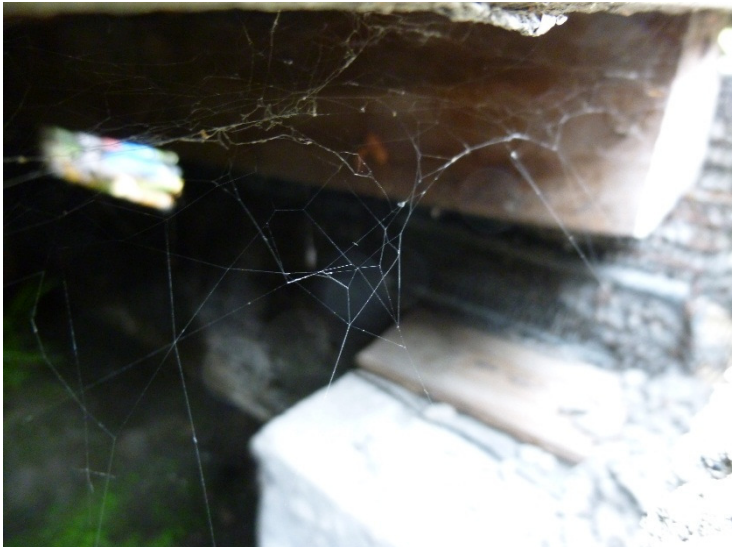
23.	Pile on the corner of Unit 14 sunk up to 140mm
