CHRISTCHURCH CITY COUNCIL
PRK_1044_BLDG_006 EQ2
Waltham Park -Toilets
30-40 Waltham Rd, Waltham

QUALITATIVE ASSESSMENT REPORT

FINAL

- Rev C
- 24 April 2014

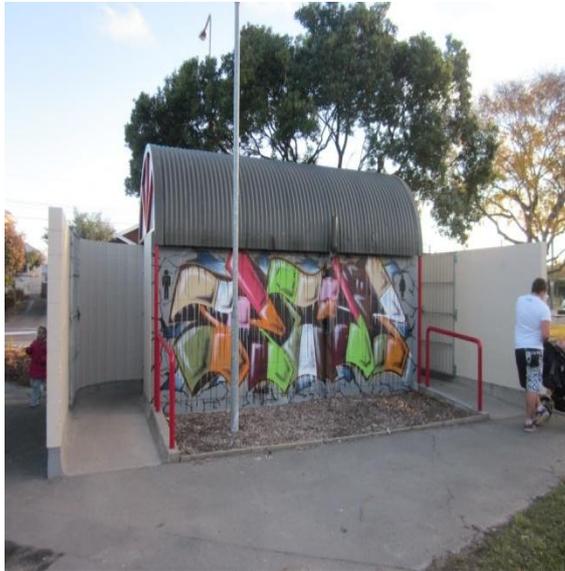
Photo 1: The east elevation of Building 6

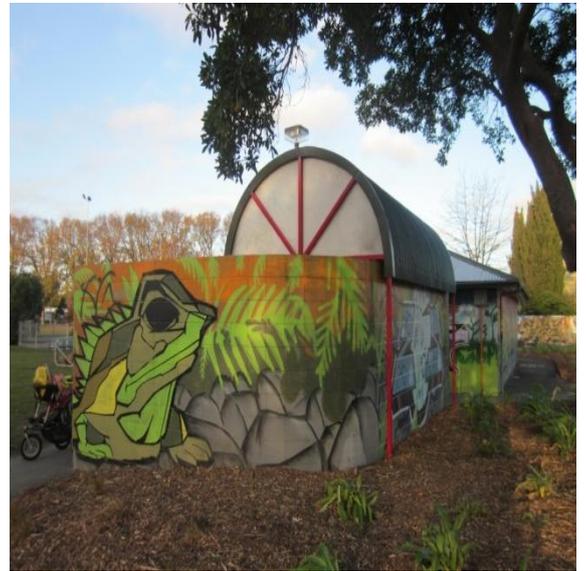
Photo 2: The north and west elevations of Building 6

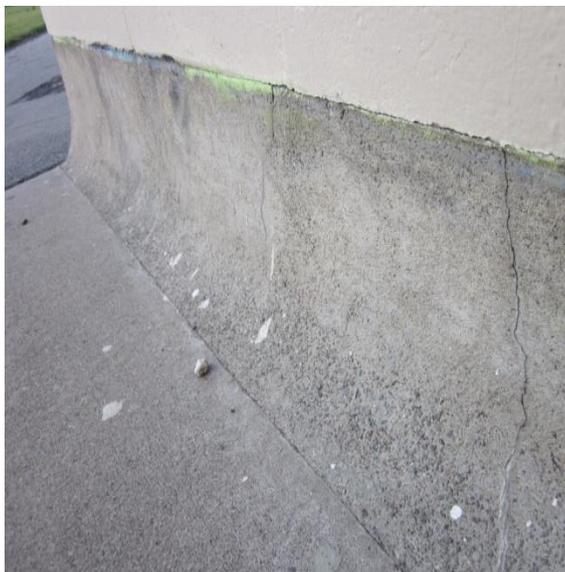
SKM undertook an inspection of the building from floor level on 22 May 2012. No structural damage to the building was observed at the time of the inspection. Some cracking was found in the concrete fillet at the base of the masonry walls; however this cracking is not thought to be earthquake related.

Photo 3: Non-earthquake related cracking in the concrete fillet at the base of the masonry walls

Pounding:	Damage?: no	Describe:
Non-structural:	Damage?: no	Describe:
Recommendations		
Level of repair/strengthening required:	minor non-structural	Repair of cracks in concrete fillet at base of masonry walls required
Building Consent required:	no	Describe:
Interim occupancy recommendations:	full occupancy	Describe:
Along:	Assessed %NBS before: 100%	%NBS from IEP below
	Assessed %NBS after: 100%	If IEP not used, please detail assessment methodology:
Across:	Assessed %NBS before: 100%	%NBS from IEP below
	Assessed %NBS after: 100%

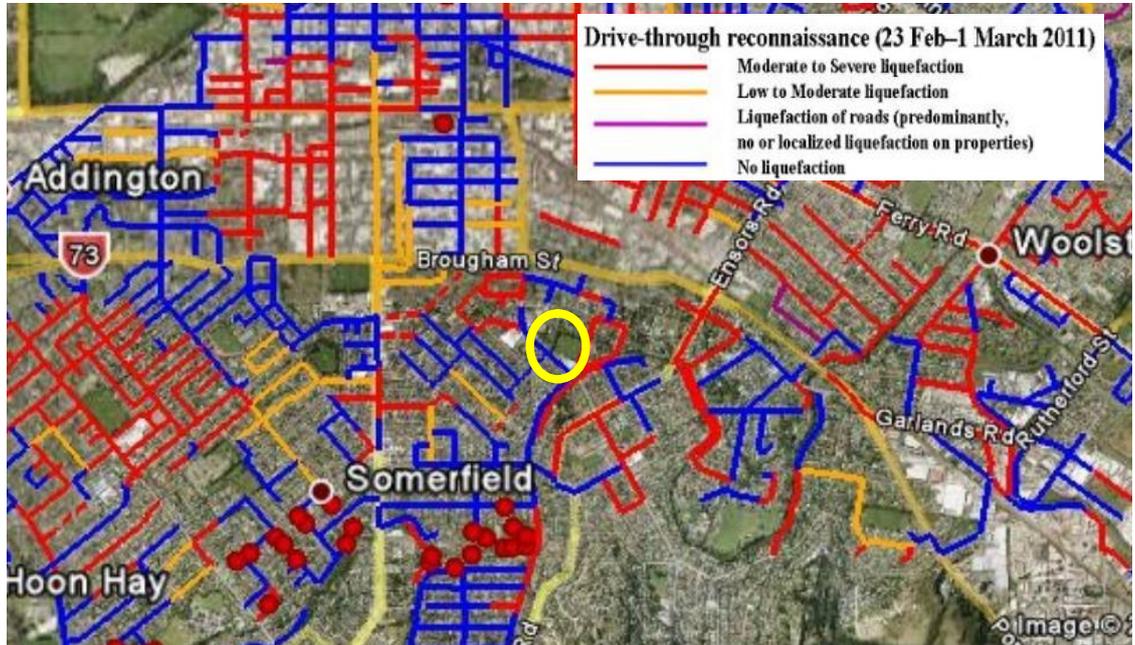
■ Figure 4 – Liquefaction map (Cubrinovski & Taylor, 2011). Site marked in yellow.

Following the 22 February 2011 event drive through reconnaissance was undertaken from 23 February until 1 March by M Cubrinovski and M Taylor of Canterbury University. Their findings show no liquefaction along Waltham Road which is immediately to the south of Waltham Park. However moderate to severe liquefaction is highlighted along Wilsons Road and Fifield Terrace located approximated 130 m east of the site.

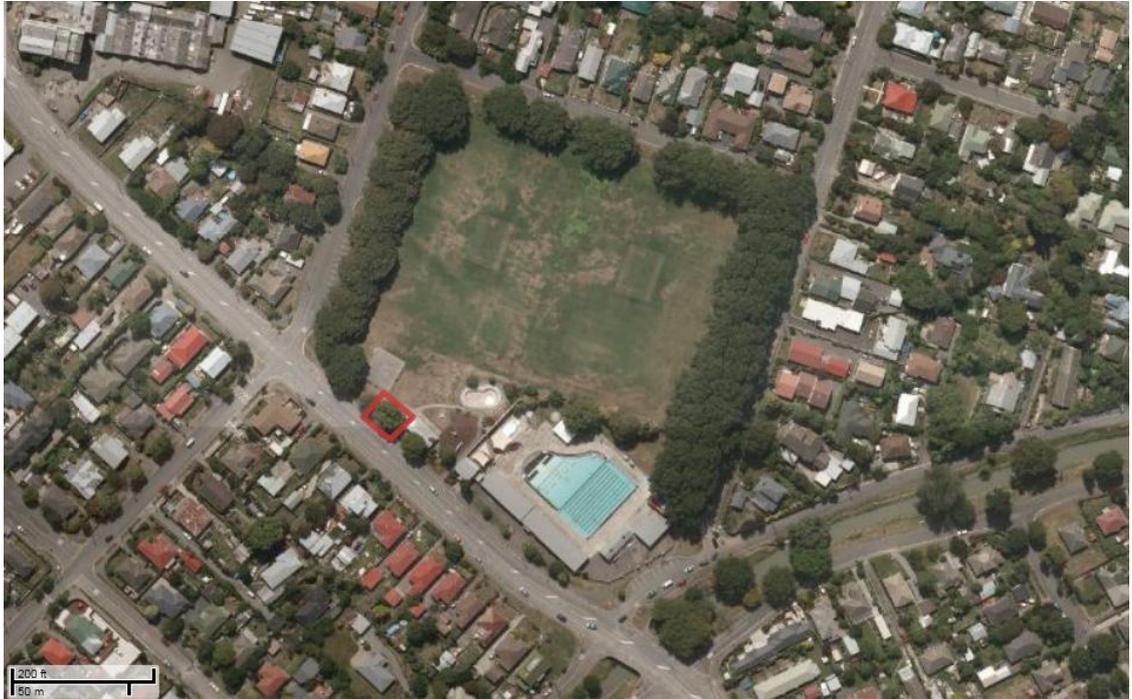
- **Figure 5 – Aerial photography from 24 Feb 2011 (<http://viewers.geospatial.govt.nz/>)**

Aerial photography does not show any obvious signs of liquefaction in the local area after the 22 Feb 2011 event, including at a road intersection to the south west of the site. No evidence of lateral spreading associated with the nearby Heathcote River to the south east is observed.

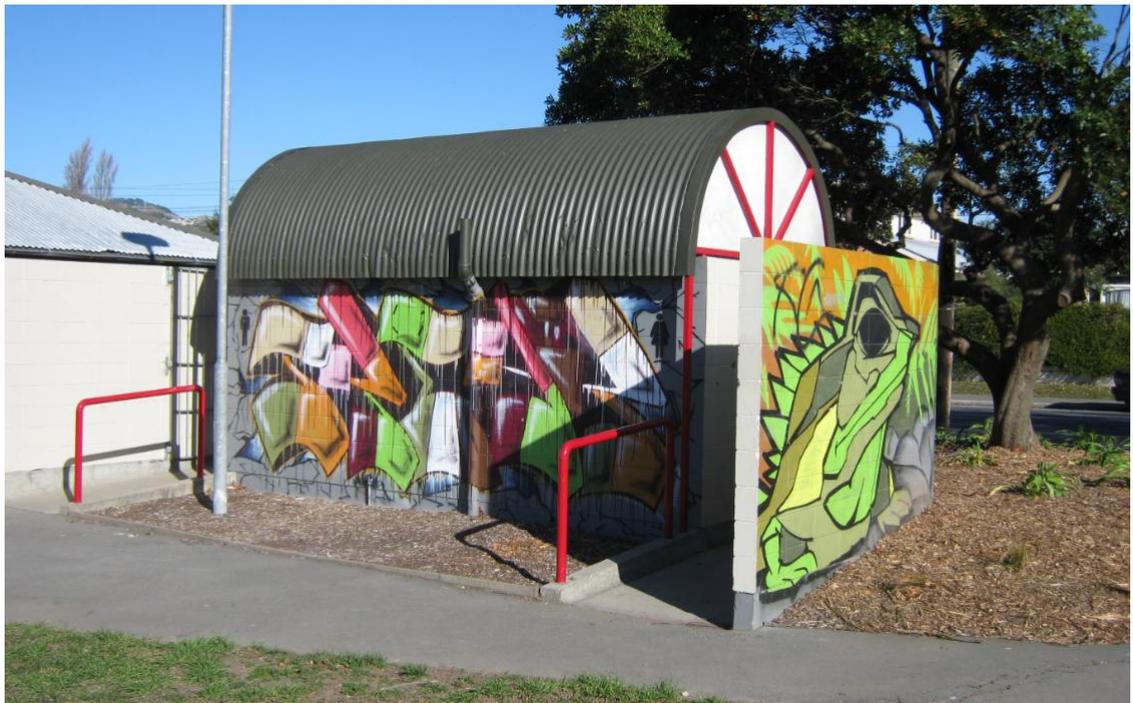
The toilet block is a masonry block building with corrugated iron roof and has a concrete slab on grade foundation. Very little indication of damage could be observed of the toilet buildings on site, with minor hairline cracks on the concrete masonry block wall. The adjacent pavilion building did not exhibit any damage.

■ **Figure 7** Toilet block at Waltham Park

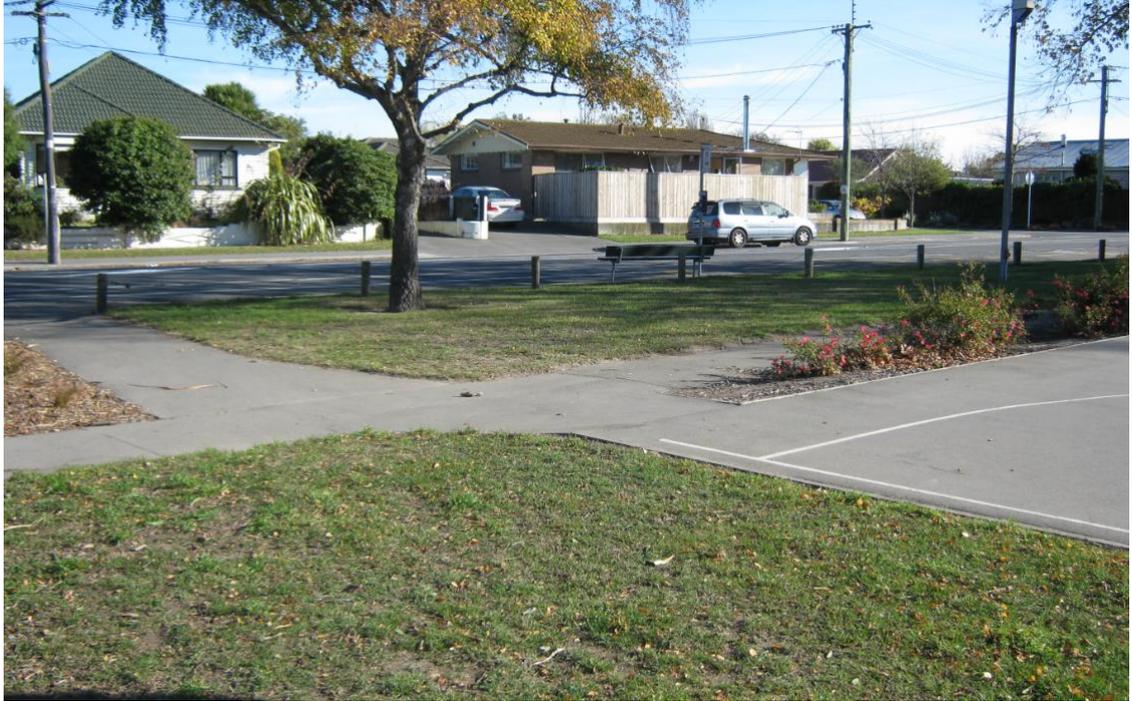
The asphalt, cobble and concrete paths close the toilet block did show some minor settlement. It is possible that this is settlement of fill, however their condition was generally poor and root damage was common. The nearby basketball court was undamaged. Waltham Road appeared to be undamaged.

- **Figure 8** A view from the toilet block of Waltham Rd and the basketball court with no damage observed.
