Waltham Pool Plant Room
BU 1044-003 EQ2
Detailed Engineering Evaluation
Qualitative Report
FINAL

Waltham Park, 30-40 Waltham Road,
Christchurch

Christchurch City Council

Date
21 May 2013

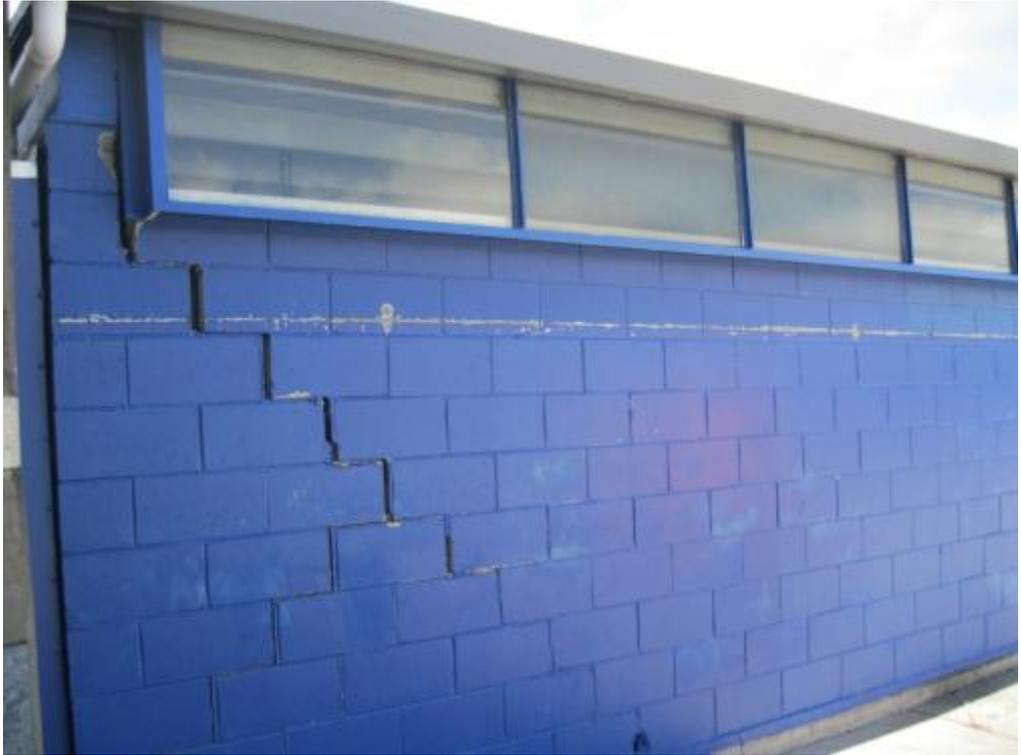
The differential settlement and seismic damage has caused diagonal shear failure in the northwest, northeast, and southeast walls, with extensive large cracks to the mortar between concrete masonry blocks and separation of the unreinforced blockwork, up to 30mm in width. Daylight is visible through several of these cracks, as shown in the photographs in Appendix A of this report.

Photograph 1: Northwestern exterior wall shear damage.

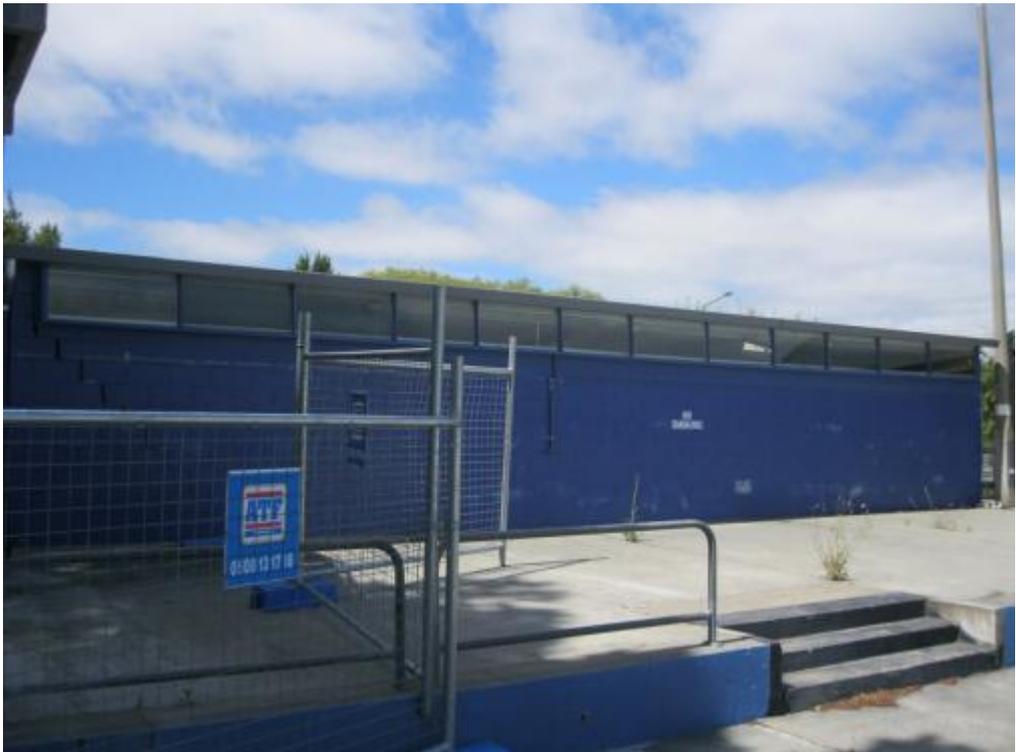
Photograph 2: Northwestern exterior wall elevation (damage at left).

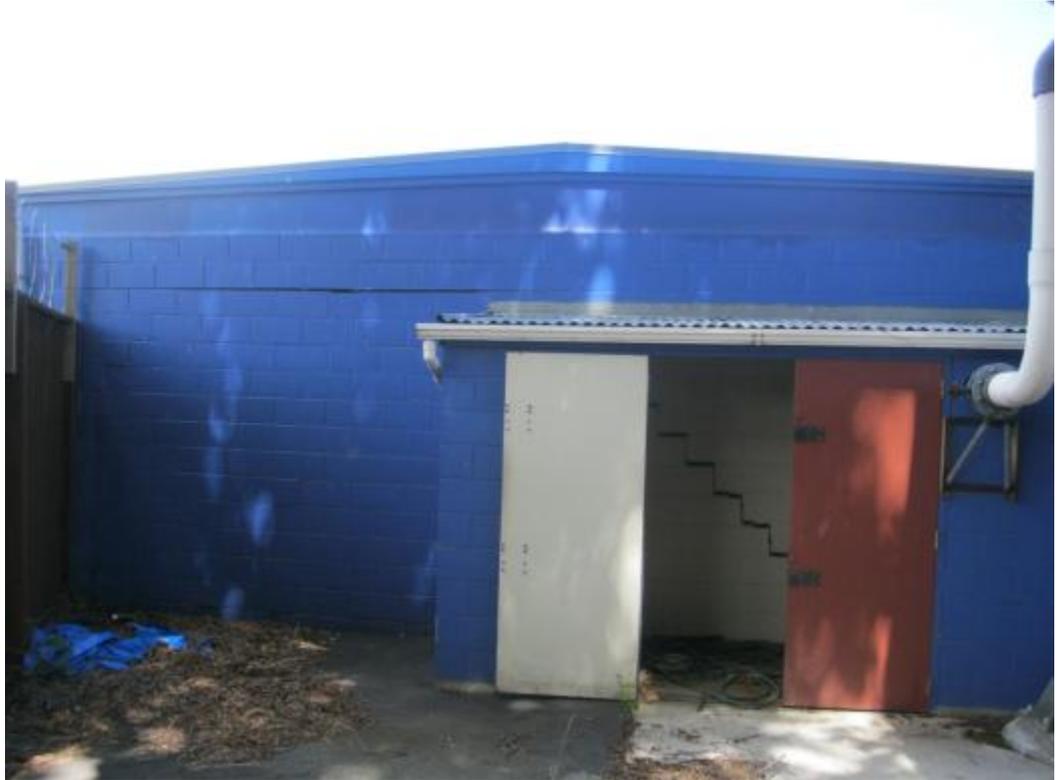
Differential settlement was noted in the middle area of the northeast wall. This has caused cracks to develop in the floor slab inside the plant room, of roughly 10mm width, and in the northeast wall, where large cracks show evidence of this settlement and of lesser lateral movement. The northeastern wall has settled overall, in the order of 100mm to 200mm change in level.

Photograph 3: Northeastern exterior wall and addition – note settlement and lateral movement.

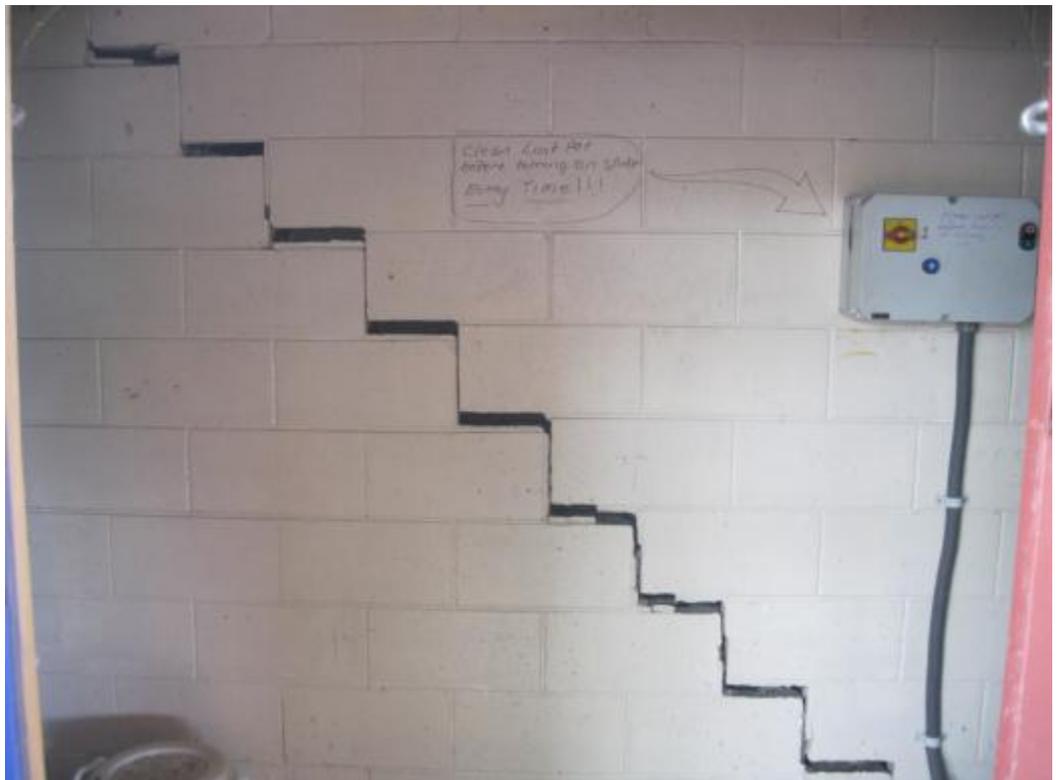
Photograph 4: External view of northeastern exterior wall damage (inside addition).

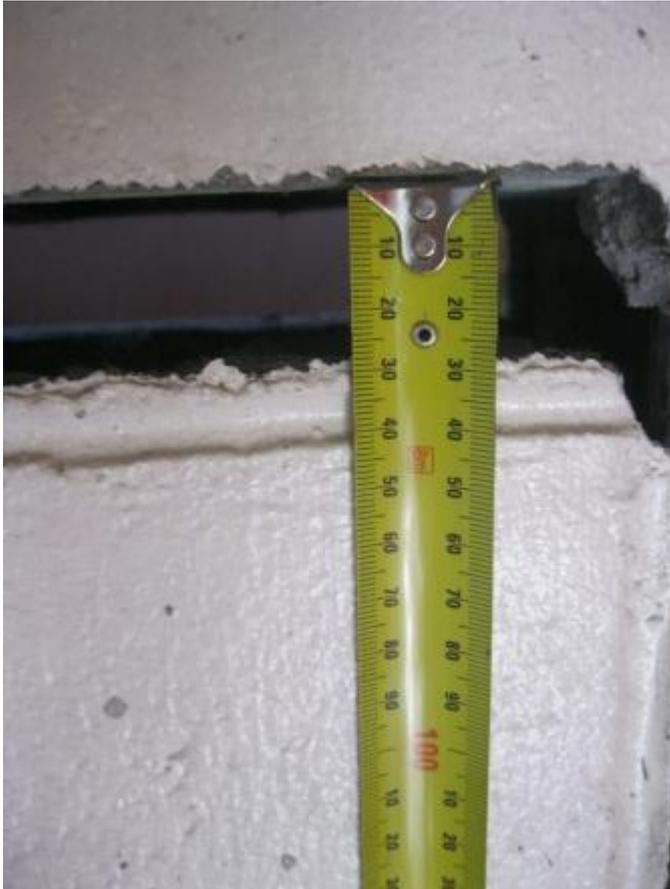
Photograph 5: Damage to northeastern exterior wall (inside addition).

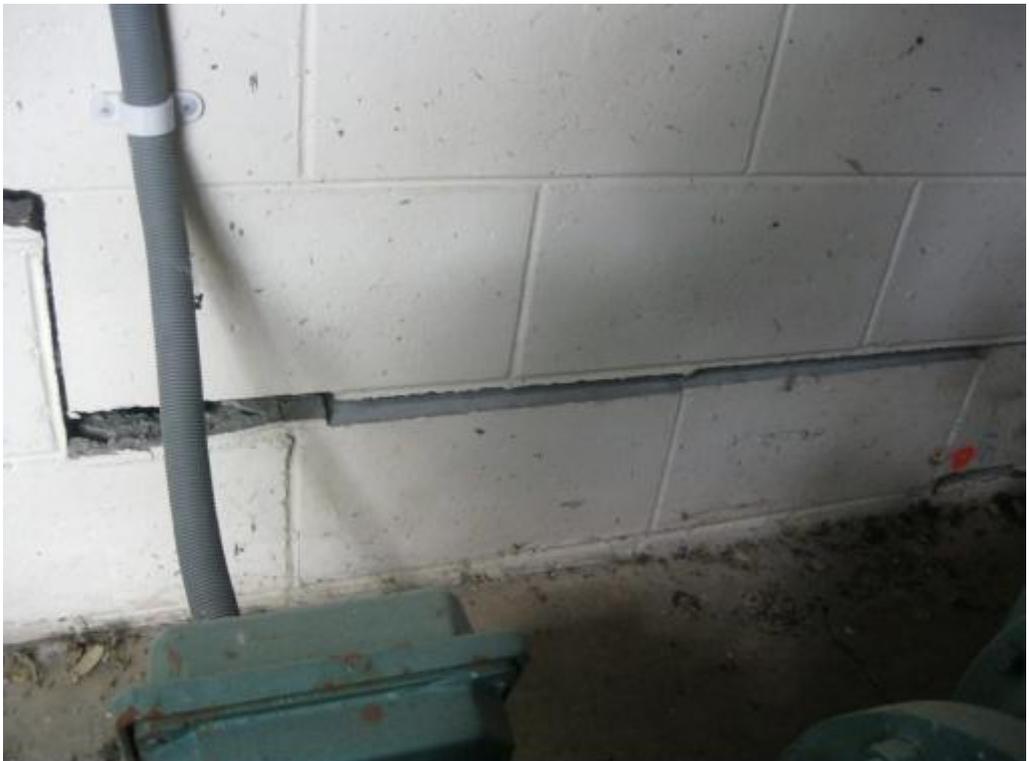
Photograph 6: Damage to external northeastern wall.

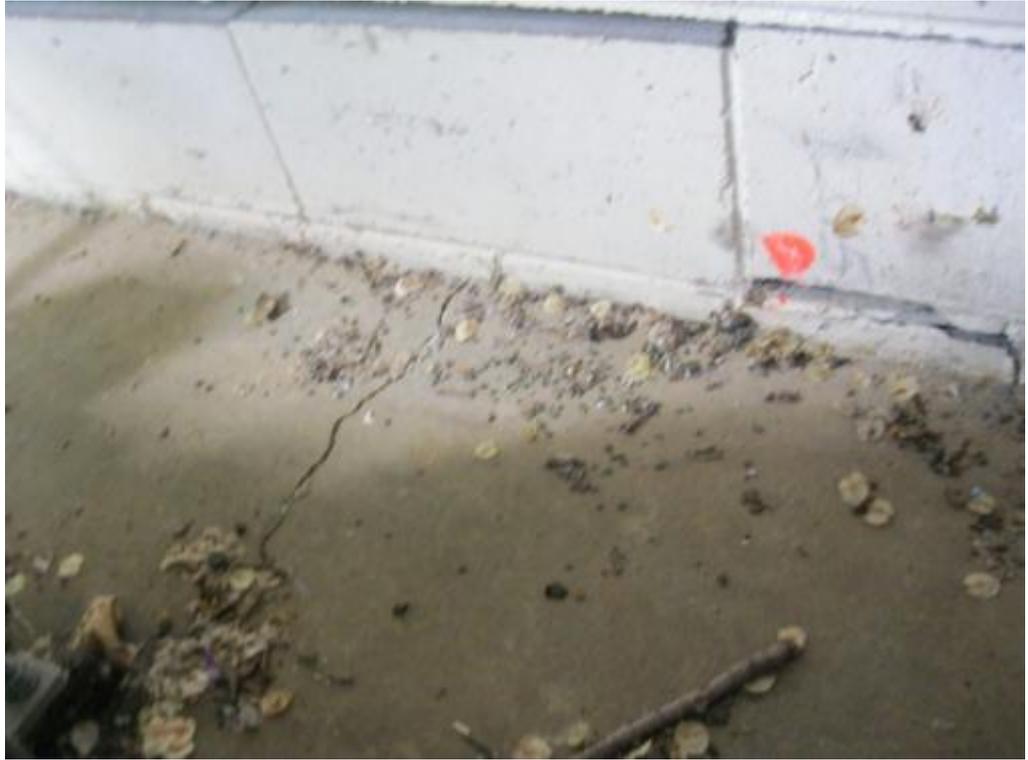
Photograph 7: Floor cracking at northeastern external wall.

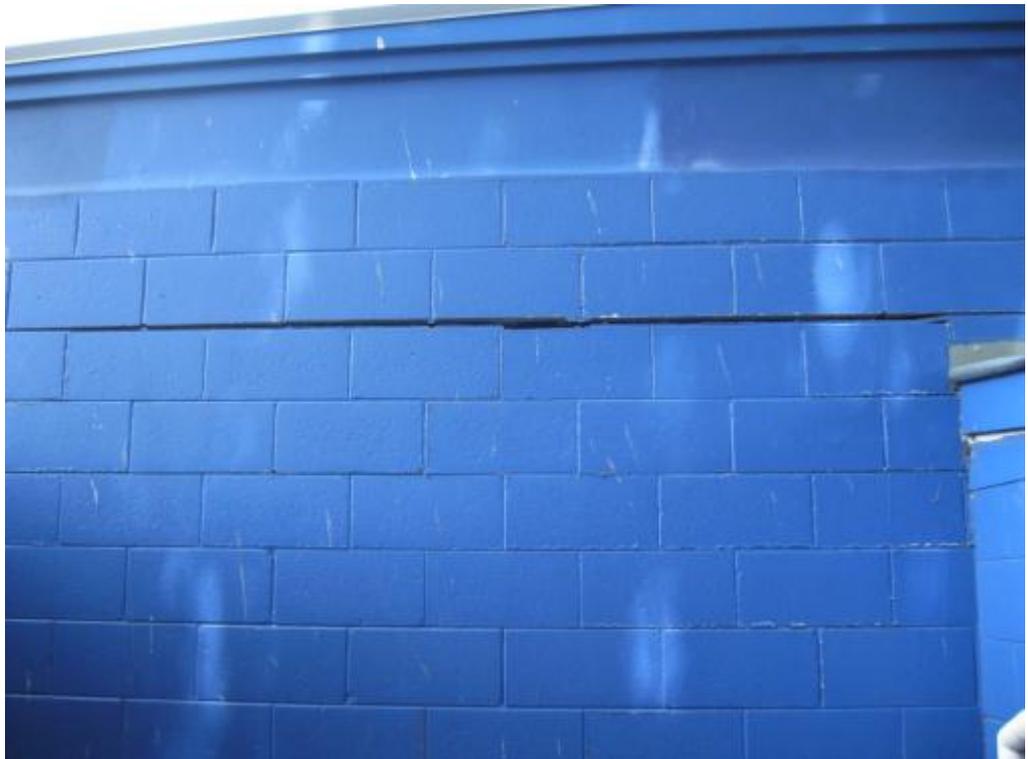
Photograph 8: Settlement damage at southern side of northeastern external wall.

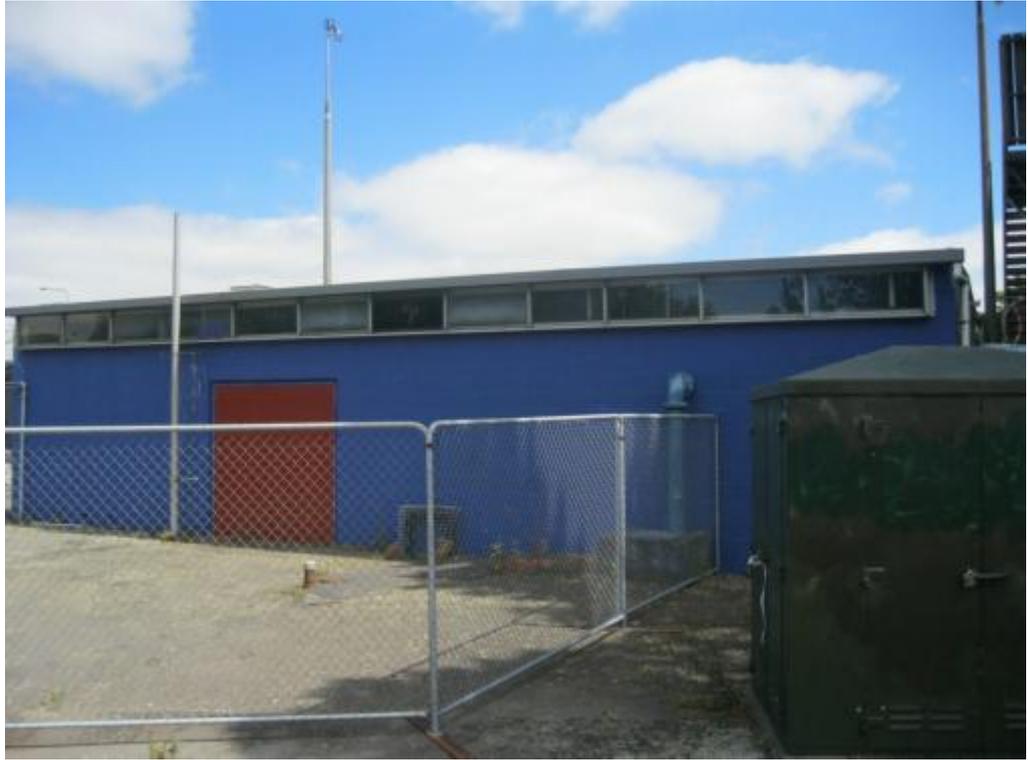
Photograph 9: Southeastern external wall elevation.

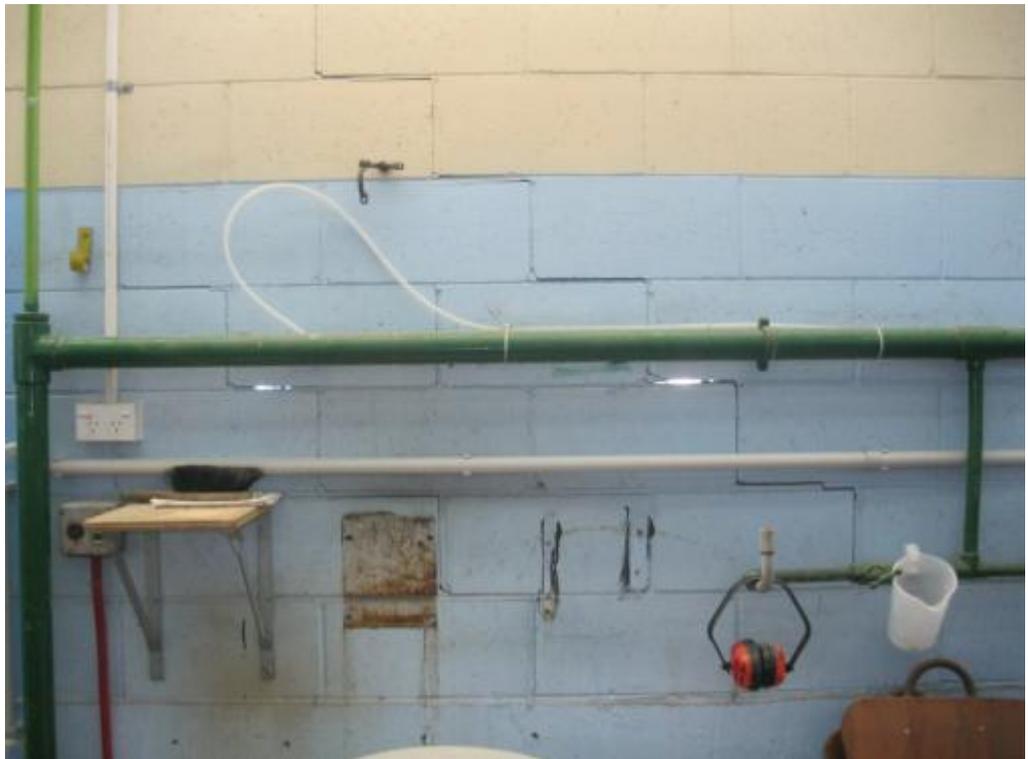
Photograph 10: Shear damage to southeastern external wall.

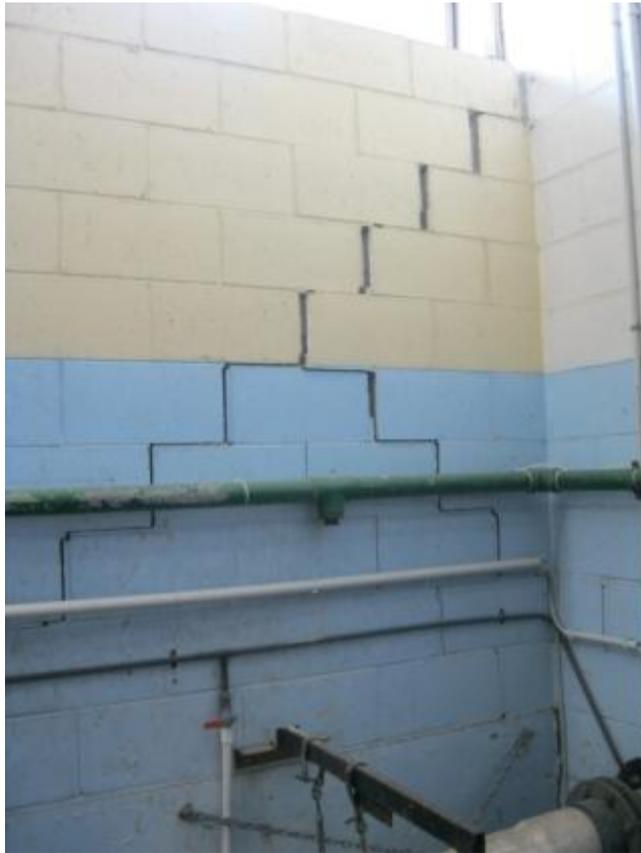
Photograph 11: Internal view of damage to northwestern external wall.

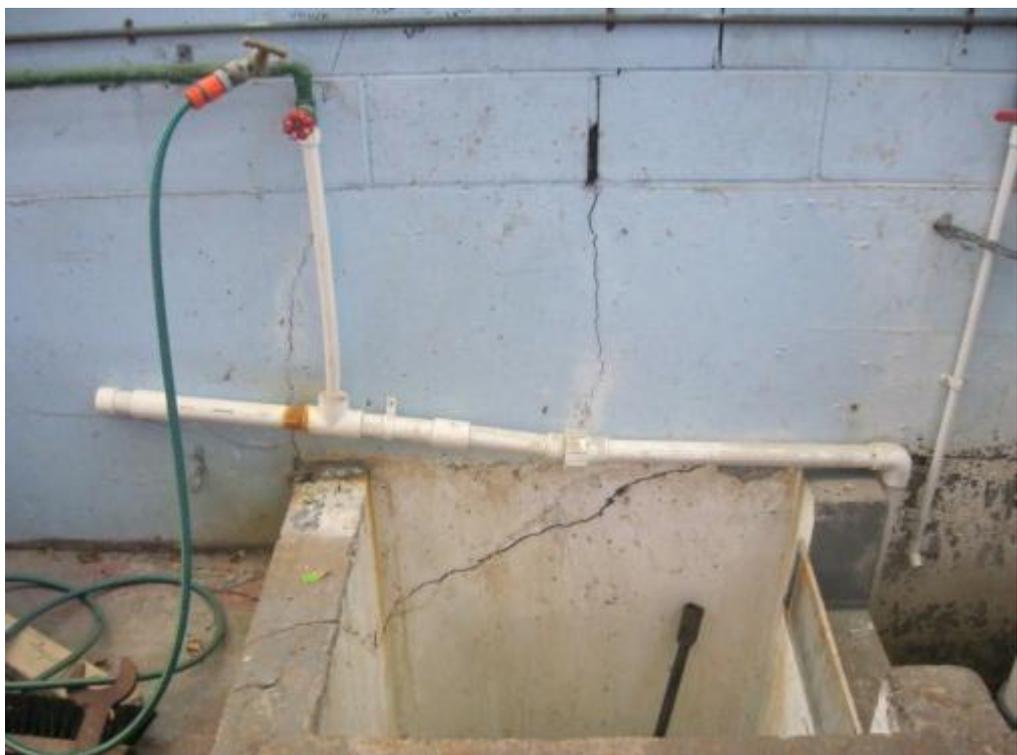
Differential settlement has induced cracking in the foundation around the service pit area, with cracks up to 5mm in width. These cracks occur just below the southeastern wall section where shear cracking is evident.

Photograph 12: Damage to wall and foundation at service pit.

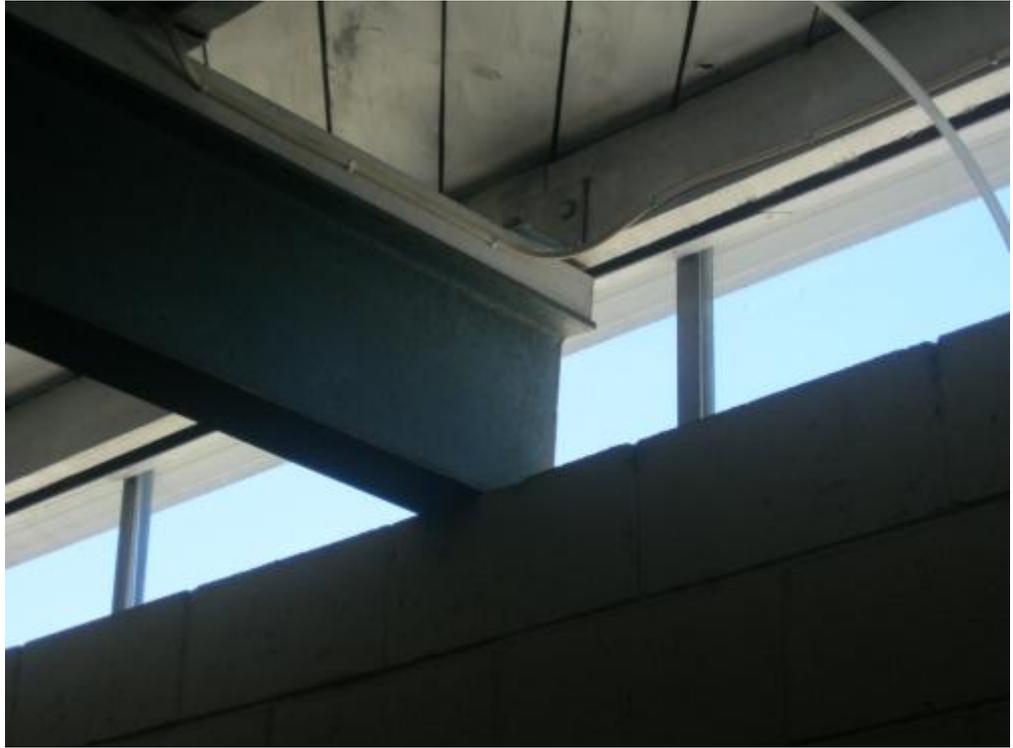
Photograph 13: Steel rafter rollover damage.
