Waltham Pool Staff Room
BU 1044-002 EQ2
Detailed Engineering Evaluation
Qualitative Report
Version FINAL

Waltham Park, 30-40 Waltham Road,
Christchurch

Christchurch City Council

Date
13/09/12

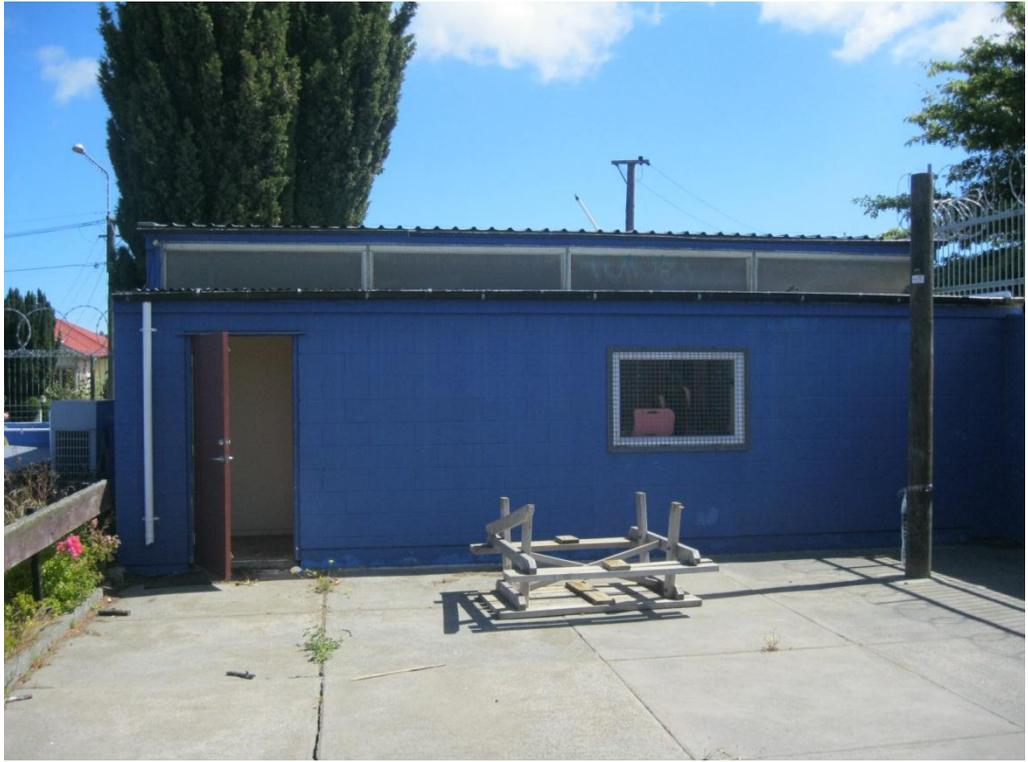
Photograph 1: Eastern front wall elevation.

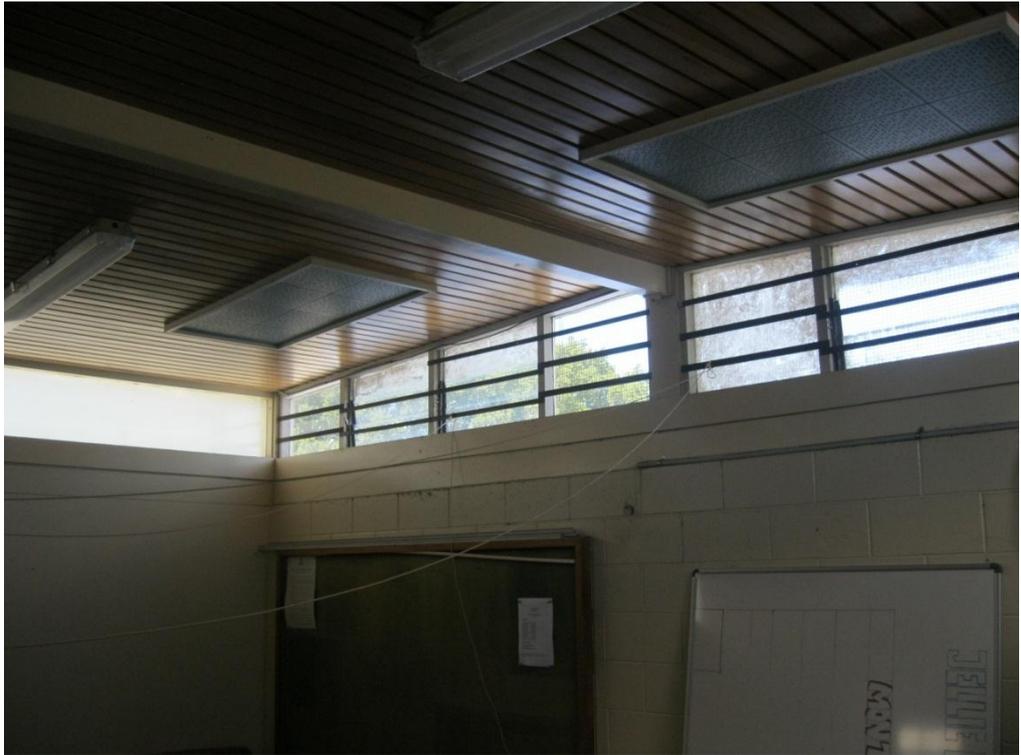
Photograph 5: Timber gable roof beam and windows.

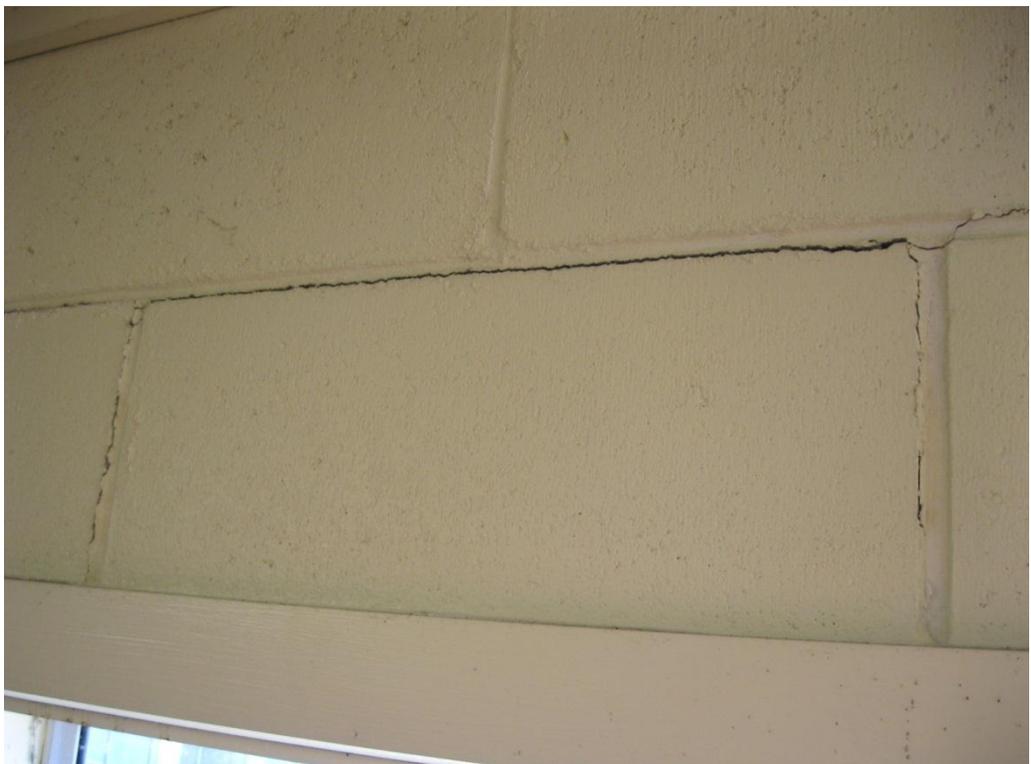
There was some minor zig-zag cracking observed in the mortar between concrete masonry units on the front external wall. The concrete lintel above the window in the front wall showed the most cracking damage. This minor damage in the front wall is attributed to seismic actions on the structure.

Photograph 6: Seismic damage to front external wall.

The damage to the building during recent seismic activity in Christchurch has caused minor damage to the building, with minor cracking in the front external block walls and concrete lintel above the window in this wall. The structure achieves only 3% NBS due to its poor design, critical structural weakness and date of construction. The building should be classified as potentially Earthquake Prone and should undergo a detailed seismic assessment to determine its seismic capacity.

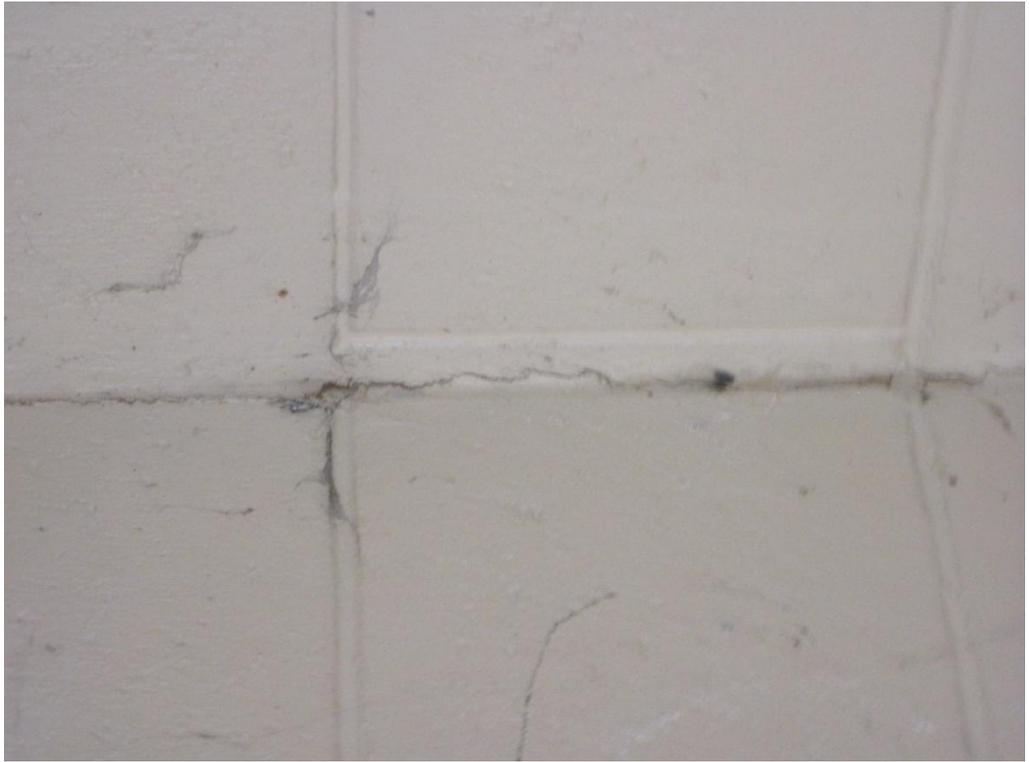
Photograph 7: Seismic damage to front external wall.

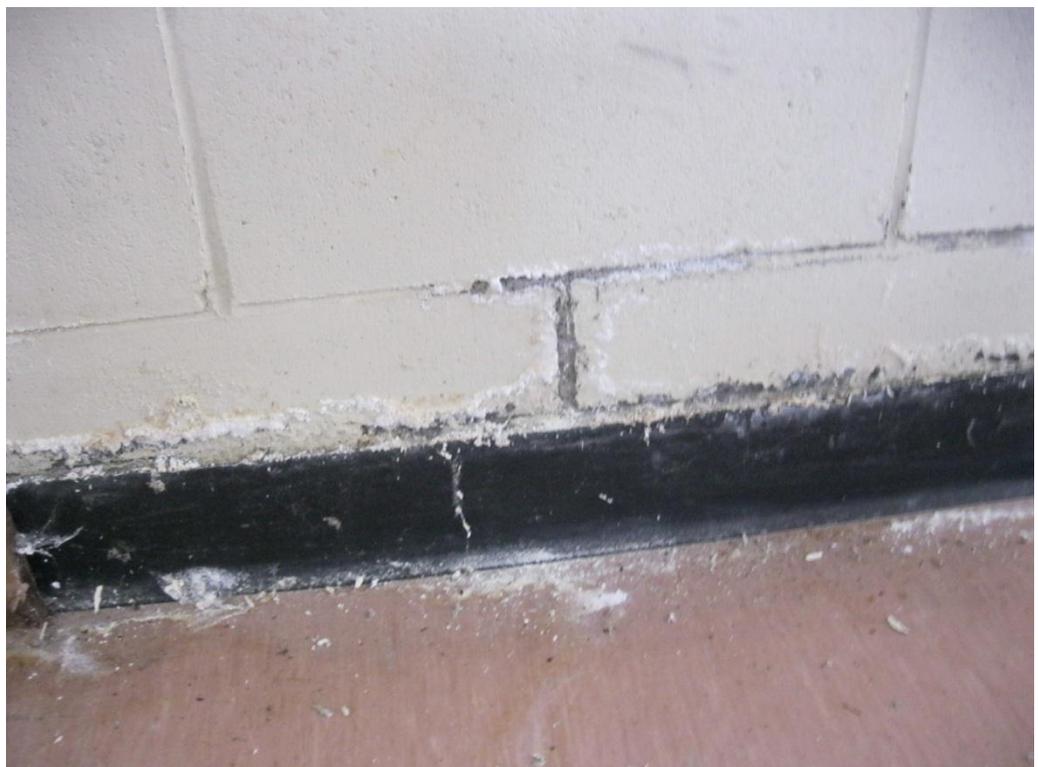
Some chloride deterioration was observed in the mortar of the bottom course of the front wall.

Photograph 8: Chloride deterioration at base of front external wall.
