Waltham Pool Tank
BU 1044-004 EQ2
Detailed Engineering Evaluation
Qualitative Report
FINAL

Waltham Park, 30-40 Waltham Road,
Christchurch

Christchurch City Council

Date
07/12/12

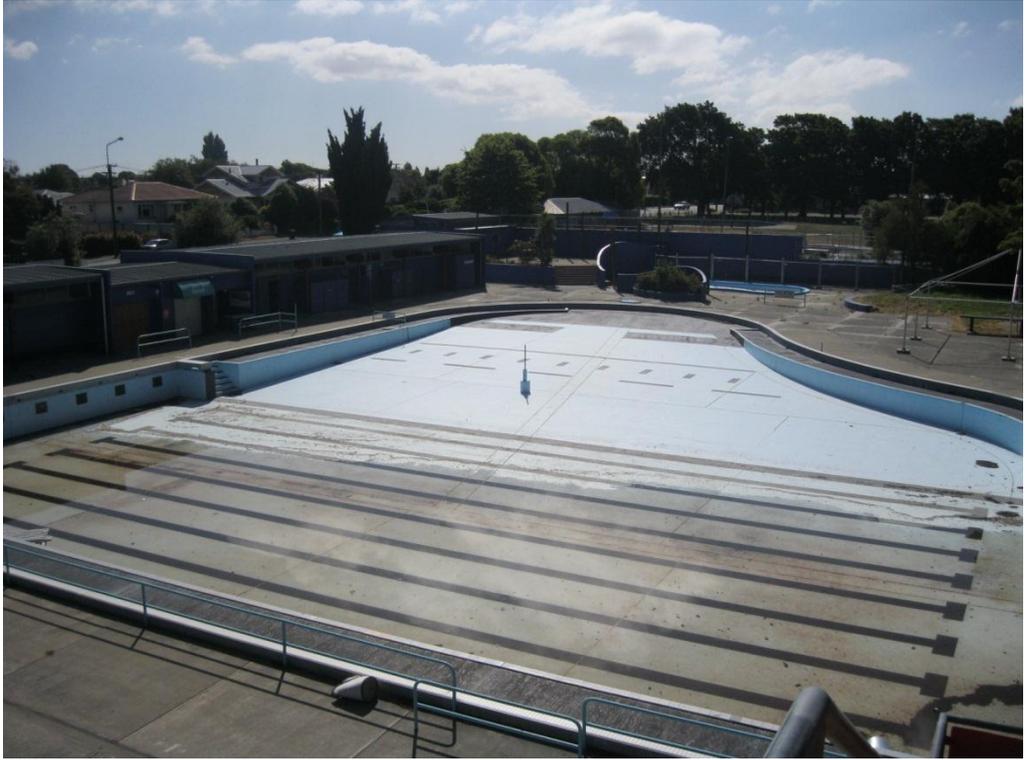
Photograph 1: Unfilled Pool Tank looking Northwest.

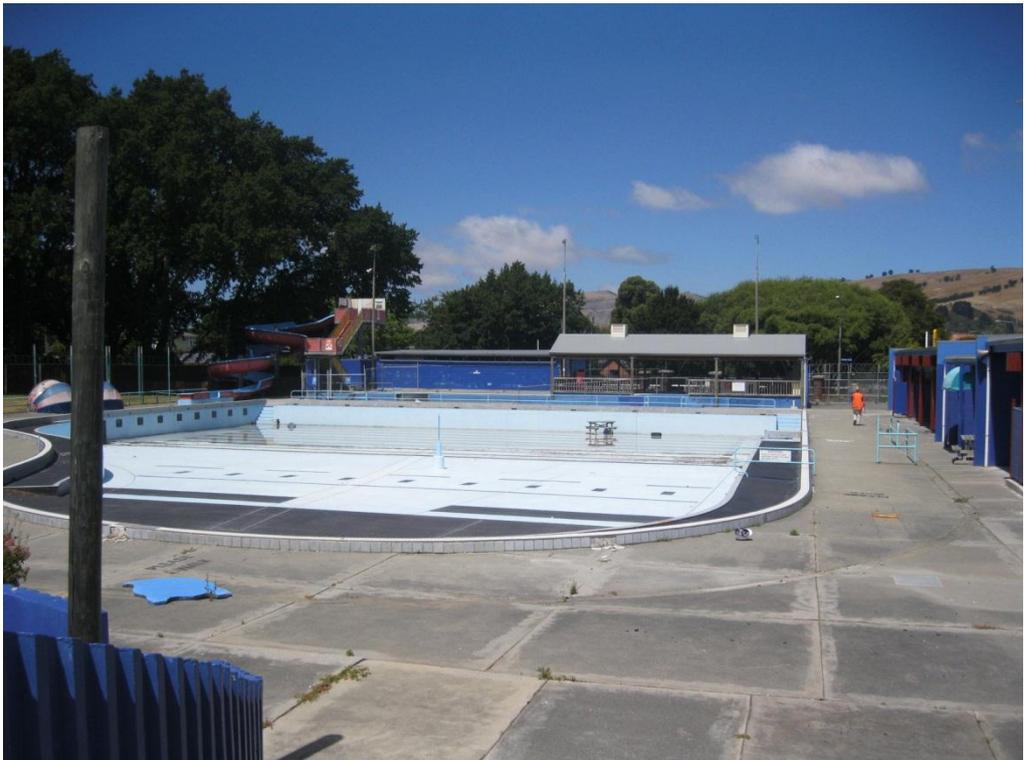
Photograph 2: Unfilled Pool Tank looking Southeast.

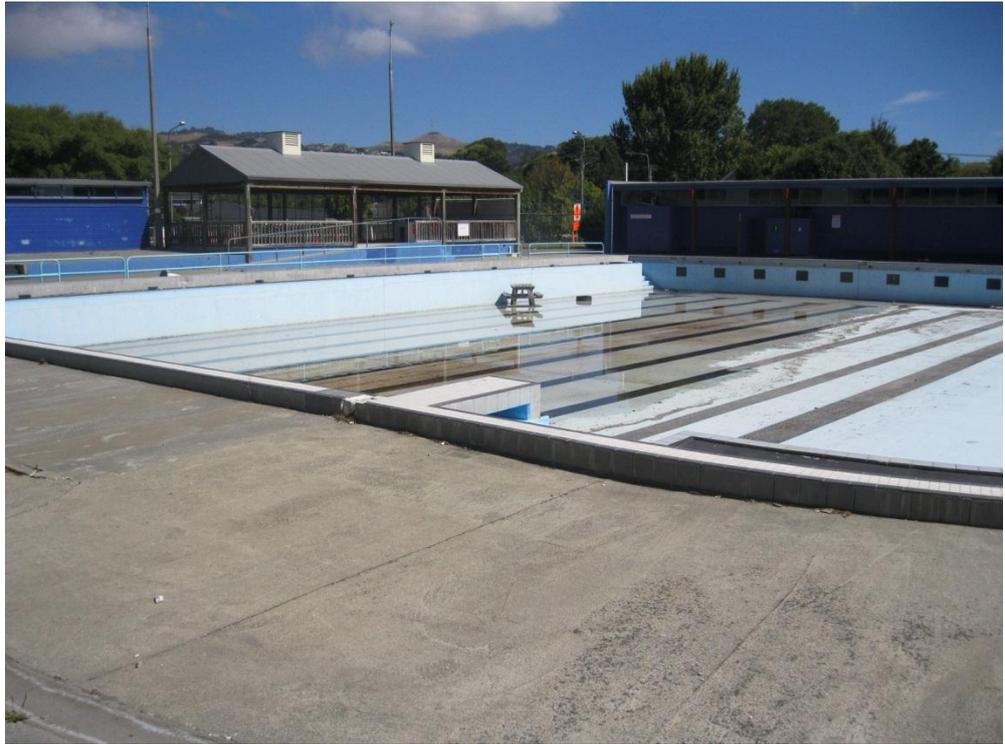
Photograph 3: Unfilled Pool Tank looking South. Note concrete block bund.

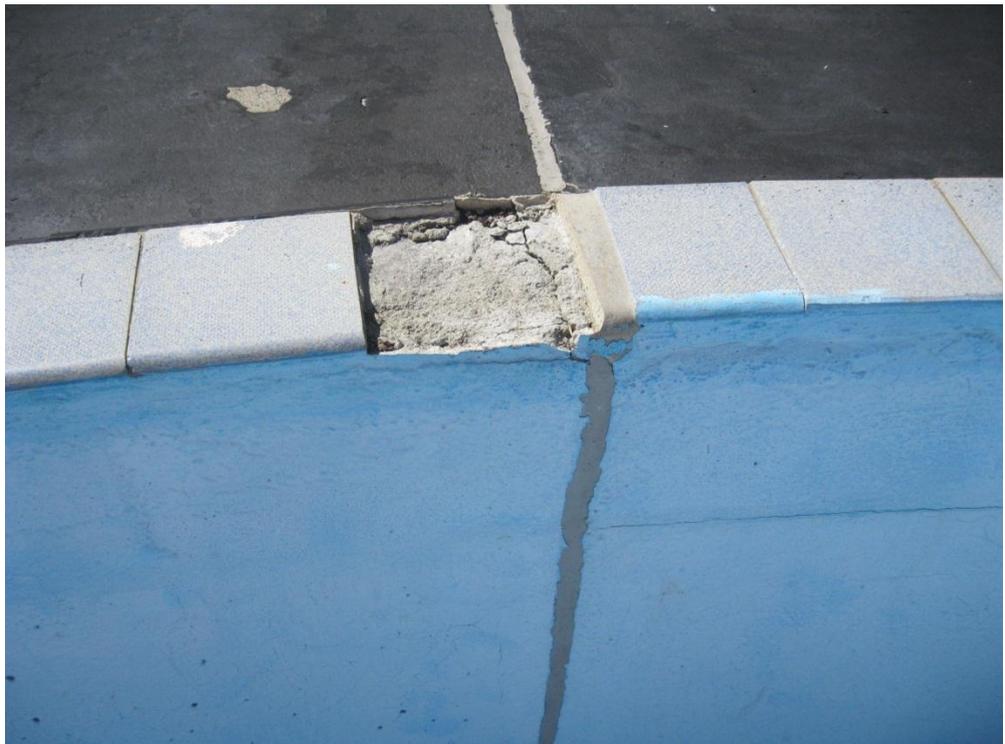
Photograph 4: Damage to tile at top of tank wall.

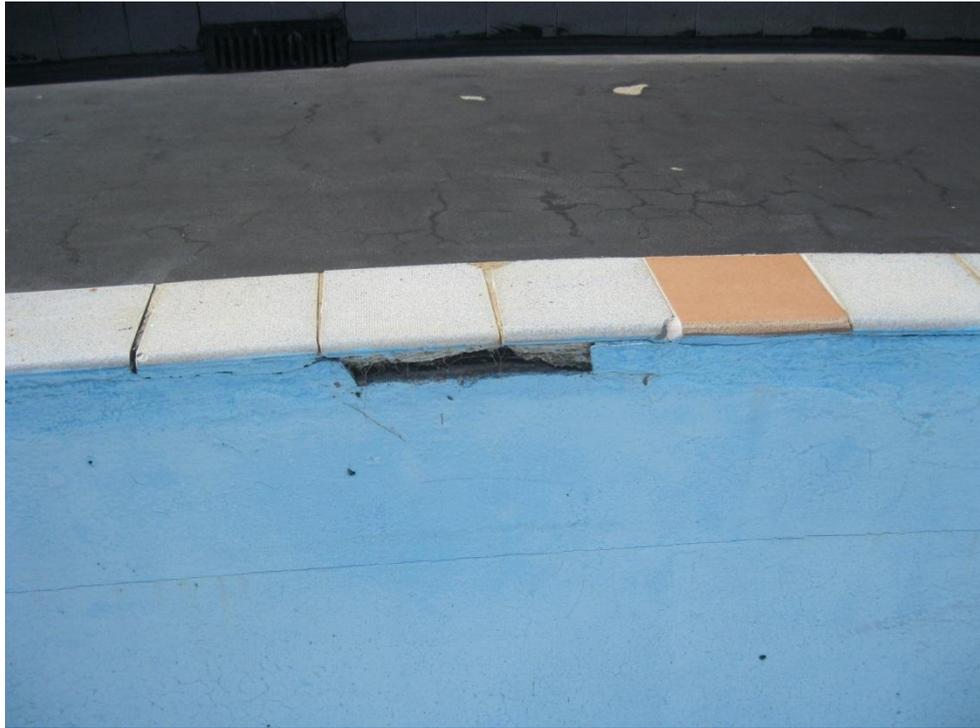
The pool tank structure is largely undamaged. A large crack was noted in the mortar between concrete blocks at the top of the wall, above one of the tank wall control joints. A few small cracks were noted in the concrete tank walls that appear to be related to shrinkage and not seismic damage.

Photograph 5: Damage at top of tank wall.

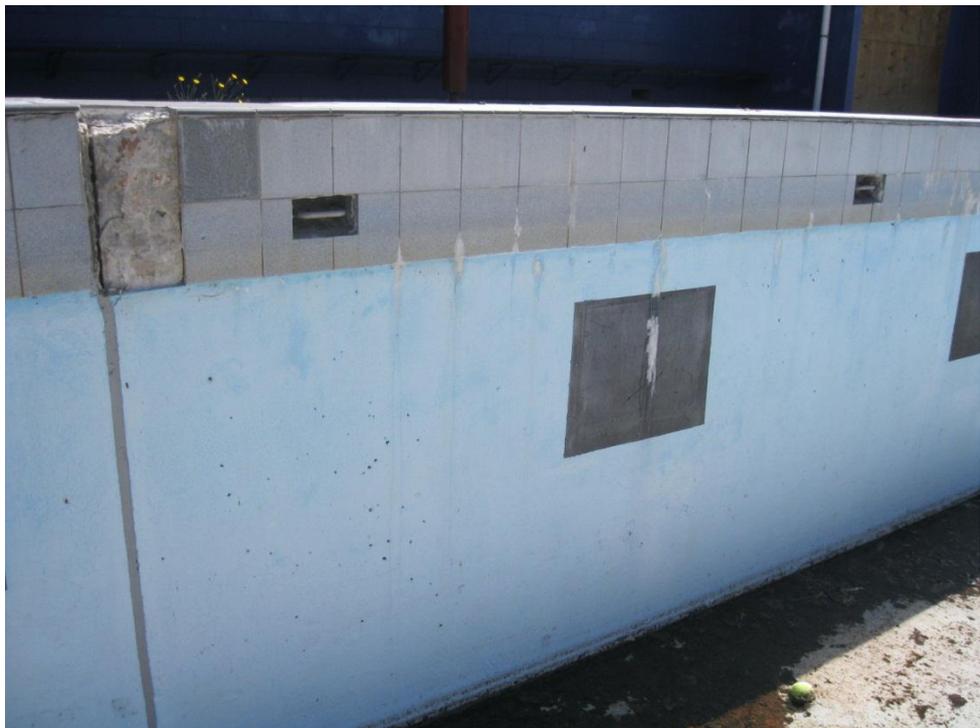
The pool tank appears to be in good condition structurally. There were some minor shrinkage cracks observed, and one crack along the mortar between the top of the reinforced concrete tank wall and the concrete block, which could be due to previous seismic action. There was no other apparent damage that should be attributed to seismic action.

Photograph 6: Damage to mortar surrounding concrete block bund at top of tank wall.

| Recommendations | | Level of repair/strengthening required: <input type="text" value="minor non-structural"/> | Describe: <input type="text" value="Repair minor cracks"/> |

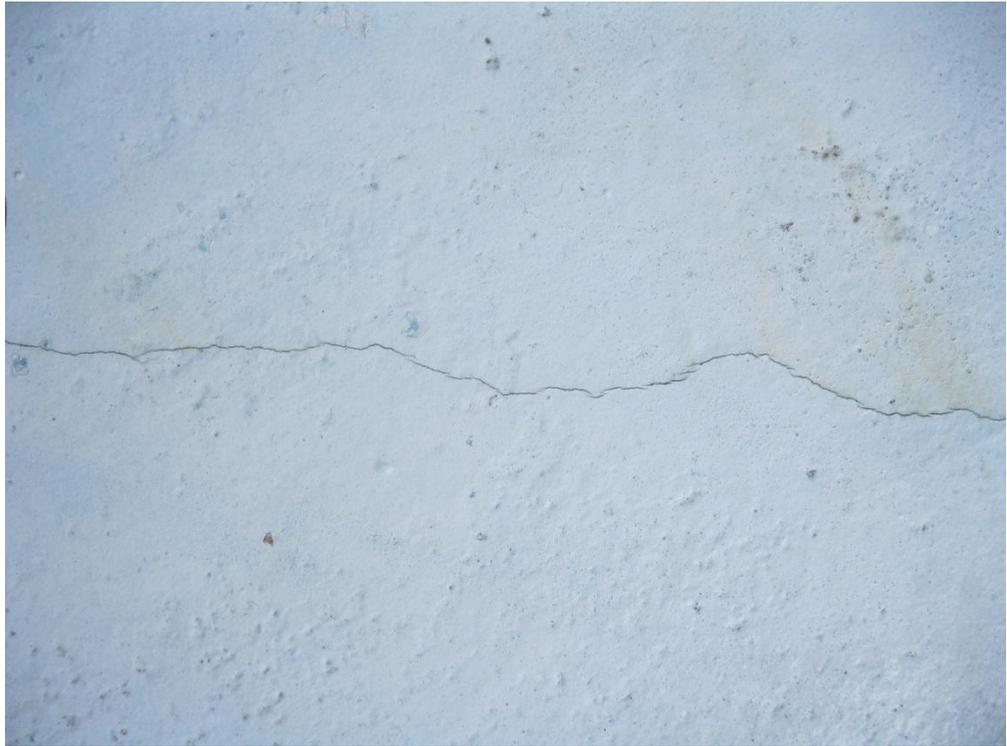
Photograph 7: Shrinkage crack in reinforced concrete tank wall.
