Warren Park Community Building

PRK 1567 BLDG 003

Detailed Engineering Evaluation

Quantitative Engineering Report

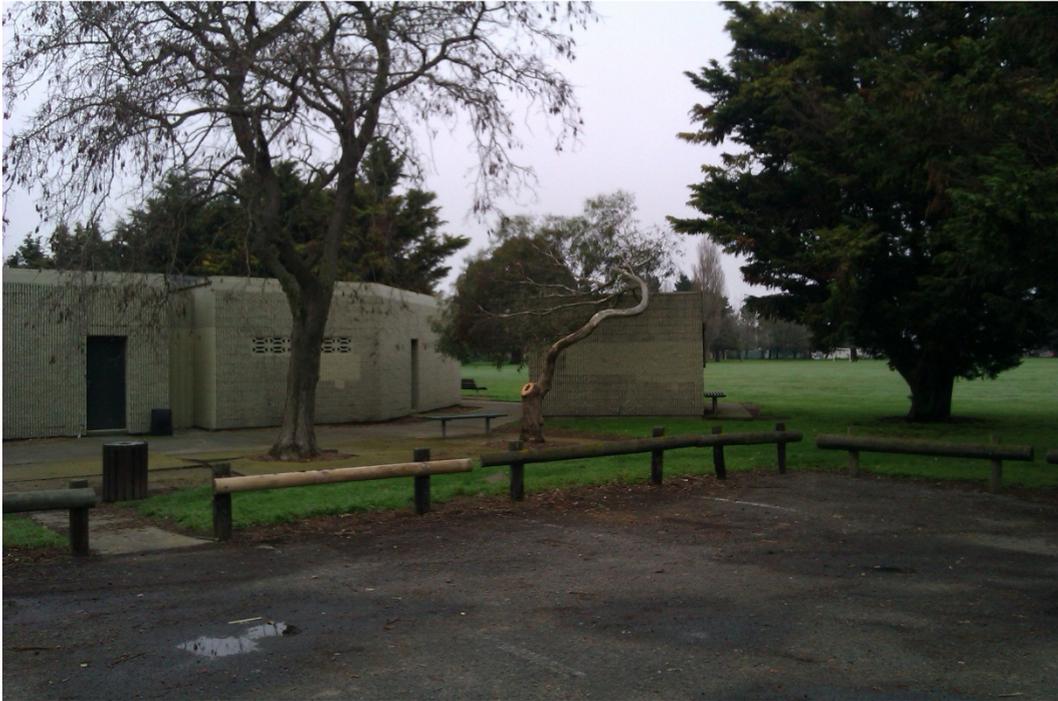
Photo 1: View of the building (right)

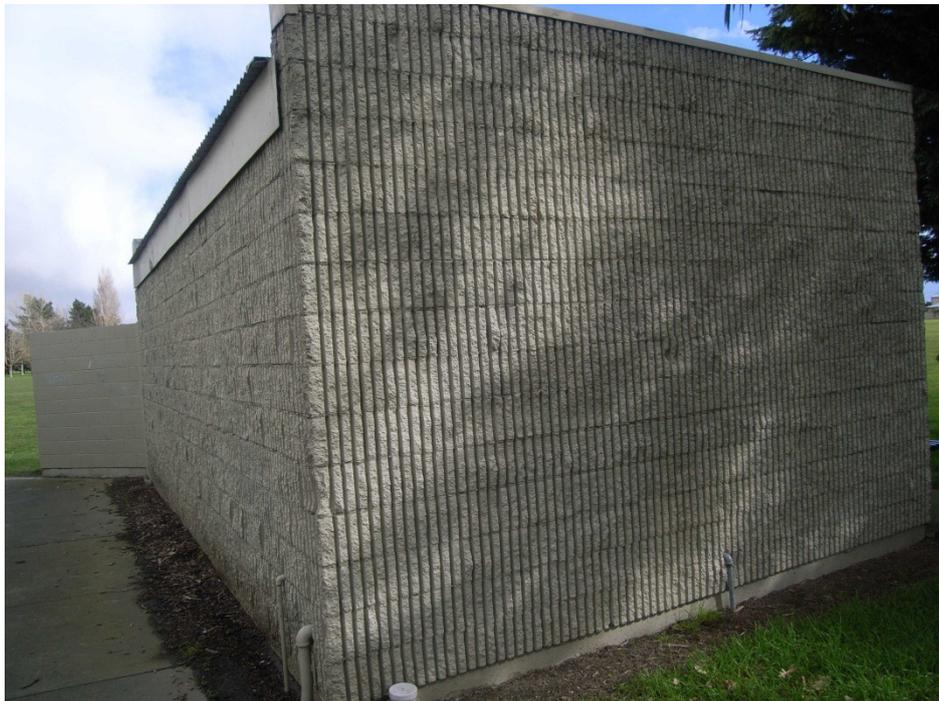
Photo 2: View of eastern wall
