Warren Park Dressing Sheds

PRK 1567 BLDG 001

Detailed Engineering Evaluation

Quantitative Engineering Report

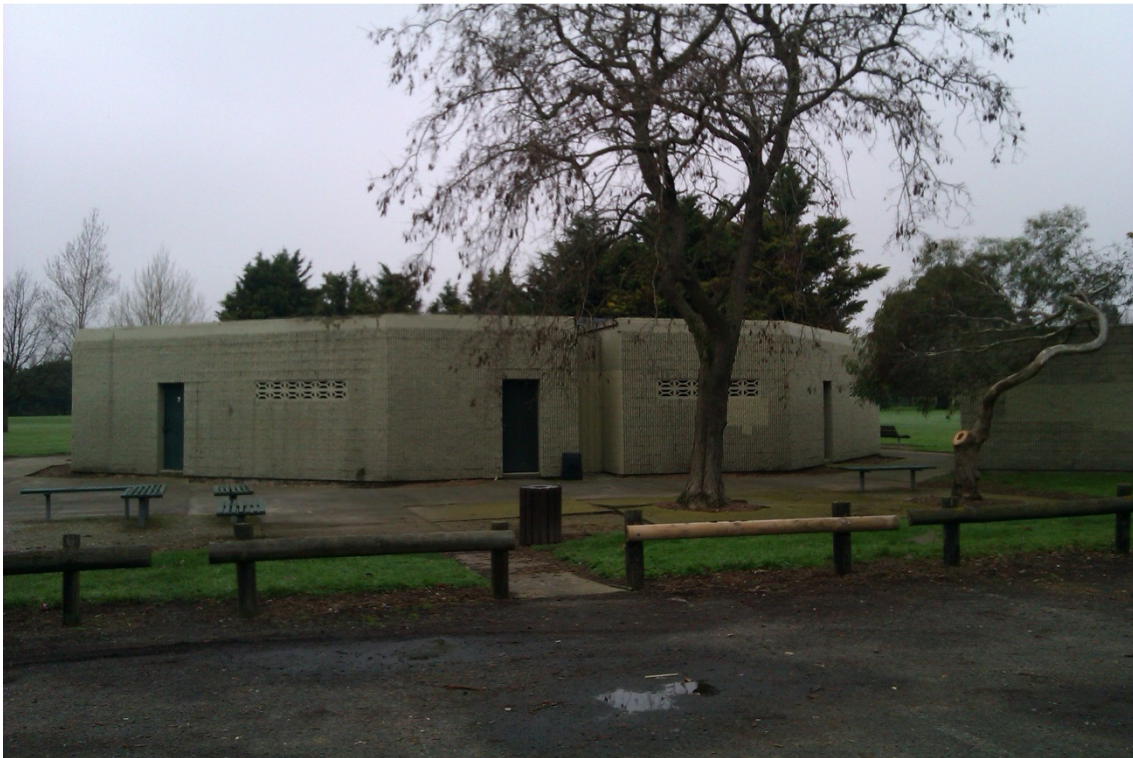
Photo 1: Exterior View

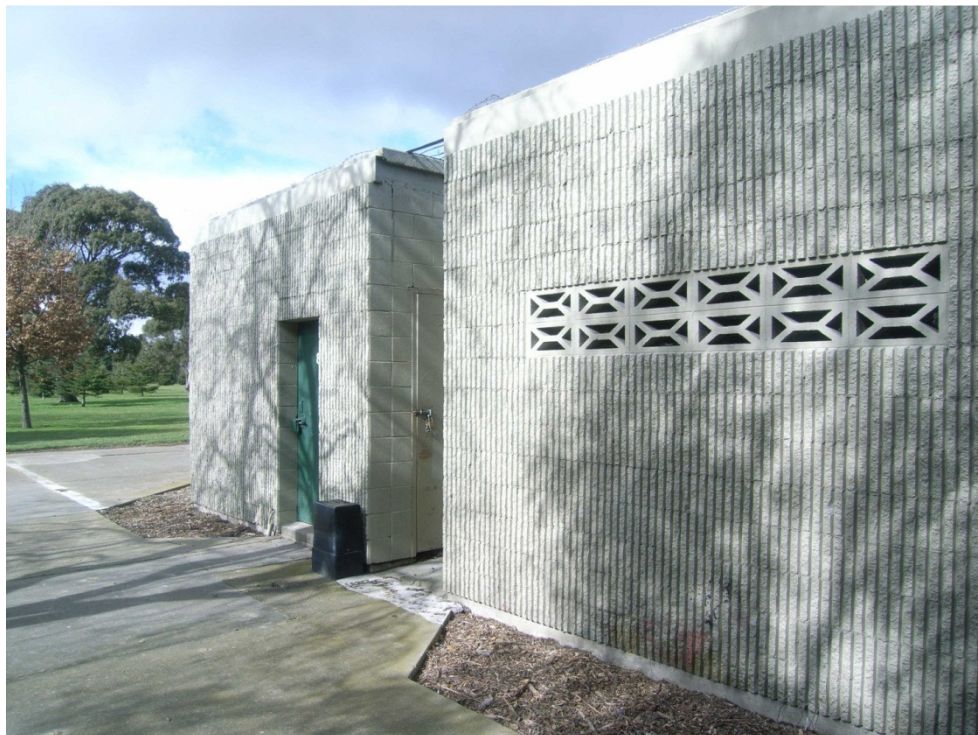
Photo 2: Exterior View

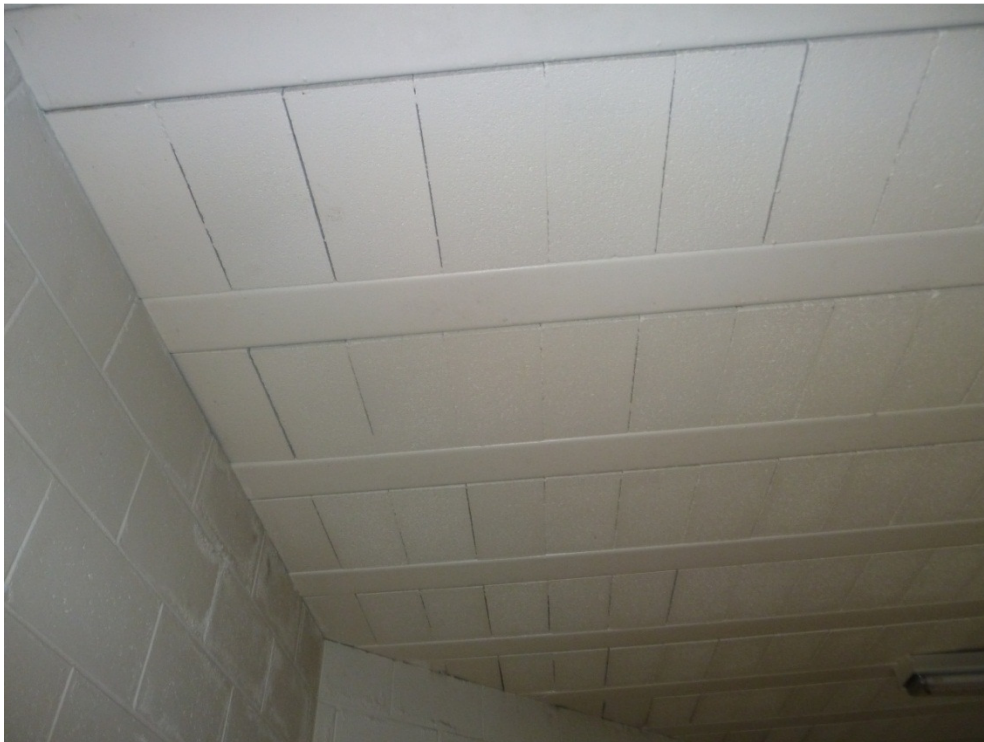
Photo 3: View of Roofing System

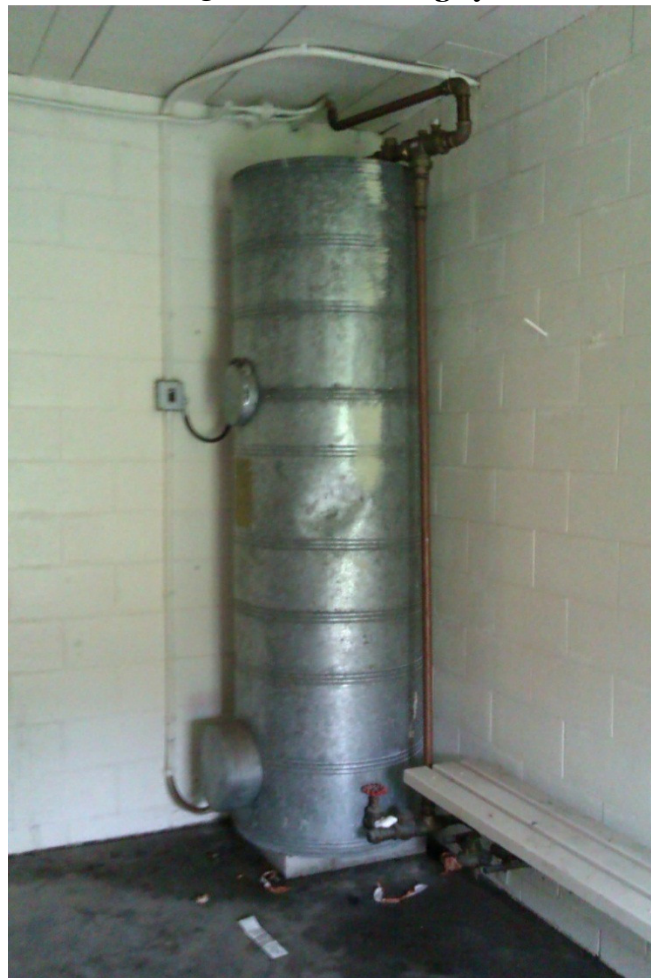
It is noted that unrestrained hot water cylinders in the dressing sheds were still intact and did not appear to have suffered damage to the cylinders or associated pipework.

Photo 4: Hot Water Cylinder

- (a) The hot water cylinders should be appropriately seismically restrained.
- (b) The minor cracking to mortar in block walls should be repaired.
