Weaver Courts Housing Complex PRO 1565

**Detailed Engineering Evaluation
Quantitative Assessment Report**

**Weaver Place, Sockburn, Christchurch
8042**

Date: November 2013
Reference: 6-QC415.00
Status: Final

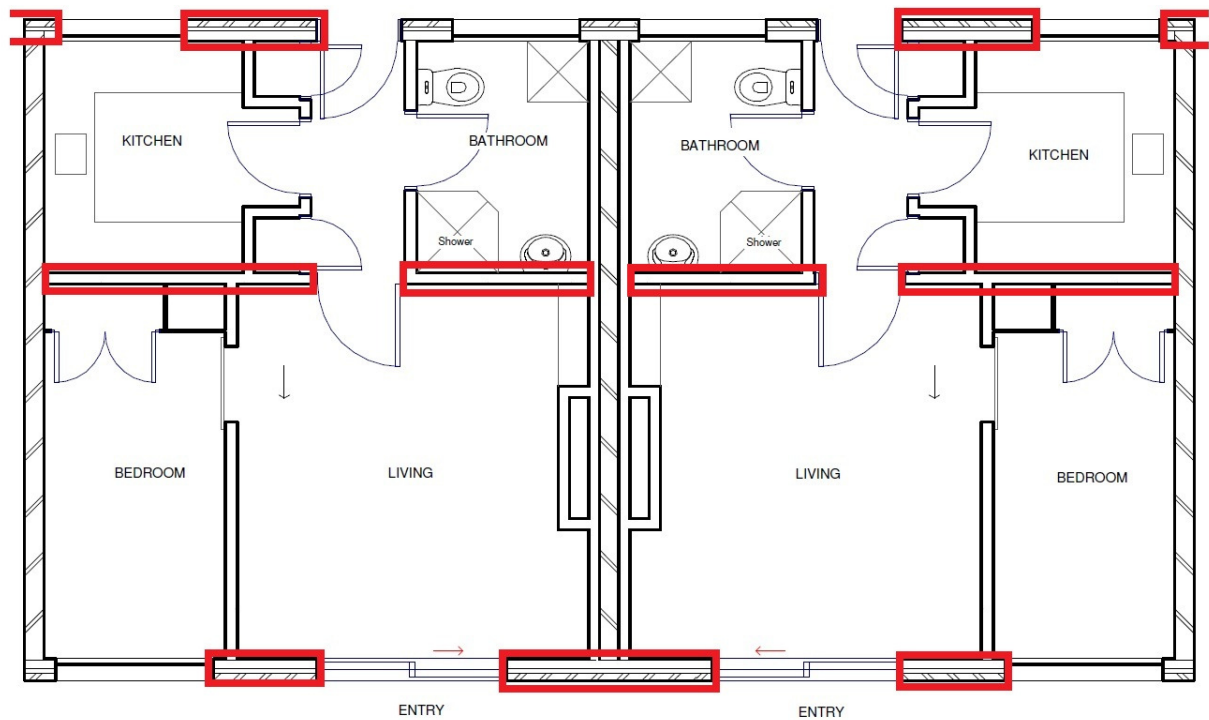
The residential units numbered 1-25 have capacities of 72%NBS and are limited by the in-plane shear capacity lined timber-framed shear walls in the longitudinal direction. The residential units numbered 26-35 have capacities of 100%NBS.

Figure 8: Walls used for bracing in the longitudinal direction (Units 1-25).

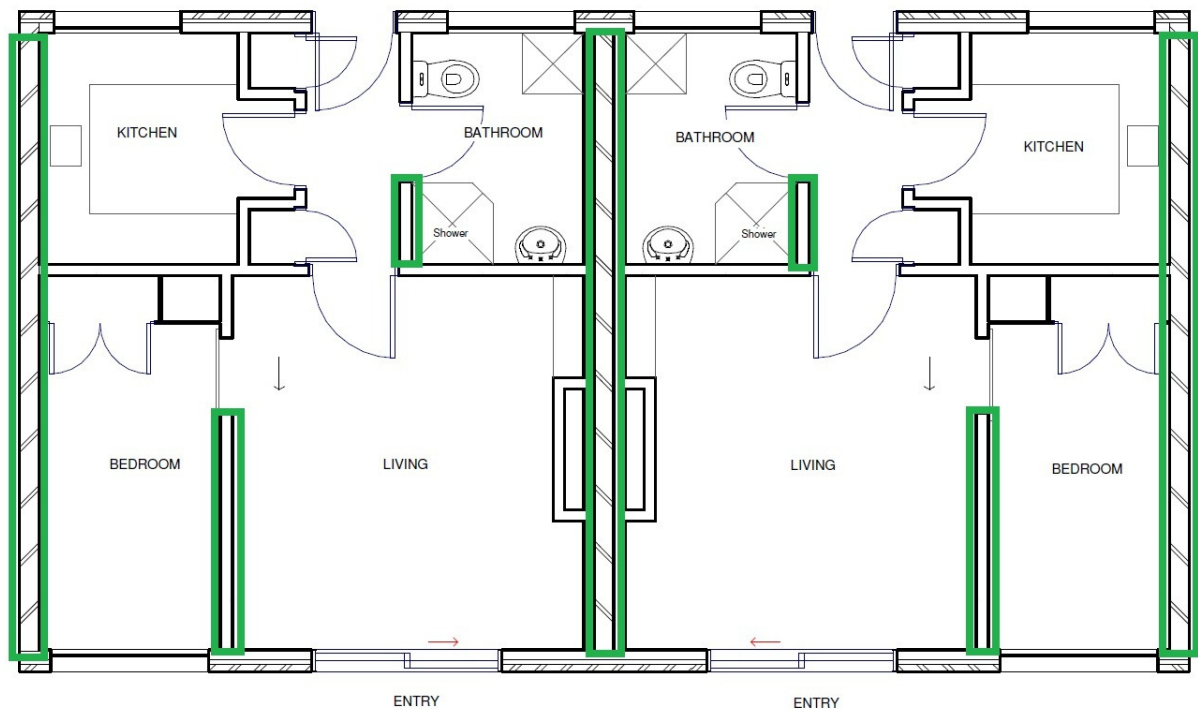
Figure 9: Walls used for bracing in the transverse direction (Units 1-25).

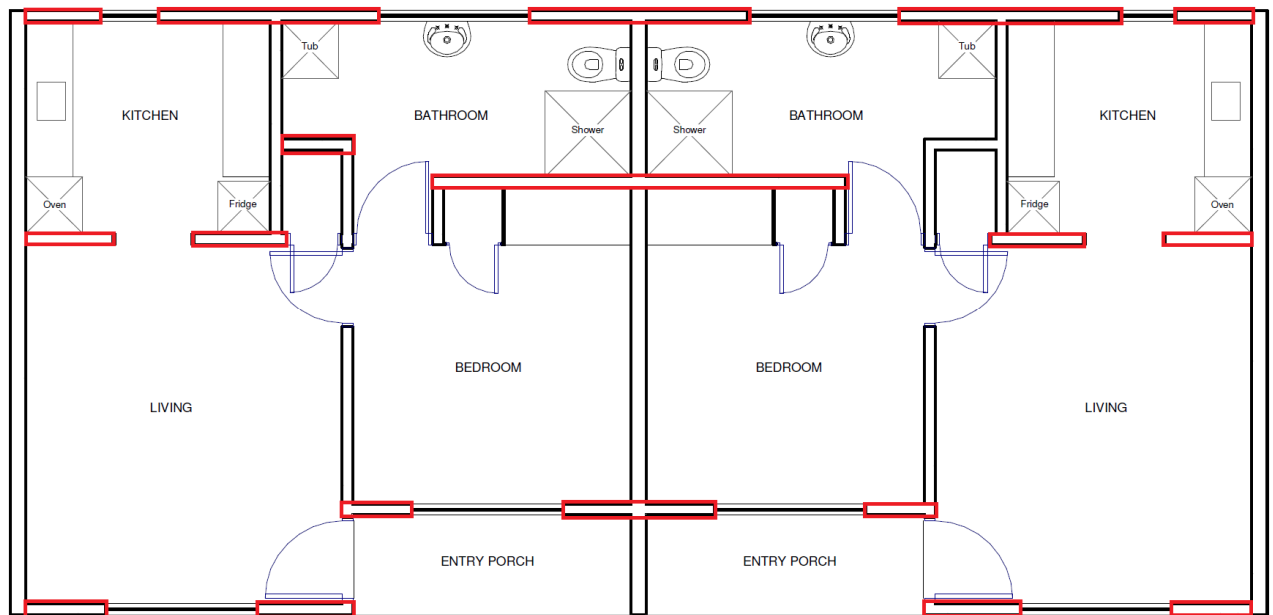
Figure 10: Walls used for bracing in the longitudinal direction. (Units 26-35)

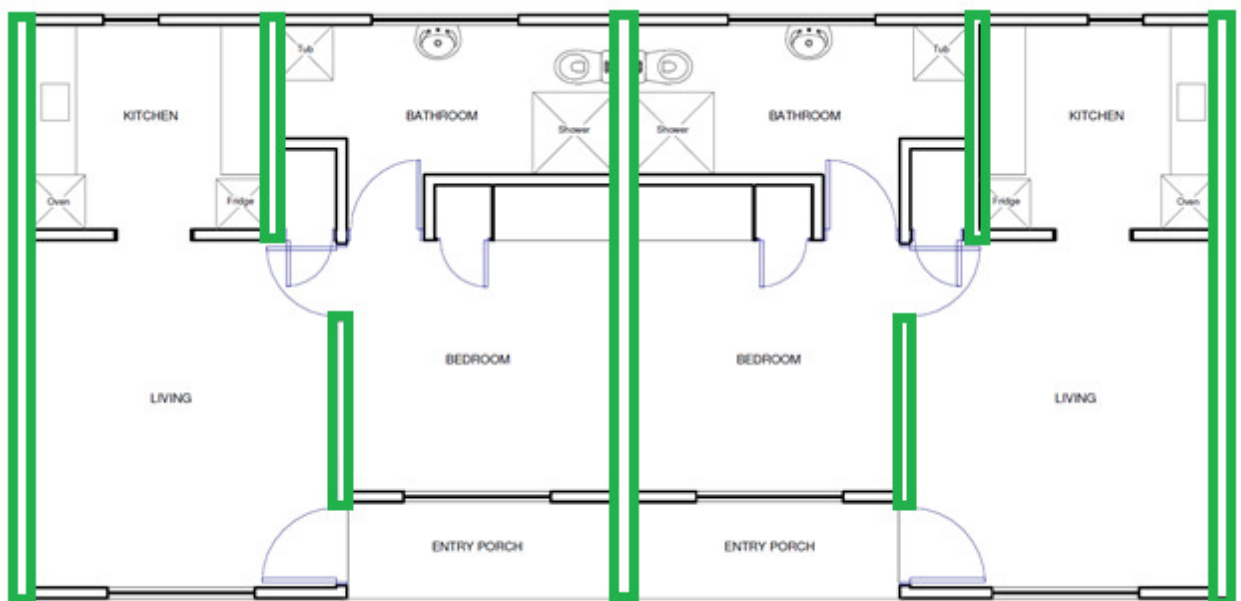
Figure 11: Walls used for bracing in the transverse direction (Units 26-35).

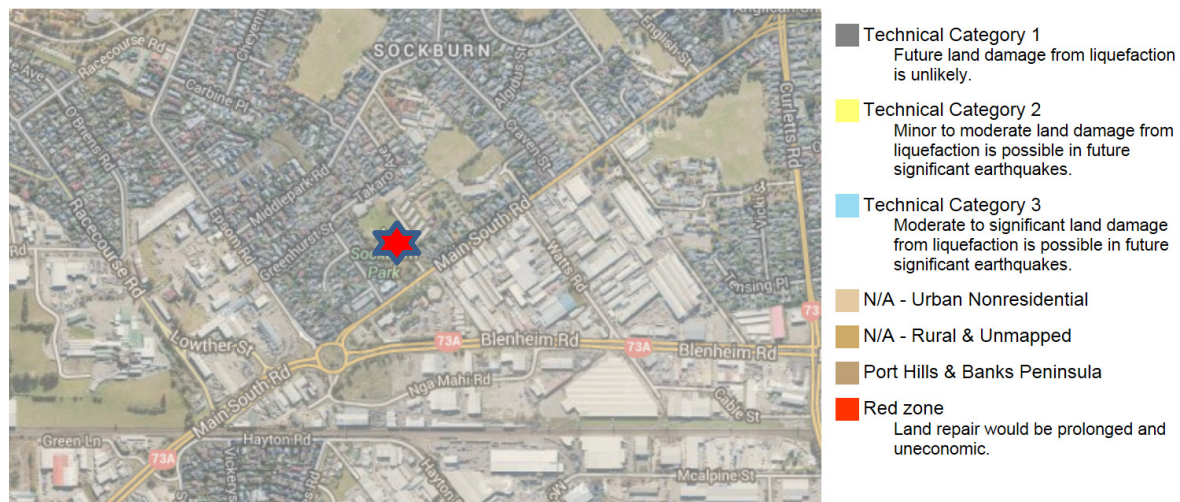
CERA indicates that Weaver Courts Housing Complex is located in a TC1 zone (as shown in Figure 12). This classification suggests future significant earthquakes will cause negligible land damage due to liquefaction and settlement.

Figure 12: TC1 zoning for Weaver Courts Housing Complex.

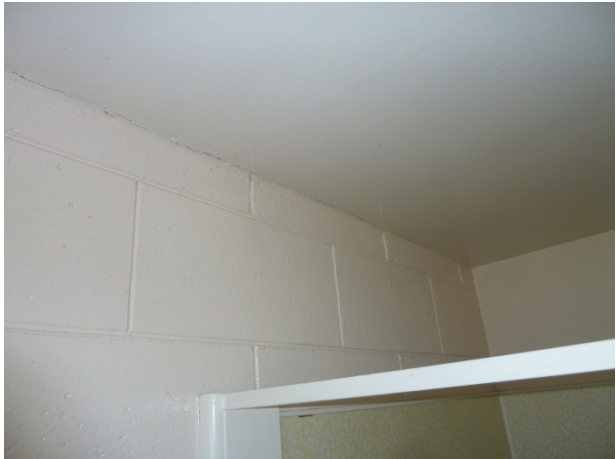
Some minor cracking of GIB-lined walls was observed in the majority of units that were inspected. The blocks containing units 26-35 suffered slightly more damage to the GIB linings than other units on site.

| 8. | Typical cracking | |

- Veneer at height (gable ends) have the veneer ties checked.
- Cosmetic repairs are undertaken.

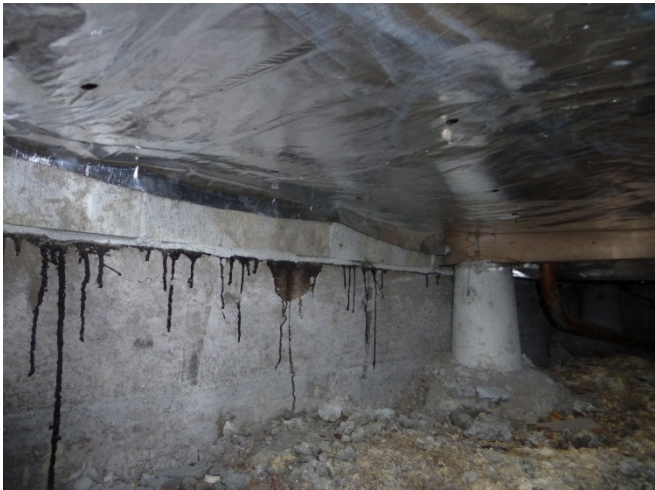
No damage was observed to the foundations of the residential units or to the garages.

| 9. | Typical firewall foundation | |

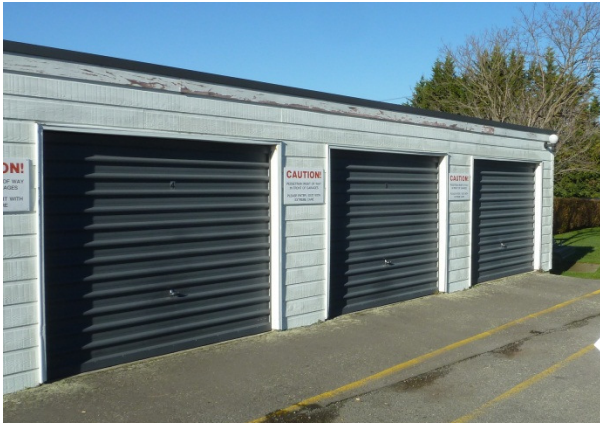
There was no damage observed to the garages.

| 23. | Exterior of garages | |
