West Lake Park Toilets and Changing Rooms
PRK 0489 BLDG 001 EQ2
Detailed Engineering Evaluation
Quantitative Report
Version FINAL

50 Westlake Drive, Halswell

Christchurch City Council

Date
7th March 2013

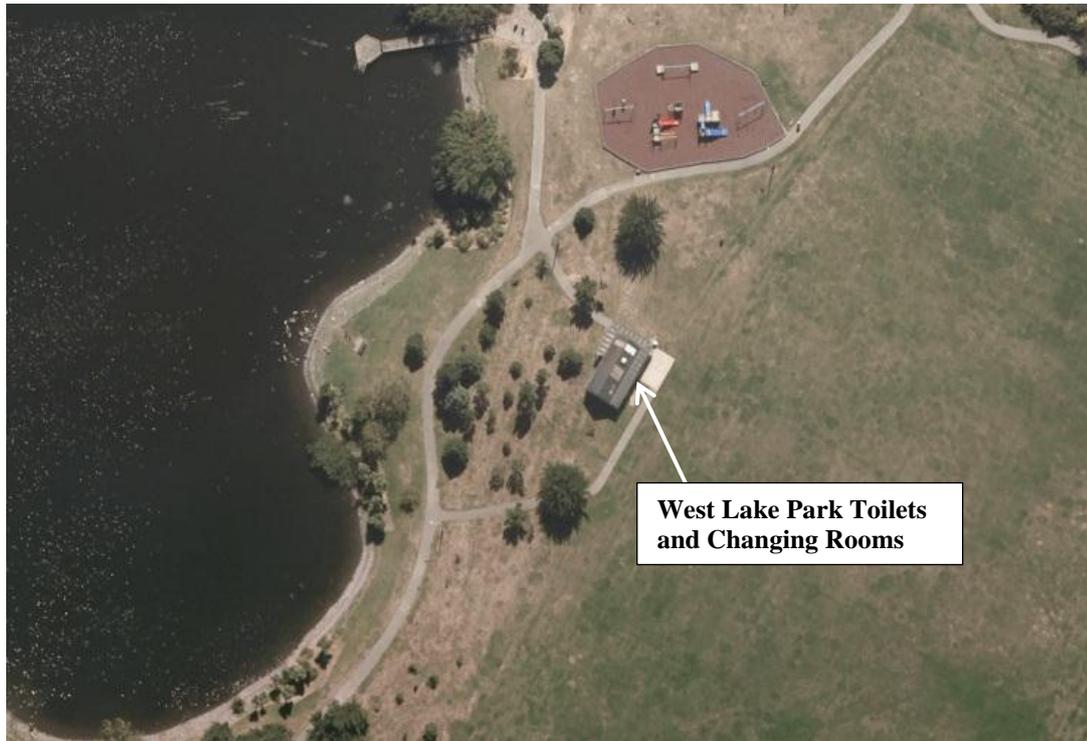
Figure 4 Post February 2011 Earthquake Aerial Photography³

Aerial photography taken following the 22 February 2011 earthquake shows signs of minor to moderate signs of liquefaction at road corridors and nearby properties, as shown in Figure 4.

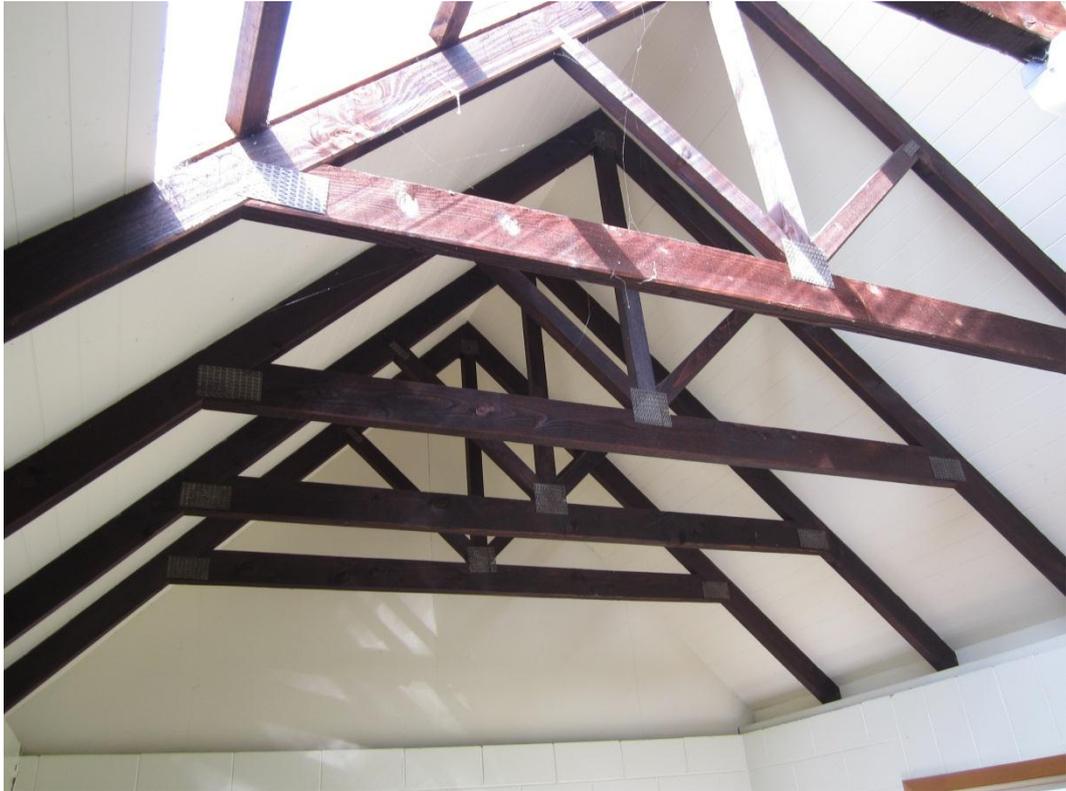
Photograph 1 **Nail plate timber trusses**

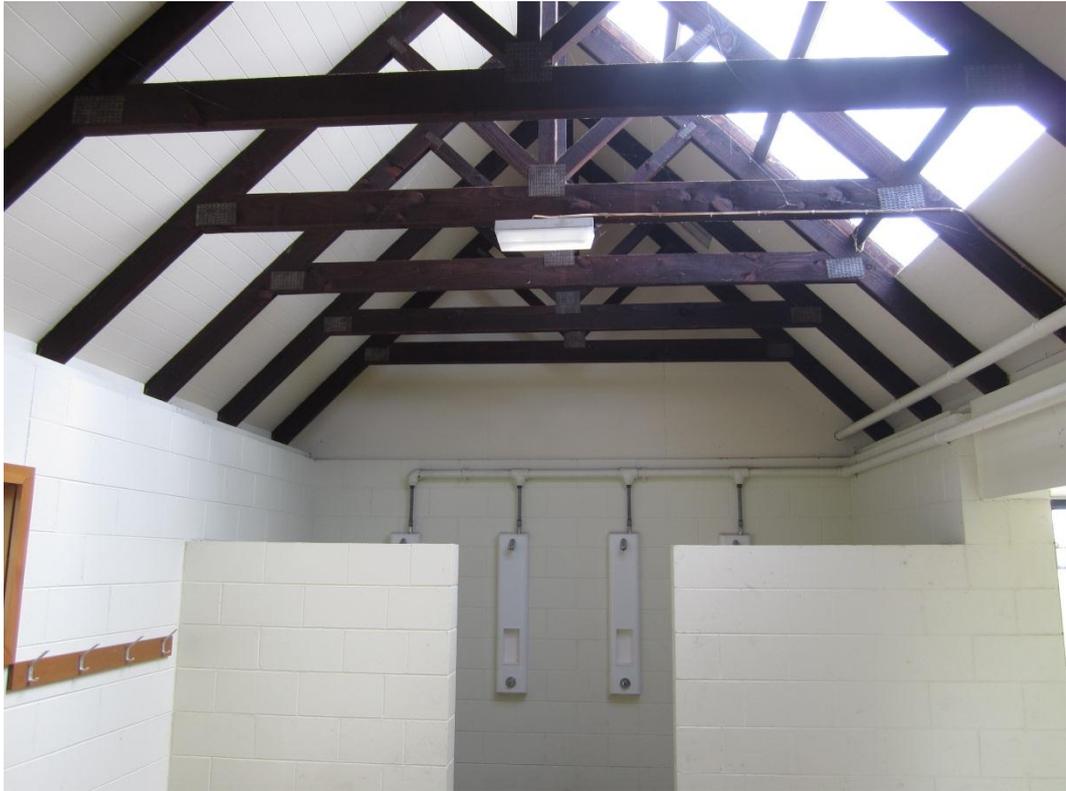
Unrestrained partial height walls form the shower area in the changing room section of the building. These walls consist of 190mm thick reinforced concrete masonry units and are 1.8m high.

Photograph 5 **Unrestrained concrete masonry shower partition walls**

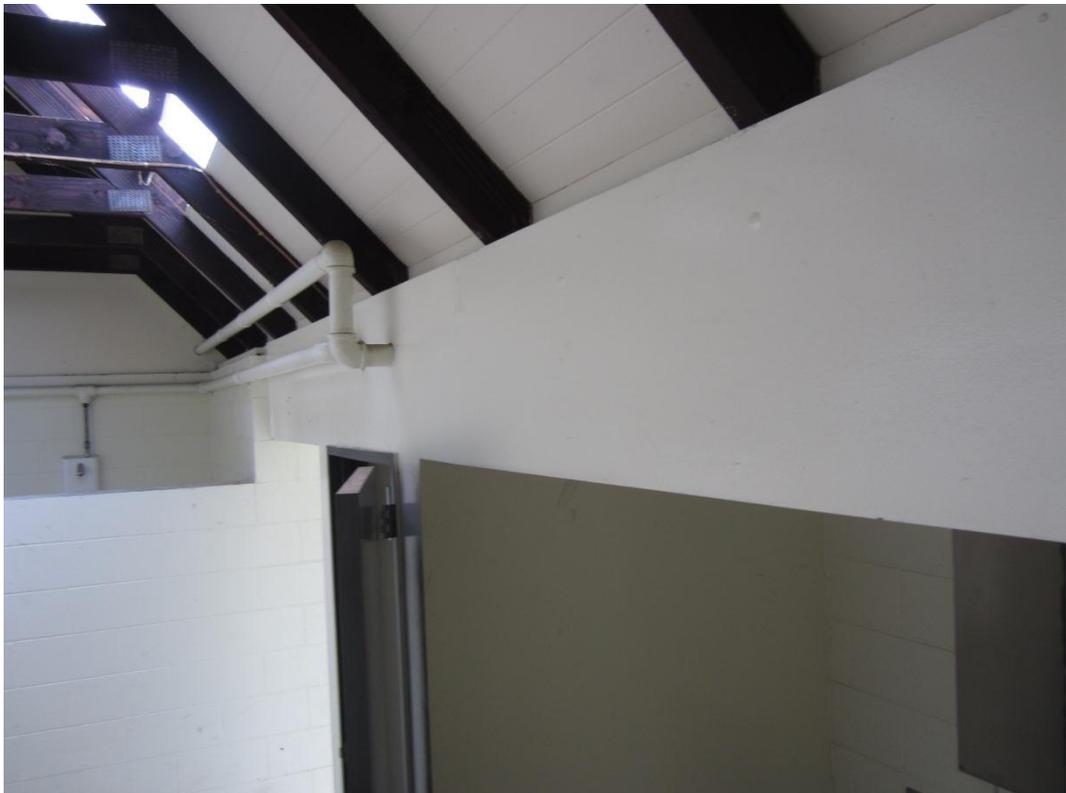
Photograph 6 **Timber beam supporting the timber roof trusses**

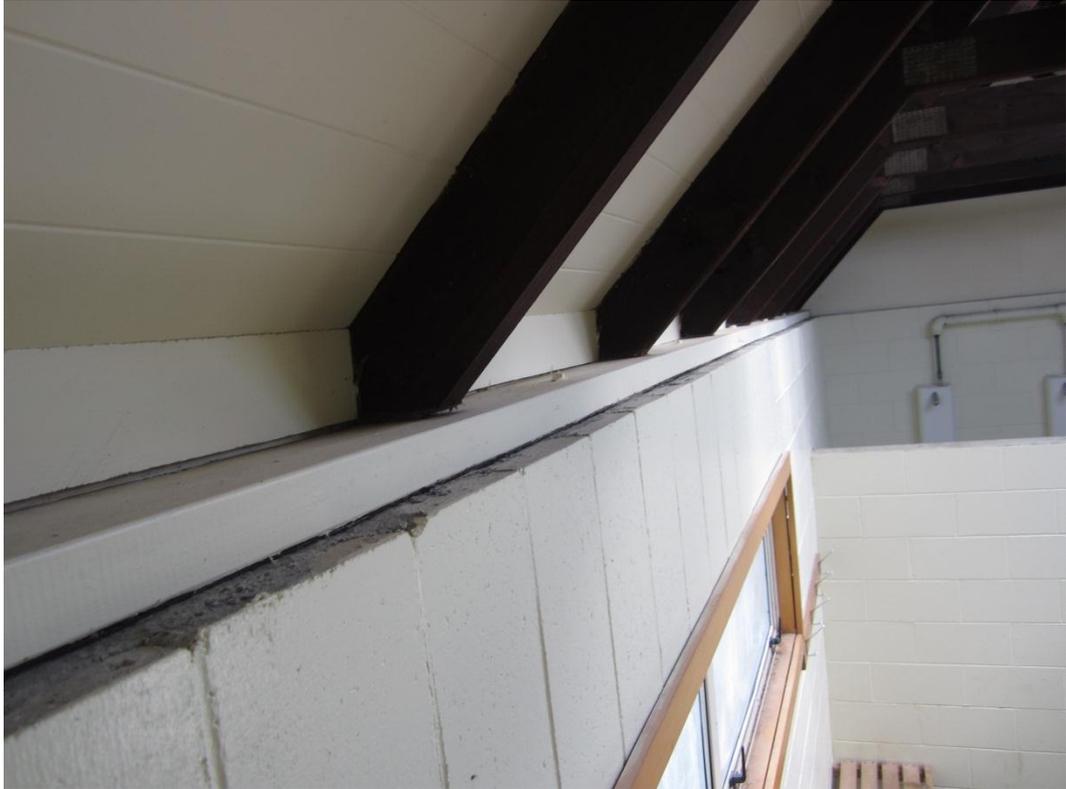
The nail plate timber trusses are nailed to the timber wall plate as shown in Photograph 7. The connection between the roof structure and walls is inadequate and is unlikely to have sufficient capacity to transfer forces from the nail plate timber trusses to the in-plane concrete masonry walls.

Photograph 7 Wall plate connection between timber trusses and concrete masonry walls

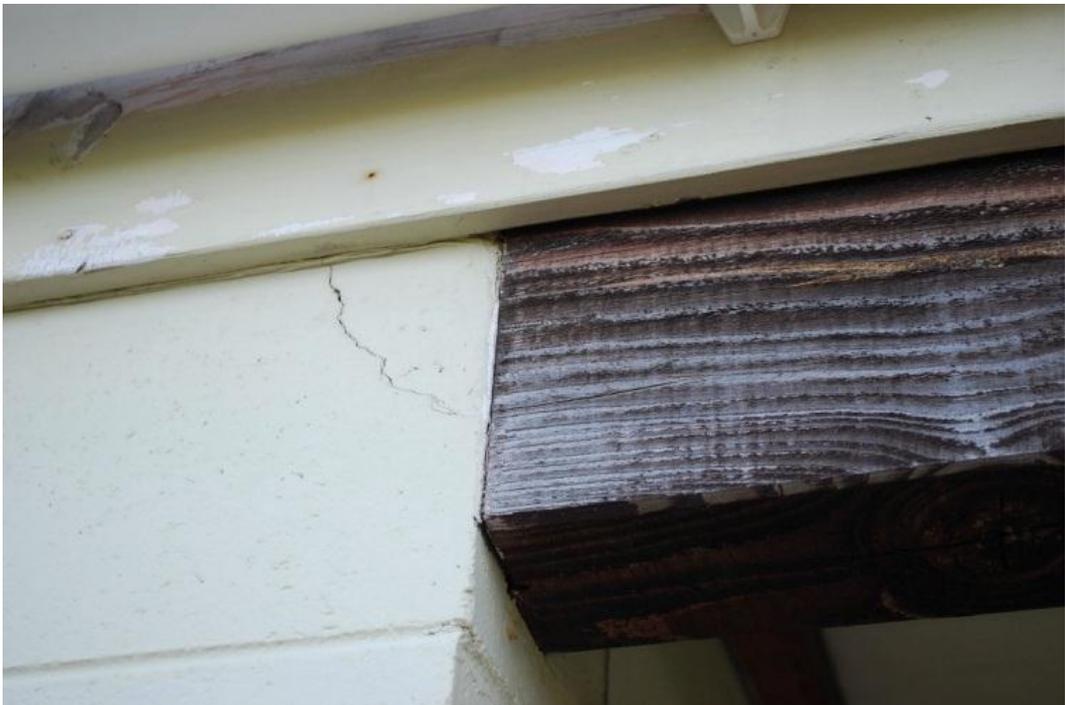
The building was observed to generally be in good condition during the inspection. Minor cracking in a concrete masonry unit was observed on the south-eastern side of the building at the connection point between an external timber roof beam and a concrete masonry wall. Minor step cracking was observed in the mortar in the concrete masonry wall on the south-eastern side of the building.

Photograph 8 Cracking in the concrete masonry unit at connection with an external timber roof beam

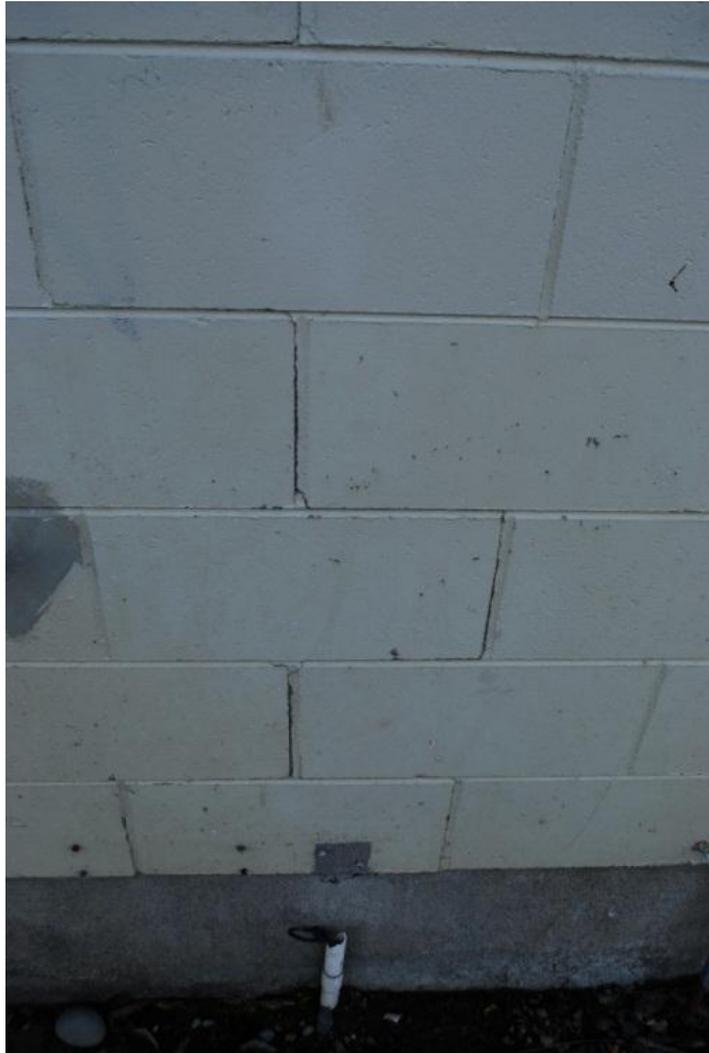
The building was observed to generally be in good condition during the inspection. Minor cracking in a concrete masonry unit was observed on the south-eastern side of the building at the connection point between an external timber roof beam and a concrete masonry wall. This is shown in Photograph 8. Minor step cracking was observed in the mortar in the concrete masonry wall on the south-eastern elevation of the building. This is shown in Photograph 9.

Photograph 9 **Minor step cracking in the mortar on the south-eastern elevation of the building**
