CHRISTCHURCH CITY COUNCIL  
PRK\_0657\_BLDG\_001 EQ2  
Westminster Park – Community Building  
274 Westminster Street, Mairehau

QUALITATIVE ASSESSMENT REPORT  
FINAL

- Rev C
- 24 September 2013

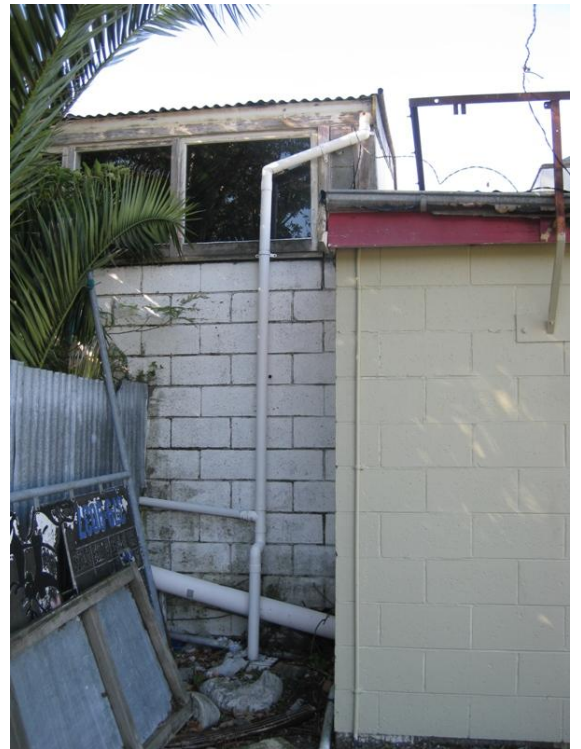
Photo 4: West wall showing lack of access and differences in the two sections of the building

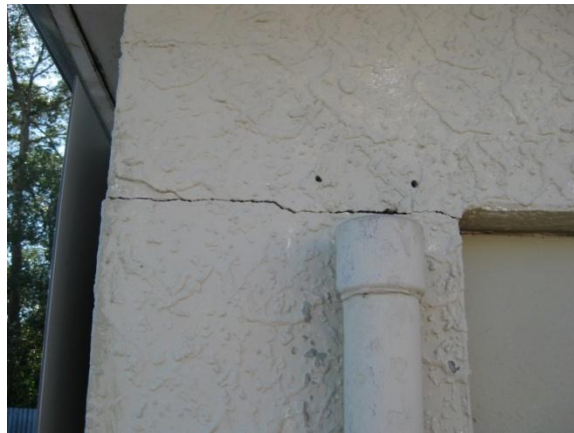
Photo 5: Hairline cracks in stucco cladding around openings on South wall.

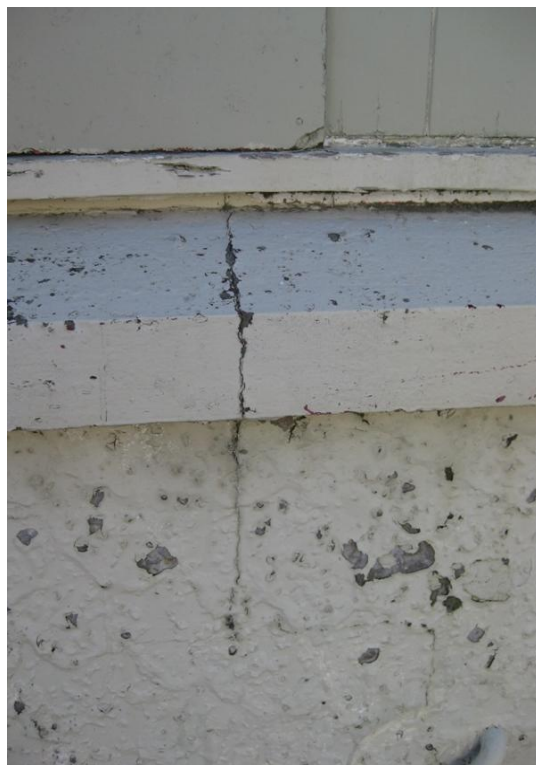
Photo 7: Crack in concrete lintel under window on South wall.

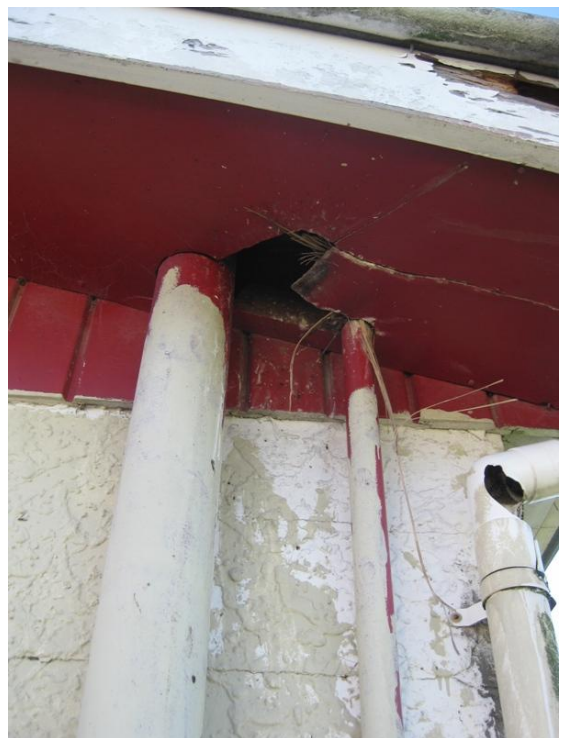
Photo 8: Existing damage to soffit lining and pipes on South side of building.

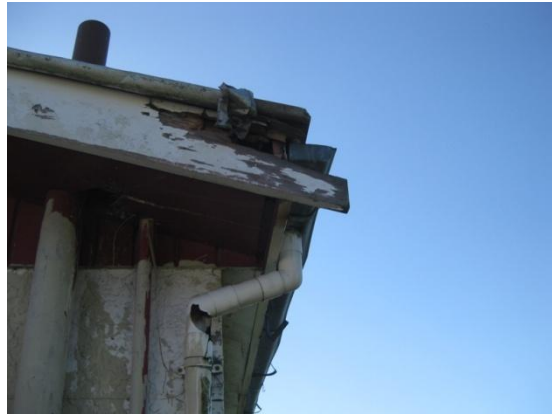
Photo 9: Suspected water damage to roof purlin on South wall.

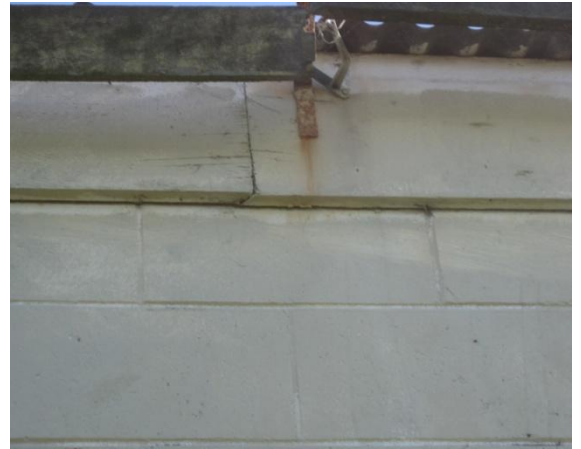
Photo 10: Gap between fascia board at the top of the wall and masonry opening up.

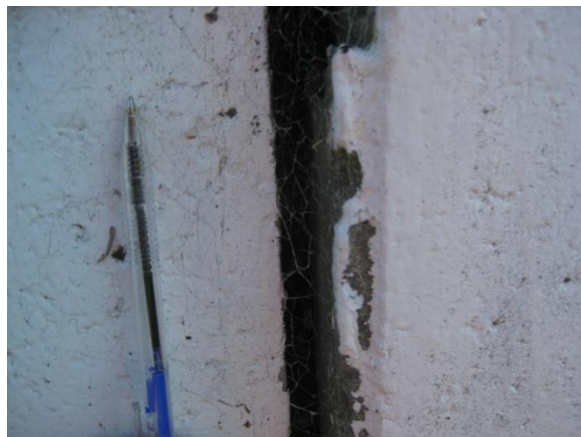
Photo 11: Close-up of gap in construction joint.

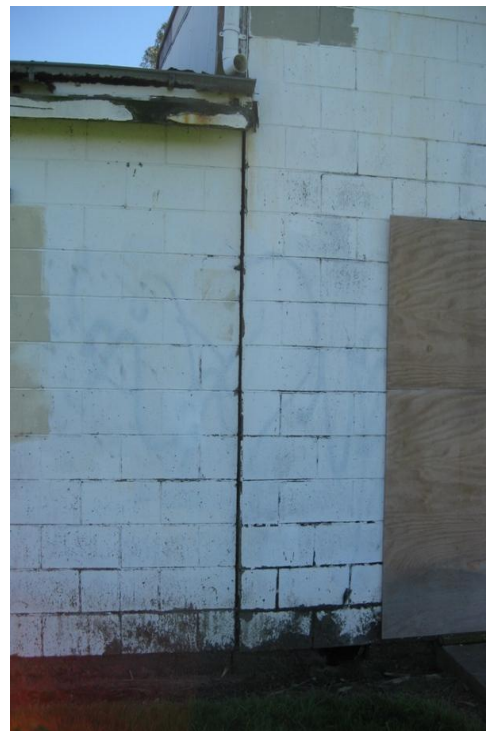
Photo 12: Gap opening up at construction joint between the two sections of the building. View of East wall.

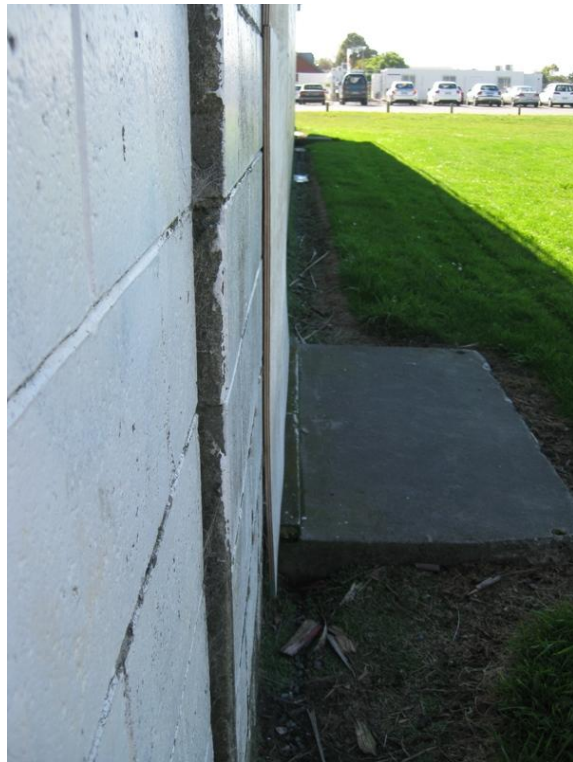
Photo 13: Close-up of gap in construction joint.

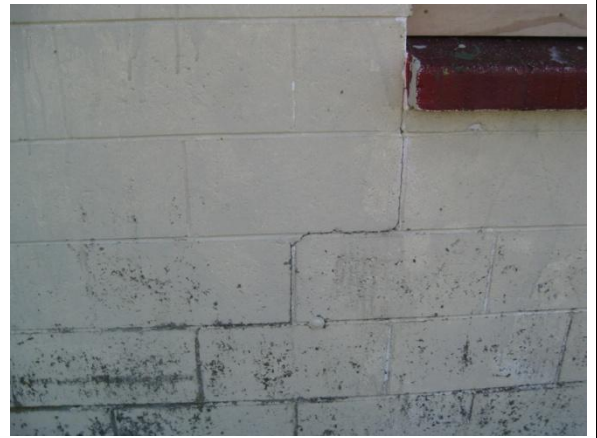
Photo 14: Step cracking along mortar joints.

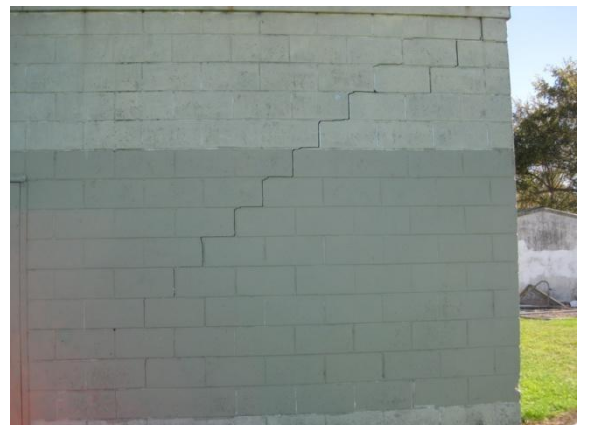
Photo 16: Step cracking along mortar joints.

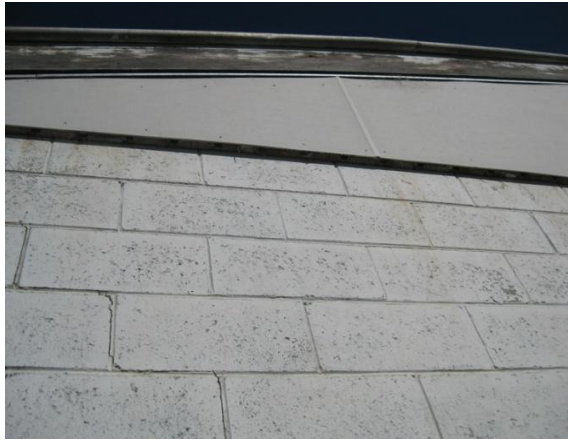
Photo 17: Vertical timber railings behind cladding above and outside blockwork on North wall, providing the masonry with no support at the top.

Based on the overturning capacity of the block wall foundation due to lack of support at top of wall. Note the block wall foundations have been assumed to be 300wx600d. Assumptions made from external visual inspection only.

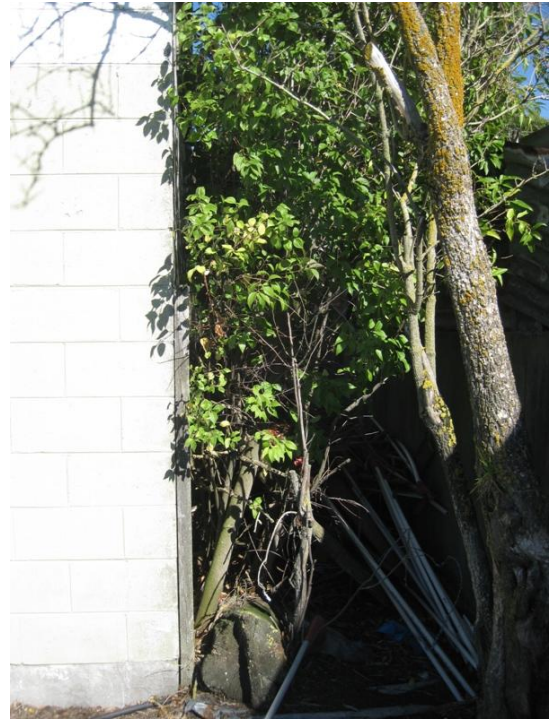
Photo 18: Lack of access to most of the West wall.

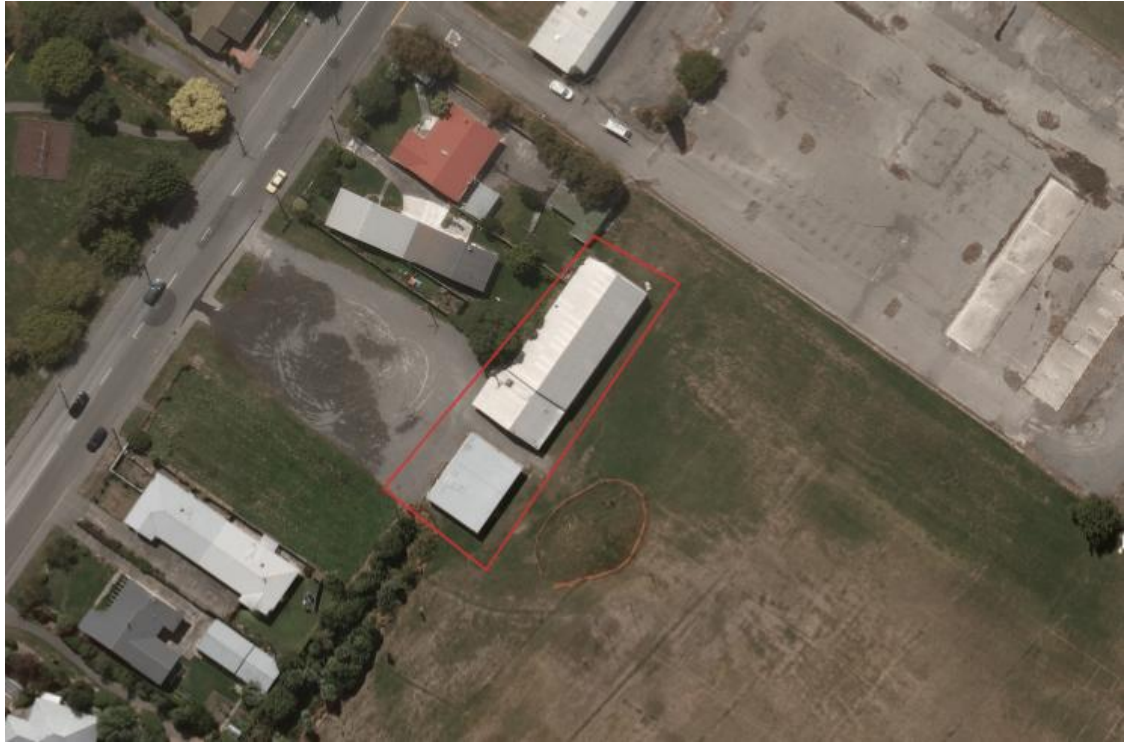
The dark patches at the front of the property may be evidence of liquefied material and pore water being ejected to the surface. Similar dark patches were observed from aerial photographs taken after the September 2010, June 2011 and December 2011 earthquake events. As no liquefaction was observed in the mapping exercise the dark colouration may also be water from a broken water main or leaking hydrant.

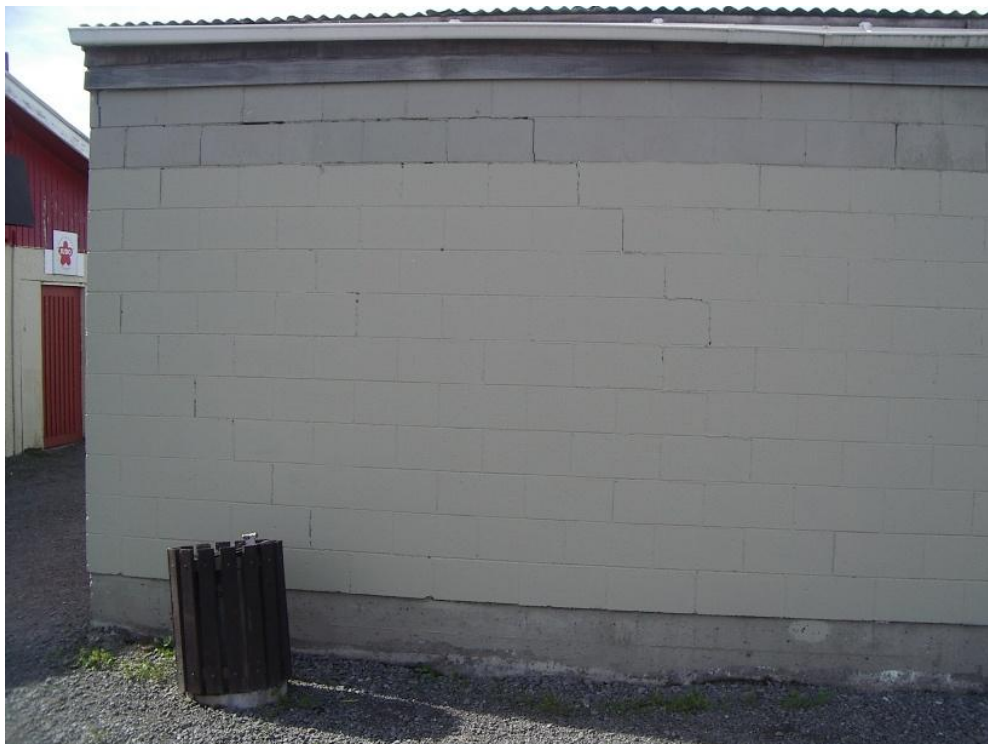
Both of the buildings on site were concrete and metal roof constructions. Some cracks in the walls of buildings were observed during the external inspection of the site. The windows on both of the building were boarded up but it is unknown if this is a result of earthquake damage. There were no signs that liquefaction occurred at the site. The site was asphalted to the NW, with large playing field to the SE of the building. There was no obvious land damage on site.

■ **Figure 7 Observed cracks in the Westminster Street community building**
