Christchurch City Council
BU 0659-001 EQ2
Westminster Street Depot - Office/Amenities
280 Westminster Street

QUANTITATIVE REPORT
FINAL

- Rev C
- 25 September 2013

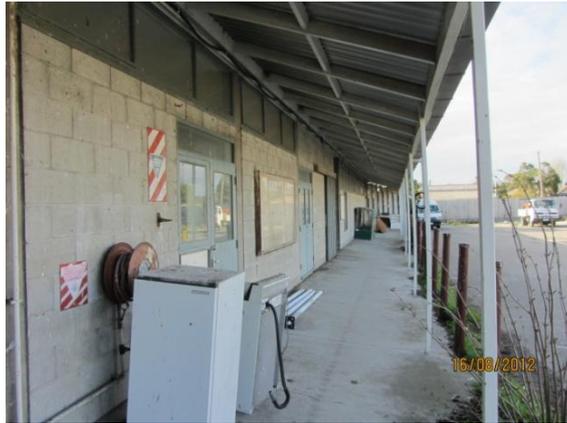
Photo 1: View along the east side of the building (1)

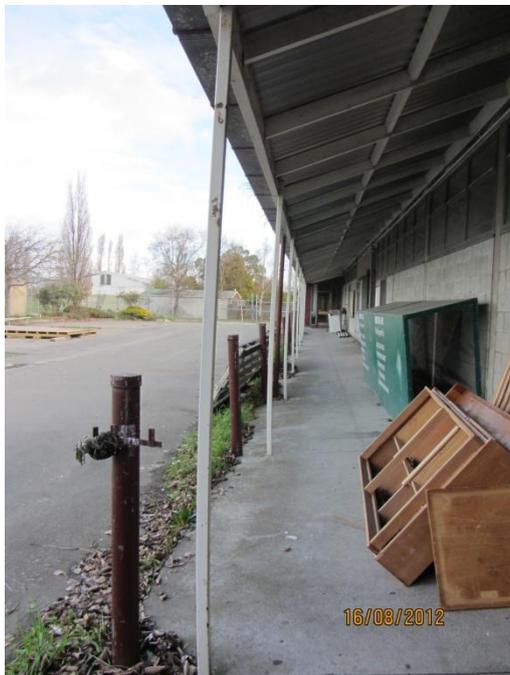
Photo 7: View along the east side of the building (2)

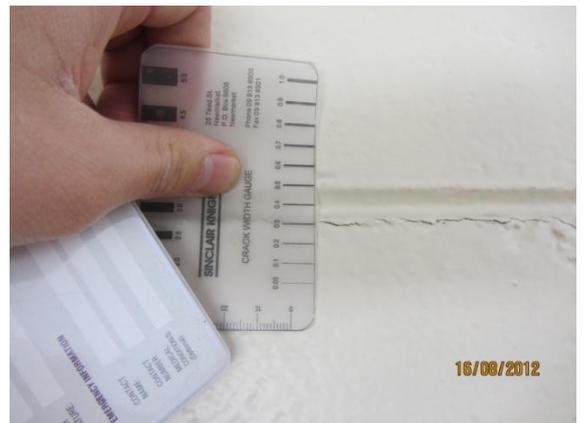
- 1) 0.3mm step cracking in some of the masonry walls
- 2) 50 x 50 SHS columns supporting the canopy roof on the east side of the building are bent outwards at the centre.

Photo 8: 0.3mm crack found in one of the interior masonry walls in the west partition

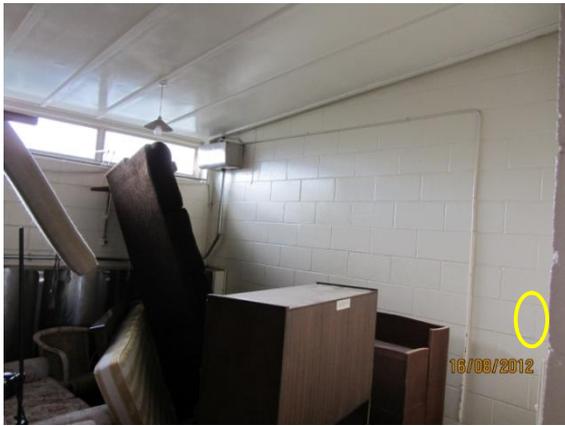
Photo 15: View of one of the interior masonry walls in the east partition, showing location of crack (1)

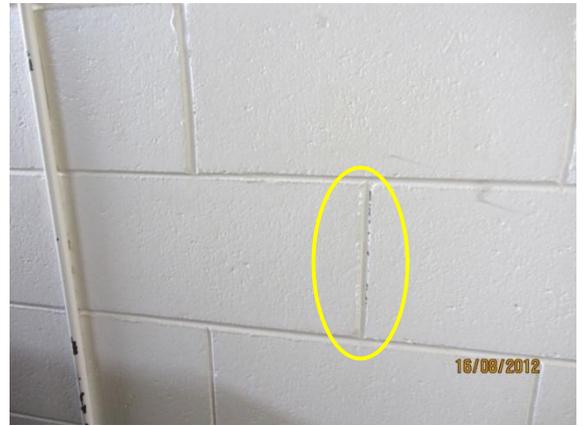
Photo 16: Close up view of one of the interior masonry walls in the east partition, showing location of crack (2)

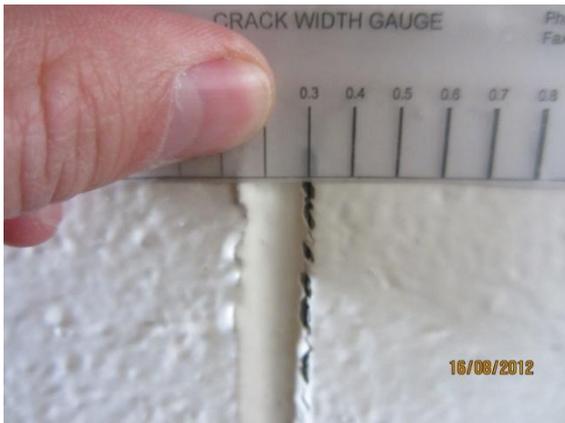
Photo 17: Close up view from photo 16

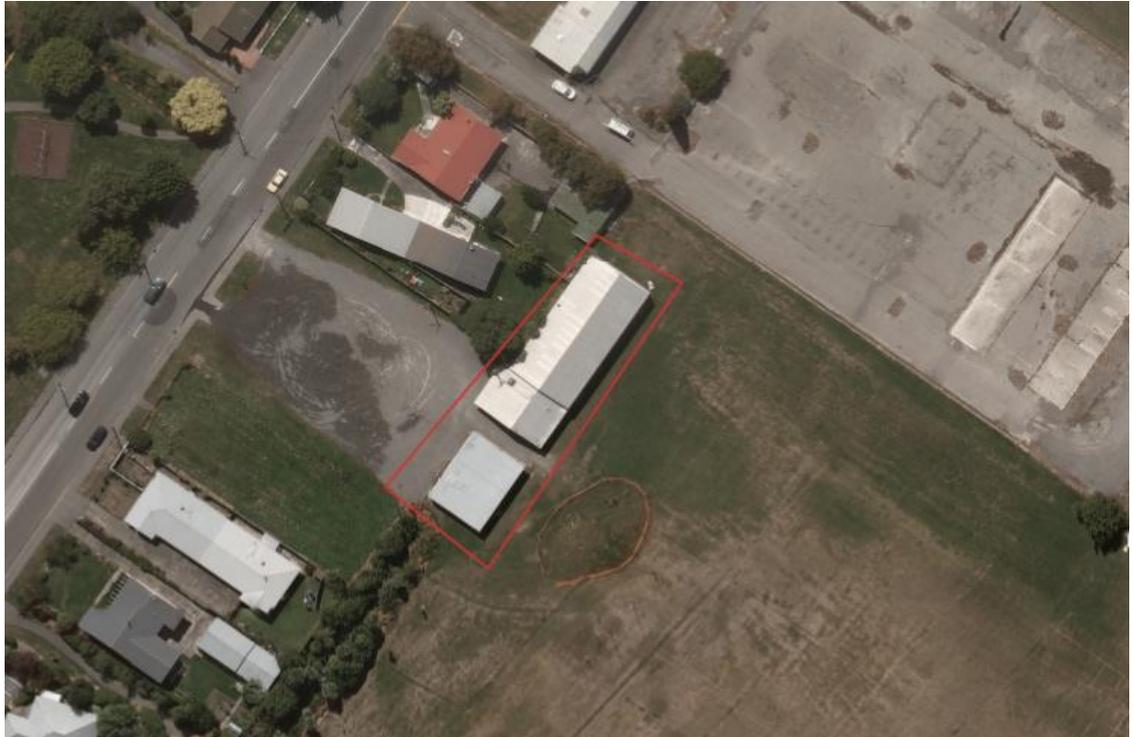
- **Figure 5 – Aerial photography from 24 Feb 2011 (<http://viewers.geospatial.govt.nz/>)**

The dark patches at the front of the property may be evidence of liquefied material and pore water being ejected to the surface. Similar dark patches were observed from aerial photographs taken after the September 2010, June 2011 and December 2011 earthquake events. As no liquefaction was observed in the mapping exercise the dark colouration may also be water from a broken water main or leaking hydrant.

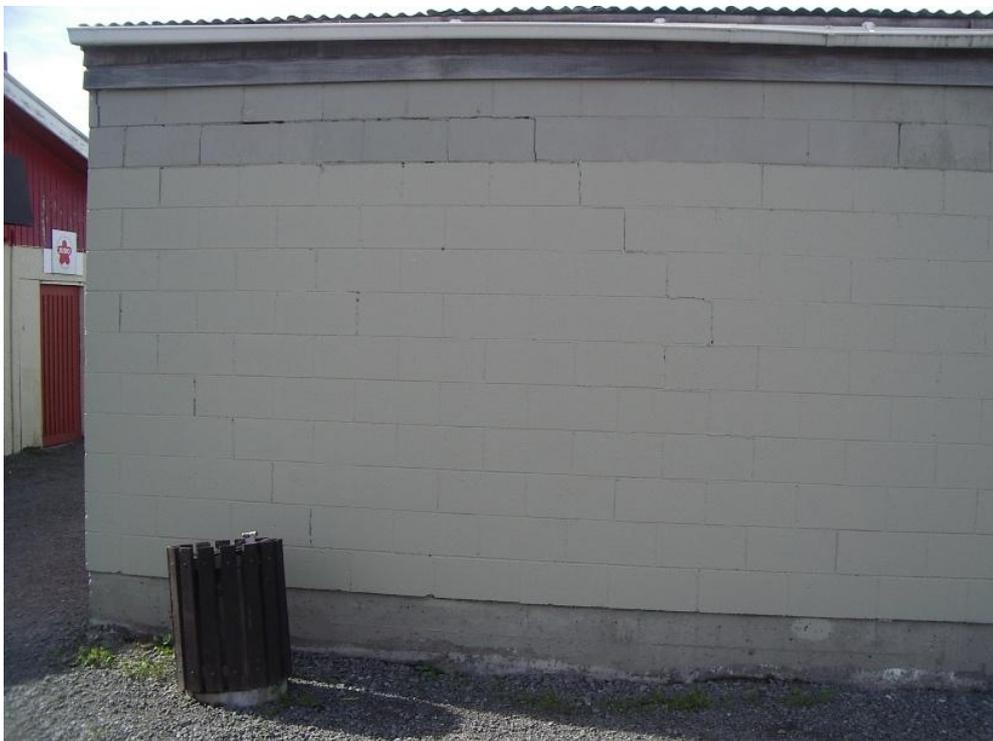
Both of the buildings on site were concrete and metal roof constructions. Some cracks in the walls of buildings were observed during the external inspection of the site. The windows on both of the building were boarded up but it is unknown if this is a result of earthquake damage. There were no signs that liquefaction occurred at the site. The site was asphalted to the NW, with large playing field to the SE of the building. There was no obvious land damage on site.

■ **Figure 7 Observed cracks in the Westminster Street community building**
