**Whakahoa Village Units Block A**  
**BU 2680-001 EQ2**  
**Detailed Engineering Evaluation**  
**Quantitative Report**  
Christchurch City Council

# **Whakahoa Village Block A**

## **Detailed Engineering Evaluation Quantitative Report**

Date: September 2012  
Reference: 6-QUCCC.93  
Status: Final

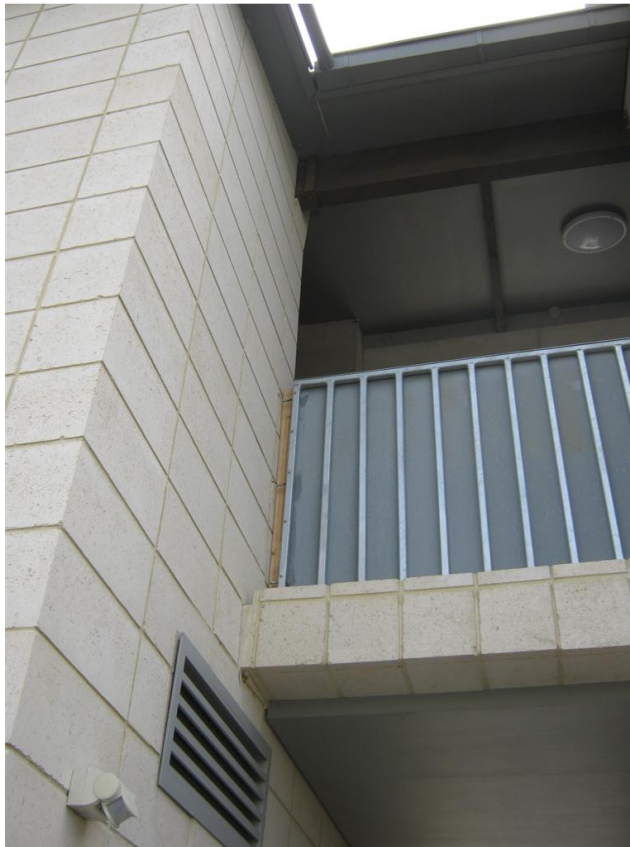
Typically, a masonry veneer wall exists to the external walls that supported on strip footings at ground level. In the central stair area, large cracks and displacements to the masonry veneer wall have been observed. In the same area some separation between the roof timbers and the ceiling plaster has occurred.

**Photo 1: Deformation to masonry veneer in central stair area**

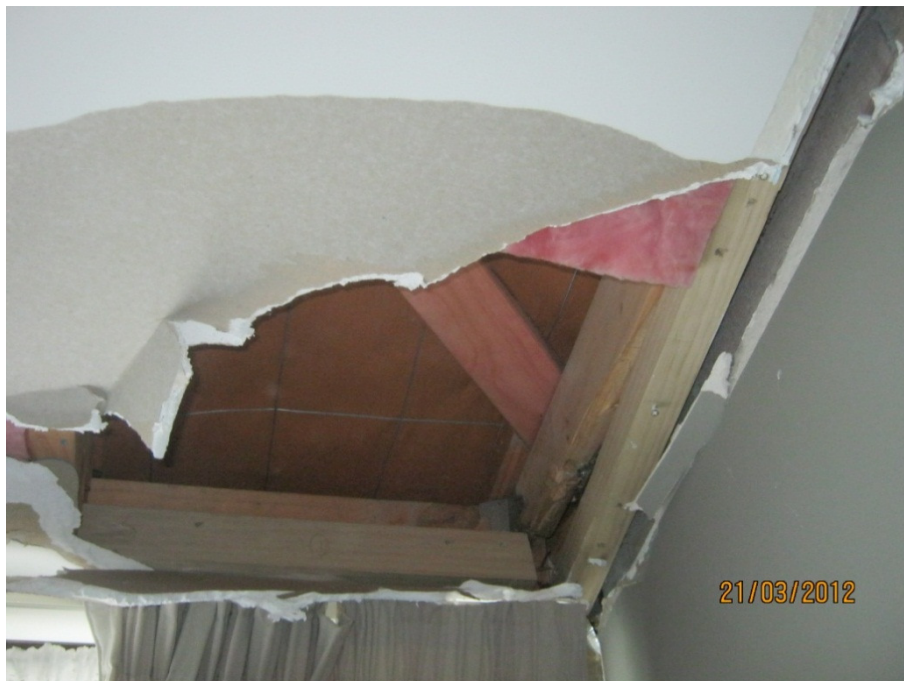
The western wall to the central stair core appears to have pulled away 50-70mm from the stair landing due to the settlement of one end of the building. Within the roof space on the internal face of this wall, the main timber roof rafter adjacent the wall has split where it was connected to the wall, which is compromising the gravity support of the roof structure in this location with some of the timber purlins not having adequate support. This damaged masonry wall at first floor level and the connected timber structure should therefore be repaired.

**Photo 2: Longitudinally split timber rafter adjacent wall to grid ae**

The wall to grid AE and the damaged timber roof frame parallel to this wall must be repaired. The designer should assess the methodology and reinstatement of the wall's connection to the concrete roof and consider some form of articulation in view of the potential for future liquefaction.

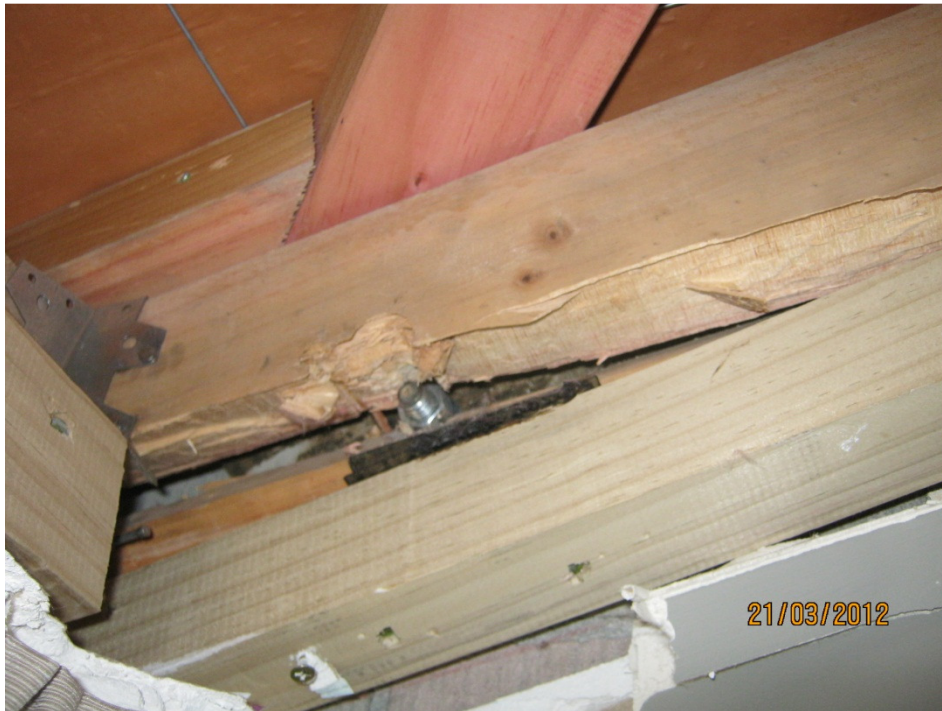
**Photo 3: Longitudinally split timber rafter plate to wall on grid ae**

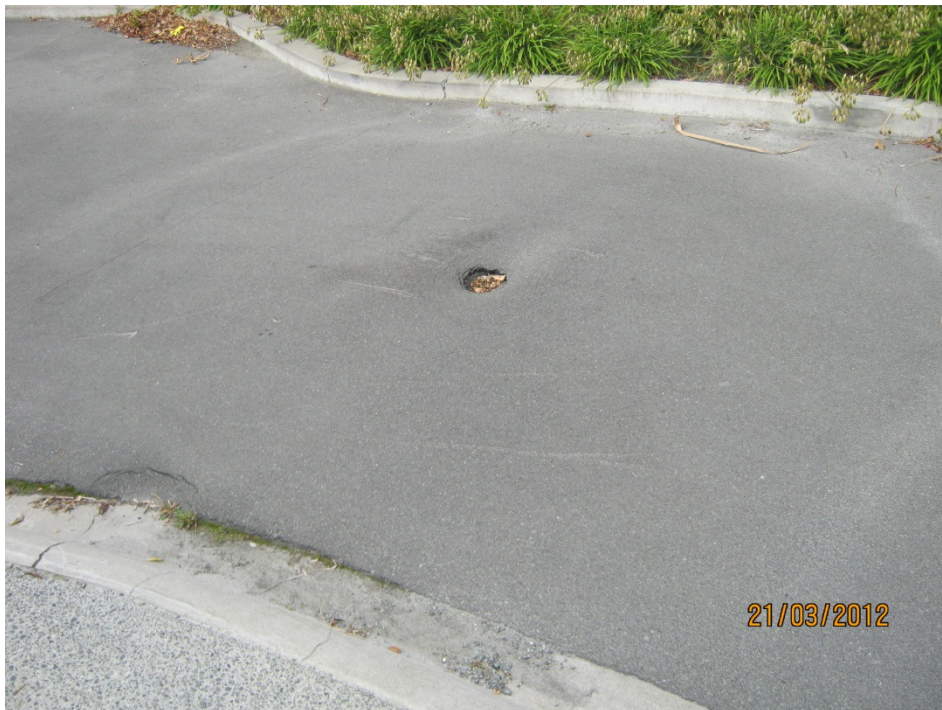
External to the building, obvious indications of ground movement exist such as fissuring and ejected silt associated with liquefaction. To properly assess any damage to the ground floor slab, carpets should be removed and the ground floor slab investigated for cracking.

**Photo 4: Evidence of liquefaction to external areas**

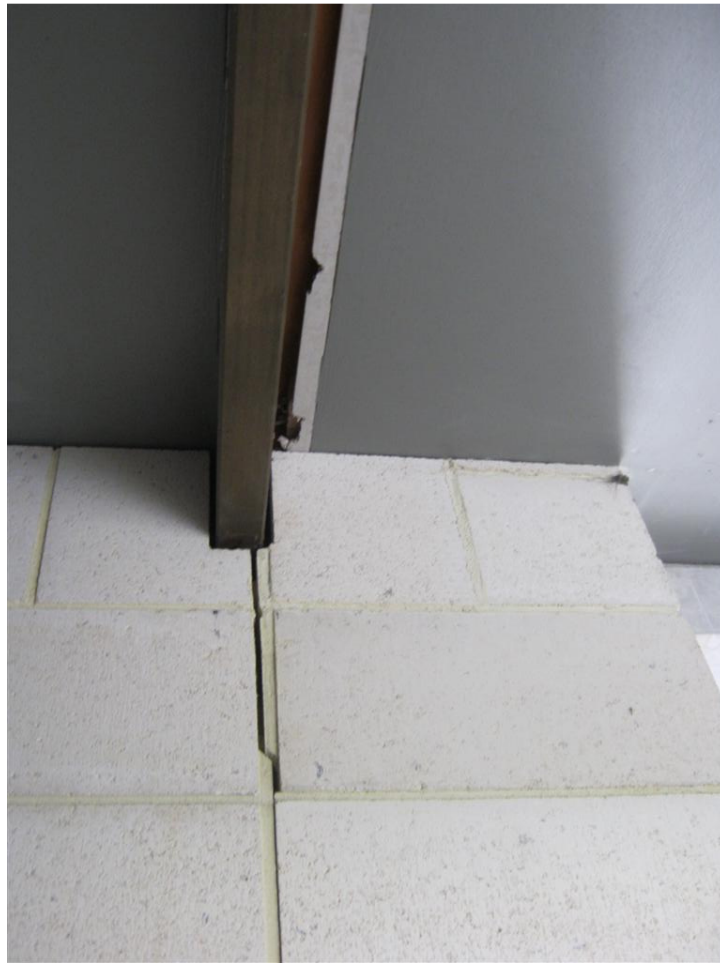
**Photo 5: Cracking to the external masonry veneer in the central stair area**

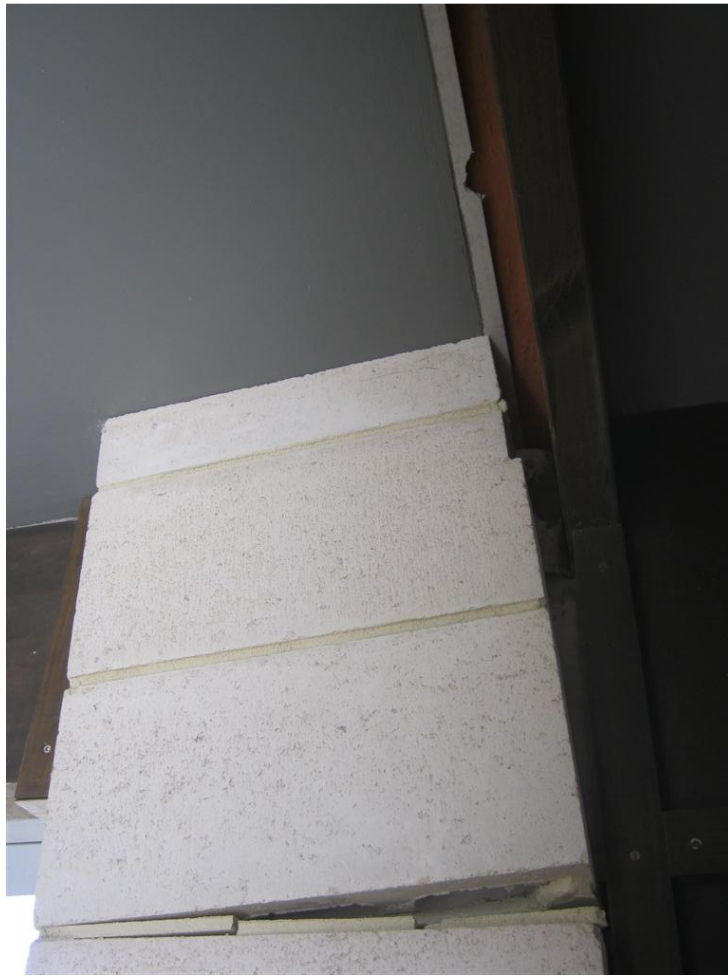
**Photo 6: Displaced masonry veneer in the central stair area**

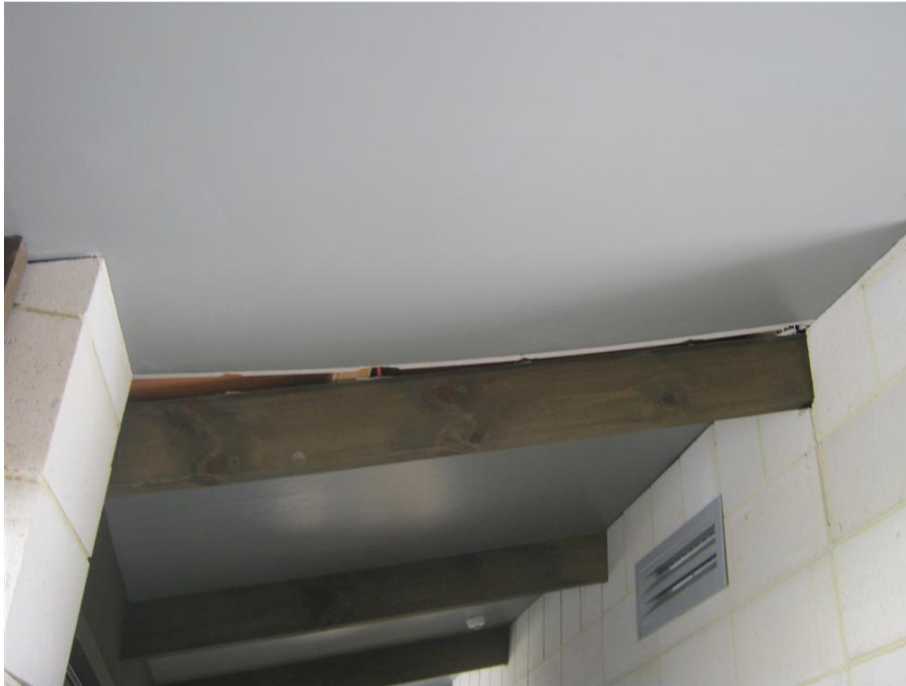
**Photo 7: Separation between the timber roof members and the plaster ceiling**

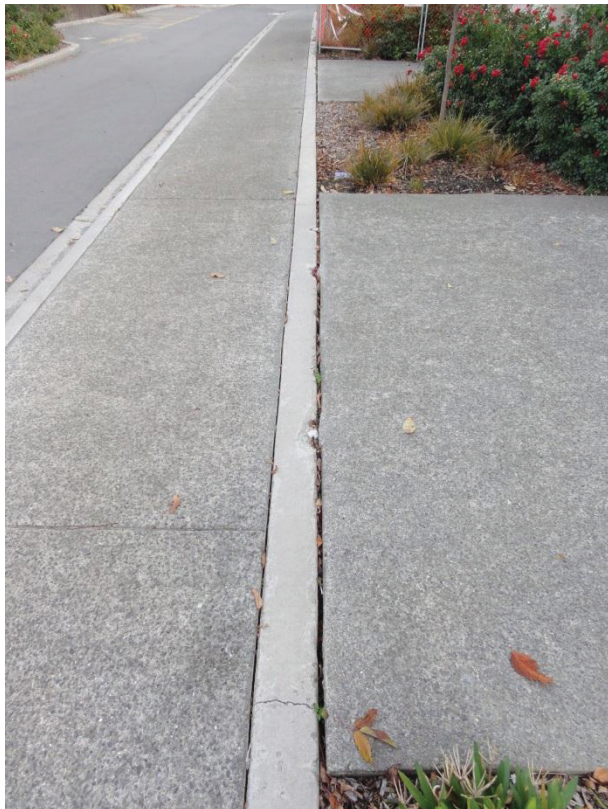
**Figure 4: Up to 30mm of lateral movement.**

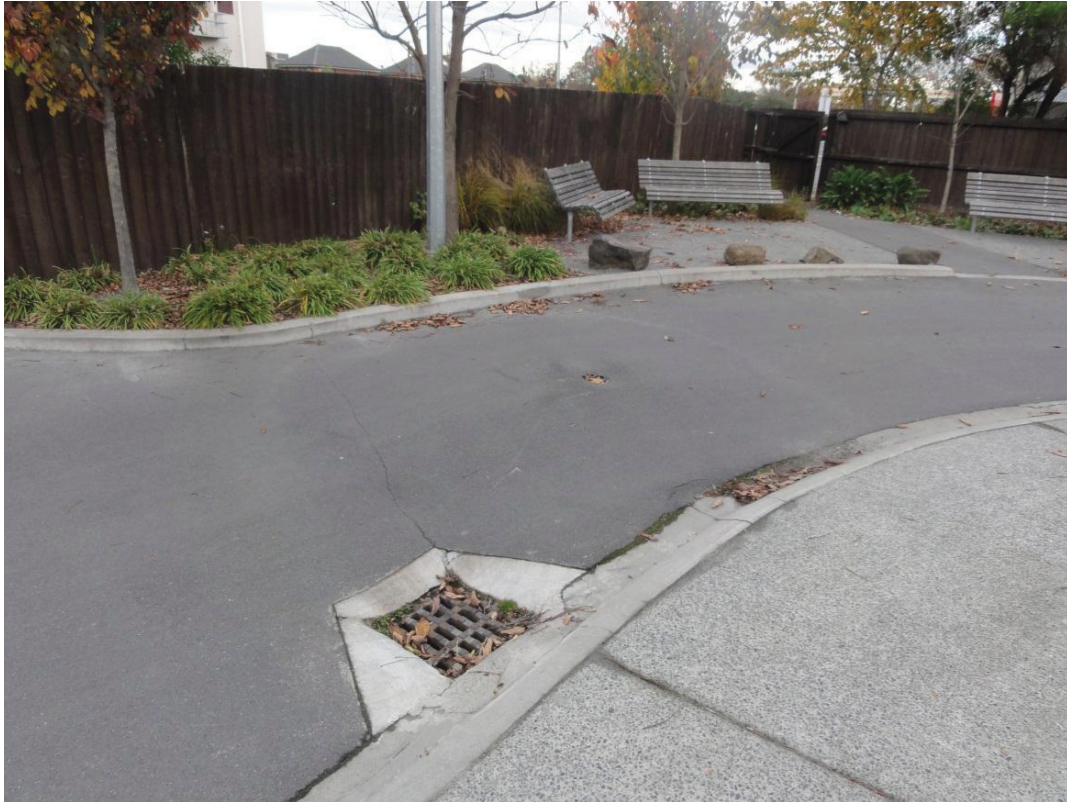
**Figure 5: Up to 200mm of heave in pavement south west of Block A.**

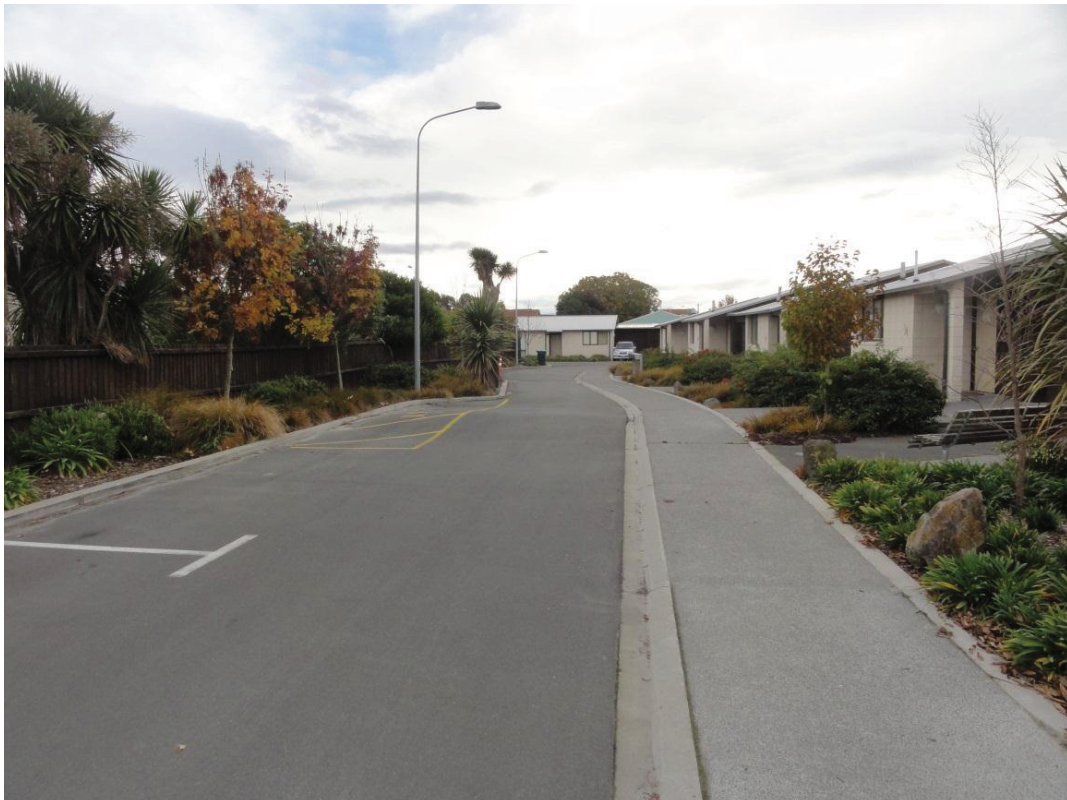
**Figure 6: Up to 300mm of heave in the pavement along the western boundary.**

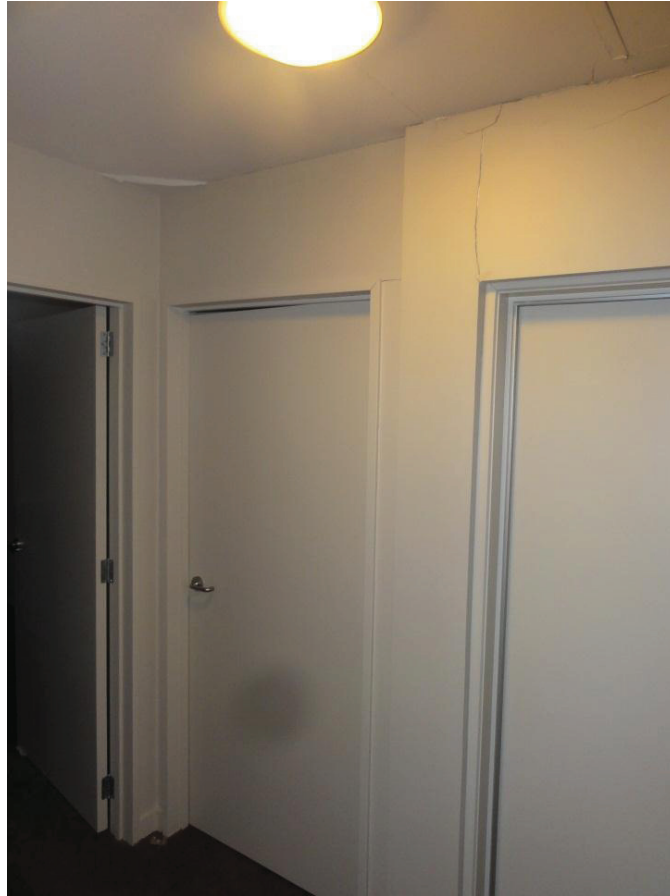
**Figure 7: The bedroom door has skewed by up to 10mm.**

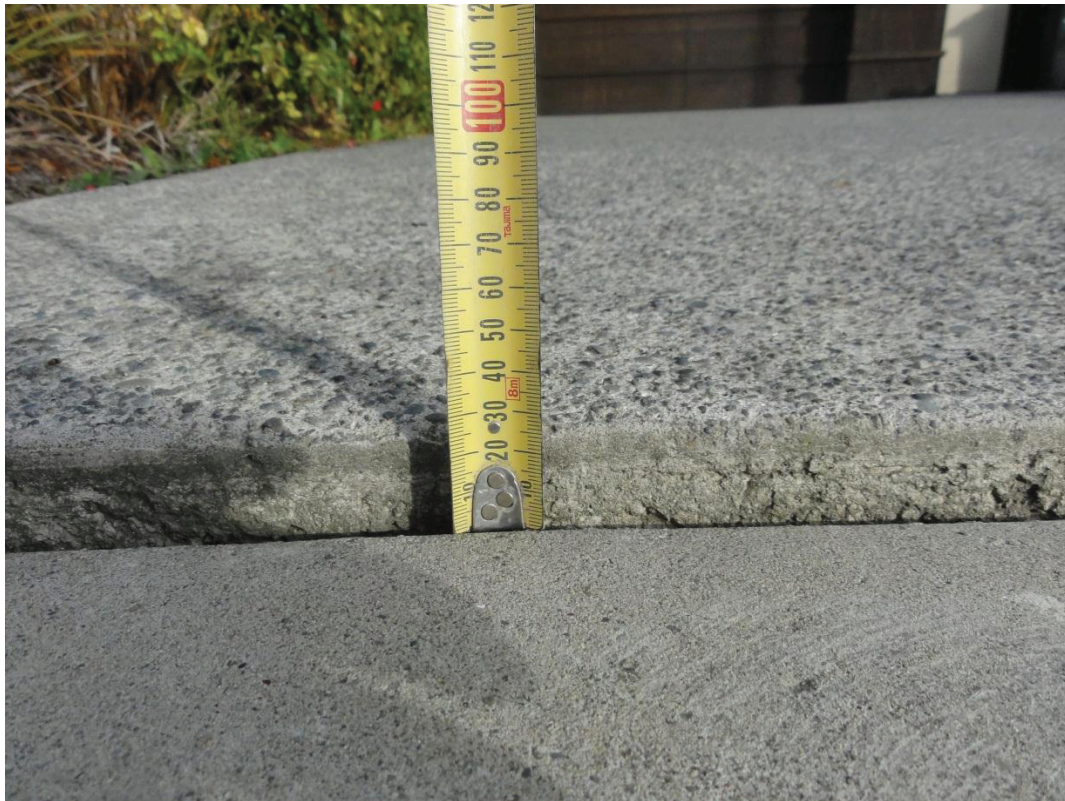
**Figure 9: Approximately 20mm of vertical settlement in footpath outside Block B.**

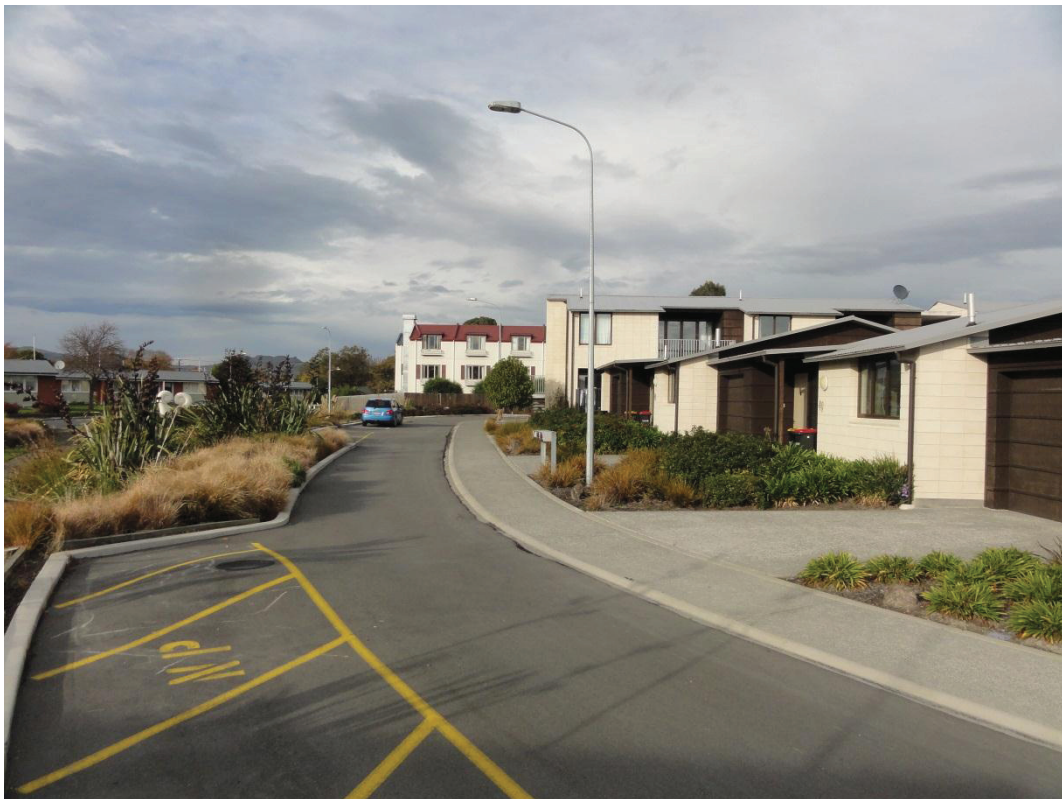
**Figure 10: Heave in the pavement along the western boundary.**

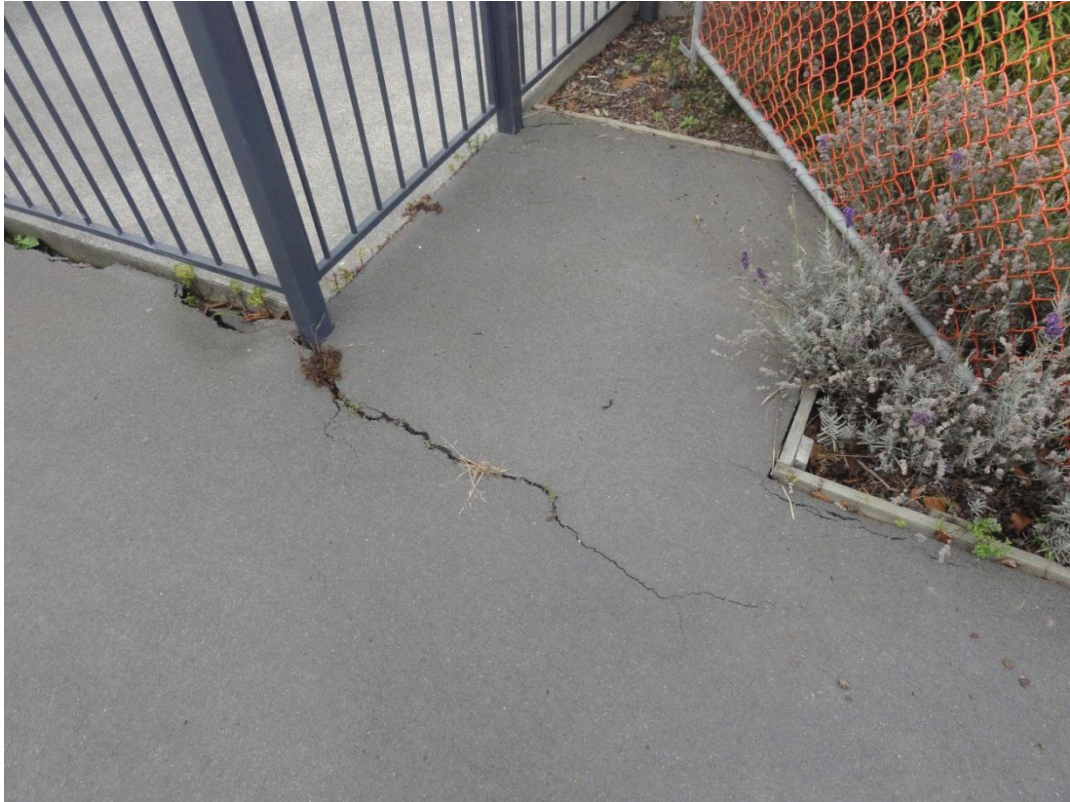
**Figure 11: A gap up to 50mm is evident between the asphalt and concrete patio north of Block A.**

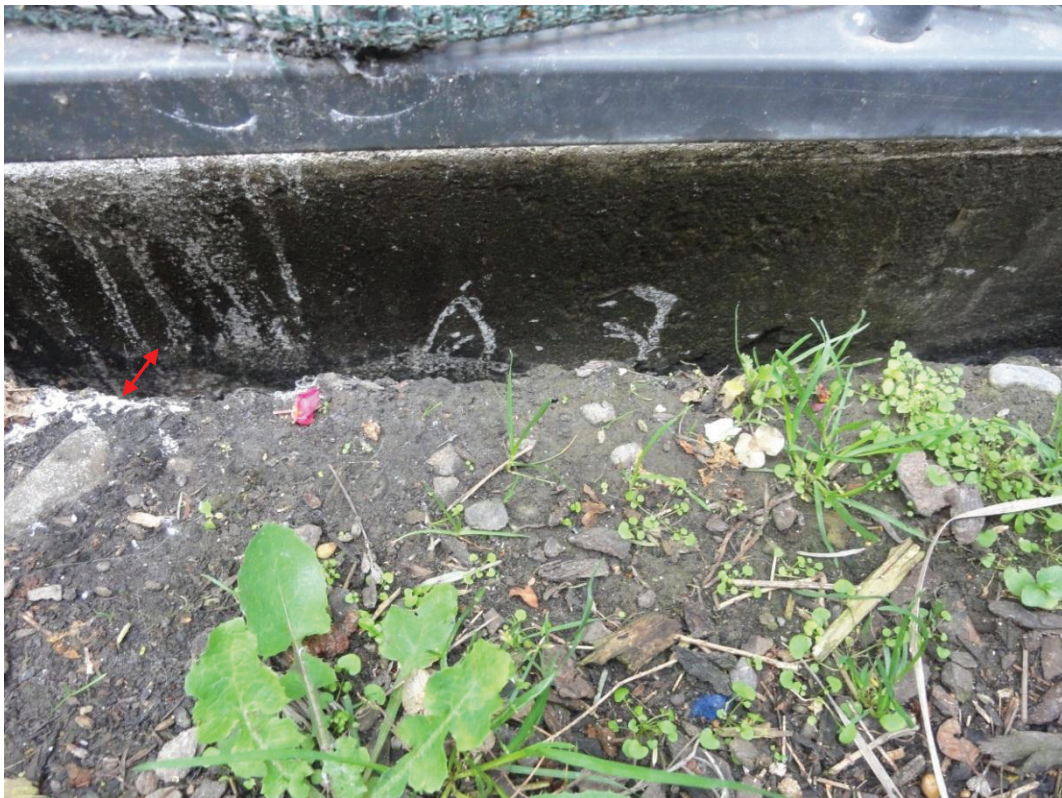
**Figure 12: A gap up to 50mm is evident between a garden and concrete patio north of Block A.**

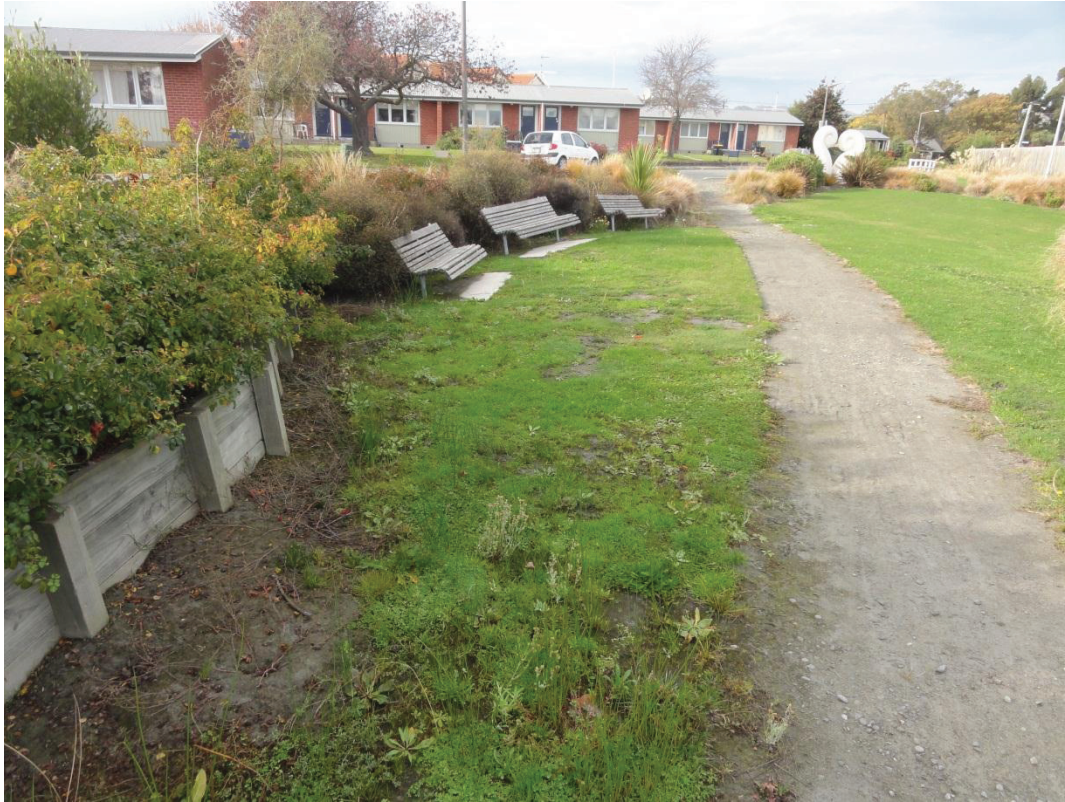
Figure 13: Liquefaction induced settlement of the park benches east of the site.

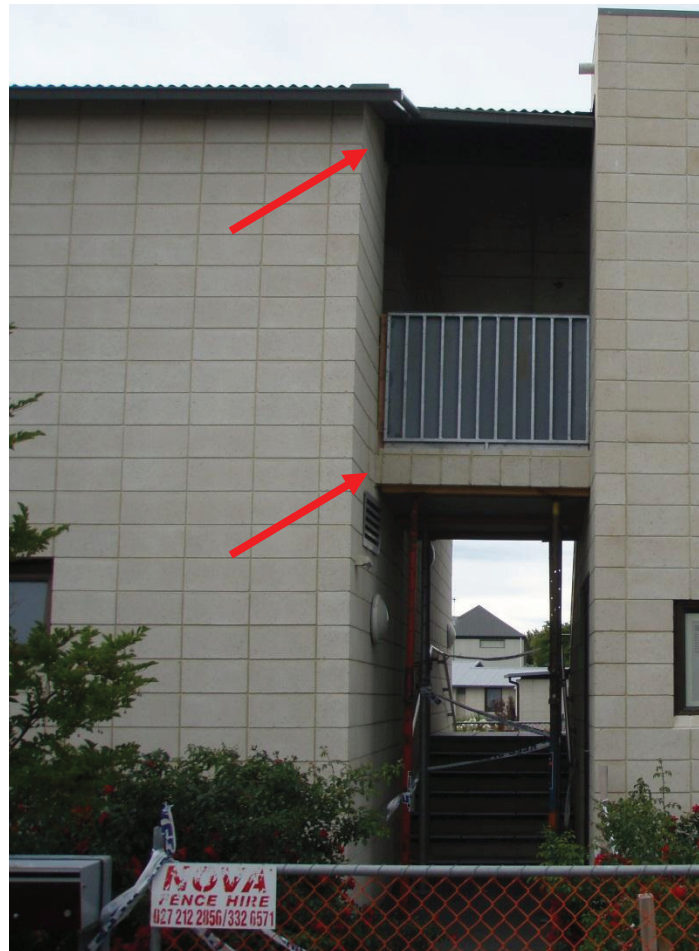
The level survey results are consistent with the observations of differential settlement of the western units of Block A. Observations include pavement cracking of the driveway outside the western most unit (unit 43) separating from the stair well.

Figure 14: Separation between west side of Block A and the stair well.
