Wigram Aerodrome - Harvard Lounge  
BU 2556-002 EQ2  
Detailed Engineering Evaluation  
Quantitative Report  
Version Final

8 Corsair Drive, Hornby

Christchurch City Council

**Date**  
28 January 2013

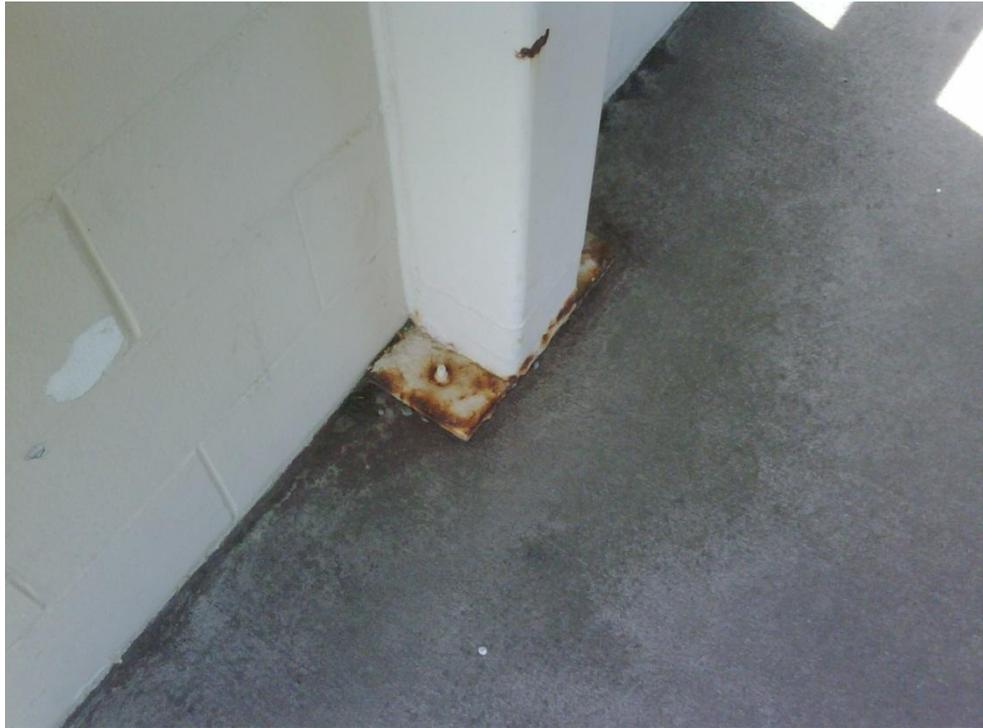
**Photograph 3** Connection at base of RHS posts supporting the entrance canopy.

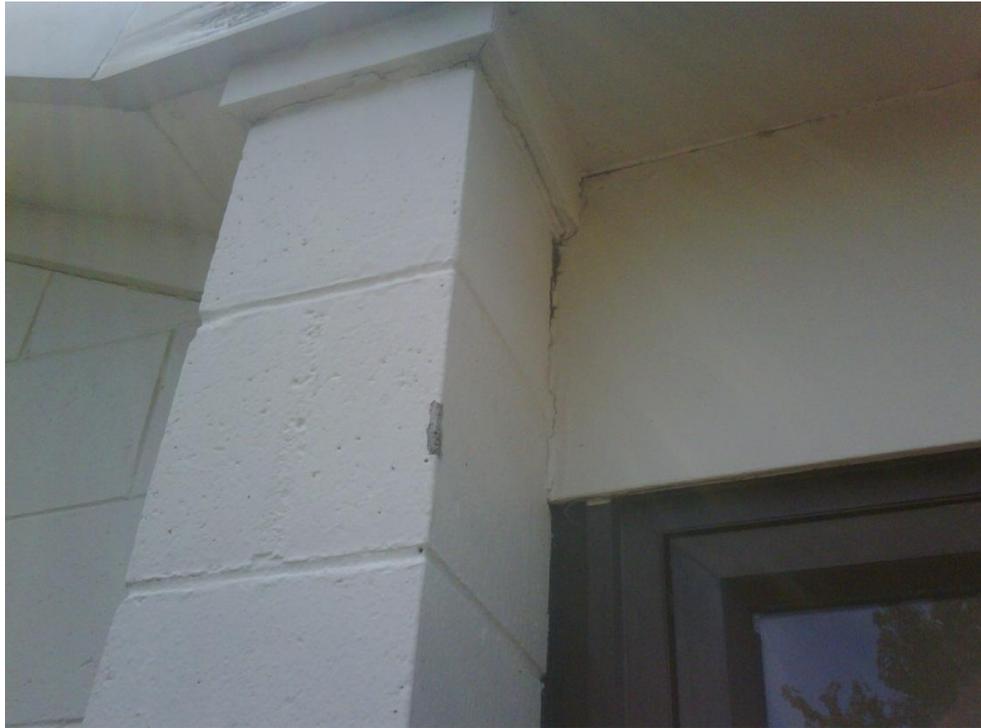
- ▶ Minor cracking between the external cladding and the top of the concrete masonry piers.

Minor cracking was observed between the cladding and the top of the concrete masonry piers as can be seen in Photographs 5 and 9.

**Photograph 5** Cracking between the external cladding and the top the concrete masonry piers.

- ▶ The current placard status of green remains.
- ▶ The building can still be used, as per CCC's policy to occupy "Earthquake Risk" buildings.
- ▶ A strengthening scheme is developed to increase the seismic capacity of the building to at least 67% NBS.
- ▶ Minor repairs are undertaken to fill the minor cracks identified at the top of the concrete masonry piers.

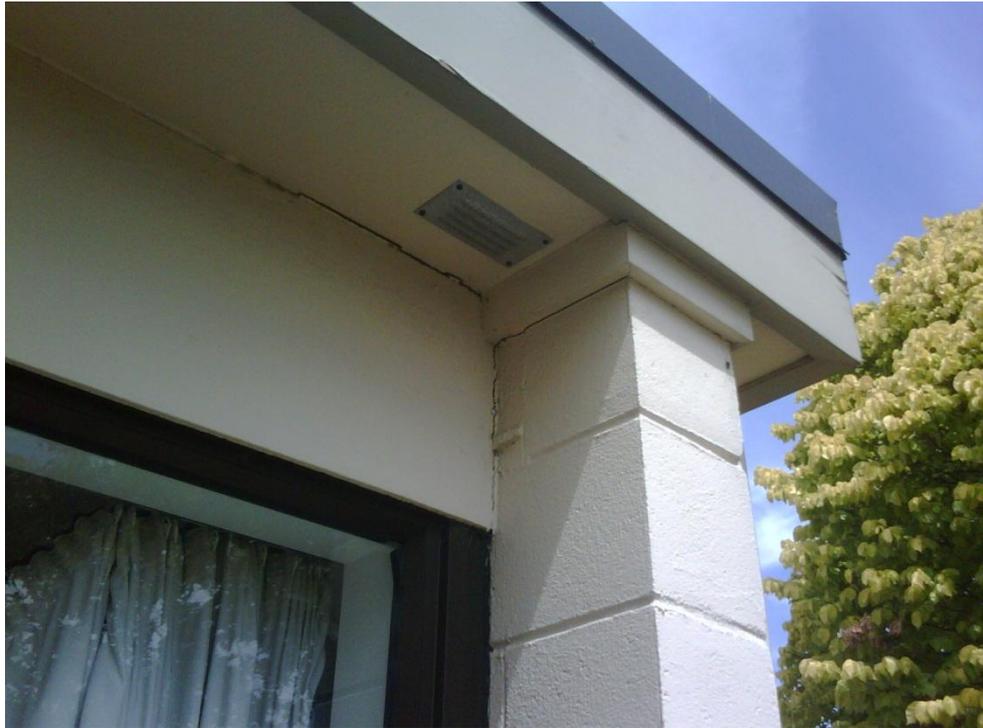
**Photograph 9** Further cracking between the external cladding and the top the concrete masonry piers.
