**William Massey
Housing Complex
PRO 0925**

**Detailed Engineering Evaluation
Quantitative Assessment Report**

**182 Ensors Road, Woolston,
Christchurch 8023**

Date: September 2013
Reference: 6-QC418.00
Status: Final

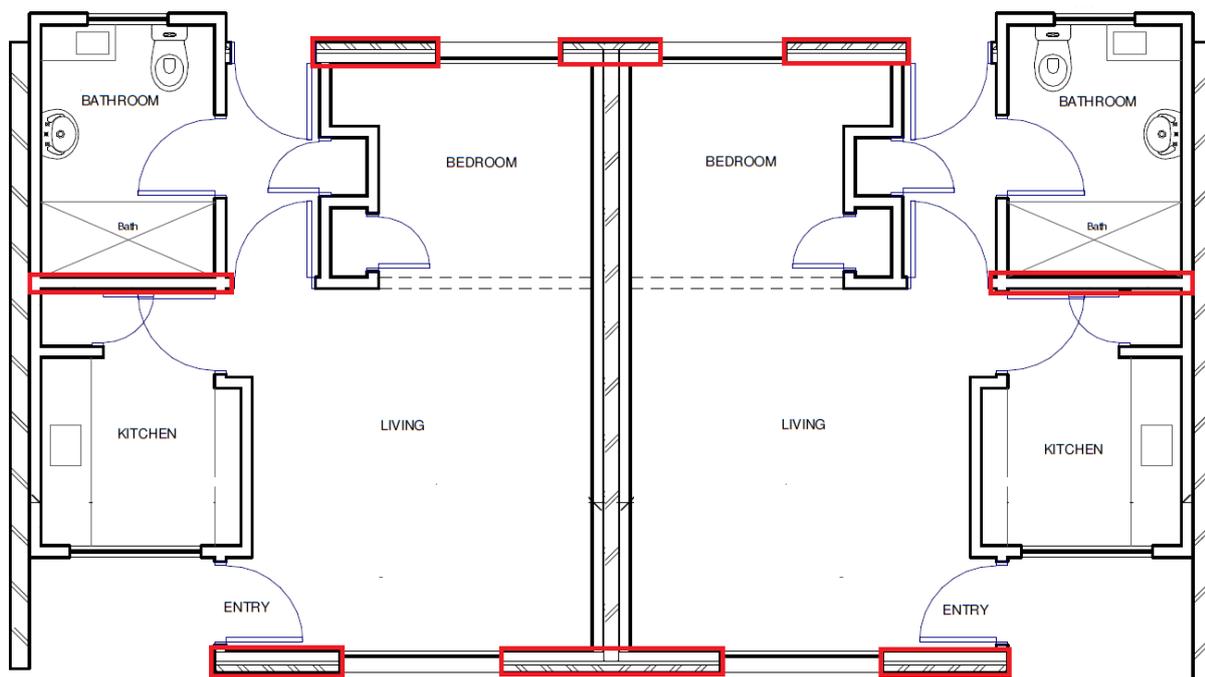
Figure 6: Walls used for bracing in the longitudinal direction.

The residential units have capacities of 58% NBS and are limited by the in-plane shear capacity lined timber-framed shear walls in the longitudinal direction.

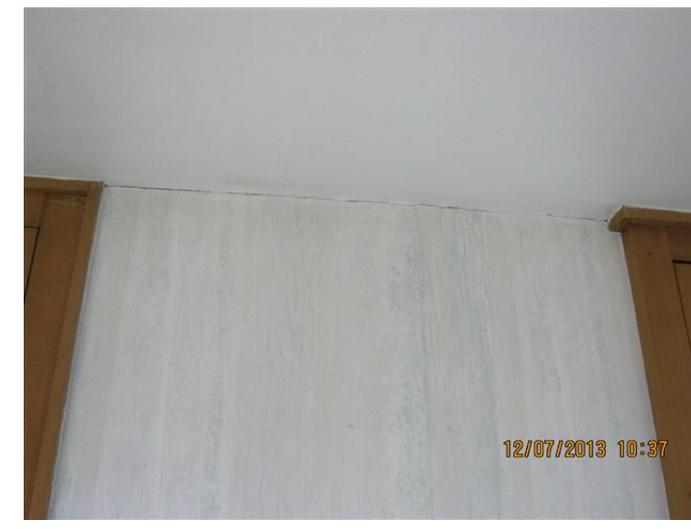
Minor cracking of ceiling diaphragms and of GIB-lined walls was observed in the majority of the units (photos 6 and 7).

- All buildings be strengthened to at least 67% NBS.
- Veneer at height (gable ends) have the veneer ties checked.
- Cosmetic repairs are undertaken.

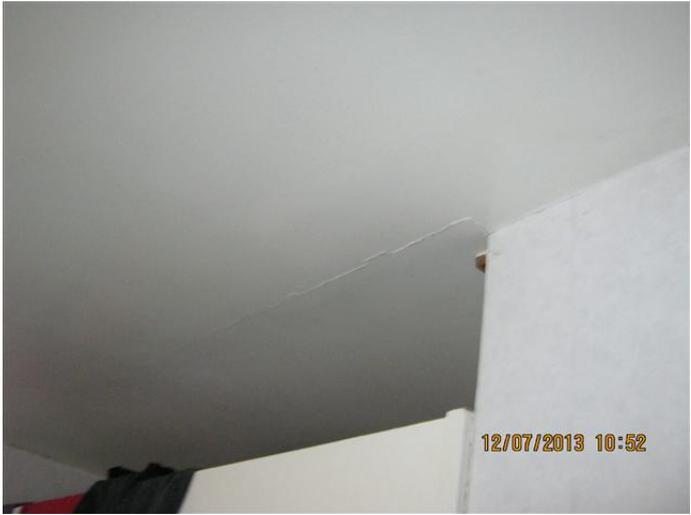
7.	Typical cracking to ceiling

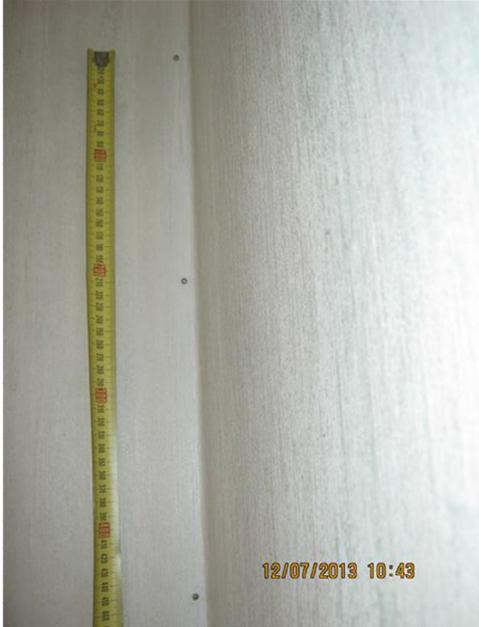
Increasing the number of nails in the plasterboard will not significantly improve the strength of the building.

8.	Typical GIB nail spacing

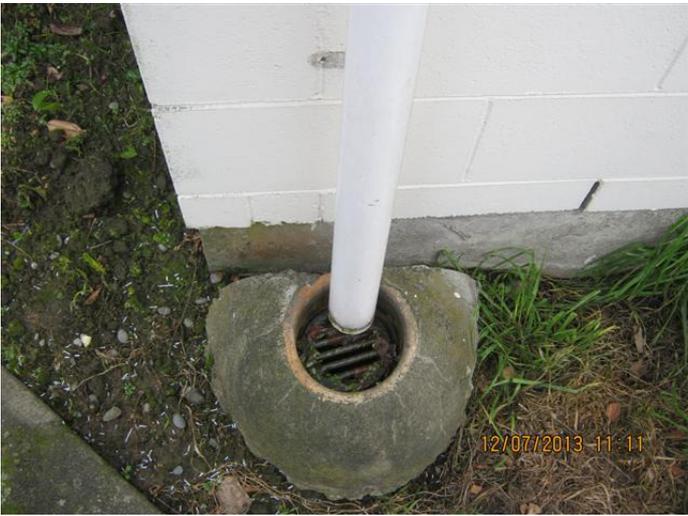
9.	Settlement of stormwater traps
