Woodham Park Toilets (Woodham Road)
Qualitative Engineering Evaluation

Functional Location ID: PRK 0697 BLDG 008 EQ2

Reference: 229186

Date: 13 February 2013

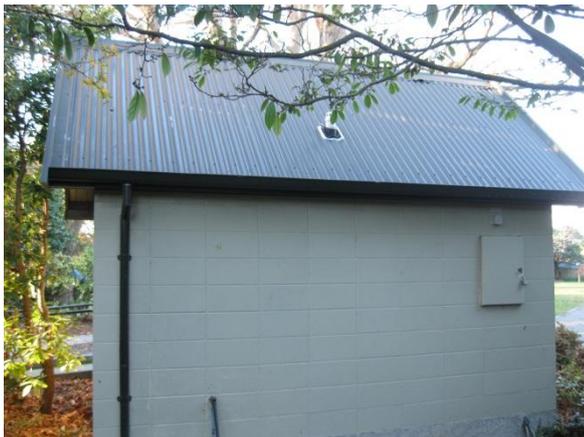
Building eastern elevation.

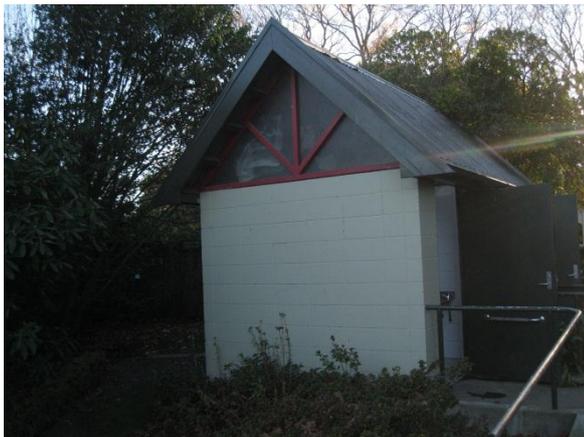
Building southern elevation.

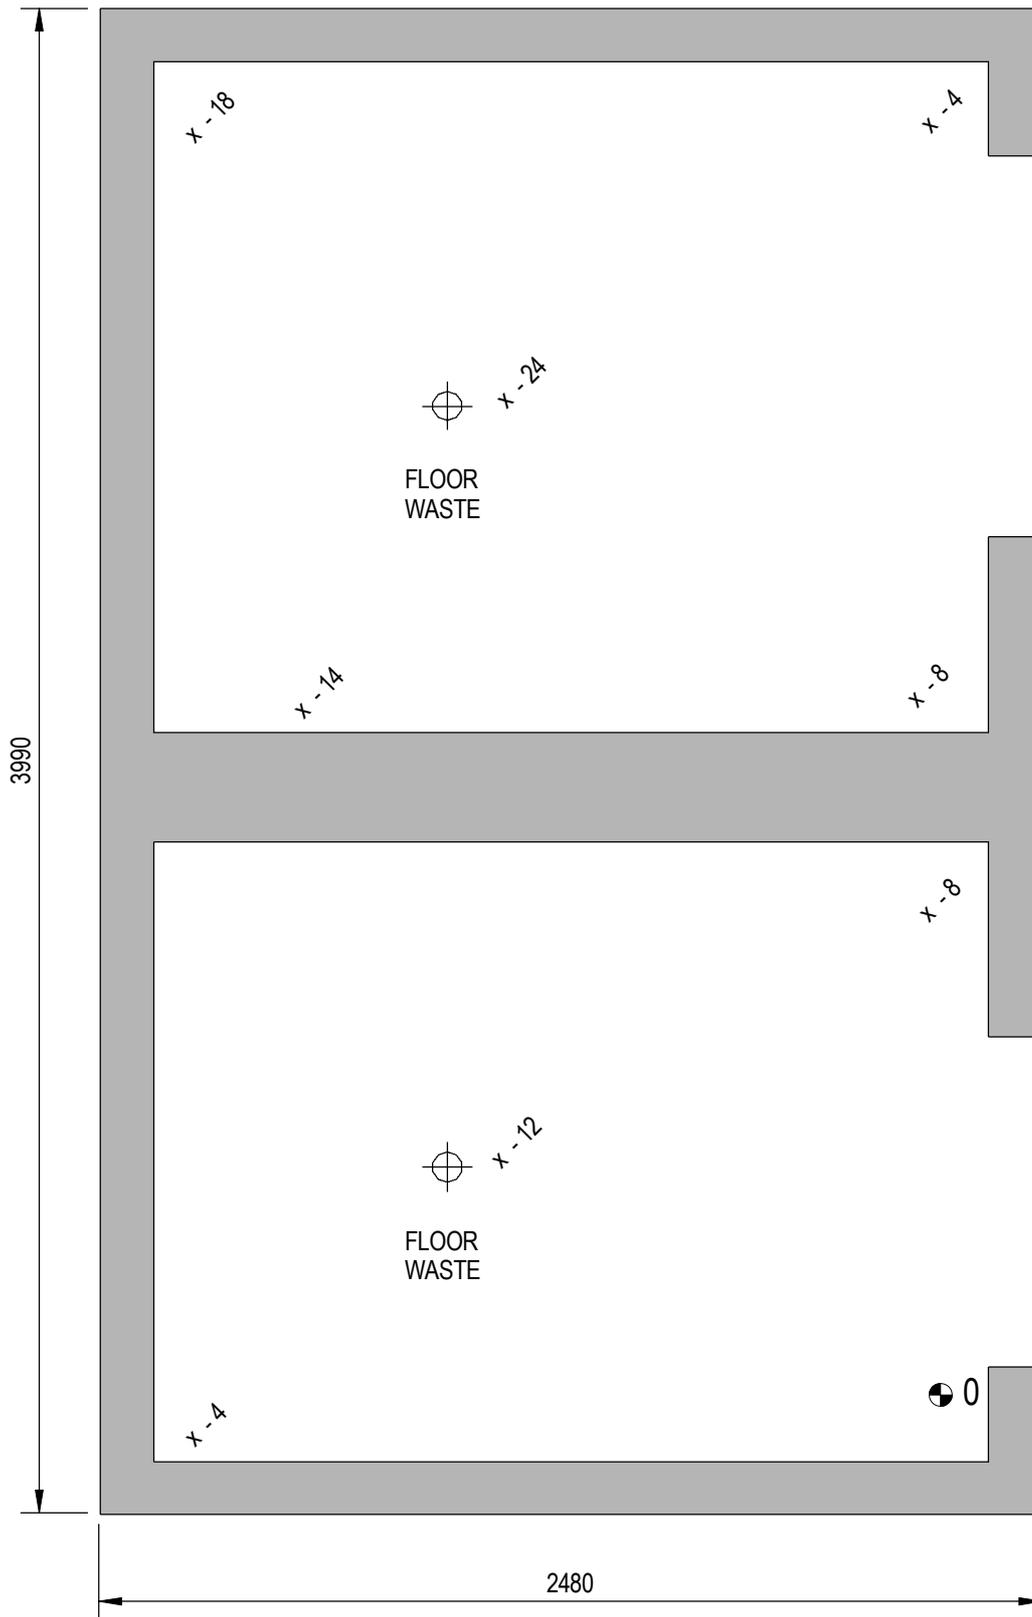
PRELIMINARY NOT FOR CONSTRUCTION	
PROJECT No. 229186	
SCALE 1 : 20	SIZE A4
DRAWING No. SK-001	REV A

The floor levels for the Woodham Park Toilets were found to be within acceptable levels. The variations in floor level that were recorded related slopes in the floor for drainage purposes.
