Woolston Community Centre  
Qualitative Engineering Evaluation

**Reference:** 227680

**Prepared for:**  
Christchurch City Council

Address: 502 Ferry Road

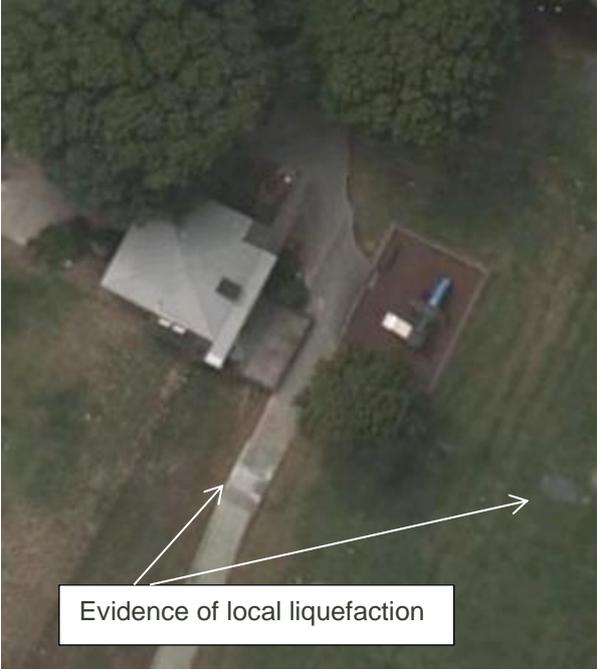
The most significant damage observed to Woolston Community Centre was to the surrounding land due to evidence of local minor liquefaction. However it is not certain that this damage is reflected within the structure.

<p>Evidence of local liquefaction</p>
<p>East elevation of the Woolston Community Centre.</p>

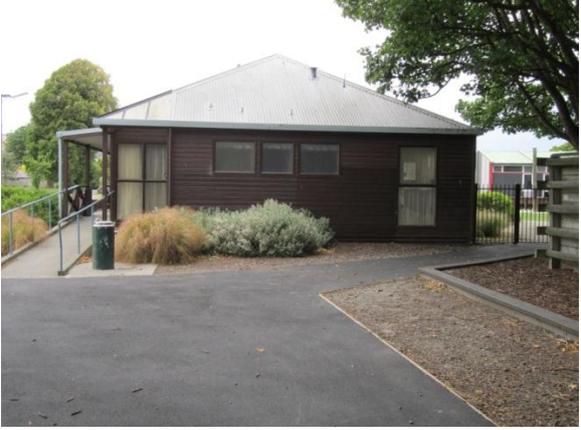
South elevation of the Woolston Community Centre.

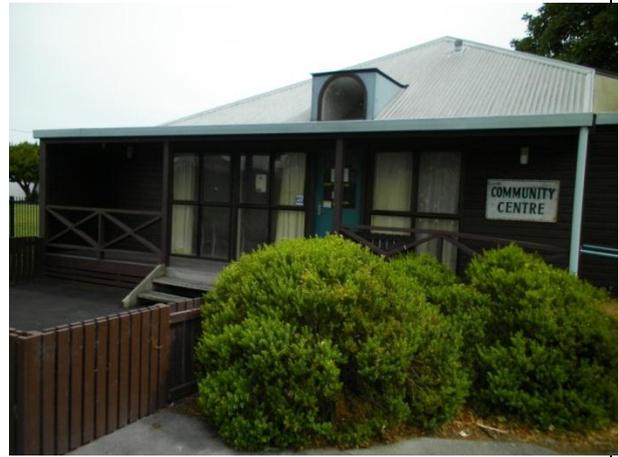
Potential internal movement in door frame.

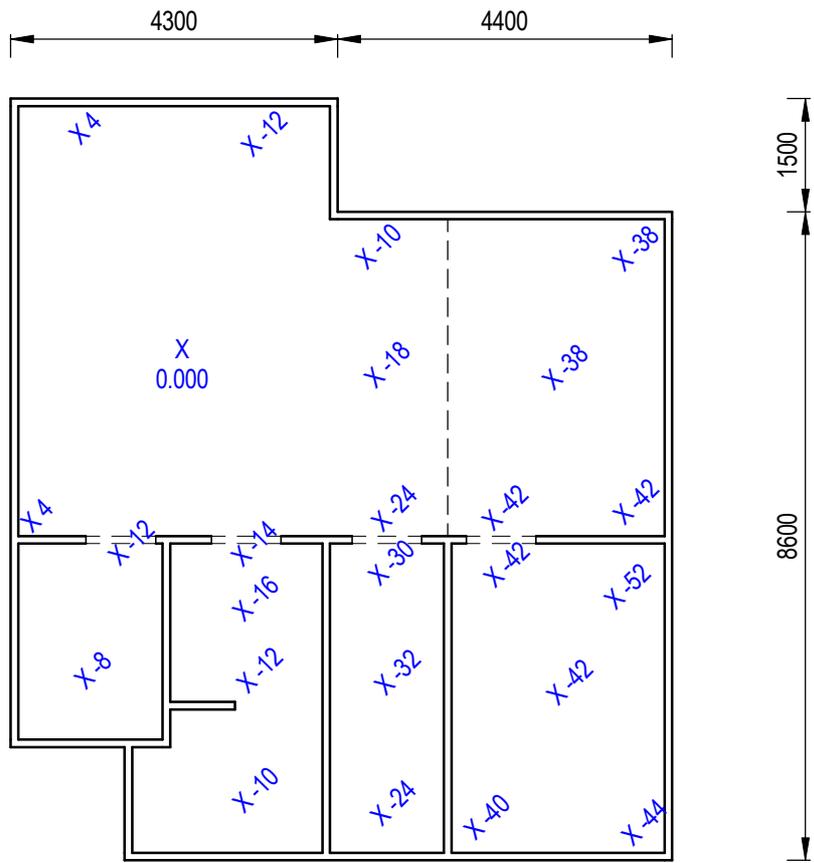
PROJECT
WOOLSTEN COMMUNITY CENTRE
TITLE
FLOOR LEVEL SURVEY

<b>Levels Survey Results</b>	Y	Levels survey results are not within acceptable limits. The identified level damage is very likely earthquake related. Re-leveling is recommended.			
<b>Building %NBS From Analysis</b>	100%	Based on an analysis of bracing capacity and demand.			
<b>Qualitative L4 Report Recommendations</b>					
<b>Geotechnical Survey Required</b>	N	A geotechnical survey not required.			
<b>Proceed to L5 Quantitative DEE</b>	N	A quantitative DEE is not required for this structure.			
<b>Approval</b>					
<b>Author Signature</b>

The level survey showed that the floor was sloping down towards the north. The slope is greater than the allowable limits. It is suggested the floor is re-levelled.

The land below the Woolston Community Centre is zoned TC2 and as such has been identified as somewhat prone to liquefaction and settlement. Additionally there is some minor local evidence of liquefaction in the surrounding land. Accordingly **it is recommended that the floor is re-levelled.**
