Christchurch City Council

Wycola Courts Housing Complex PRO 1556

**Detailed Engineering Evaluation
Quantitative Assessment Report**

**38 – 44 Manurere Street, Hei Hei,
Christchurch 8042**

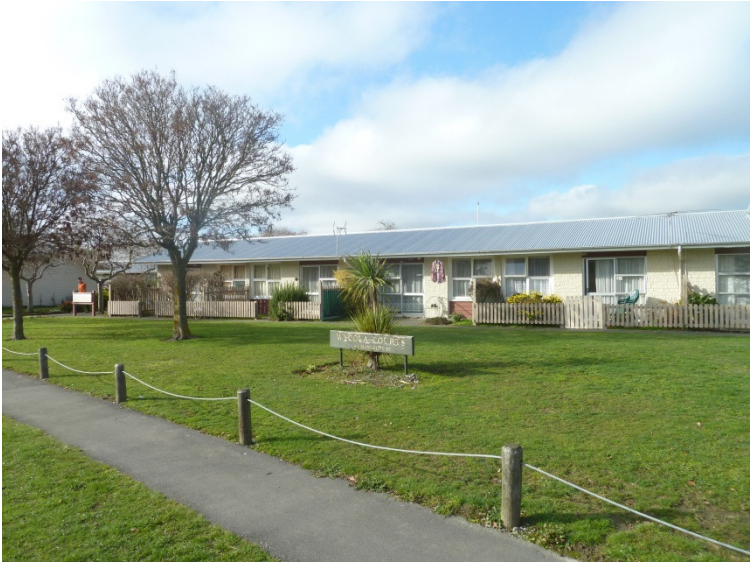
Wycla Courts Housing Complex		
Residential Units		
1	<p>Front of units 13-18. (North west facing side)</p> <p>Typical layout of the front of the units</p>

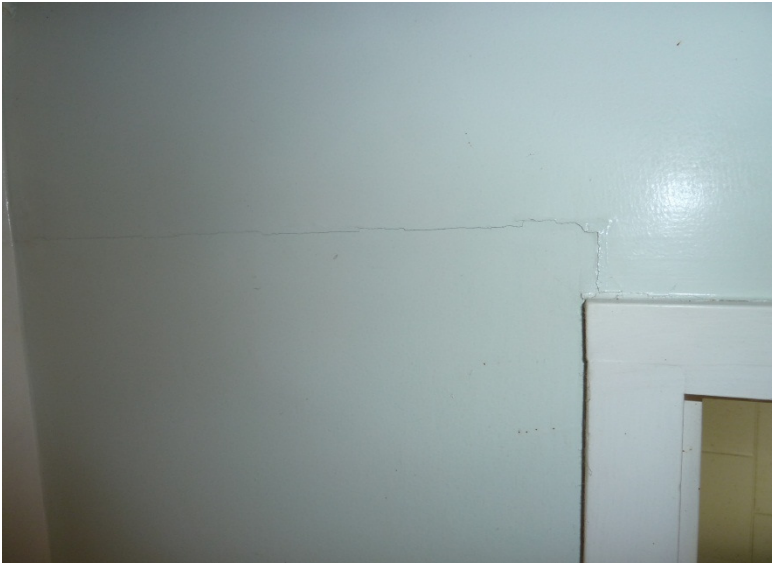
Some minor cracking of ceiling diaphragms and of GIB-lined walls was observed in the majority of units that were inspected.

6	Typical crack in GIB lined wall

It is recommended that cosmetic repairs be undertaken.

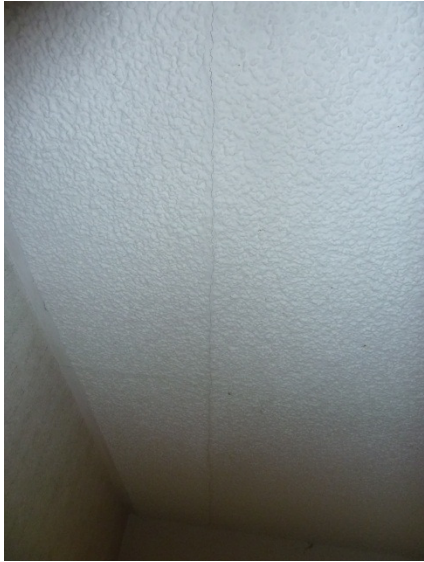
7	Typical crack in the ceiling diaphragm

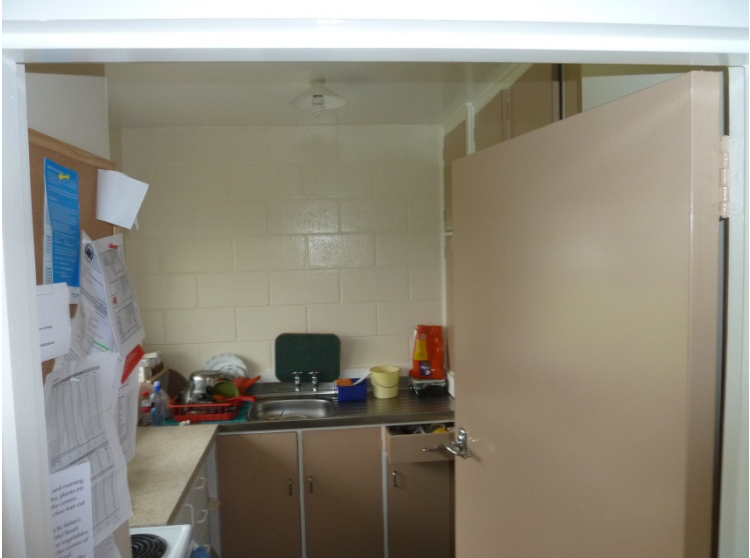
8	Typical kitchen layout with block wall

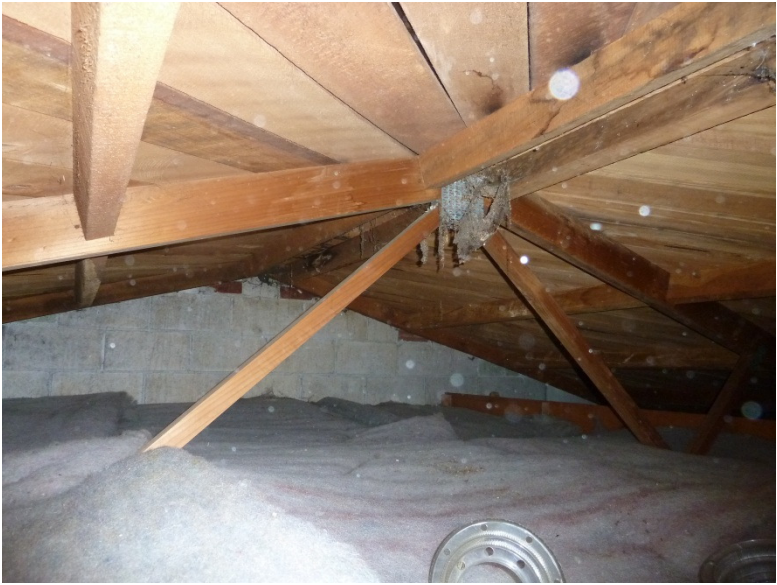
12	Typical roof structure layout and fire wall to roofline
