Wycola Park Hockey Pavilion
PRK 1557 BLDG 005
Detailed Engineering Evaluation
Quantitative Report
Version FINAL

34 Manurere Street, Hei Hei

Christchurch City Council

Date
27 May 2013

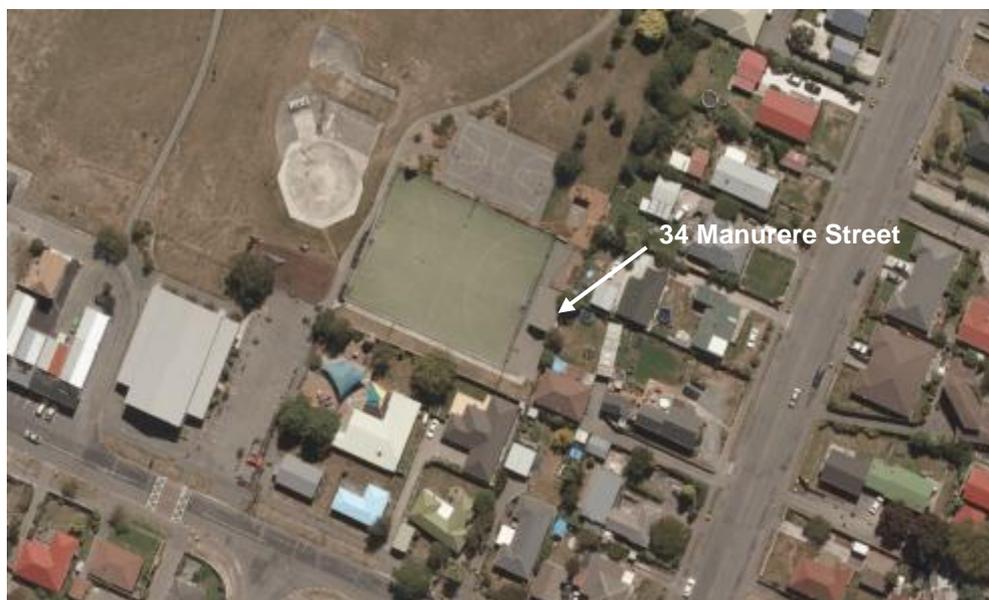
Figure 4 Post February 2011 Earthquake Aerial Photography²

Aerial photography taken following the 22 February 2011 earthquake shows no signs of liquefaction outside the building footprint or adjacent to the site, as shown in Figure 4.

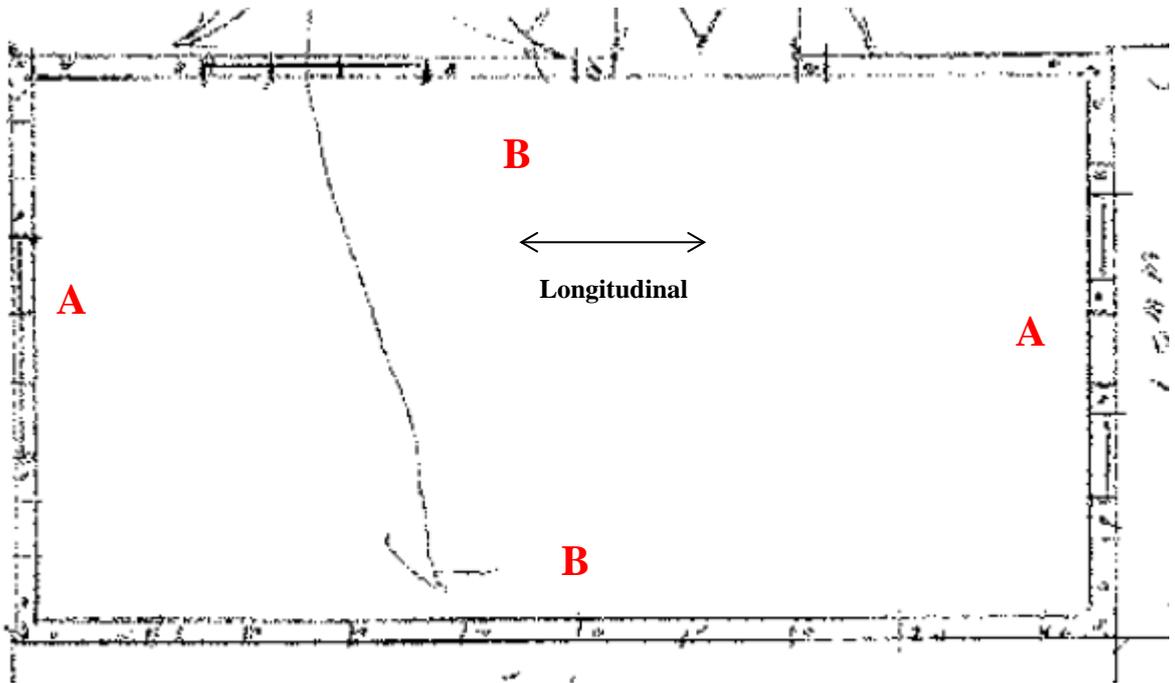
Figure 5 Plan identifying wall panels.

The structure was found to be relatively symmetrical with the opposing wall panels achieving similar performances. The structure is divided into two groups of wall panels as identified in Figure 9-1.

The critical loading condition for the concrete masonry panels in this structure is lateral loading perpendicular to the wall panels. Hence the critical load condition for Wall A is lateral loads in the longitudinal direction. Similarly, the critical load condition for Wall B and therefore the overall structure, is lateral loads in the transverse direction. The performance of each wall group for each load direction is quantified in Table 4 below.

It is recommended that strengthening concepts be developed to increase the structure's performance to a minimum of 67% of the New Building Standard.
