**Yaldhurst Domain  
Toilet Block  
PRK 1642 BLDG 003**

**Detailed Engineering Evaluation  
Quantitative Assessment Report**

# **Yaldhurst Domain Toilet Block Quantitative Assessment Report**

**Yaldhurst Domain, Christchurch**

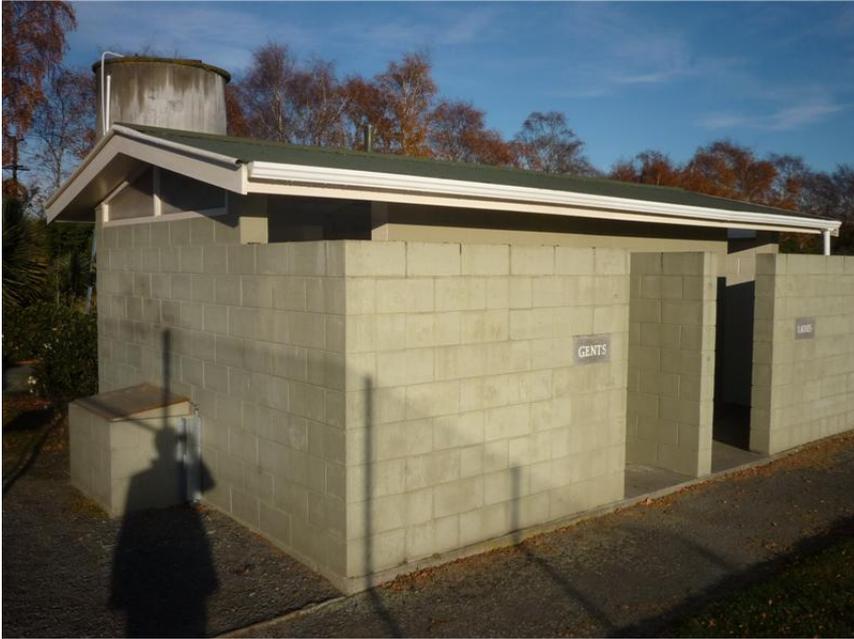
**Photo 1: Building entry**

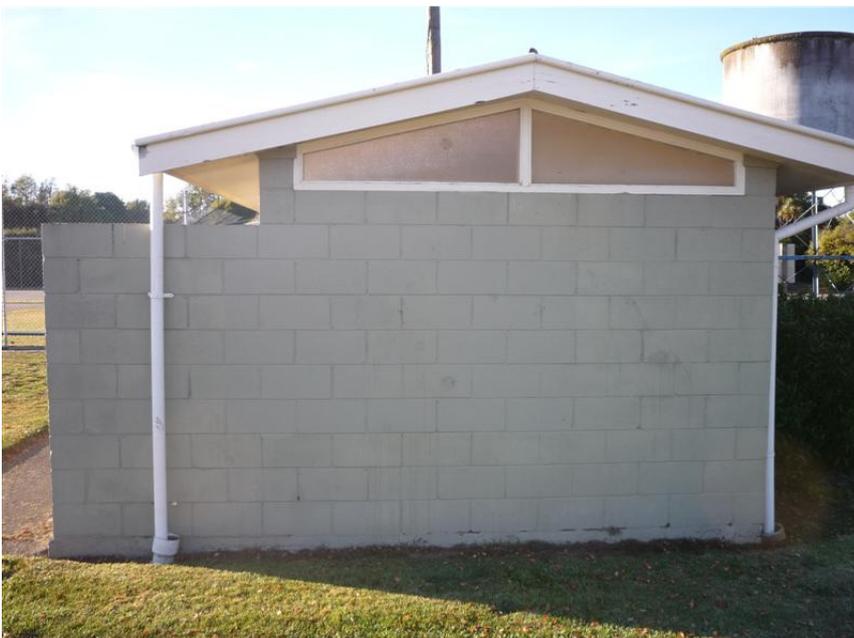
**Photo 2: Building end wall**

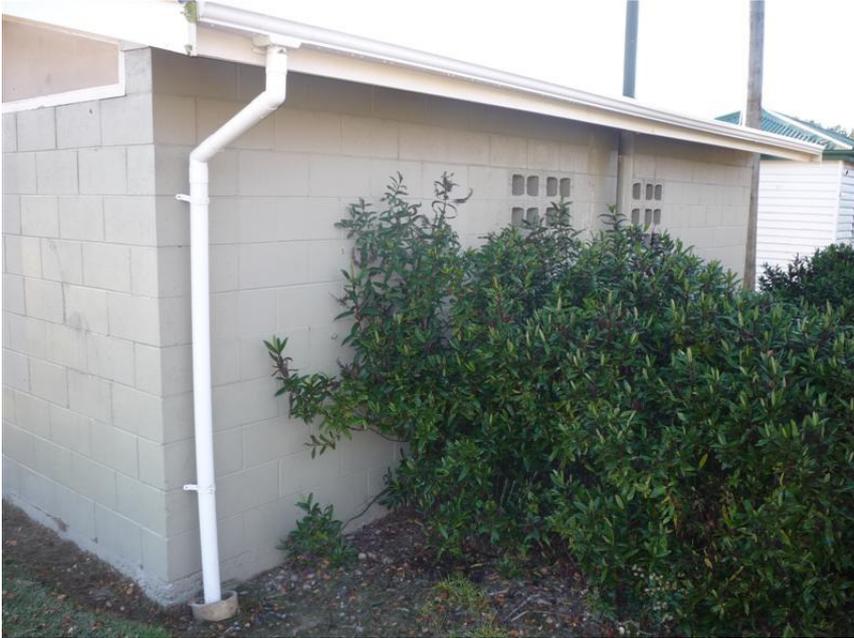
**Photo 3: Building rear wall**

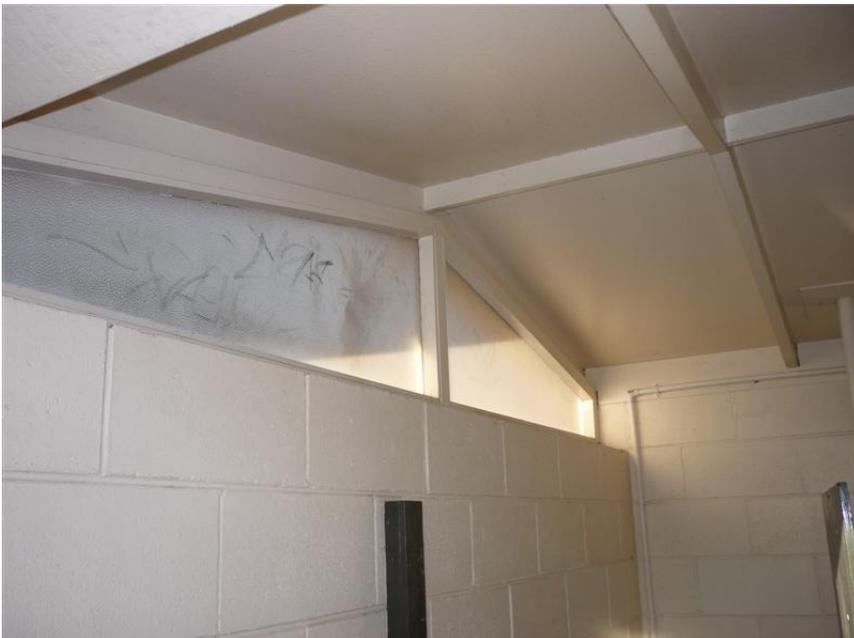
**Photo 4: Roof structure**

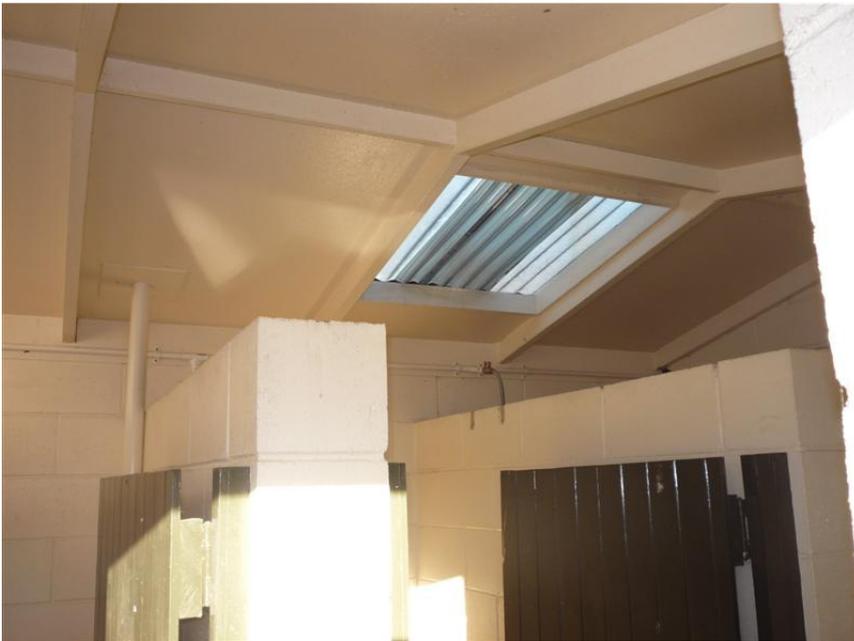
**Photo 5: Roof structure and internal walls**

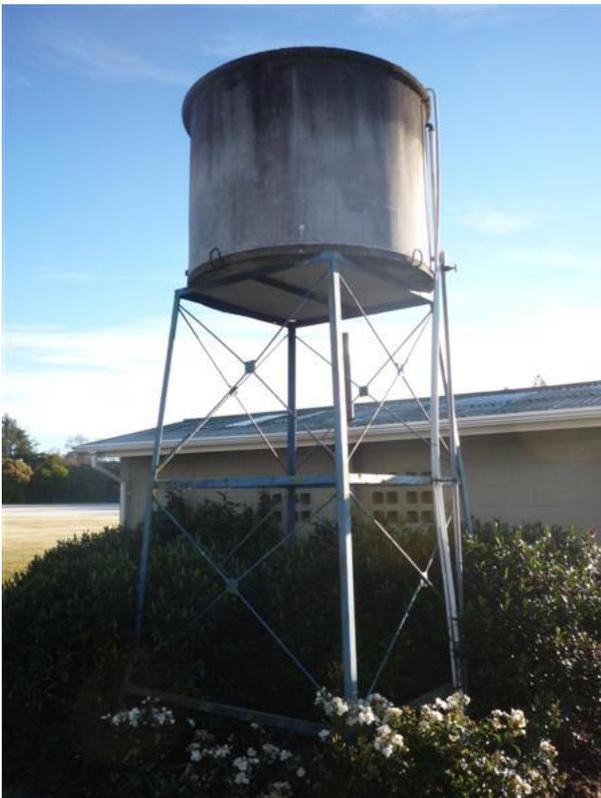
The site inspection noted impact damage to one leg of the tank stand. This damage reduces the axial load capacity of the leg and requires repair or replacement. The tank and tank stand appear stable, but being a little under code strength by calculation, and exhibiting one damaged leg, there is a moderate risk of toppling which could impact the toilet block.

**Photo 6: Water tank and stand**

- The building is strengthened to at least 67%NBS.
- A cordon is placed around the tank and toilet block until such a time that the damaged tank stand leg is repaired or replaced.

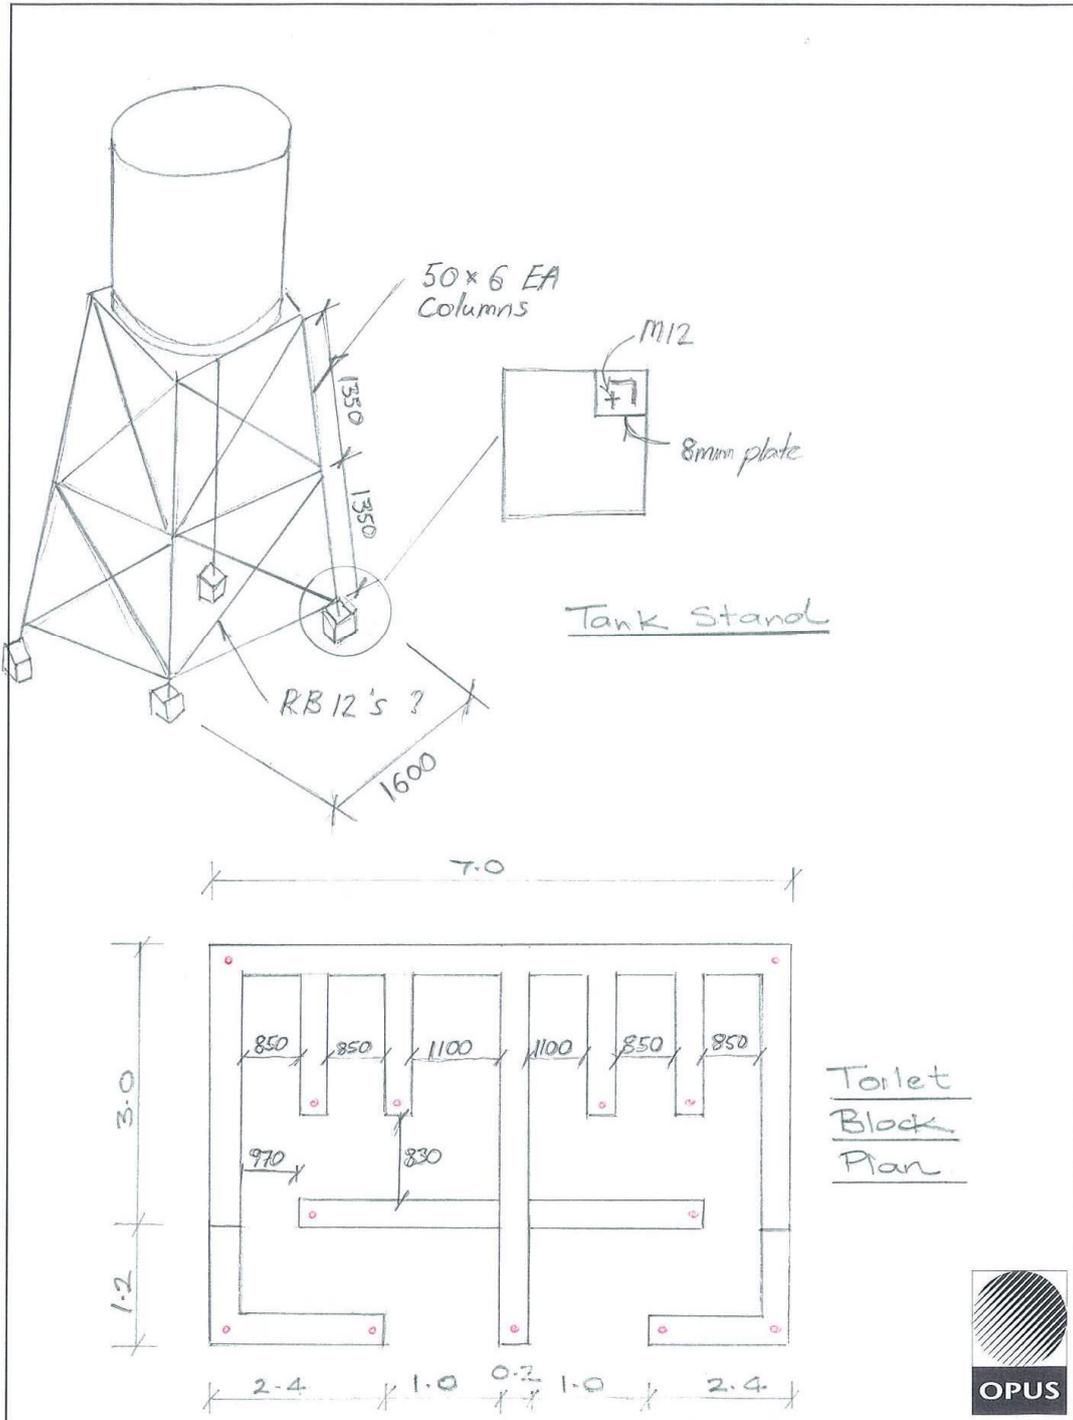
Project/Task/File No: 6-QUCCC-96	Sheet No: _____ of _____
Project/Description: Yaldhurst Domain Toilet Block & Tank Stand	Office: _____
	Computed: 10/8/12
	Checked: / /
