# AKAROA MAIN WHARF, AKAROA

Conservation Plan  
May 2019 - DRAFT

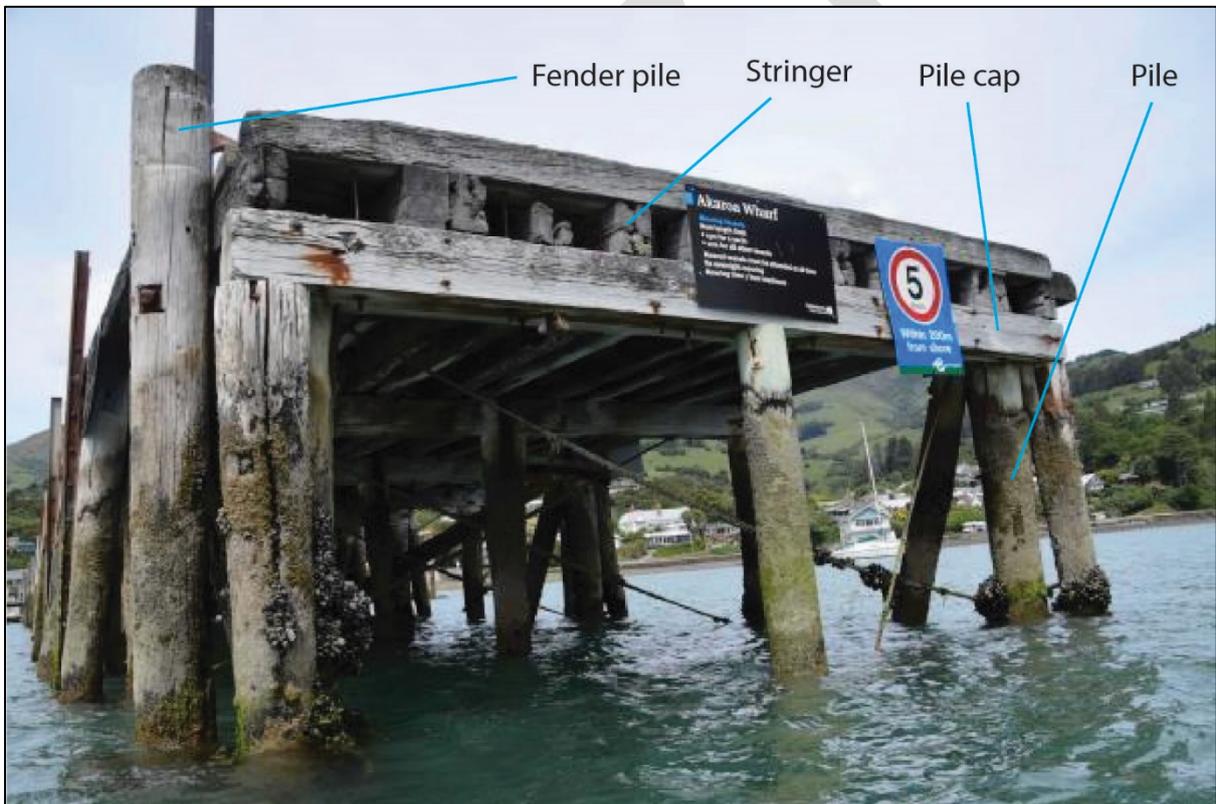
Figure 4. The end of the wharf with the principal parts of the structure identified. The whole assembly of the five piles with the pile cap running across them comprises a single 'bent.'

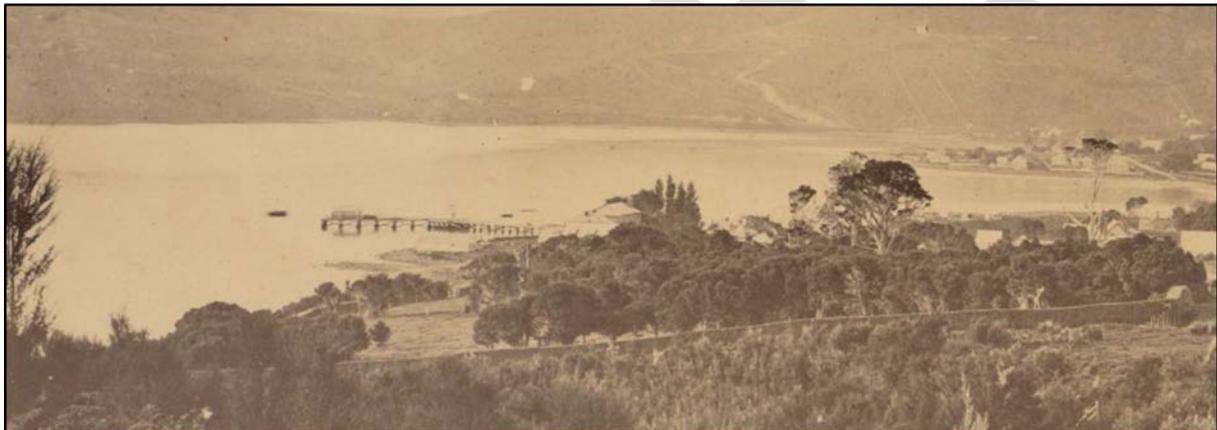
Figure 8. Detail of an 1860s image showing the 1850s Provincial Government jetty (Auckland Museum).

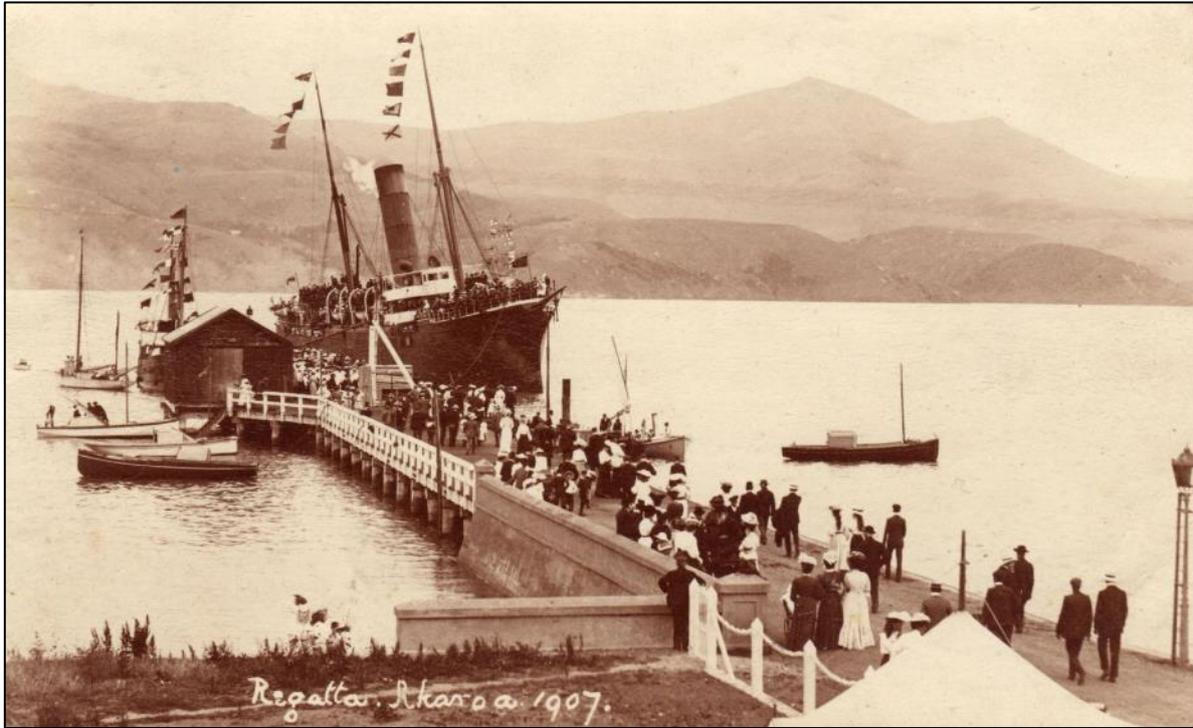
Figure 13. A public gathering at the Akaroa Main Wharf during a regatta in 1907. Though this event occurred well after the wharf's construction, it is likely representative of the scene on opening day in 1888. Contractors

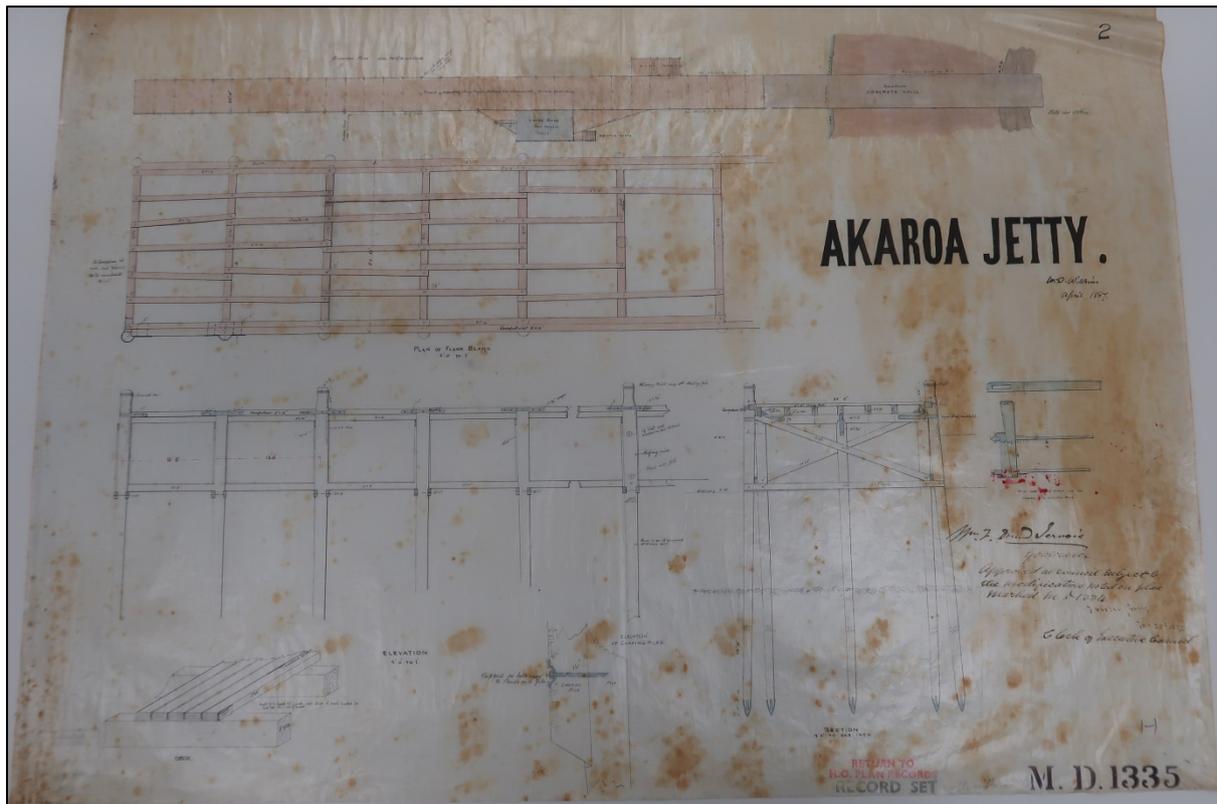
Figure 14. Plan, section, and elevation of Akaroa Wharf (Wellington Archives New Zealand).

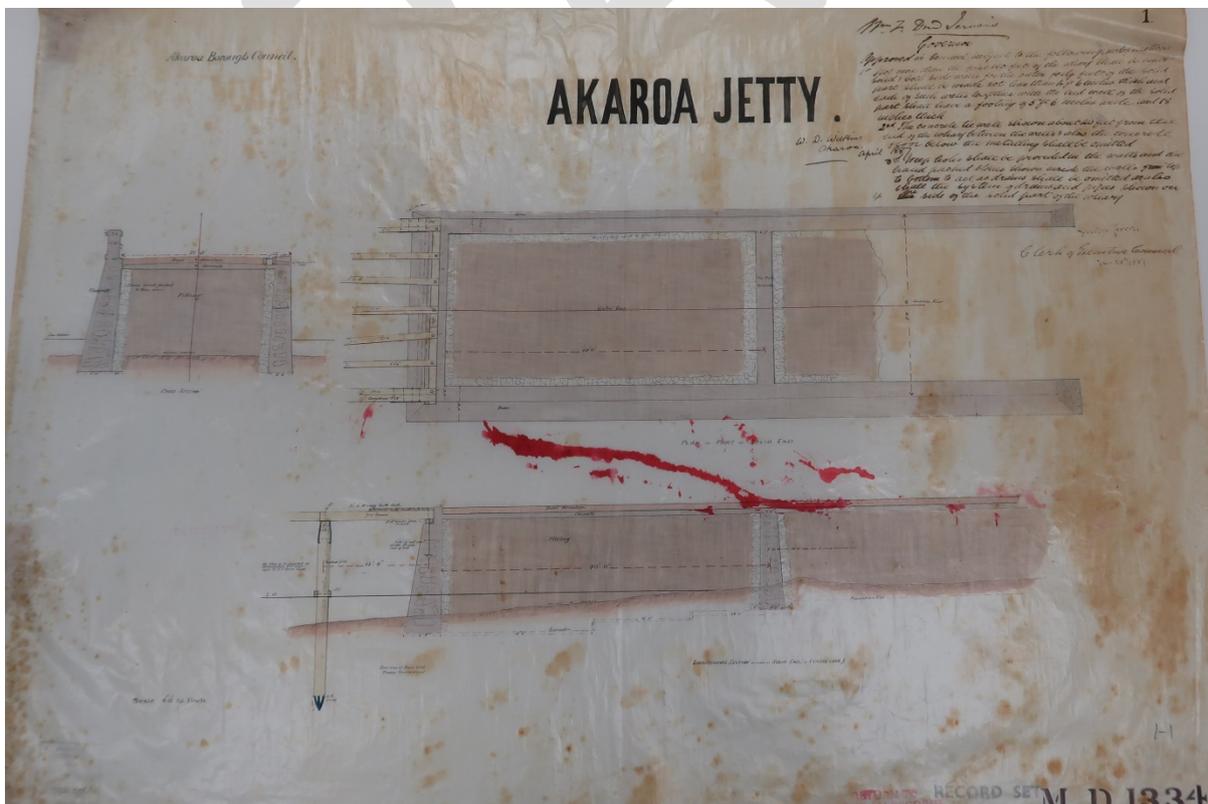
Figure 18. Section drawings of the concrete abutment to the timber portion of the wharf (Wellington Archives New Zealand).

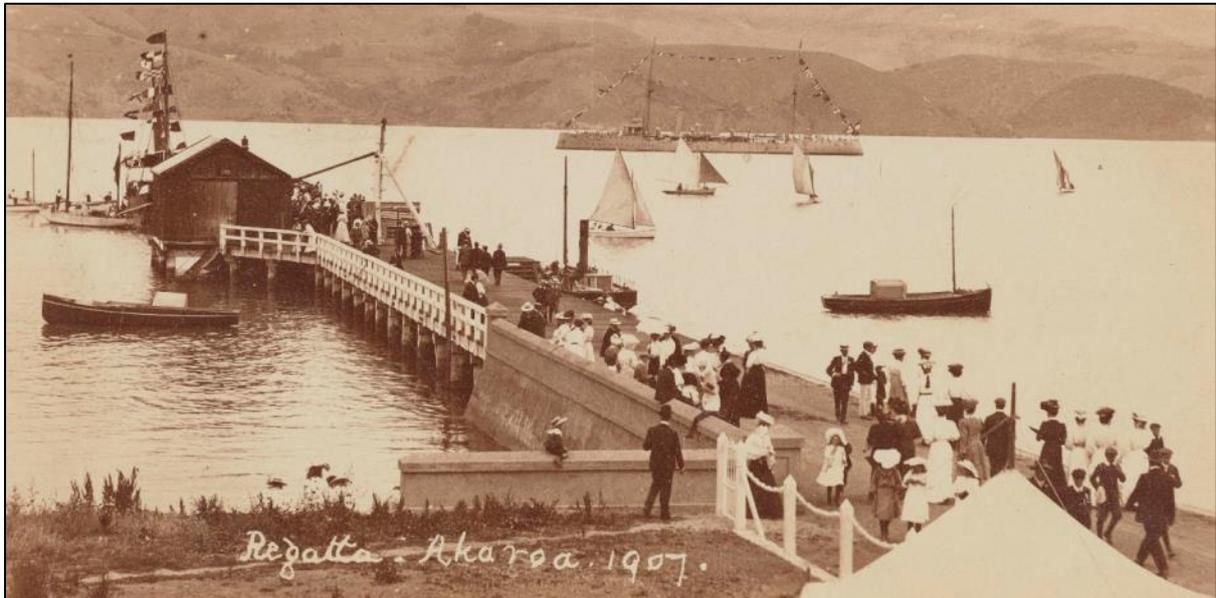
Figure 19. View of the wharf on regatta day in 1907, showing the parapet and smooth concrete wall on the south side of the solid portion (Te Papa).

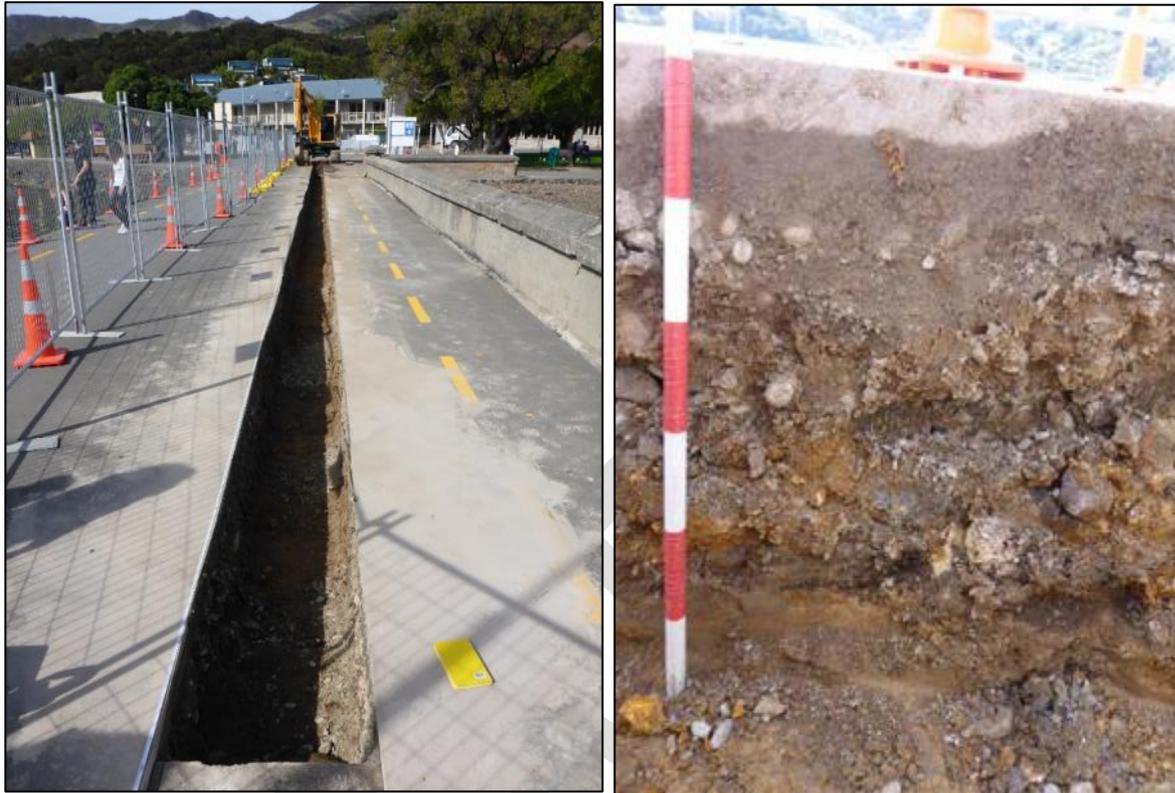
Figure 21. Left – View looking east showing the trench excavated through the solid portion of the Akaroa Main Wharf in 2015 (K. Bennett). Right – The stratigraphy exposed in a section of the northern baulk, exposing asphalt, mixed clay, stone and volcanic rock, and light brown clay (K. Bennett).

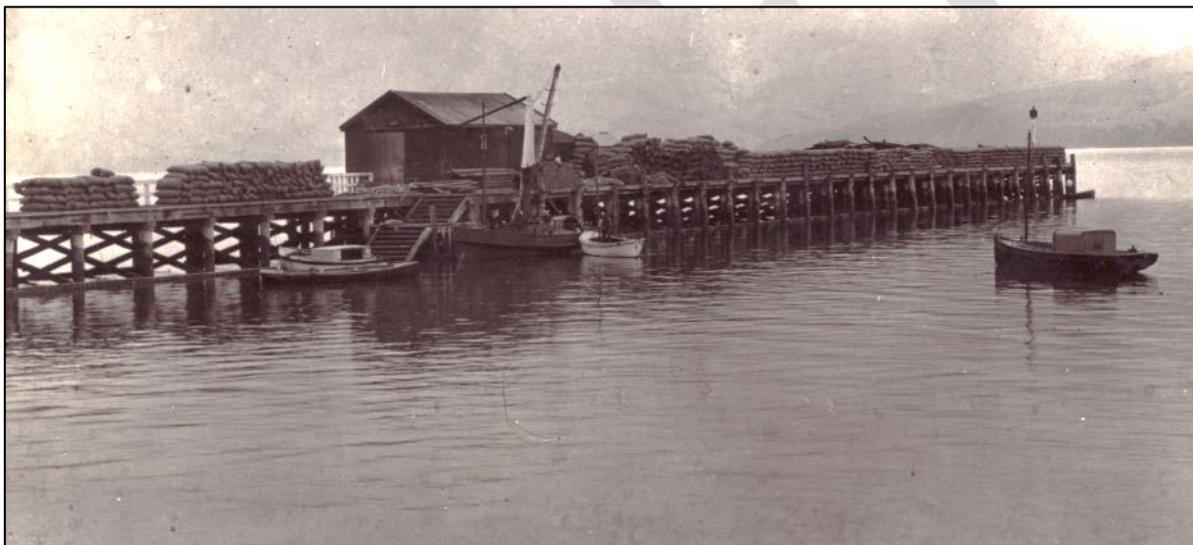
Figure 23. A brightened image of the north side of the wharf in 1910 showing the supporting structure and boat steps (Kete Christchurch).

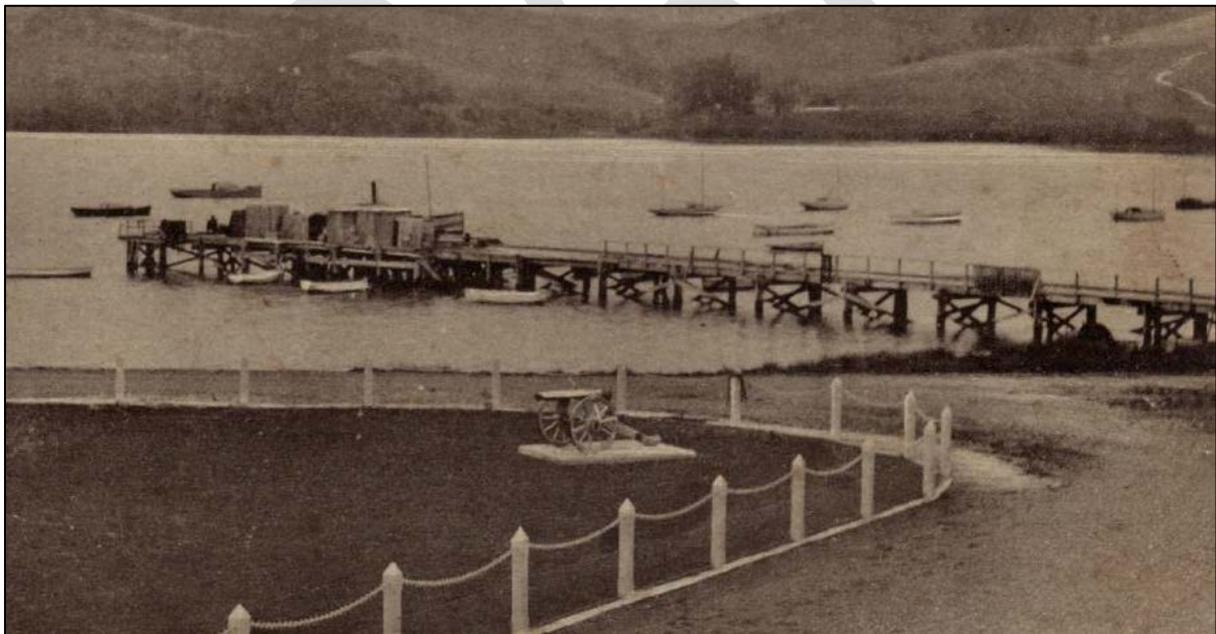
Figure 35. The deteriorating old jetty in 1910, apparently built up with fishing shanties. The Britomart Cannon is visible in the foreground (Kete Christchurch).

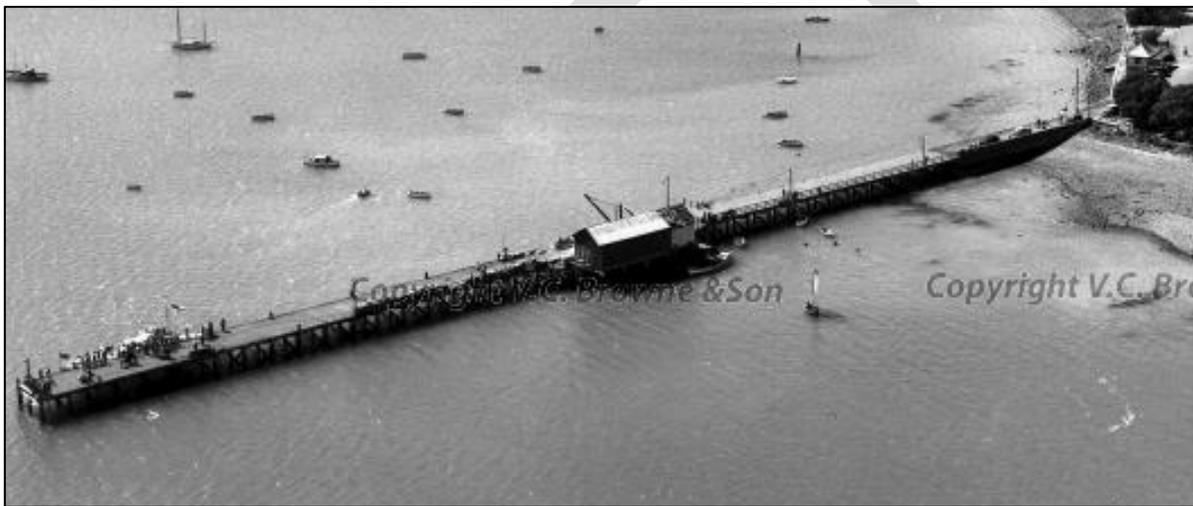
Figure 38. Detail of a 1950 photograph showing the south side of Akaroa Main Wharf (V. C. Browne and Son).

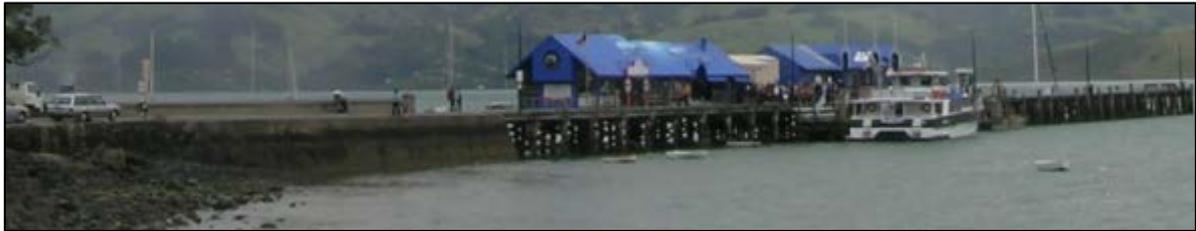
Figure 41. Detail of a 2007 photograph showing the north side of the Akaroa Main Wharf and its buildings (Kete Christchurch).

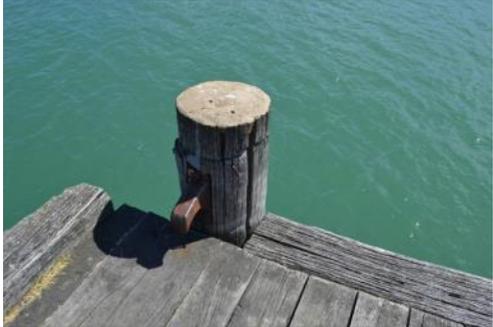
38-39	Galvanised steel mooring cleat (S)	N/C

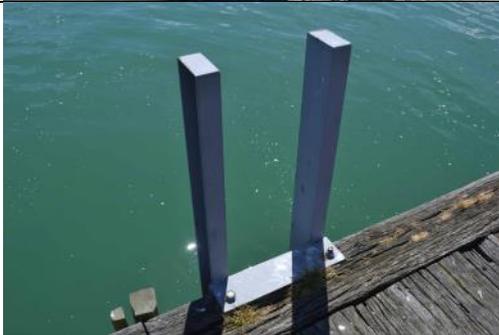
25	<p>Tanalised post and rail barrier (S)</p> <p>Remains of old iron mooring cleat (missing arms) (S)</p> <p>Timber pile head wrapped with rope (N)</p>	<p>N/C</p> <p>H</p> <p>N/C</p>

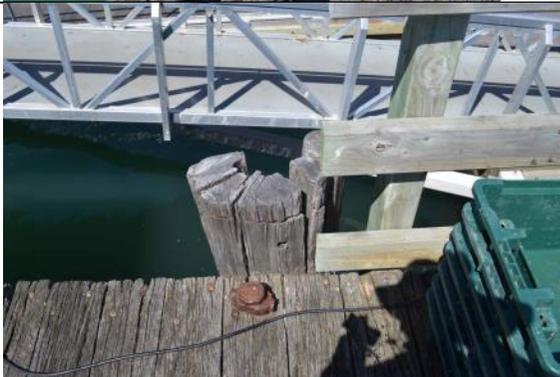
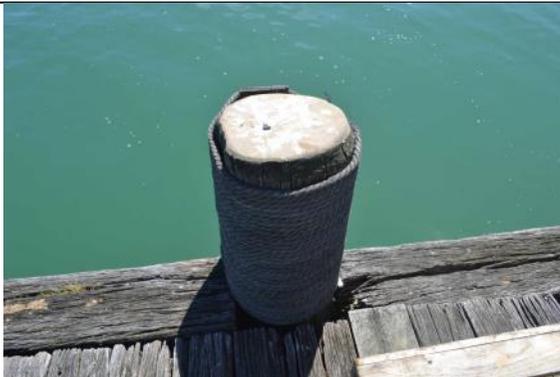
24-25	Galvanised mooring cleat (S)  Two bench seats (N)	N/C  N/C

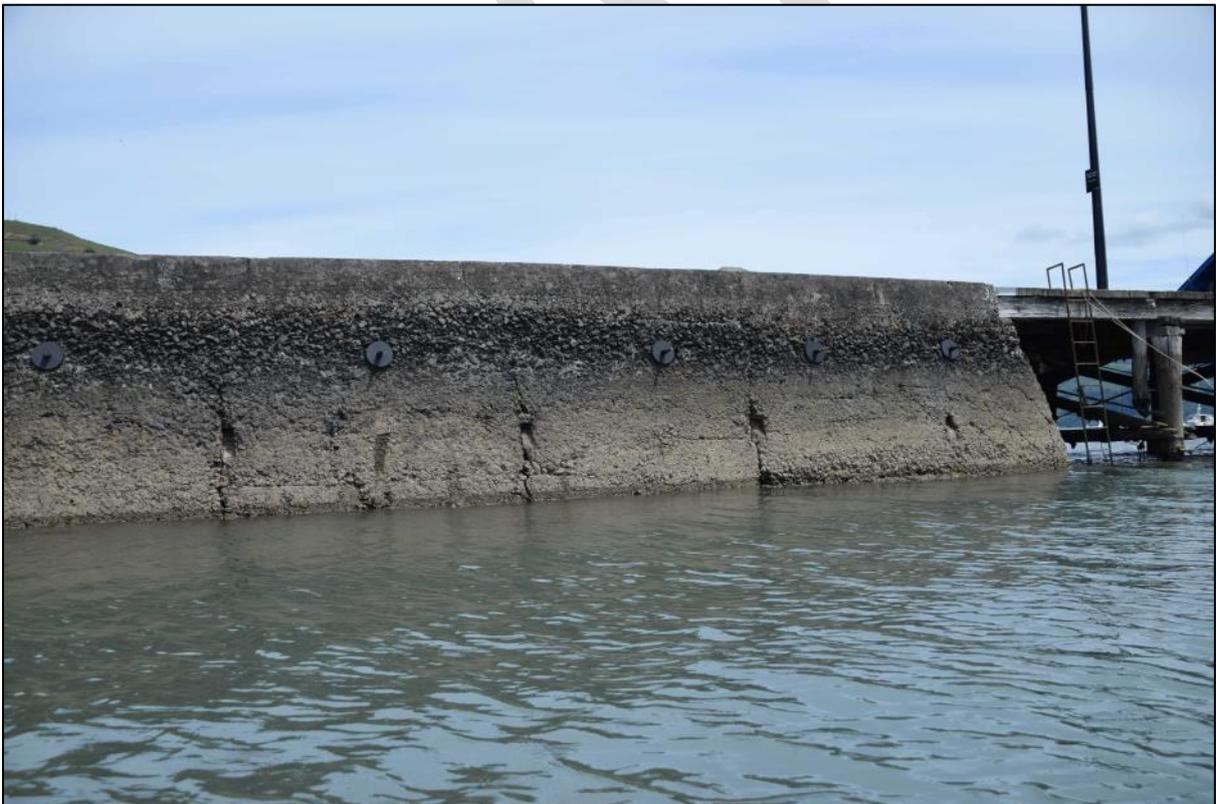
Photo 3 The outer north wall of the abutment with drainage holes, circular pattress plates to the end of the tie rods and many cracks in the masonry.

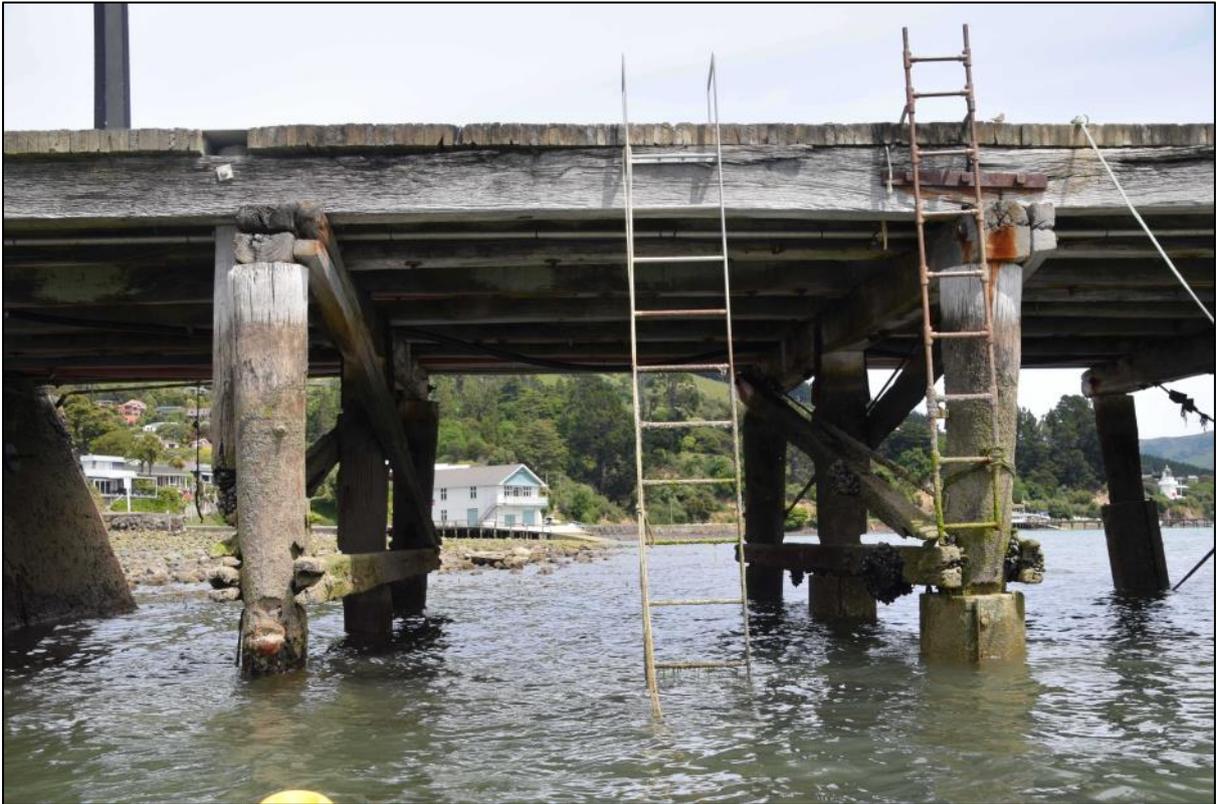
Photo 4 Three pile 'bents' under the eastern end of the wharf close to the abutment. Note the diagonal, timber braces, horizontal timber ties beneath the braces, and later steel rod braces. The original construction can be clearly seen here with timber pile caps (beams) running along the heads of the three piles in each bent and the timber stringers and decking on top. There are no fender piles to this part of the wharf. Ladders are a late 20th century addition.

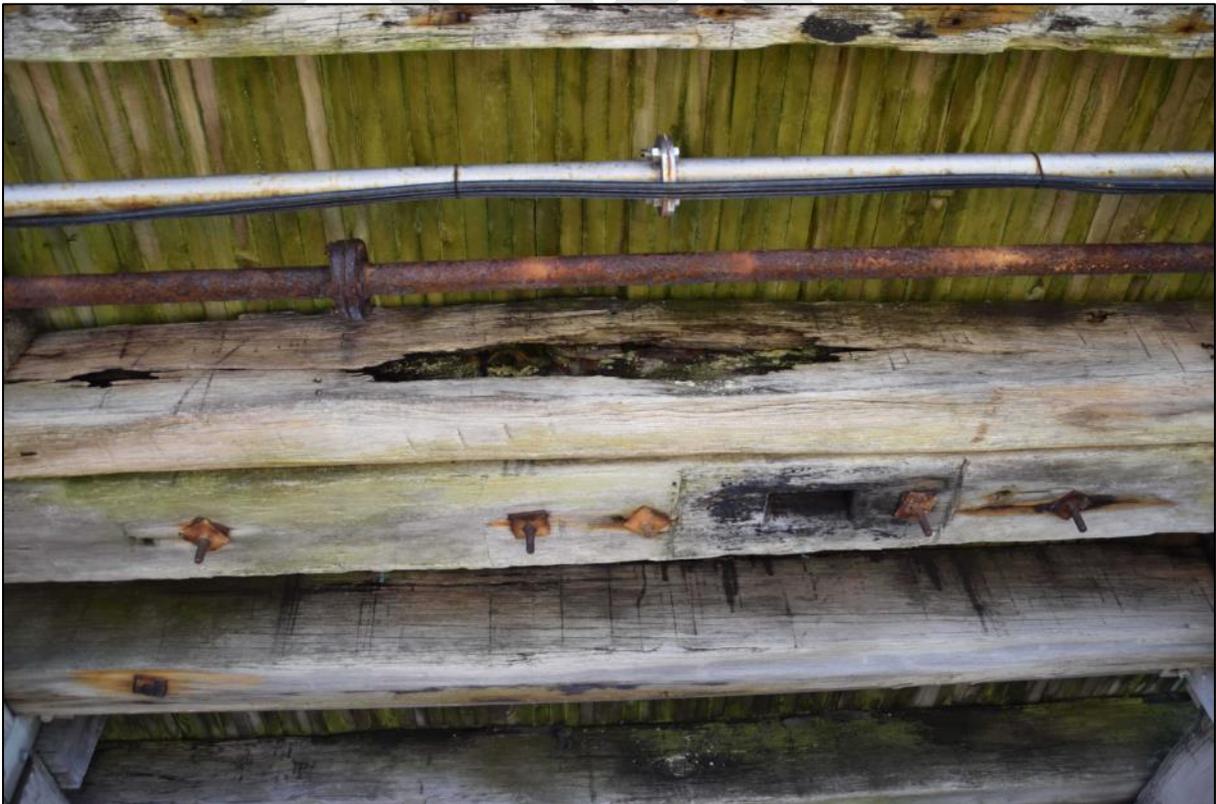
Photo 5 Clear evidence of decay in a timber stringer at the eastern end of the wharf.

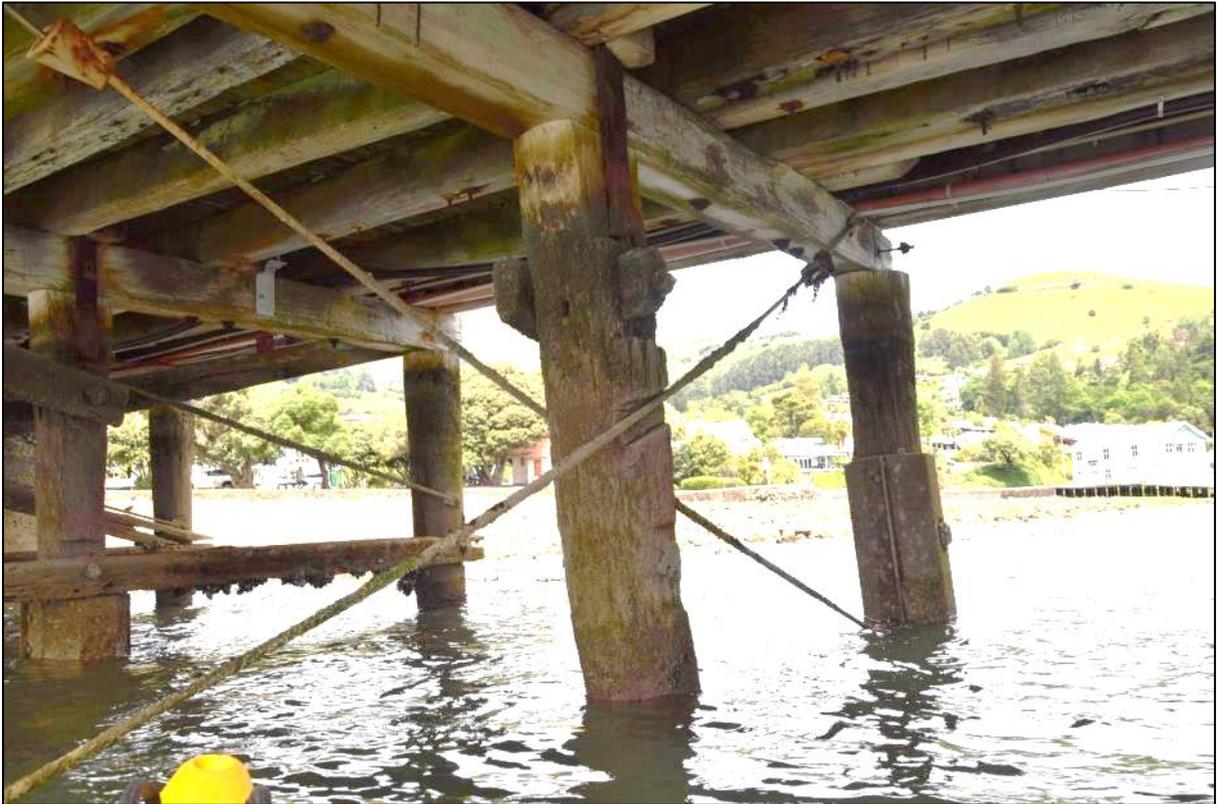
Photo 6 An example of repairs and alterations to a bent – original timber bracing cut off either side of the central pile; diagonal steel braces installed; and a steel jacket added to the right-hand pile.

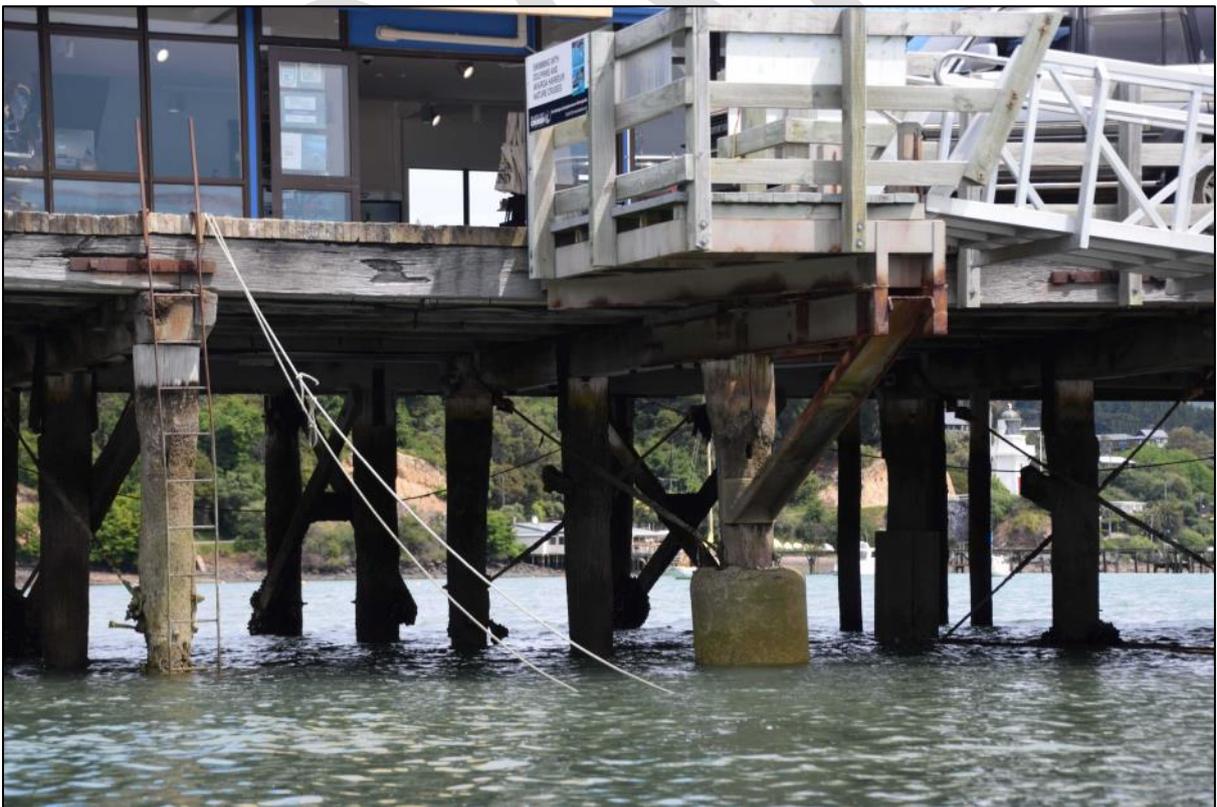
Photo 7 Further alterations on the north side of the wharf with steel added to support the gantry to the floating pontoon and concrete cast to the base of the pile supporting the steel framing.

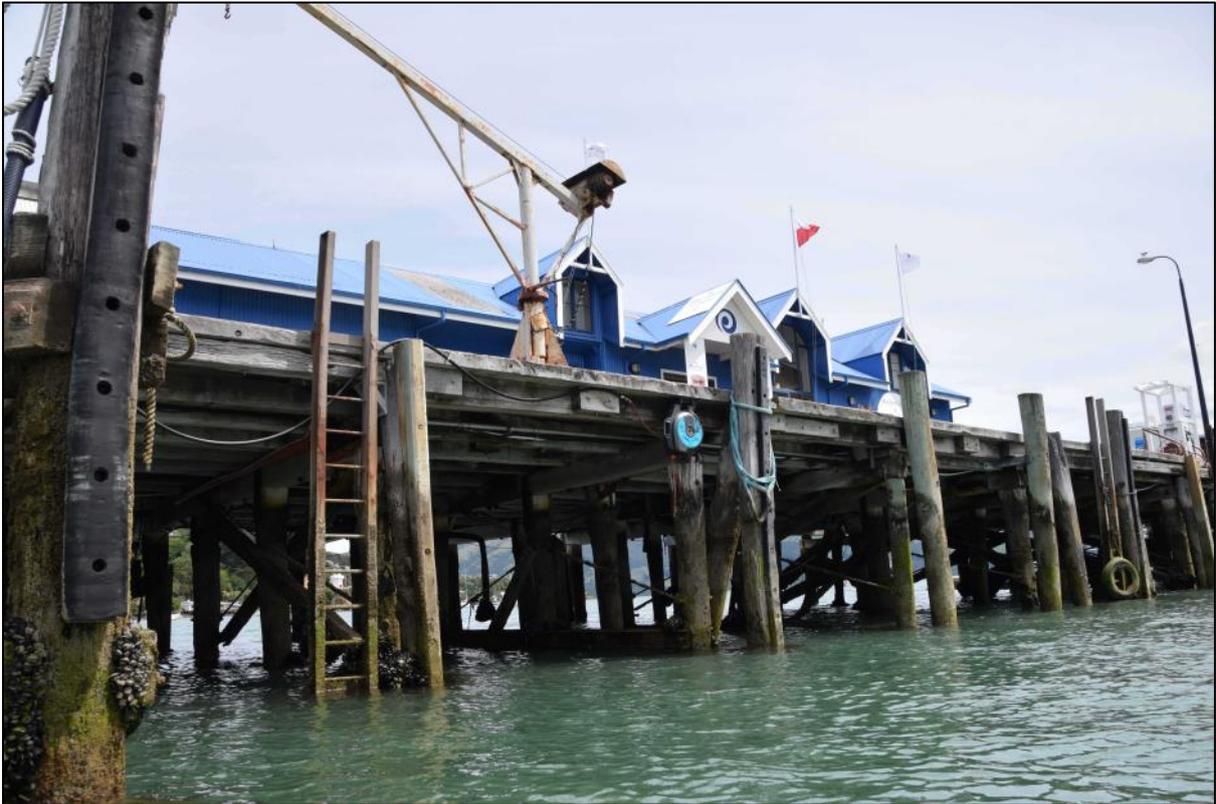
Photo 8 The north side of the wharf beyond the floating pontoon with modern ladders and replacement tanalised fender piles. The width of the wharf has substantially widened to accommodate the late 20th century sheds. Refer to Photo 9 below regarding the pile in the foreground on the left of the image.

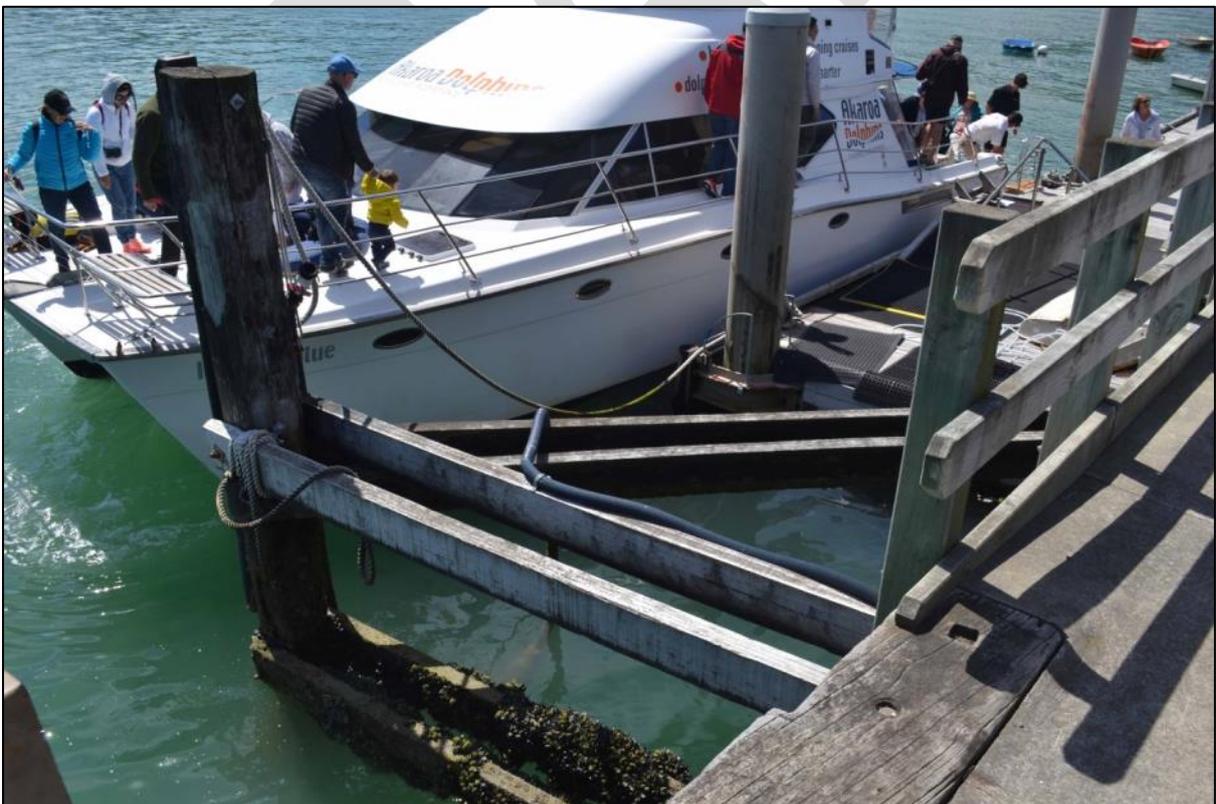
Photo 9 This older pile on the left appears to relate to the former projecting platform and main steps to water level that previously existed on the north side of the wharf.

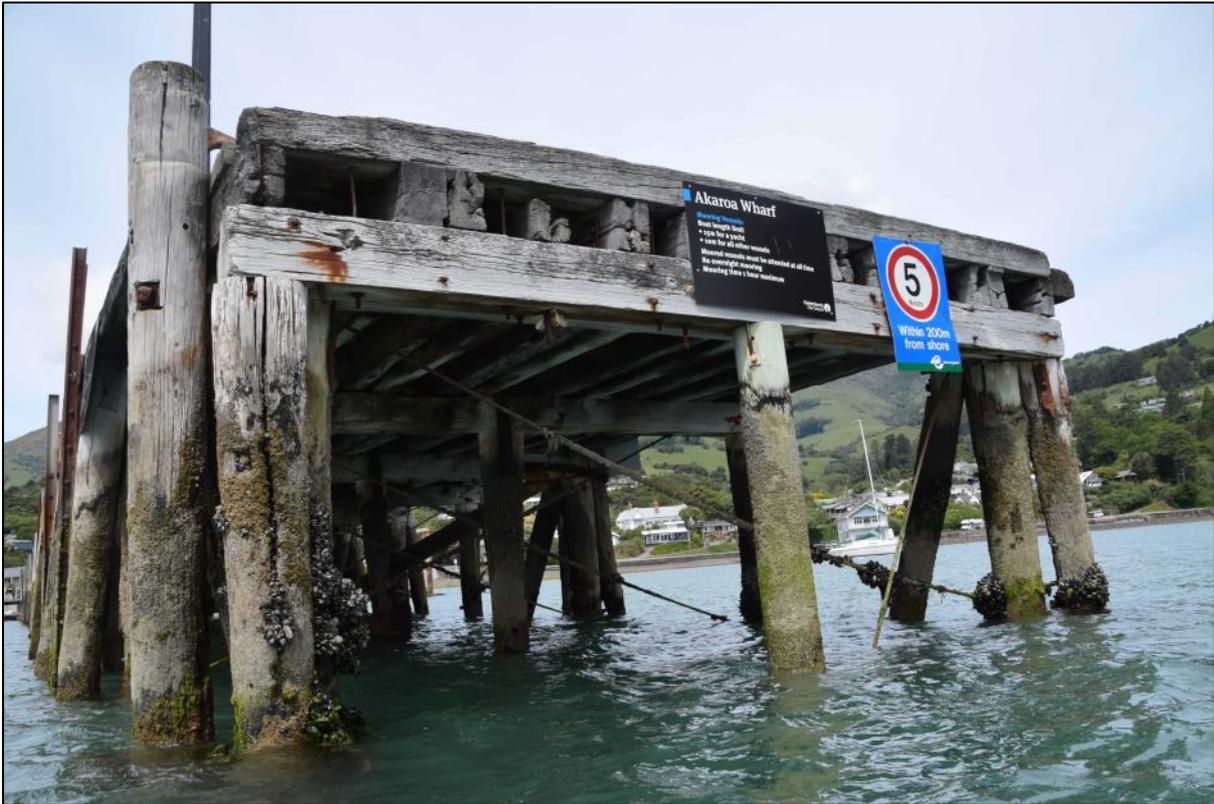
Photo 12 The outer/west end of the wharf clearly showing the original construction, although with some replacement tanalised piles. Along the top of the piles is the timber pile cap (beam). On top of that are the stringers and running parallel to the cap is the timber kerb with the timber decking behind it. On the far left and far right are fender piles and each corner has an inner bracing pile.

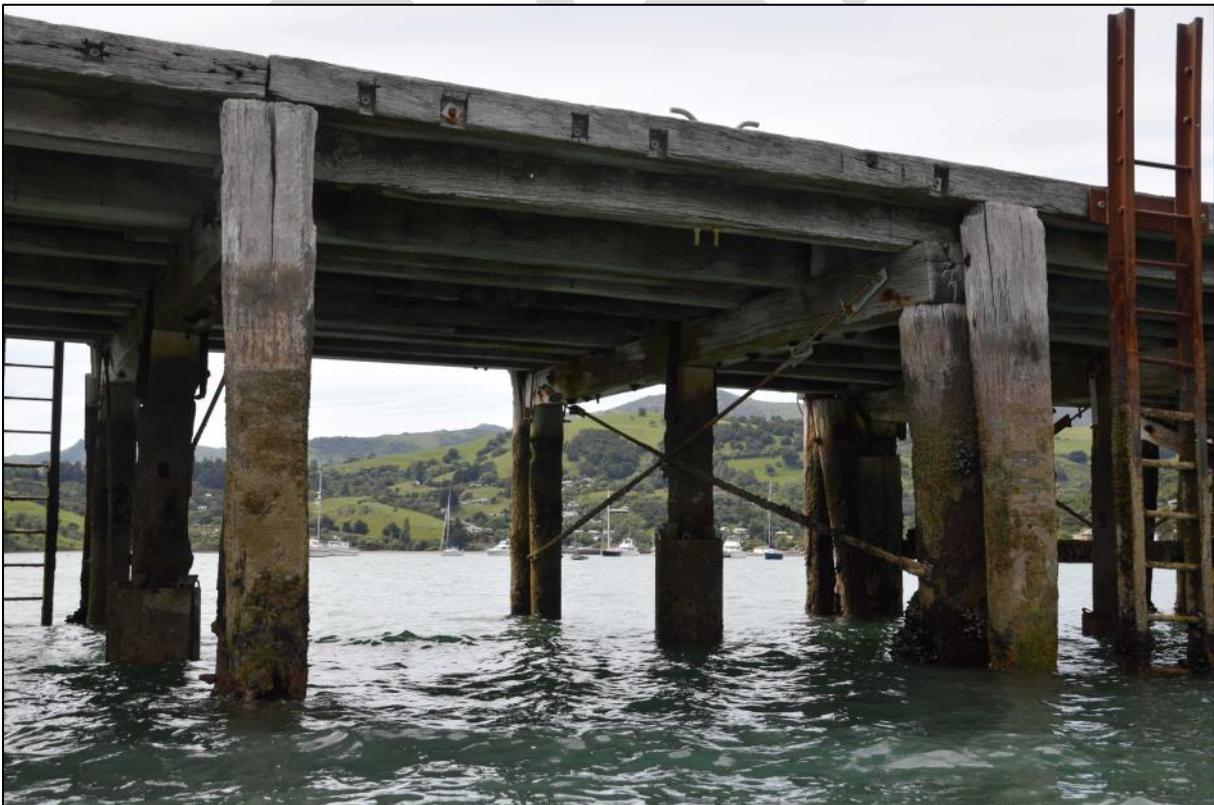
Photo 13 Here the original timber cross-braces to the bents have been replaced with modern steel bracing rods and a number of the piles have had repair 'jackets' encased around their lower sections.

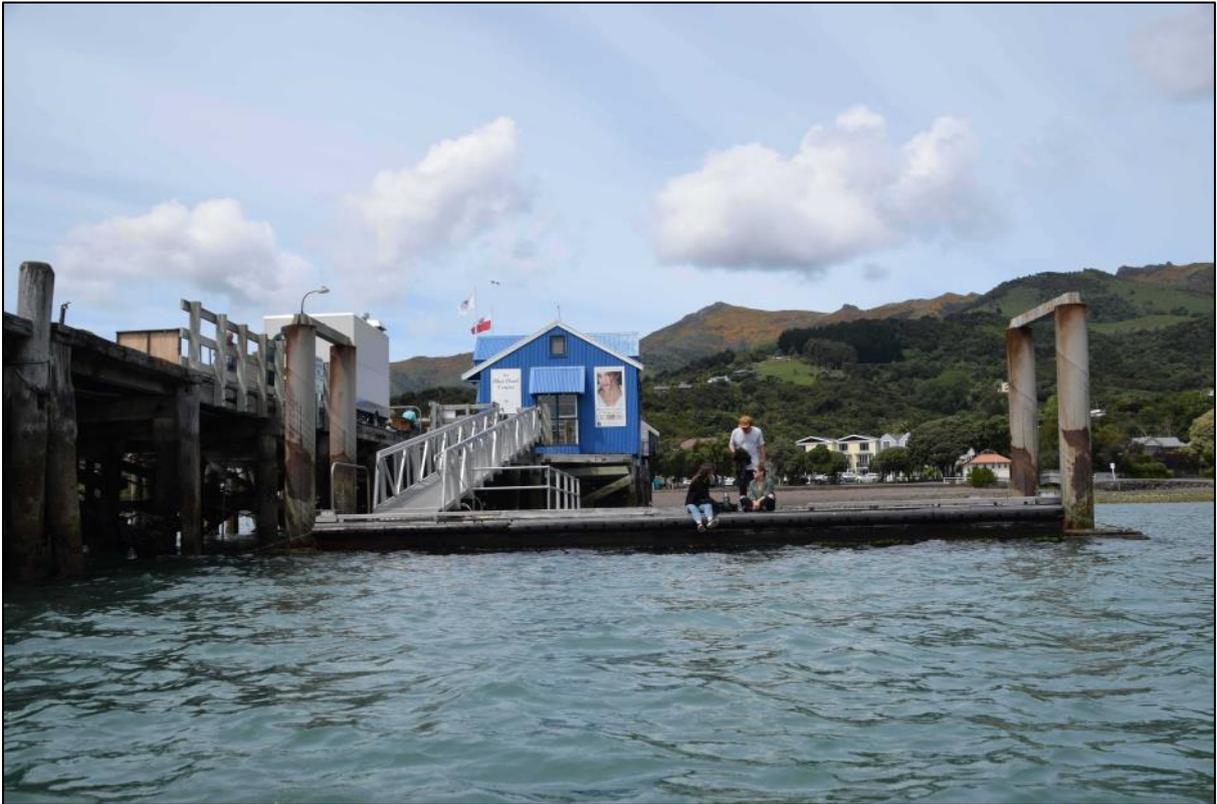
Photo 14 The floating pontoon on the south side of the wharf.

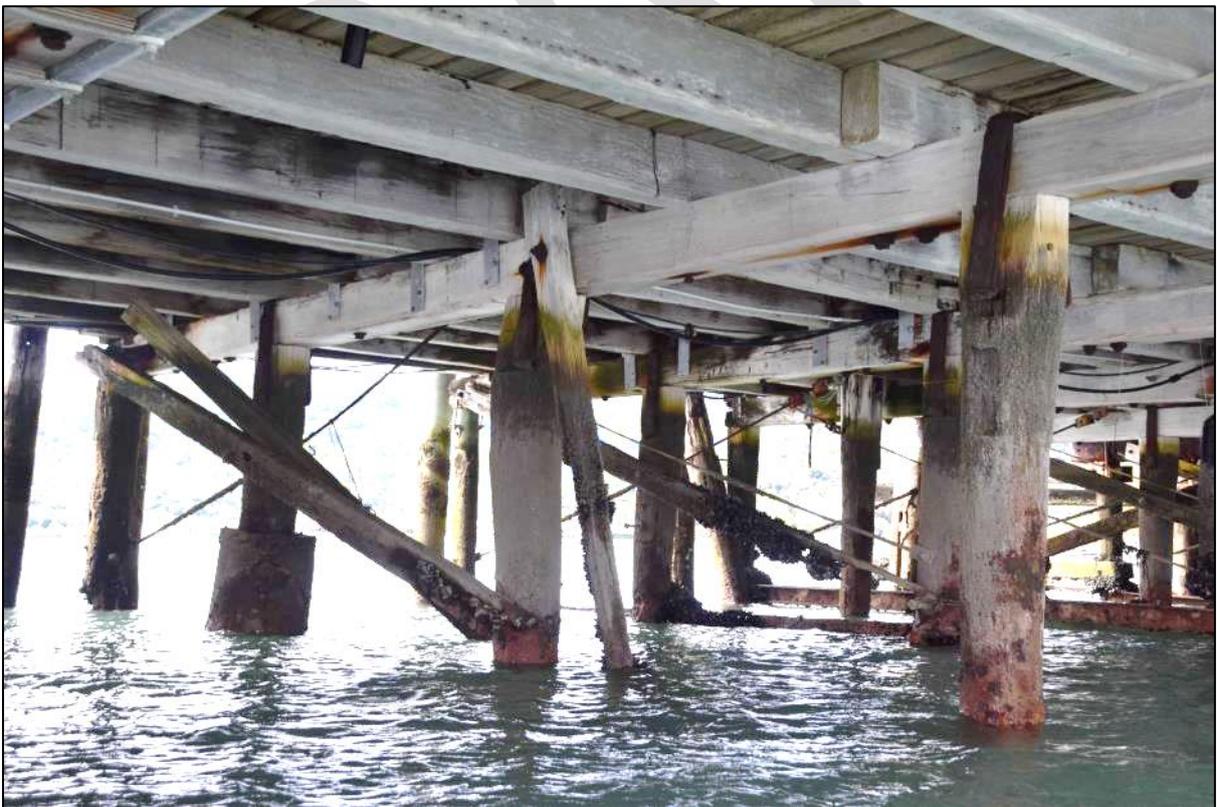
Photo 17 An image 2 bays closer to the shoreline than 16 showing the original widened structure under the original shed –with continuous pile cap spanning over the additional piles and wrought iron straps to the heads of the piles now delaminating and, in places, no longer connected to the piles. The bent in the foreground is missing bracing and one of the piles has a 'jacket' repair.

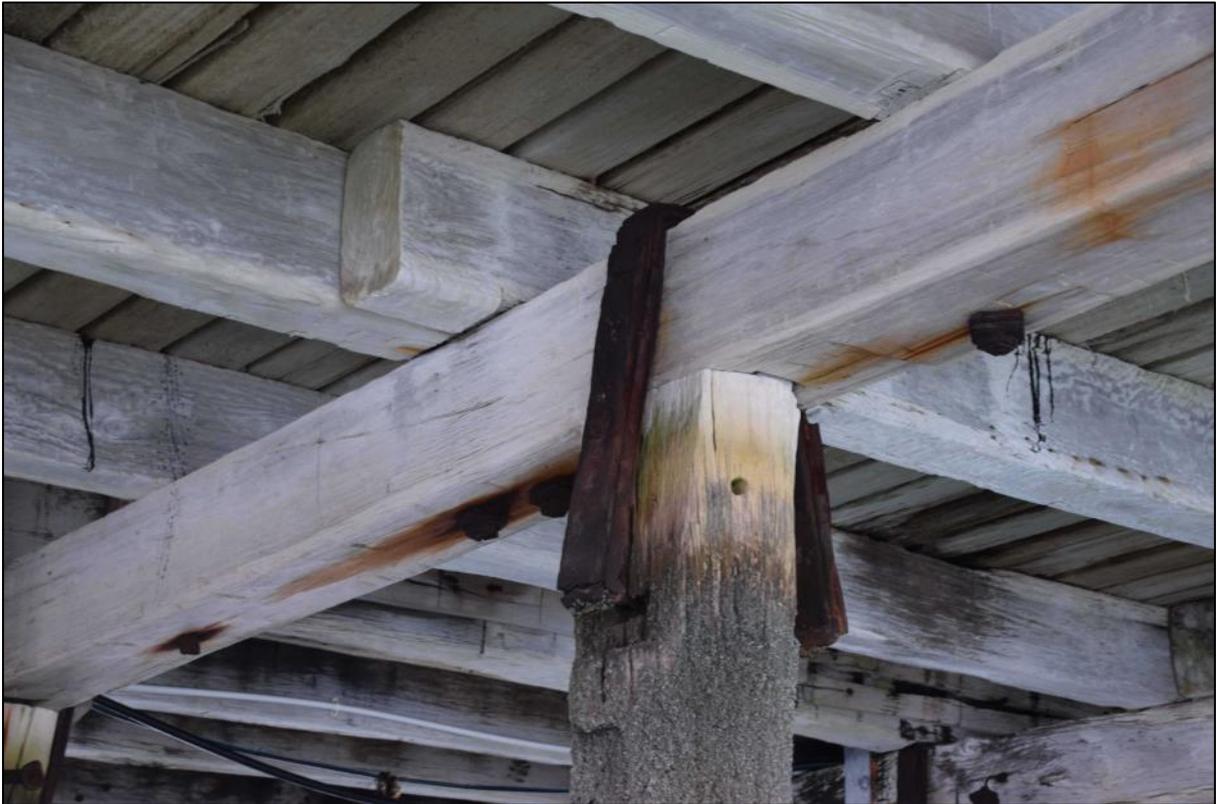
Photo 18 Close-up of the pile head on the right of Photo 17 showing the original wrought iron strap connection with the pile cap beam – now corroding/delaminating and separated from the pile head.

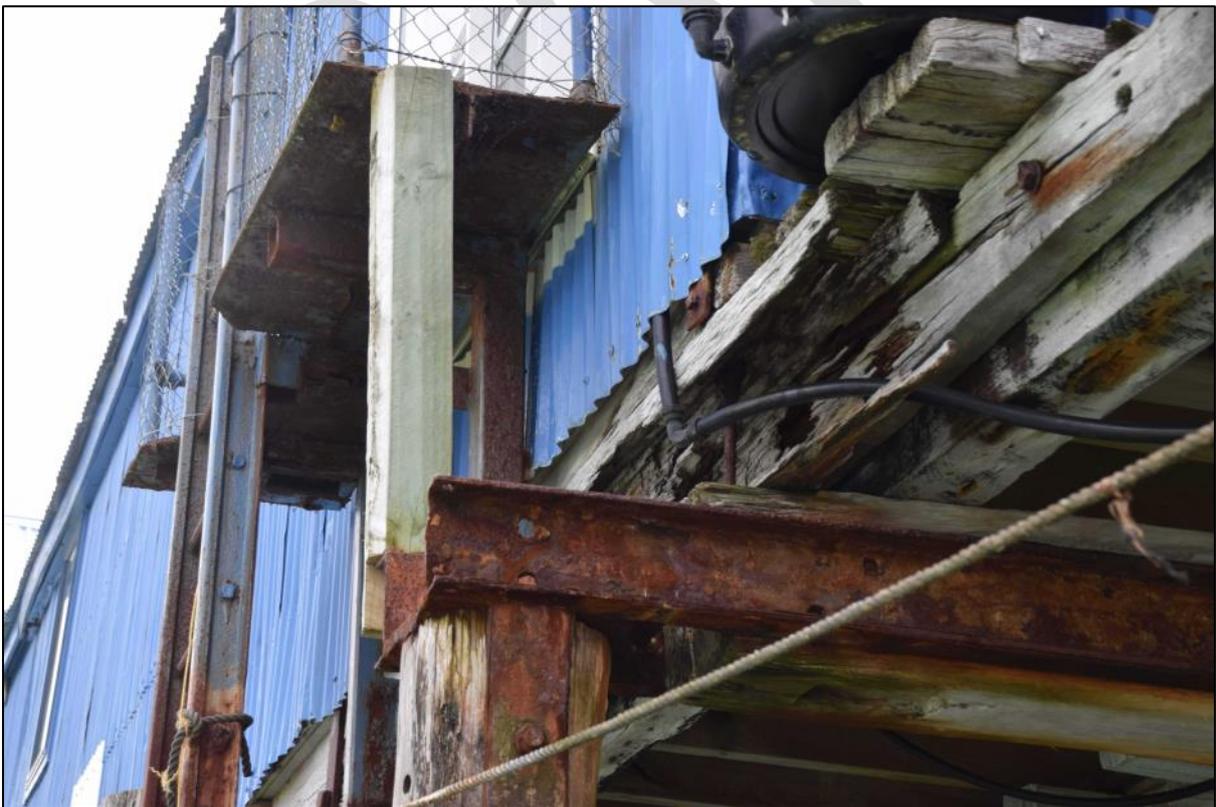
Photo 19 Timber decay and corrosion at the junction of two of the modern sheds (south side approx. 16th bent from the abutment).
