# AKAROA MAIN WHARF, AKAROA

Conservation Plan  
May 2019 - DRAFT

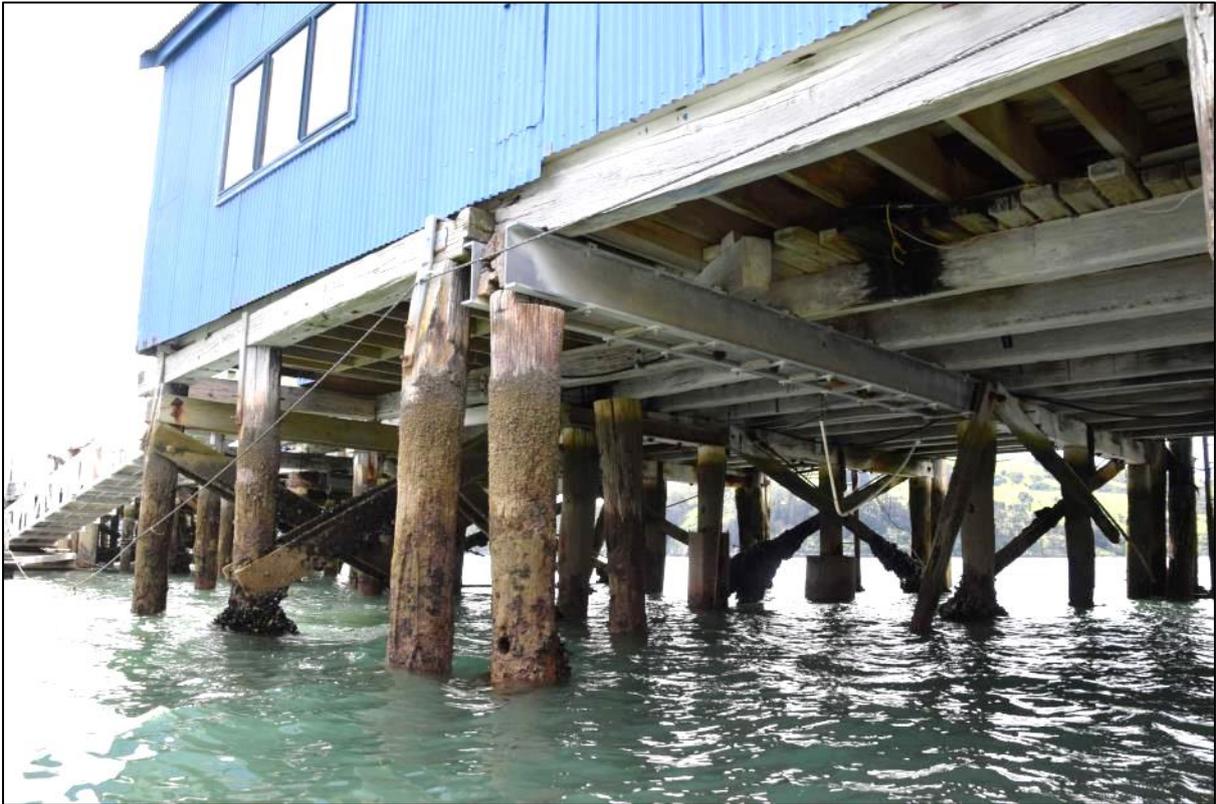
Photo 20 Steel beams either side of a pile cap. It is possible that the short section of diagonally-laid timber beam (cut face towards the camera) on top of the steel strengthening is where the original wharf structure narrowed at the end of the former wharf sheds.

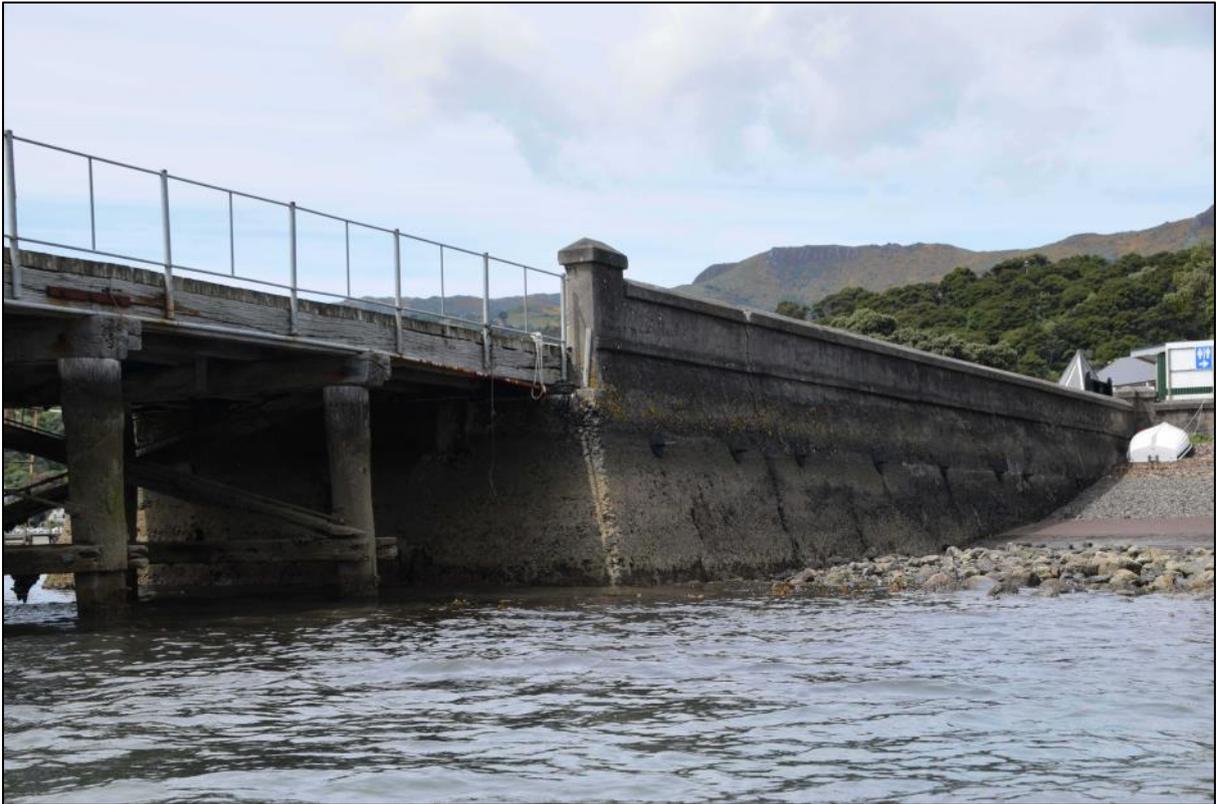
Photo 24 The junction of the abutment, and its concrete wall, and the start of the timber wharf structure on the south side. Galvanised steel railings have replaced the painted timber railings since 1973.

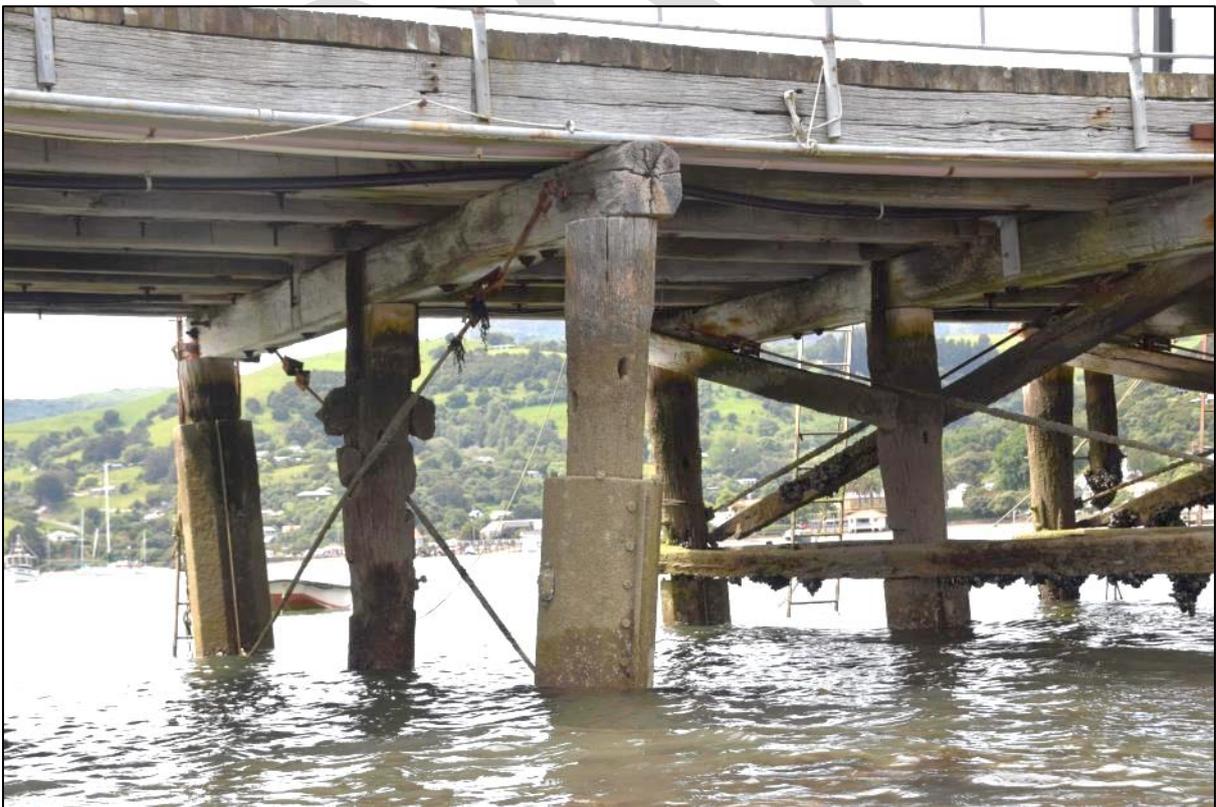
Photo 25 The same bent as in Photo 6, but from the south side. Both outer piles have 'jacket' repairs and the bent is missing its original horizontal brace. The diagonal timber braces have been cut off and replaced by steel rods.

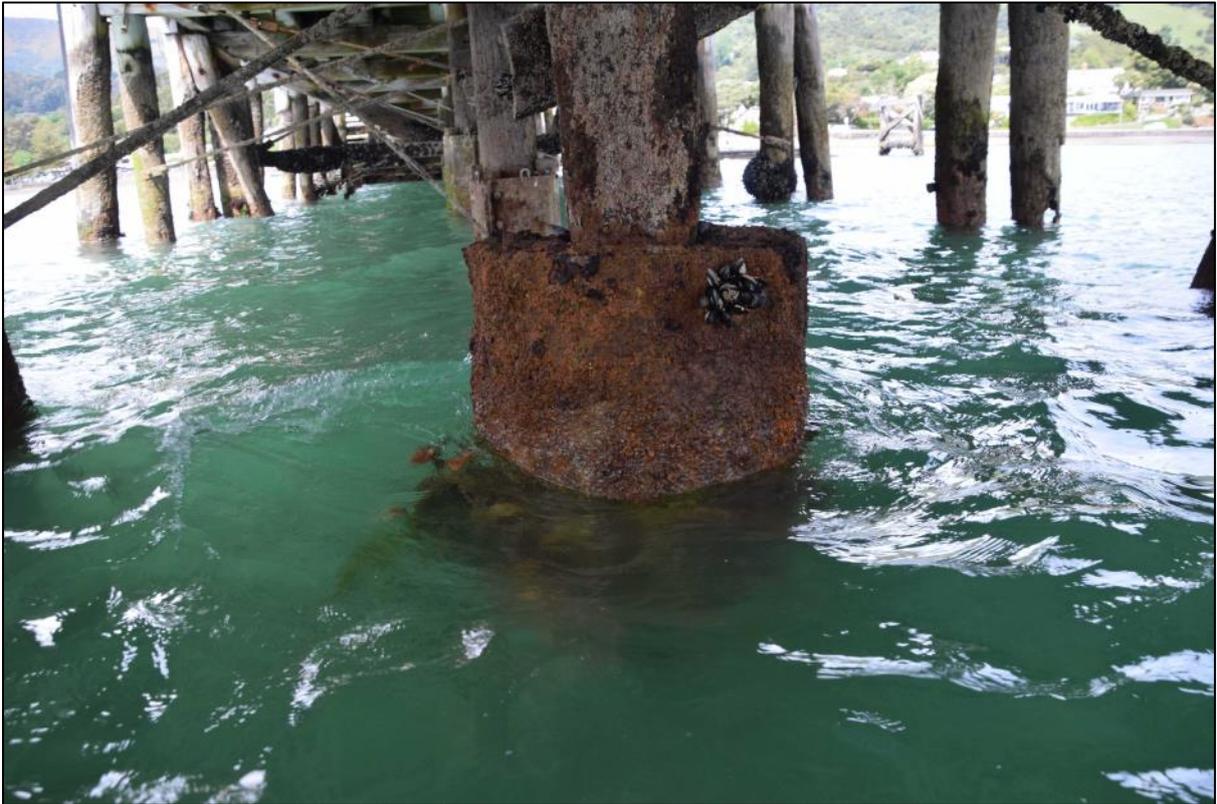
Photo 26 A 'jacket' repair to a central pile under the western end of the wharf. The pile has continued to erode above the jacket.

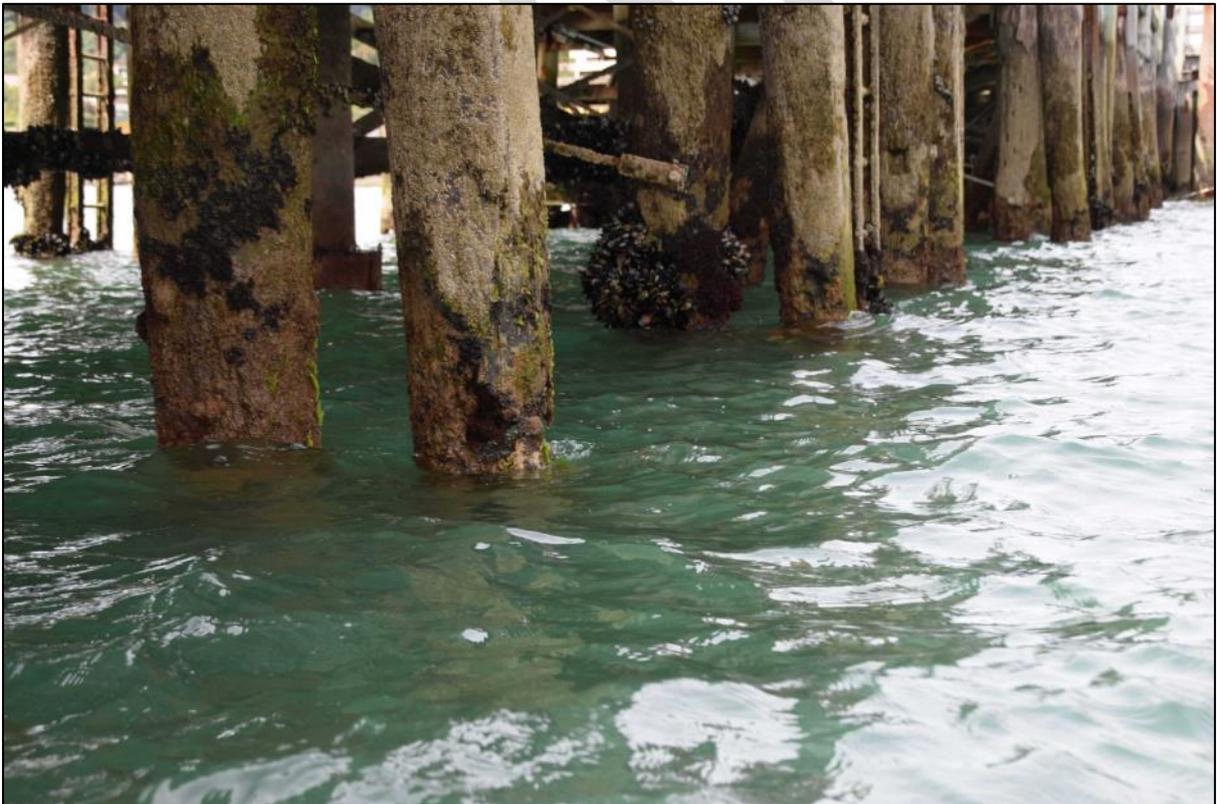
Photo 27 Severe decay at the water line to a fender pile on the south side of the wharf towards the western end. The photograph shows rows of piles and adjacent fender piles, many of which are thought to be original and of Ironbark timber.

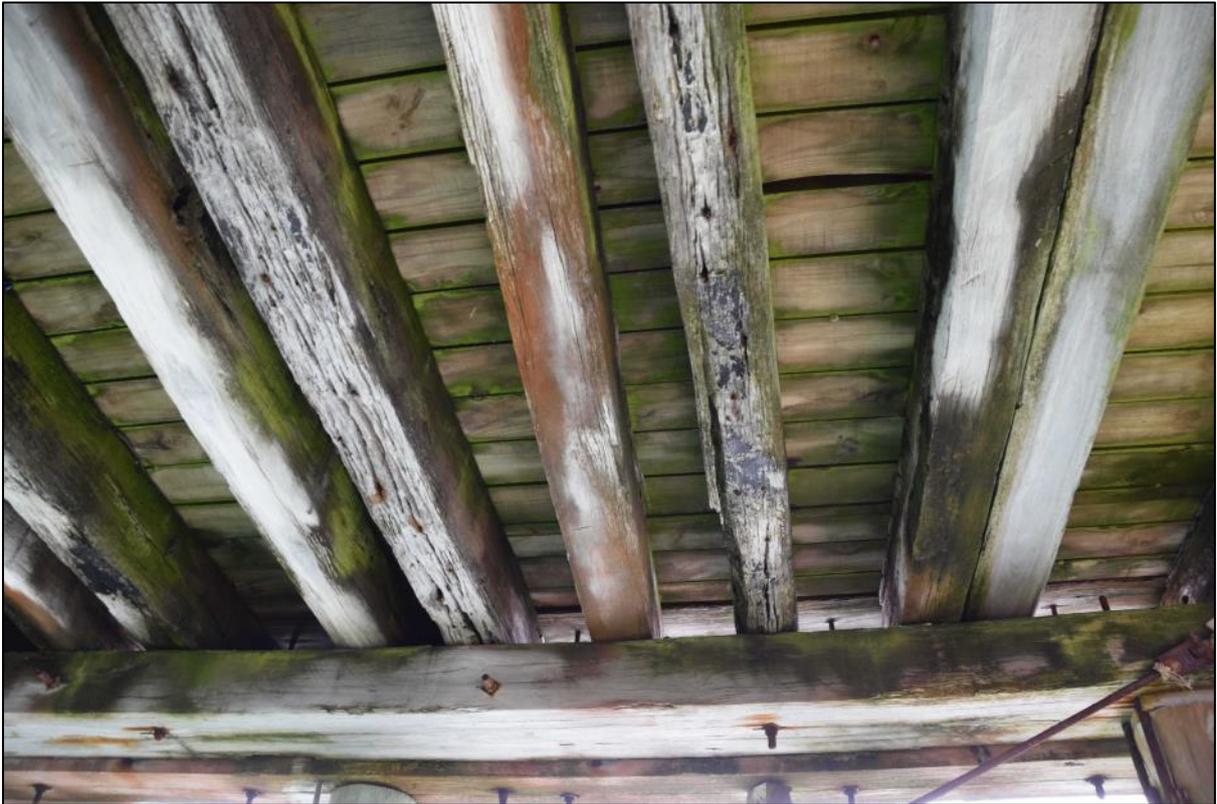
Photo 28 Additional stringers inserted to strengthen the deck at the western end of the wharf. There is considerable erosion and decay in many of the stringers here.

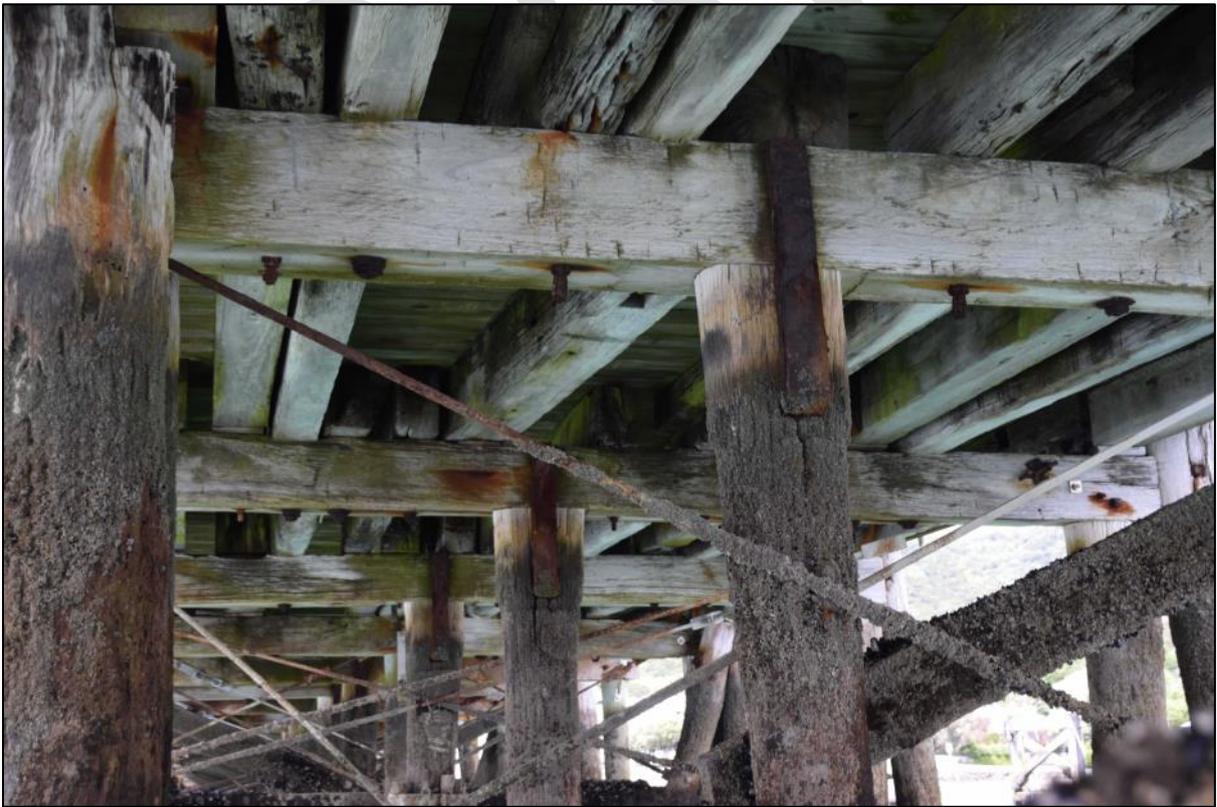
Photo 29 original wrought iron strap connections between the central piles and their pile cap. The joints also have a mortice and tenon.

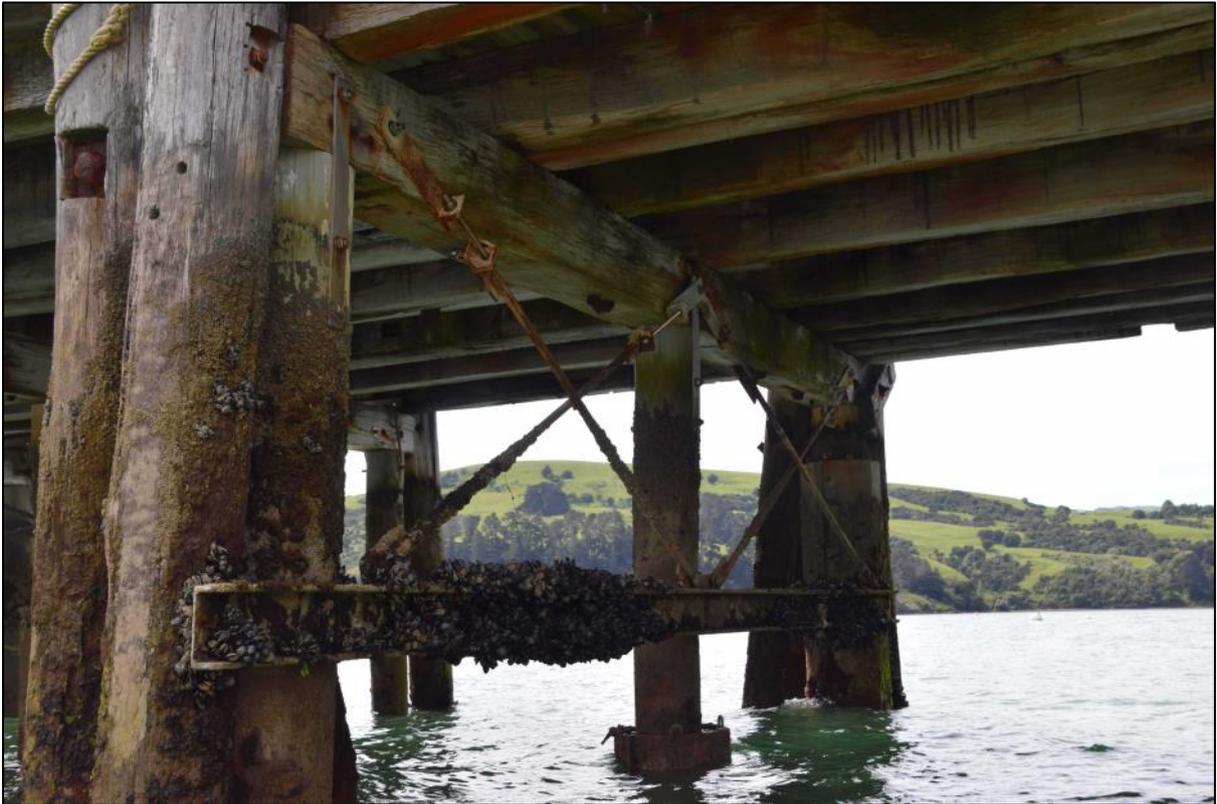
Photo 30 An example of modern steel repairs – bolted straps between the piles and cap beam, a steel PFC horizontal tie and double steel bracing rods. There is also an earlier steel jacket repair to the central pile.

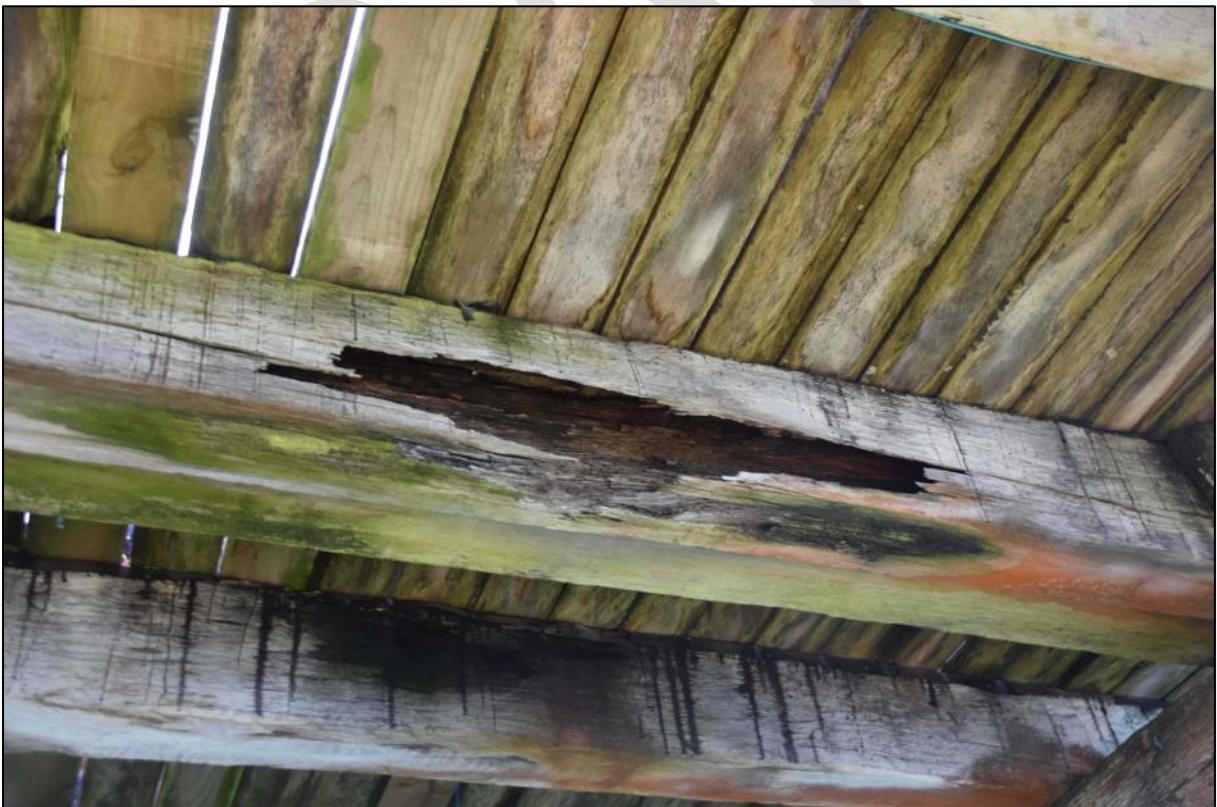
Photo 31 A large area of decay in one of the stringers close to the modern steps toward the western end of the wharf.

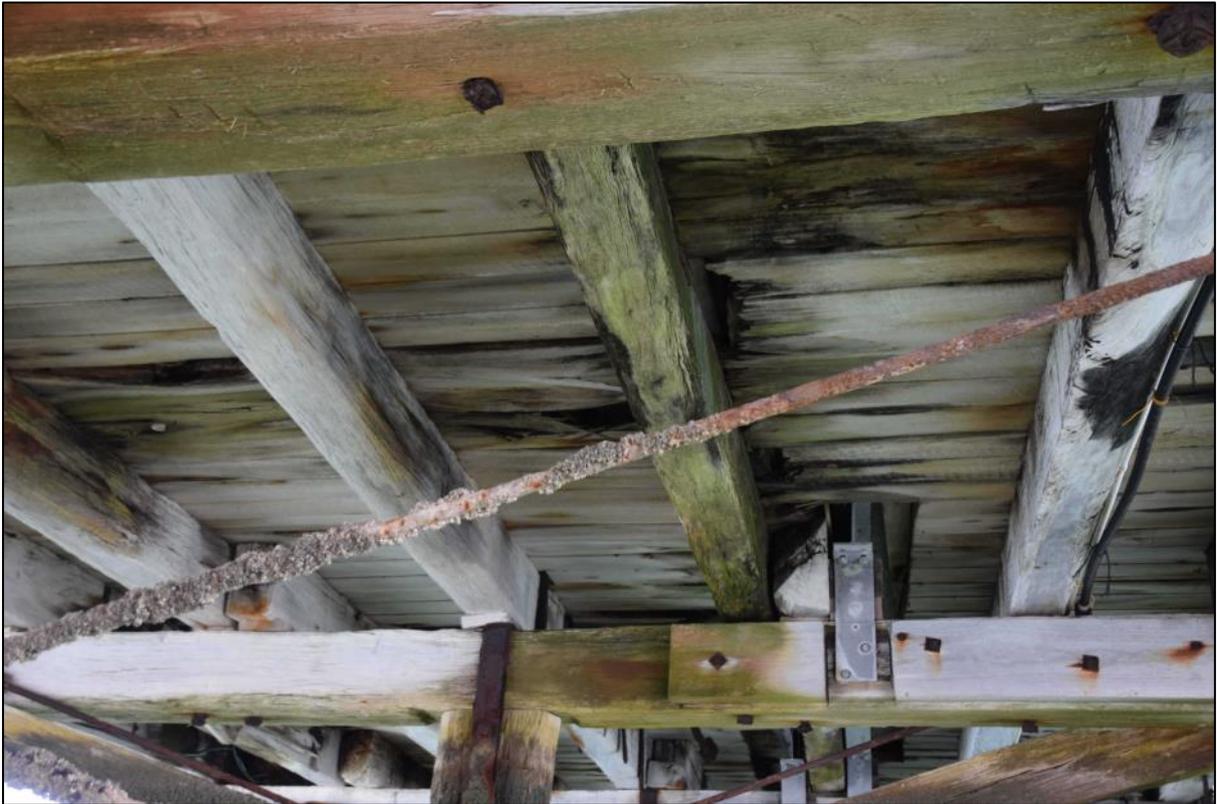
Photo 32 Decay in the decking boards and modern steel straps added.

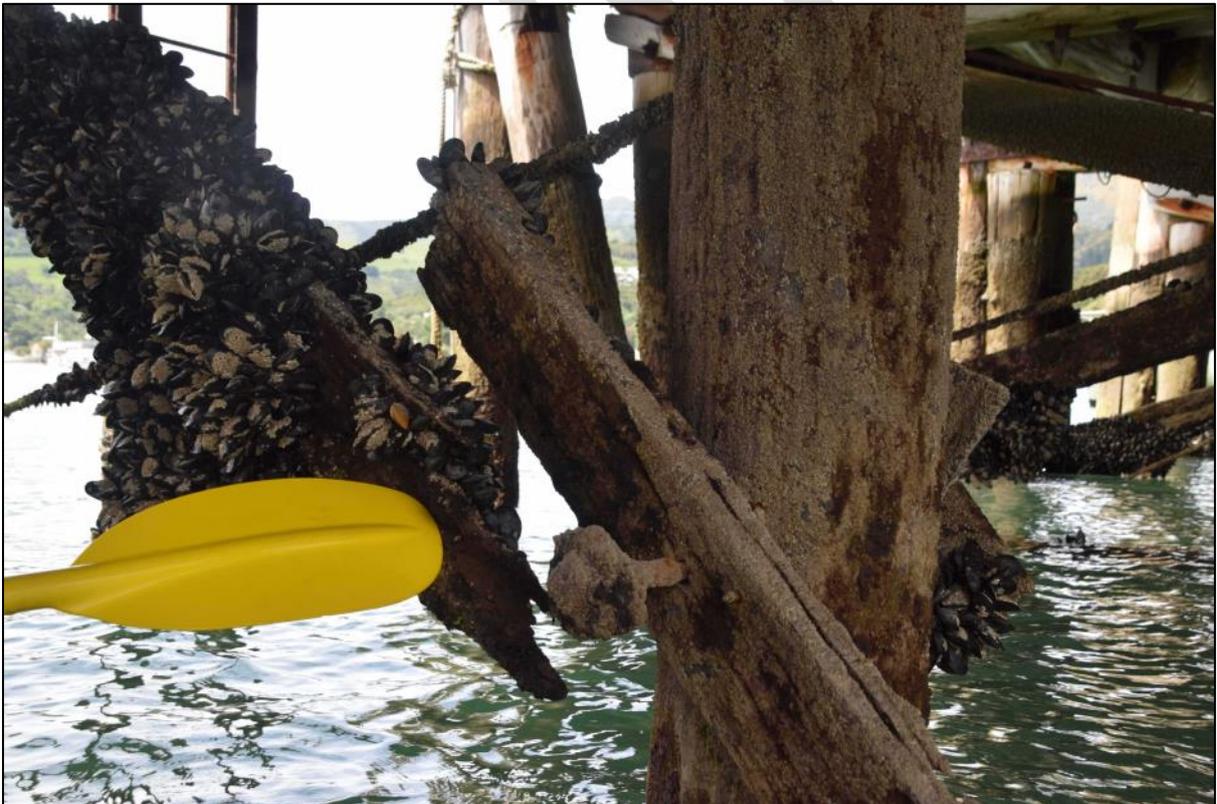
Photo 33 Broken timber brace.

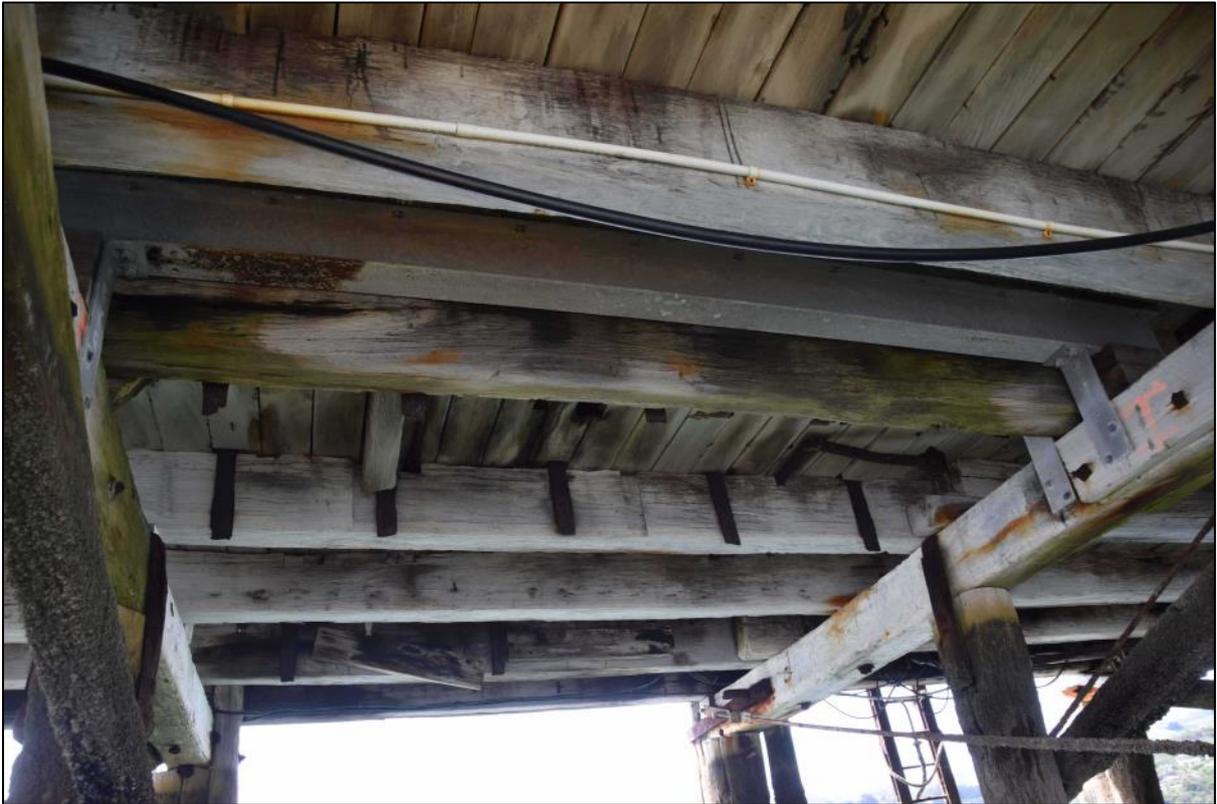
Photo 34 Steel stringer added.

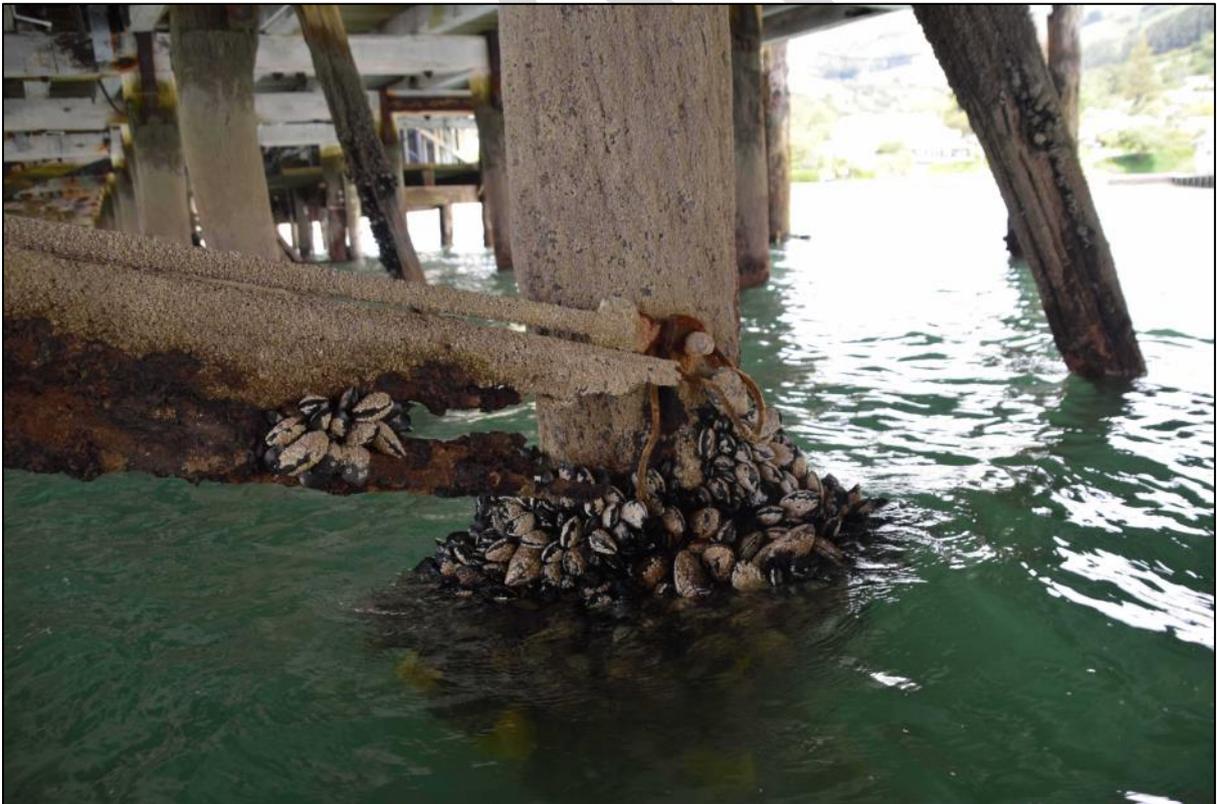
Photo 35 Broken/corroded steel brace.

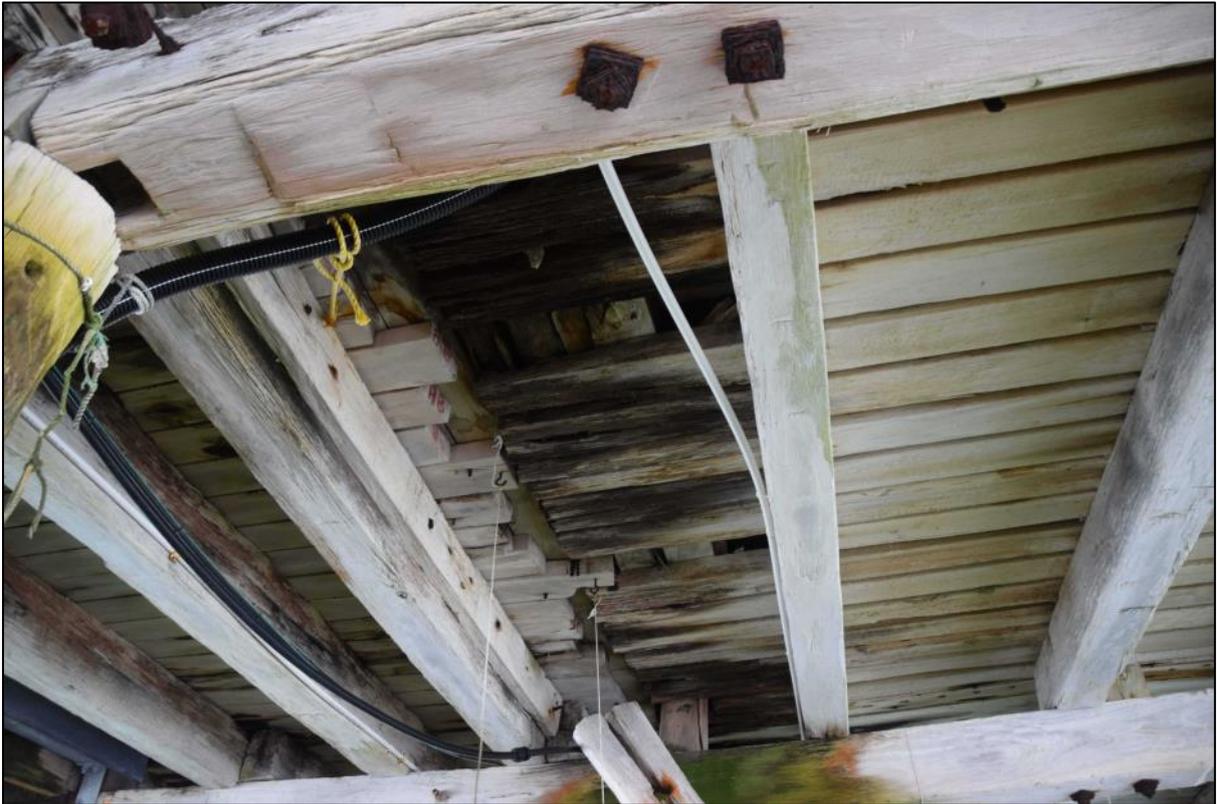
Photo 36 Decay in decking boards beneath the existing deck finish. Corrosion to original iron bolts and nuts.

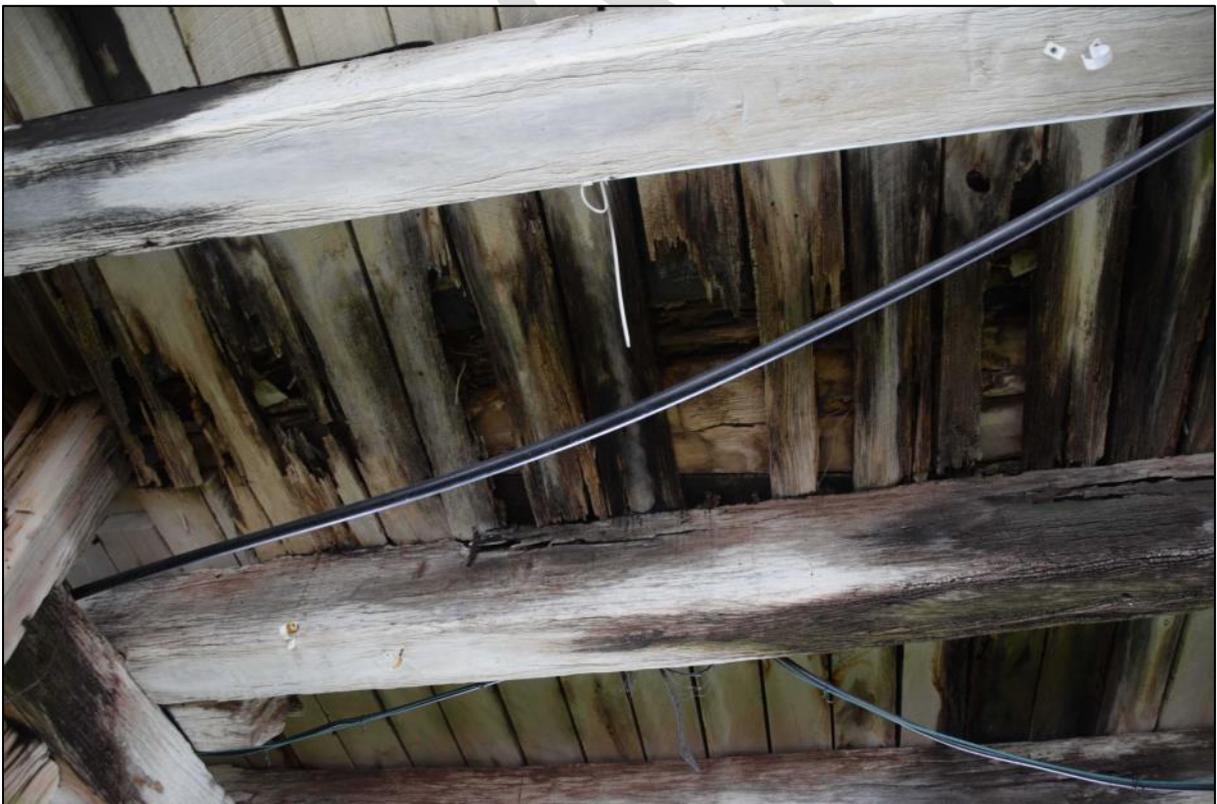
Photo 37 Further decay in decking boards beneath the existing deck finish.

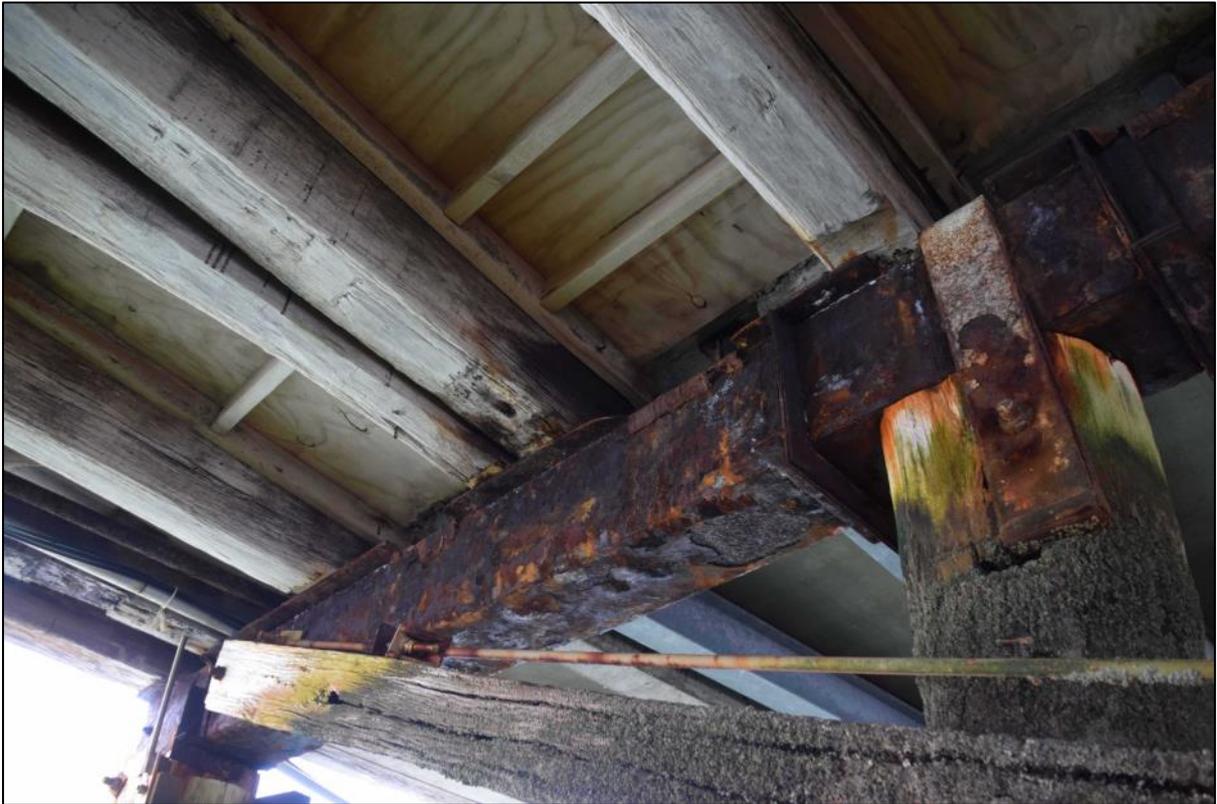
Photo 38 Severe corrosion to a past steel repair.

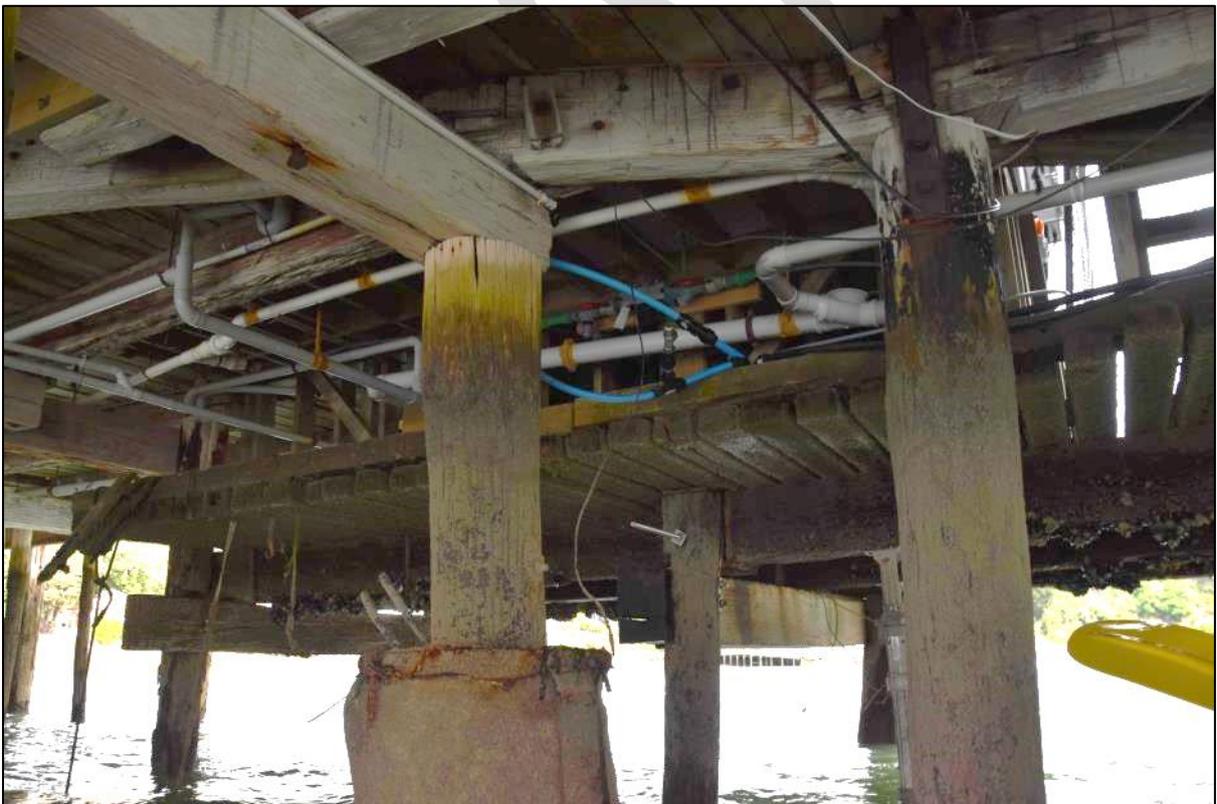
Photo 39 Tanks and modern piping on the lower deck area on the south side of the wharf (refer to Photos 21 & 22).

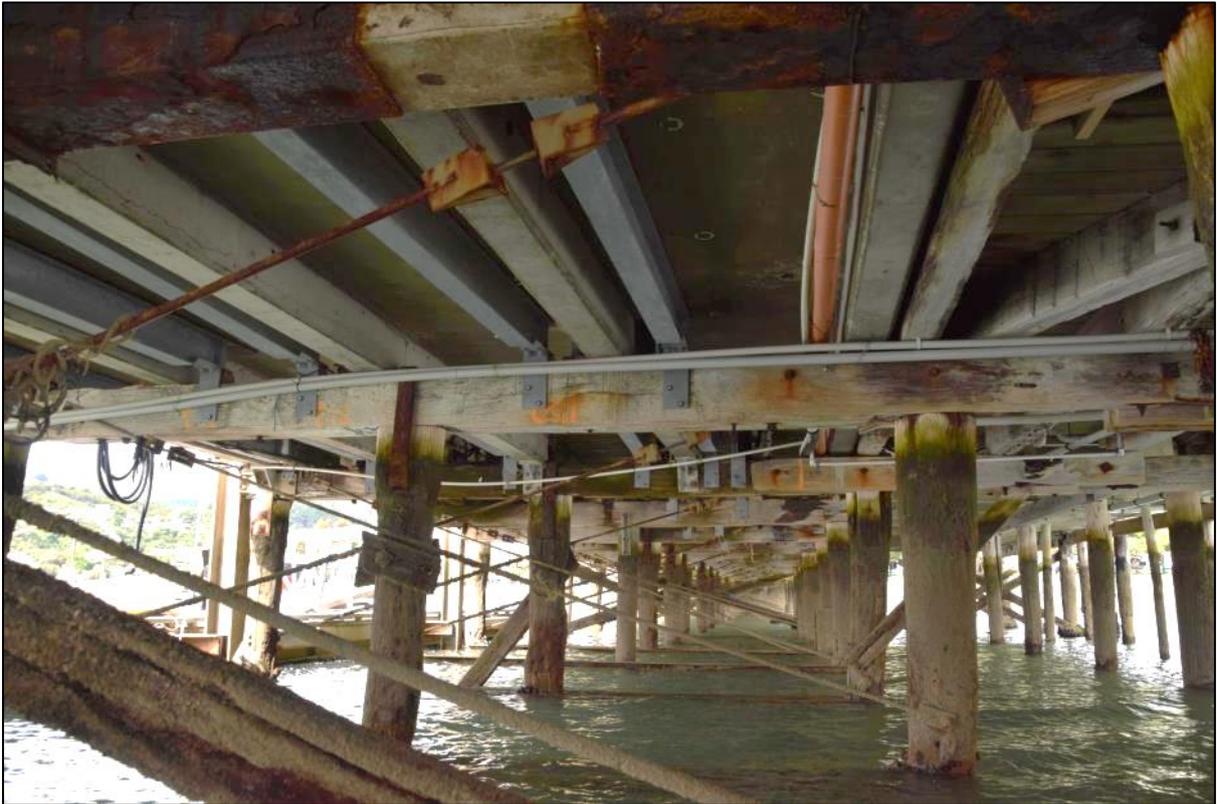
Photo 40 Substantial alterations/repairs with steel and concrete beams below the deck adjacent to the north floating pontoon.

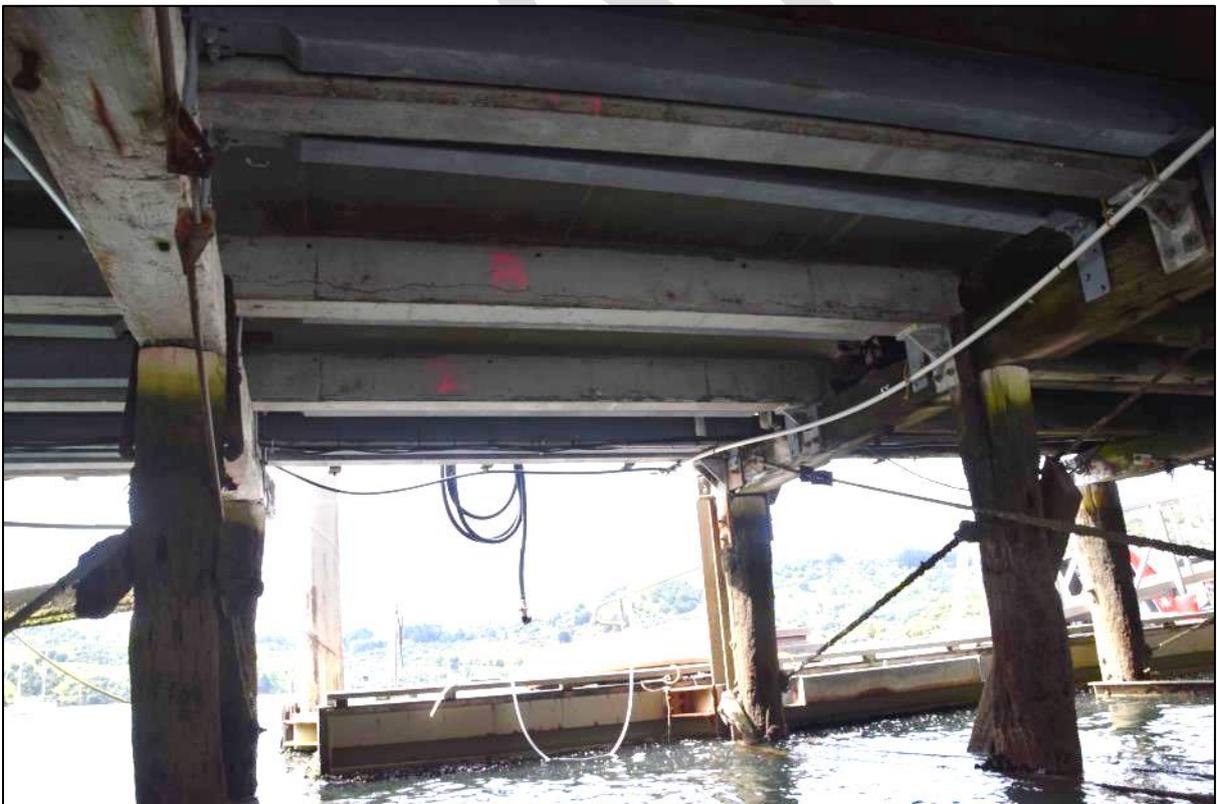
Photo 41 A close-up of inserted concrete and steel beams (Photo 40) – some of the concrete beam are cracked. Poorly restrained and concealed modern conduits.

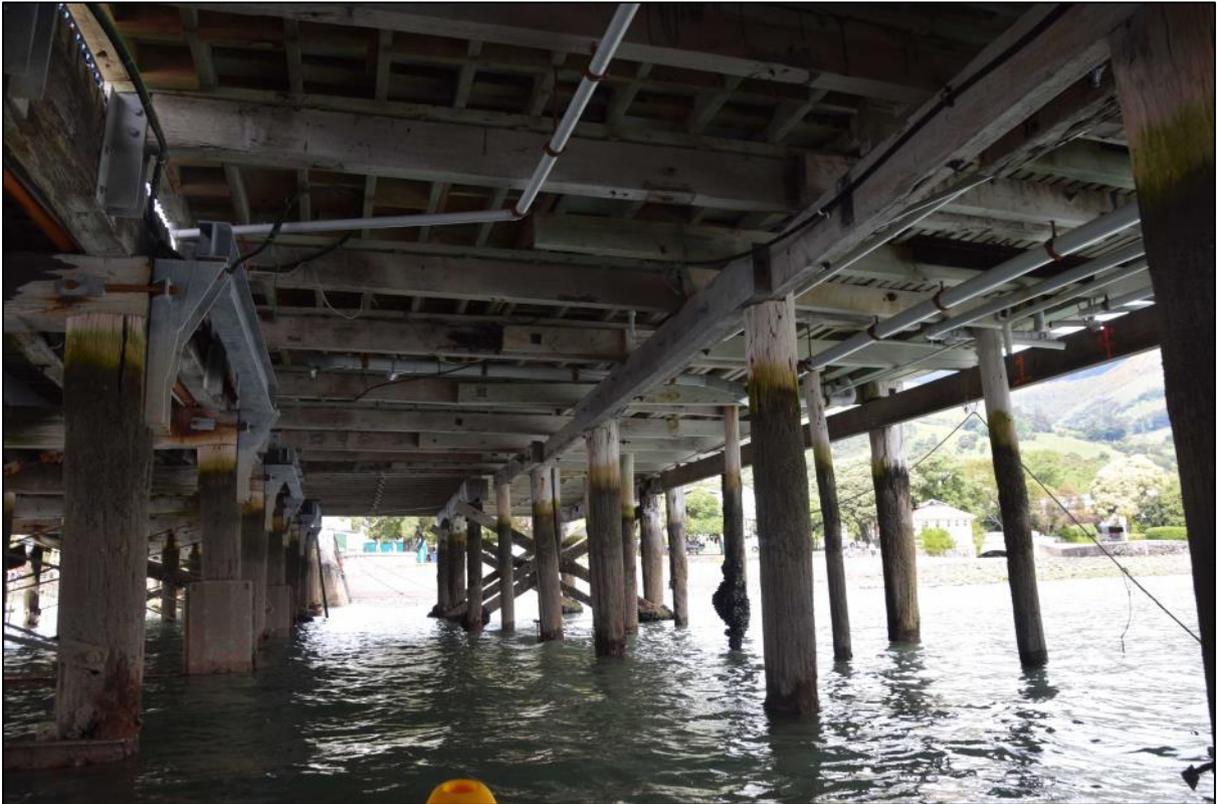
Photo 42 Modern piles, pile caps and floor framing beneath the eastern end of the sheds.
