Arboricultural Impact Assessment

**Proposed Comprehensive Care
Retirement Village**

78 Park Terrace

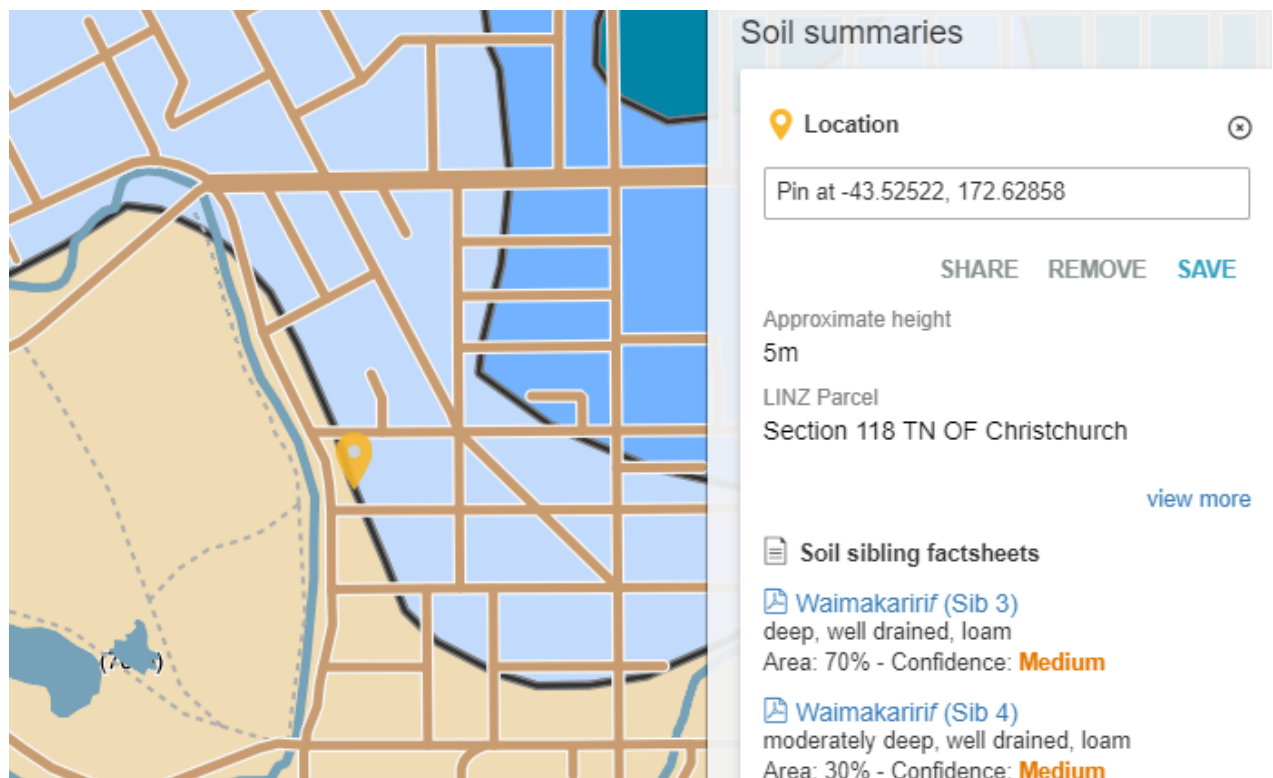
Figure 1,¹ S-map Soil Report, Landcare Research New Zealand Limited 2011-2015, Manaaki Whenua, dated: 5th September 2017.

Waimakaririf, loam soils, which provide optimal drainage characteristics and high fertility, ideal for agriculture and tree growth (See figure 1 below) underlie the site.

It is however reasonable to expect that the original soil characteristics at the Peterborough site may have changed over the years due to site development.

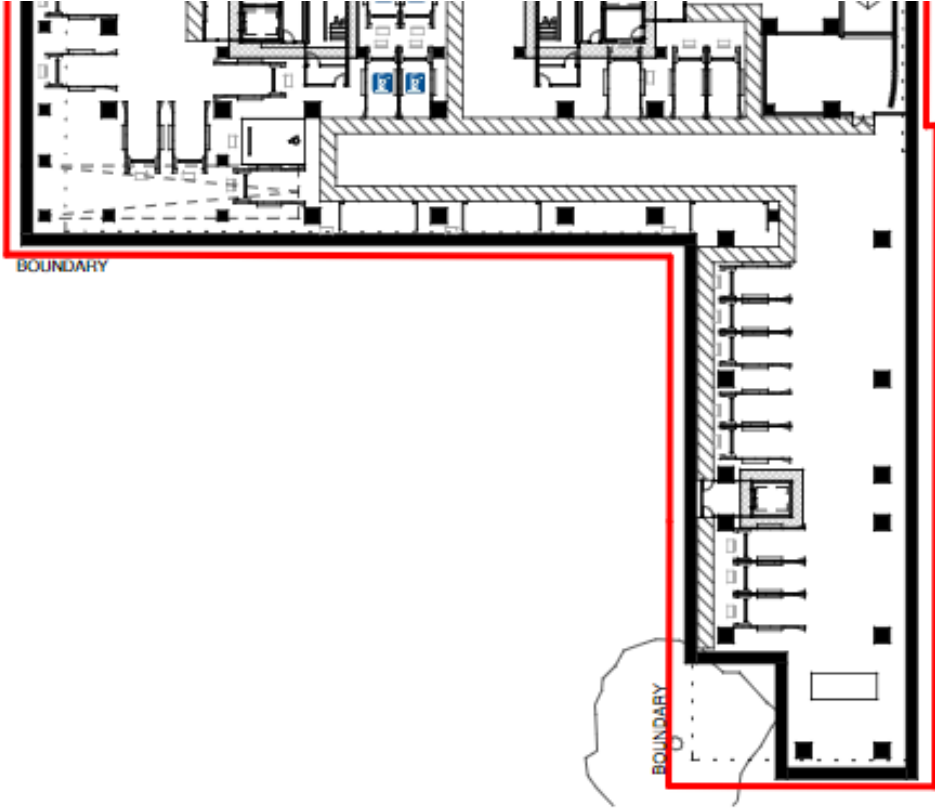
Appendix 2, Site Plan, Warren & Mahoney

Drawing B07. A1-010 (Appendix 2) shows that the excavation for the basement carpark, to a depth of approximately 3.4 metres, will extend just inside the crown spread (dripline) of the subject tree to the north of the tree, and just outside the dripline at the eastern aspect.

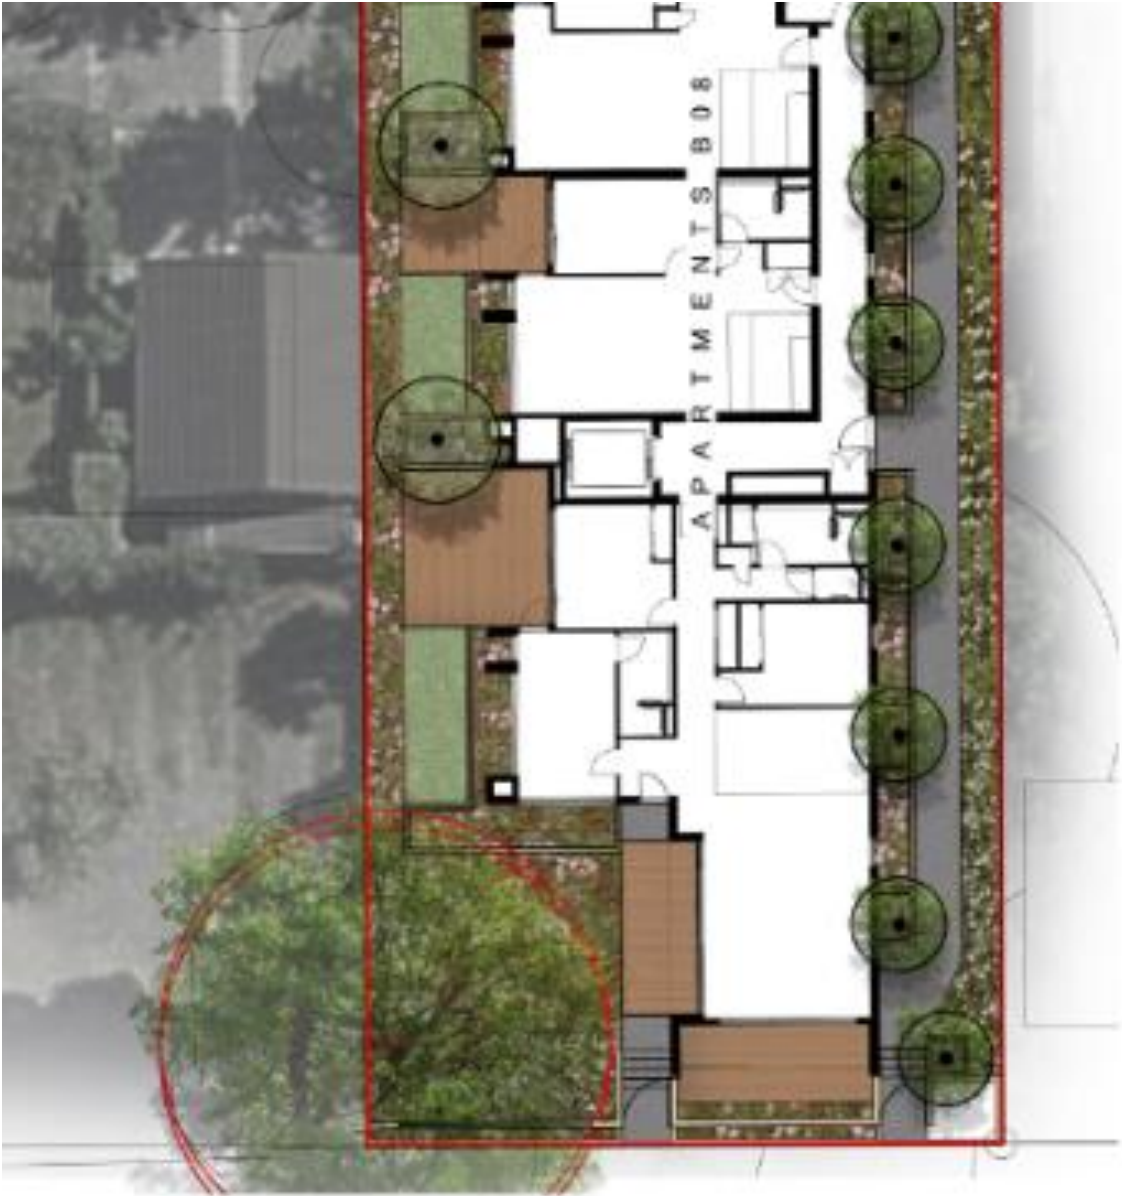
Appendix 3; Landscape Concept Plan, Design²

The Landscape Concept Plan provided by Design² (Appendix 3) similarly shows the edge of the basement wall in relation to the dripline of the tree.
