# AKAROA MAIN WHARF, AKAROA

Conservation Plan  
December 2021 - DRAFT

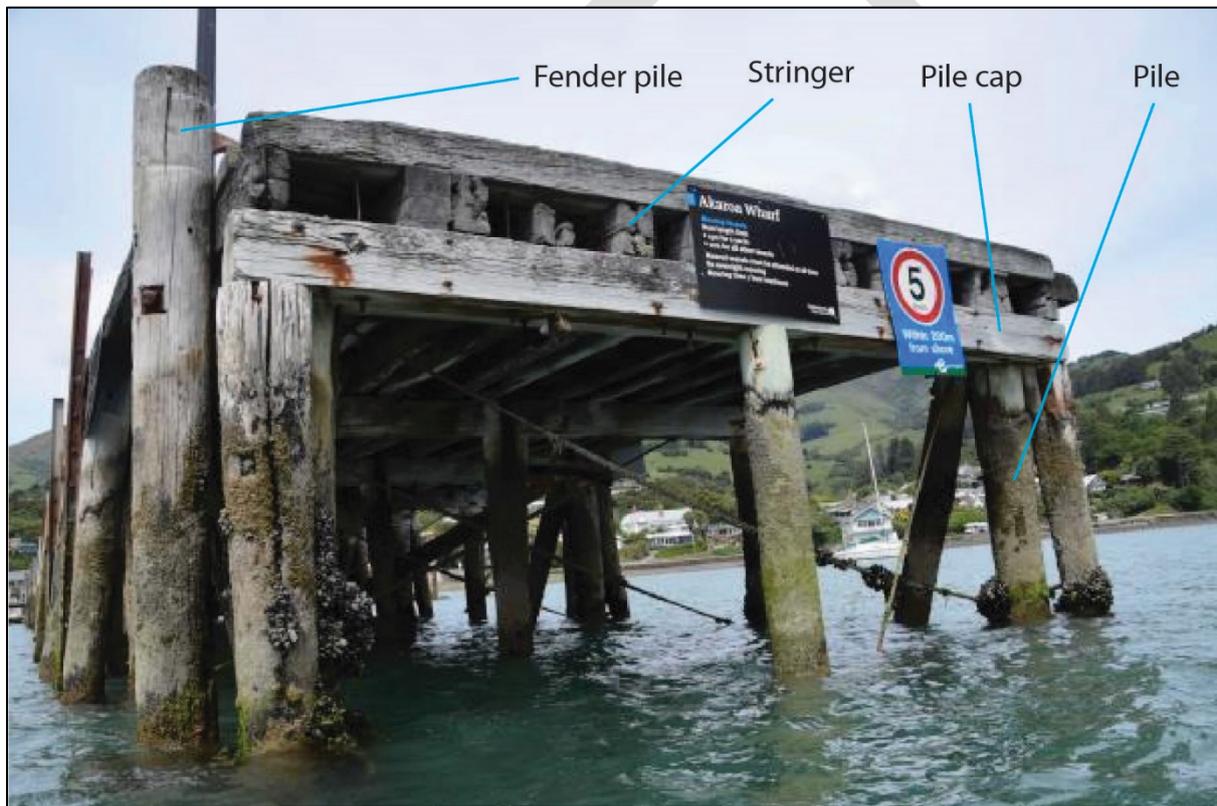
Figure 4. The end of the wharf with the principal parts of the structure identified. The whole assembly of the five piles with the pile cap running across them comprises a single 'bent.'

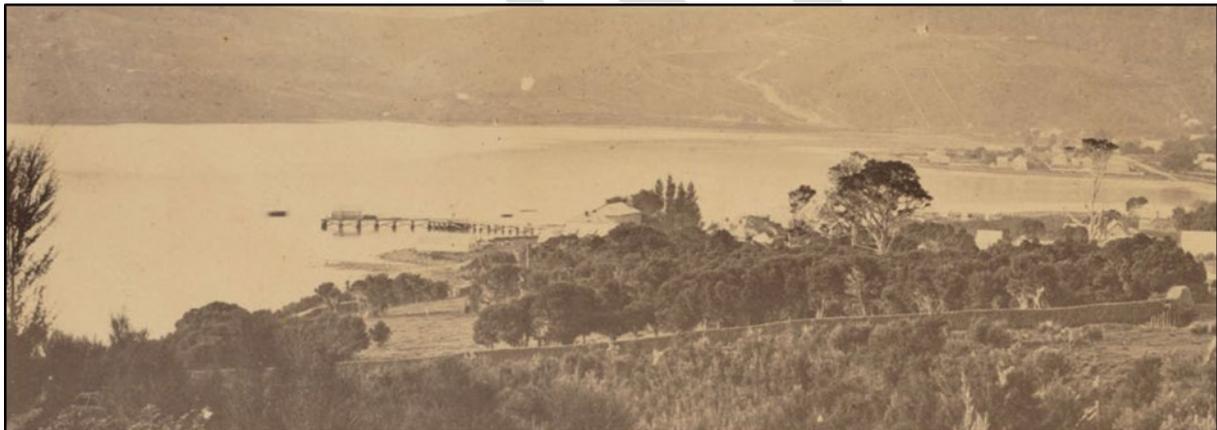
Figure 8. Detail of an 1860s image showing the 1850s Provincial Government jetty (Auckland Museum).

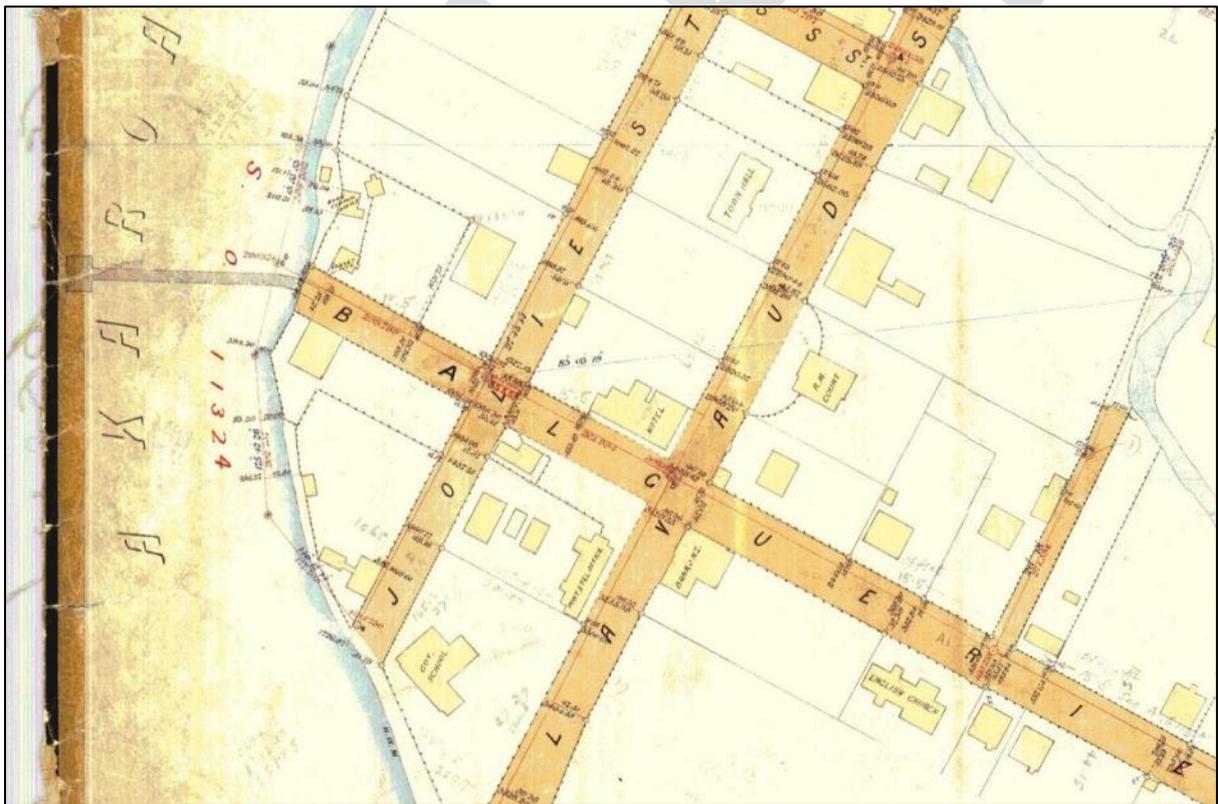
Figure 10. Detail of SO 811 from 1883 showing the northern (French) part of town with Daly's Wharf extending from Rue Balguerie (QuickMap).

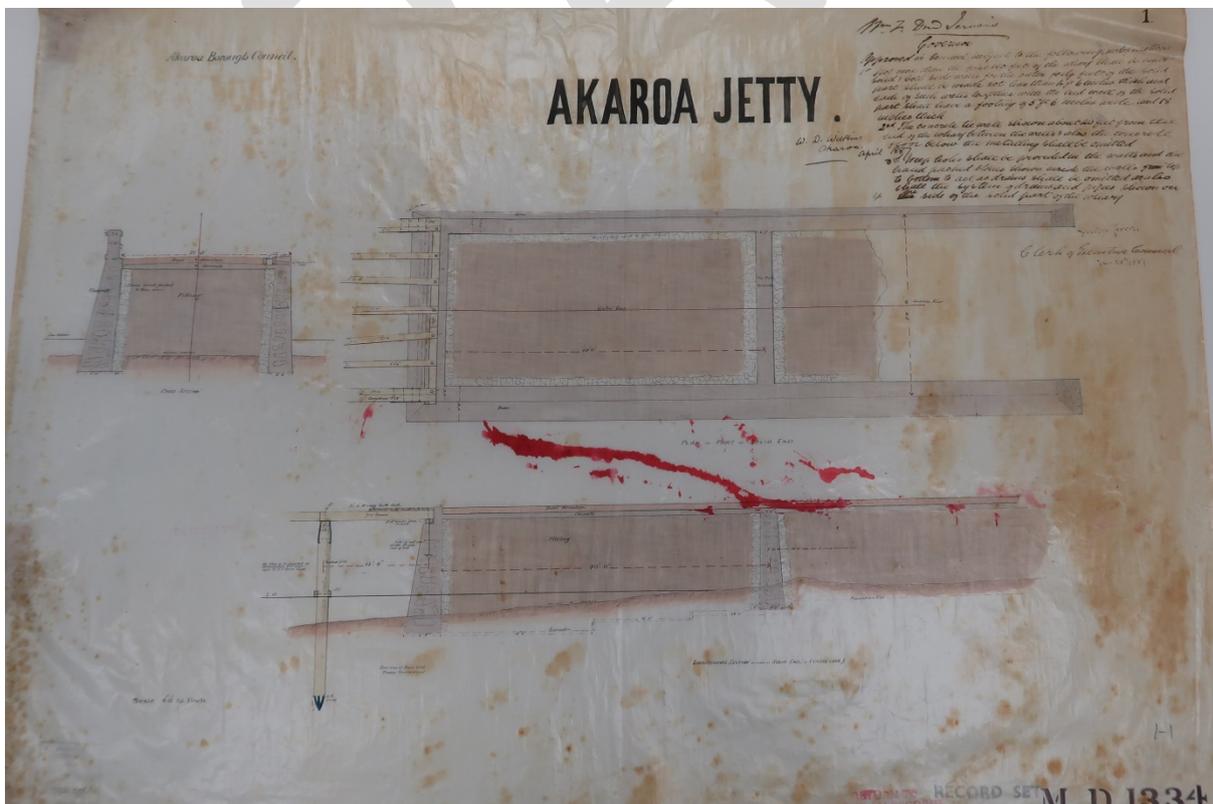
Figure 18. Section drawings of the concrete abutment to the timber portion of the wharf (Wellington Archives New Zealand).

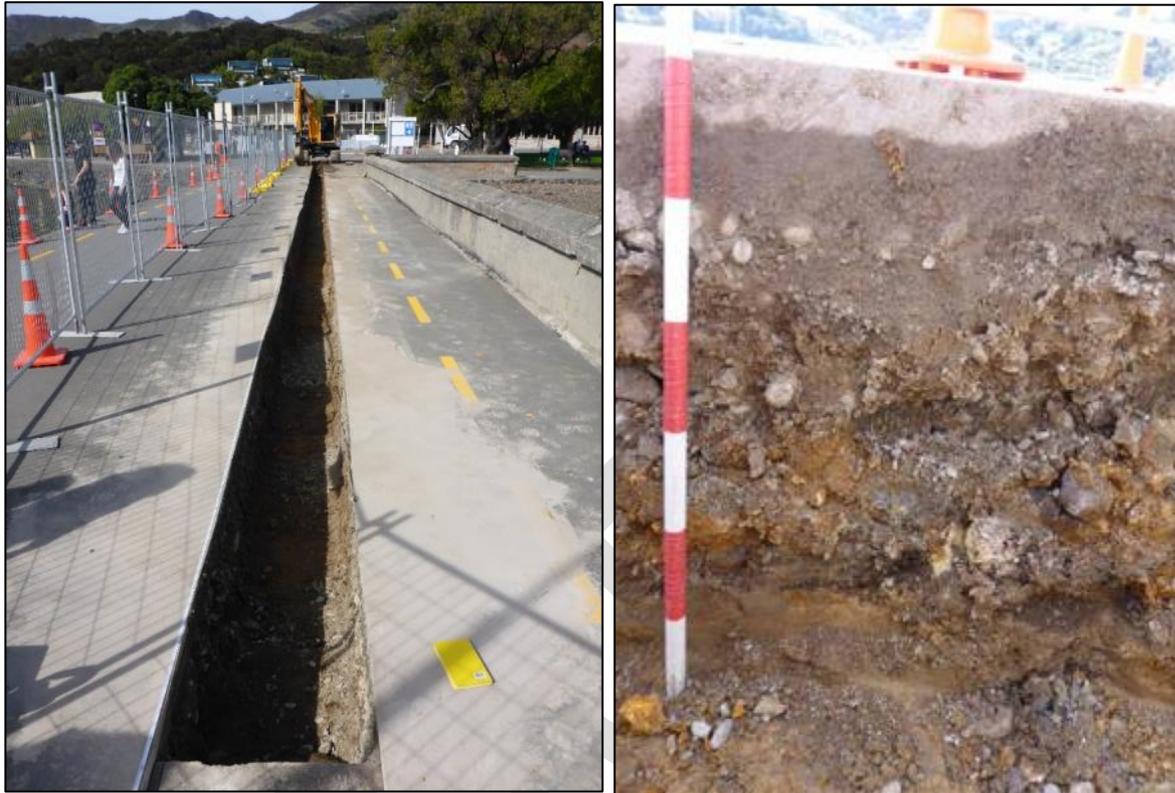
Figure 21. Left – View looking east showing the trench excavated through the solid portion of the Akaroa Main Wharf in 2015 (K. Bennett). Right – The stratigraphy exposed in a section of the northern baulk, exposing asphalt, mixed clay, stone and volcanic rock, and light brown clay (K. Bennett).

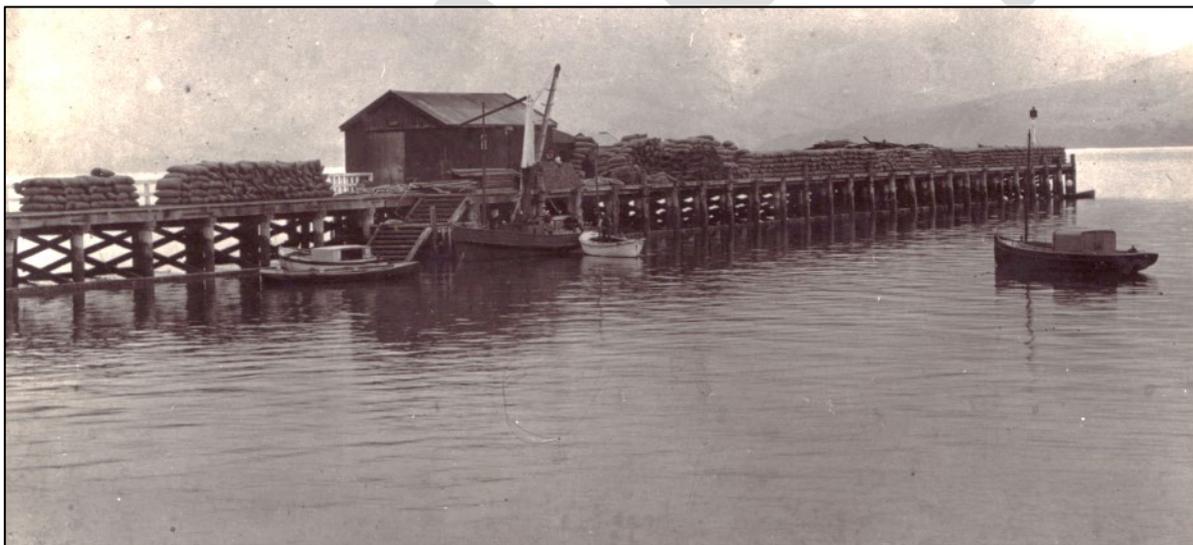
Figure 23. A brightened image of the north side of the wharf in 1910 showing the supporting structure and boat steps (Kete Christchurch).

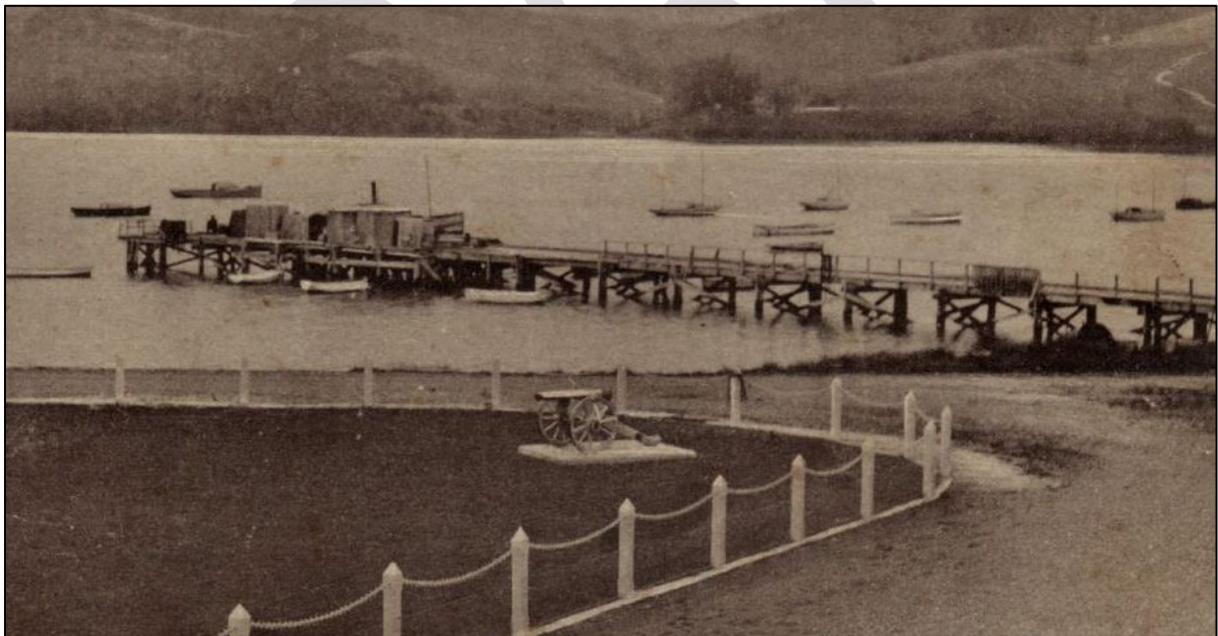
Figure 35. The deteriorating old jetty in 1910, apparently built up with fishing shanties. The Britomart Cannon is visible in the foreground (Kete Christchurch).

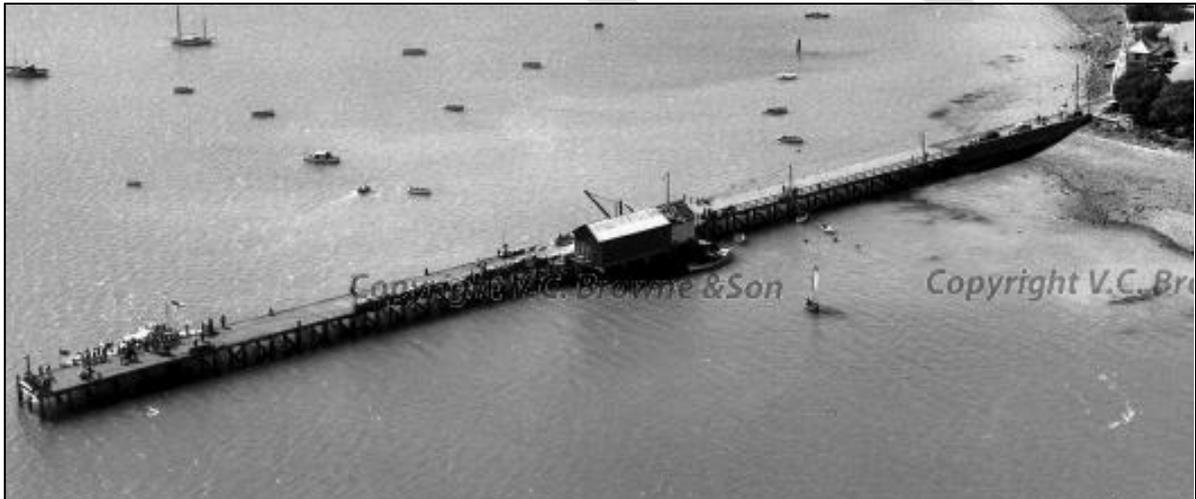
Figure 38. Detail of a 1950 photograph showing the south side of Akaroa Main Wharf (V. C. Browne and Son).

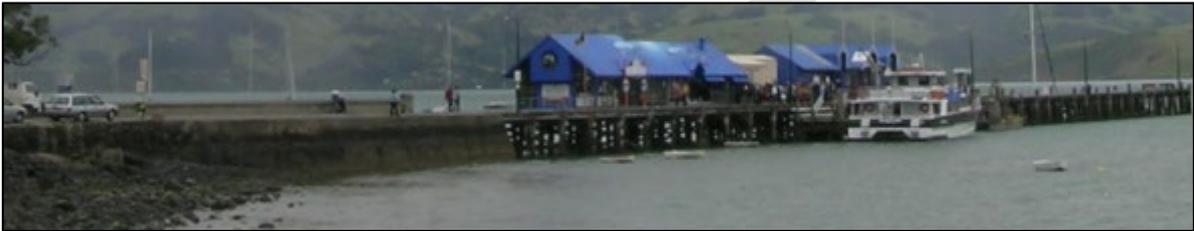
Figure 41. Detail of a 2007 photograph showing the north side of the Akaroa Main Wharf and its buildings (Kete Christchurch).

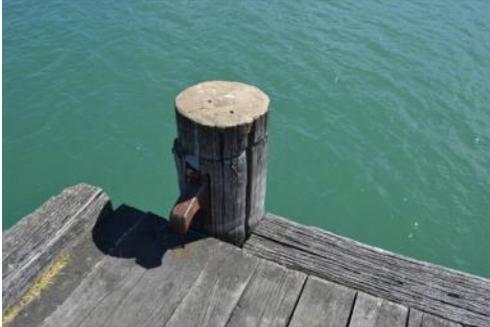
38-39	Galvanised steel mooring cleat (S)  Two steel and timber bench seats  Street light (N)  Ladder formed by 2 pieces of railway iron with deformed bar rungs between (N)	N/C  N/C  N/C  S

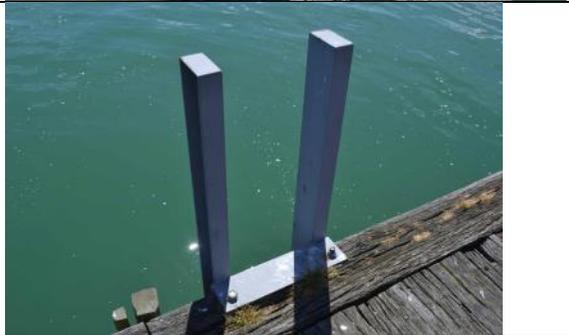
25	<p>Tanalised post and rail barrier (S)</p> <p>Remains of old iron mooring cleat (missing arms) (S)</p> <p>Timber pile head wrapped with rope (N)</p>	<p>N/C</p> <p>H</p> <p>N/C</p>

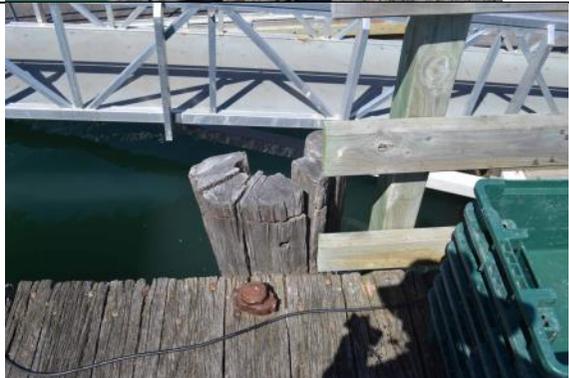
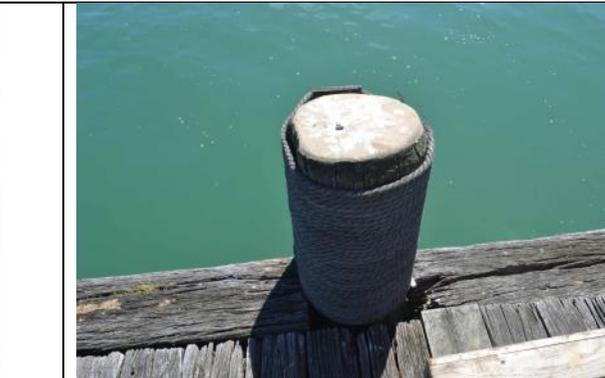
24-25	Galvanised mooring cleat (S)  Two bench seats (N)	N/C  N/C

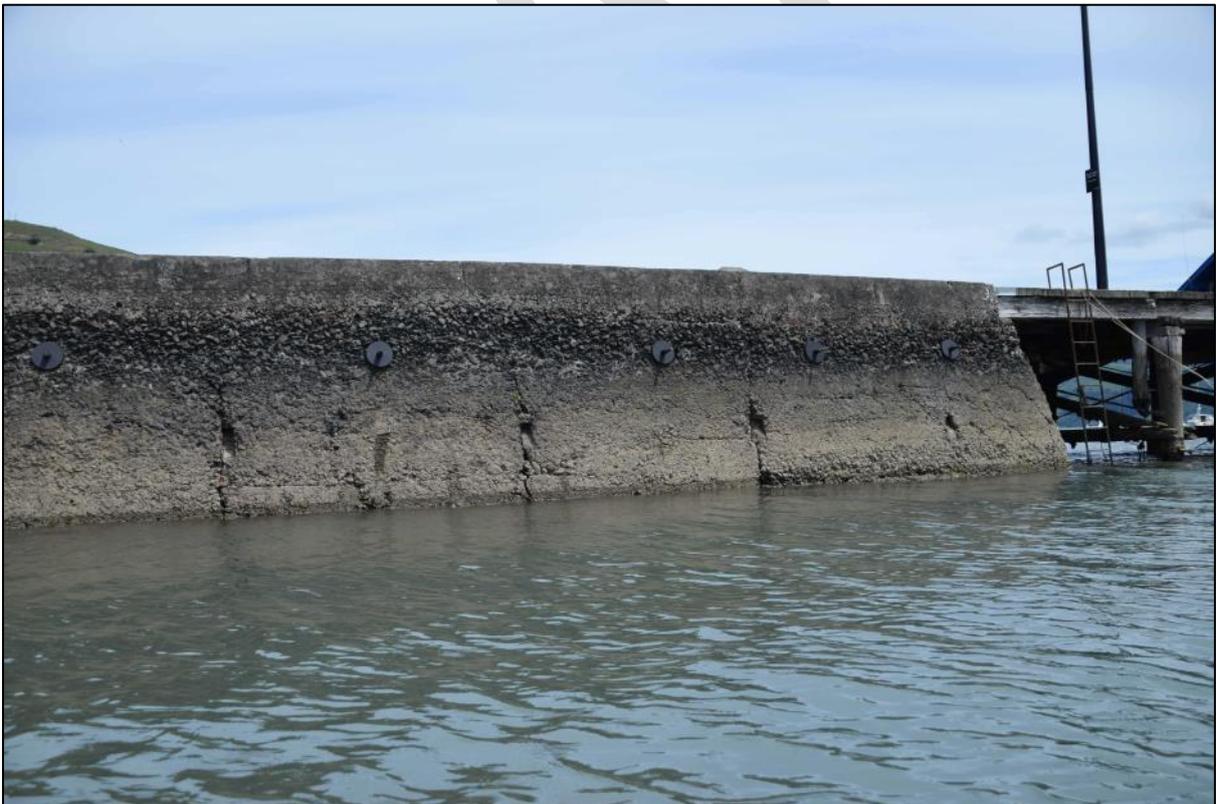
Photo 3 The outer north wall of the abutment with drainage holes, circular pattress plates to the end of the tie rods and many cracks in the masonry.

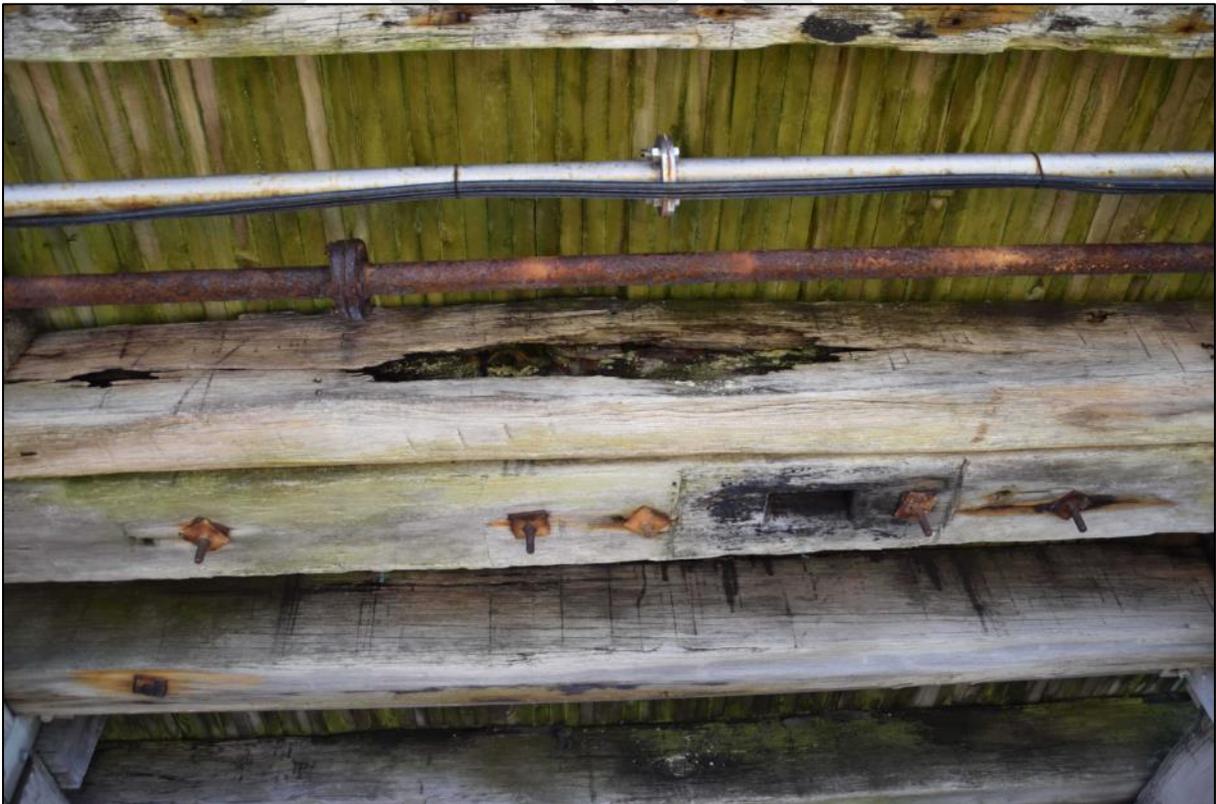
Photo 5 Clear evidence of decay in a timber stringer at the eastern end of the wharf.

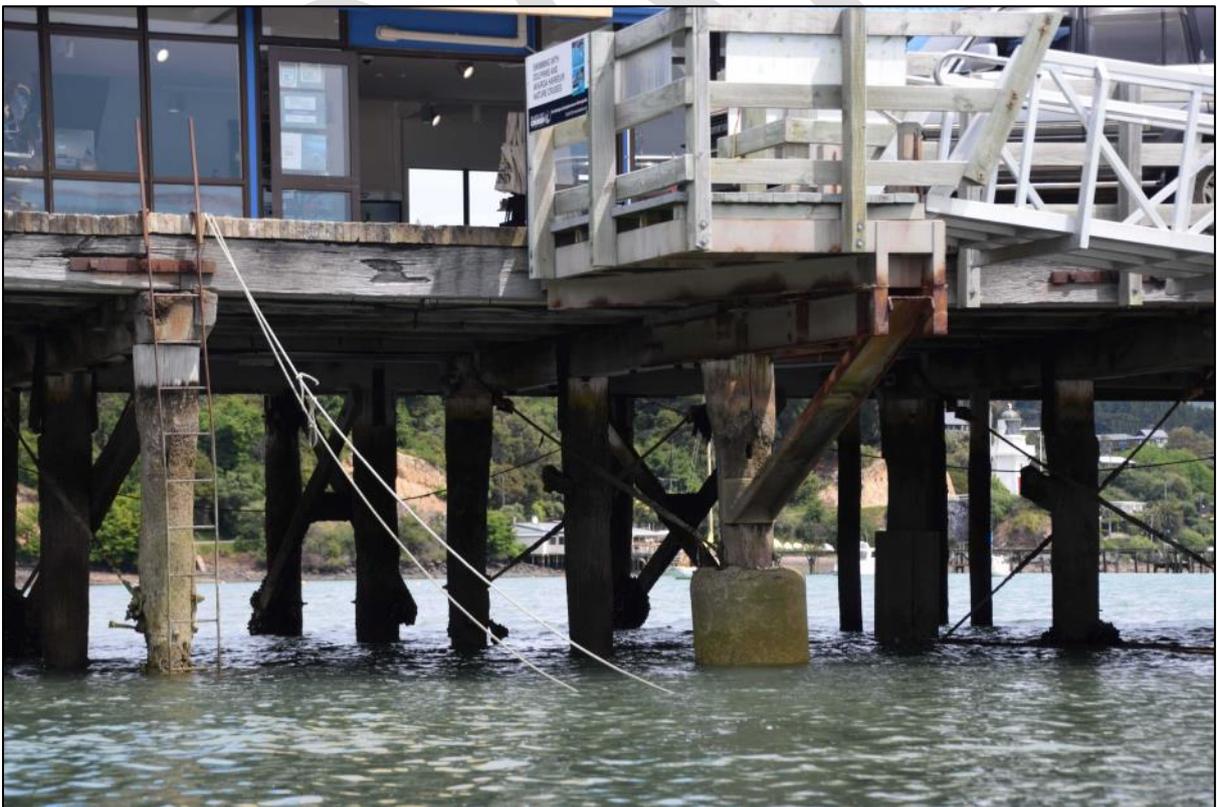
Photo 7 Further alterations on the north side of the wharf with steel added to support the gantry to the floating pontoon and concrete cast to the base of the pile supporting the steel framing.

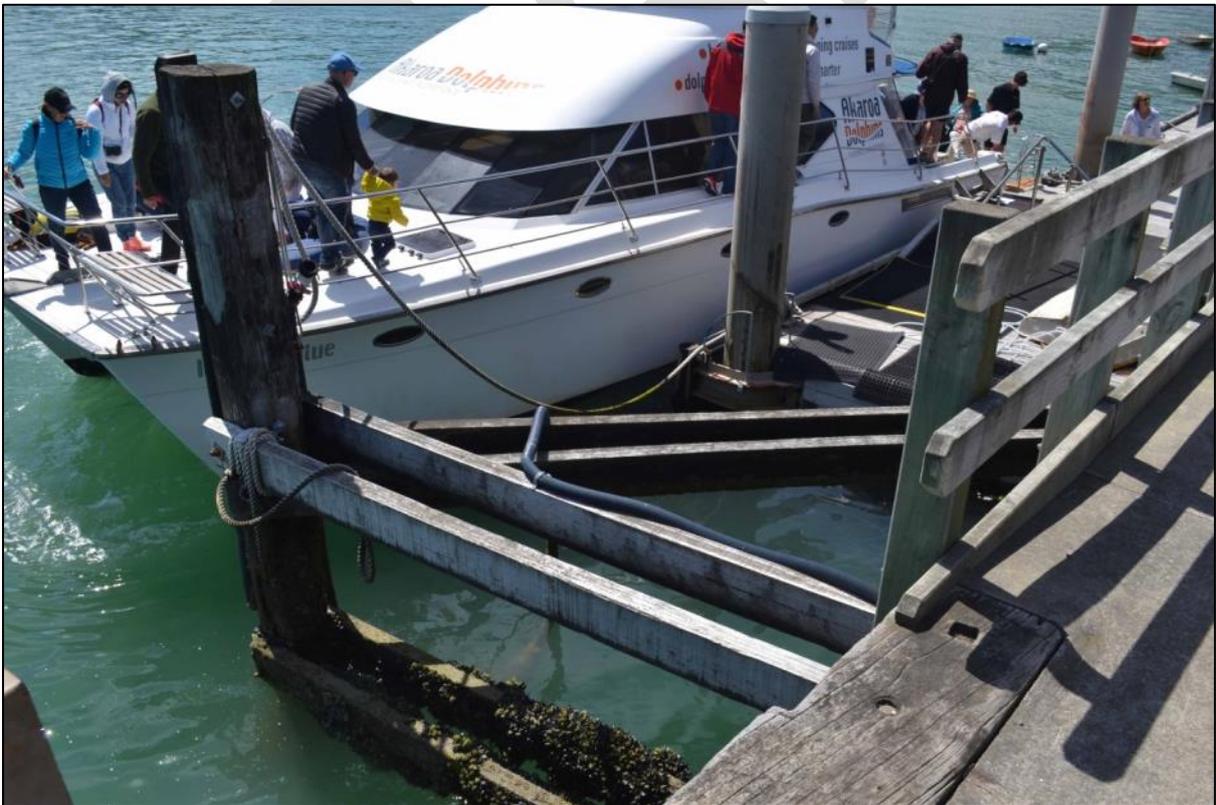
Photo 9 This older pile on the left appears to relate to the former projecting platform and main steps to water level that previously existed on the north side of the wharf.

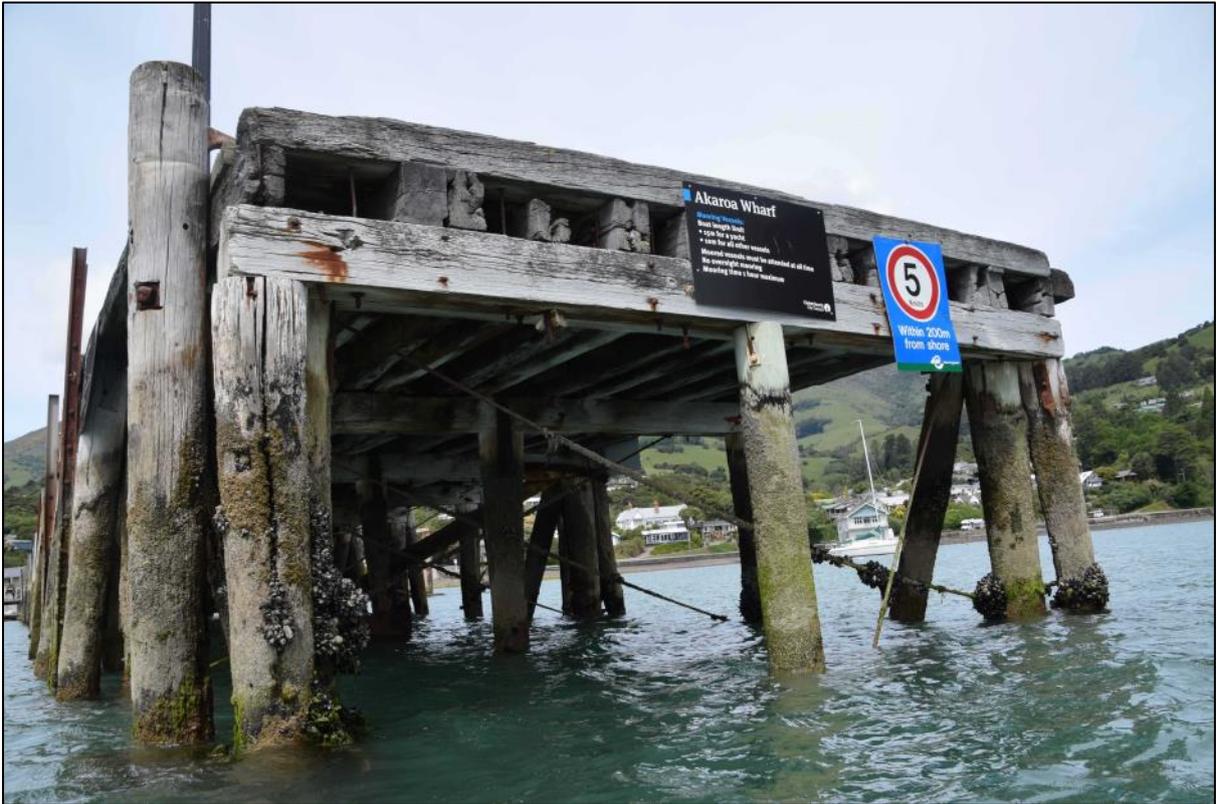
Photo 12 The outer/west end of the wharf clearly showing the original construction, although with some replacement tanalised piles. Along the top of the piles is the timber pile cap (beam). On top of that are the stringers and running parallel to the cap is the timber kerb with the timber decking behind it. On the far left and far right are fender piles and each corner has an inner bracing pile.

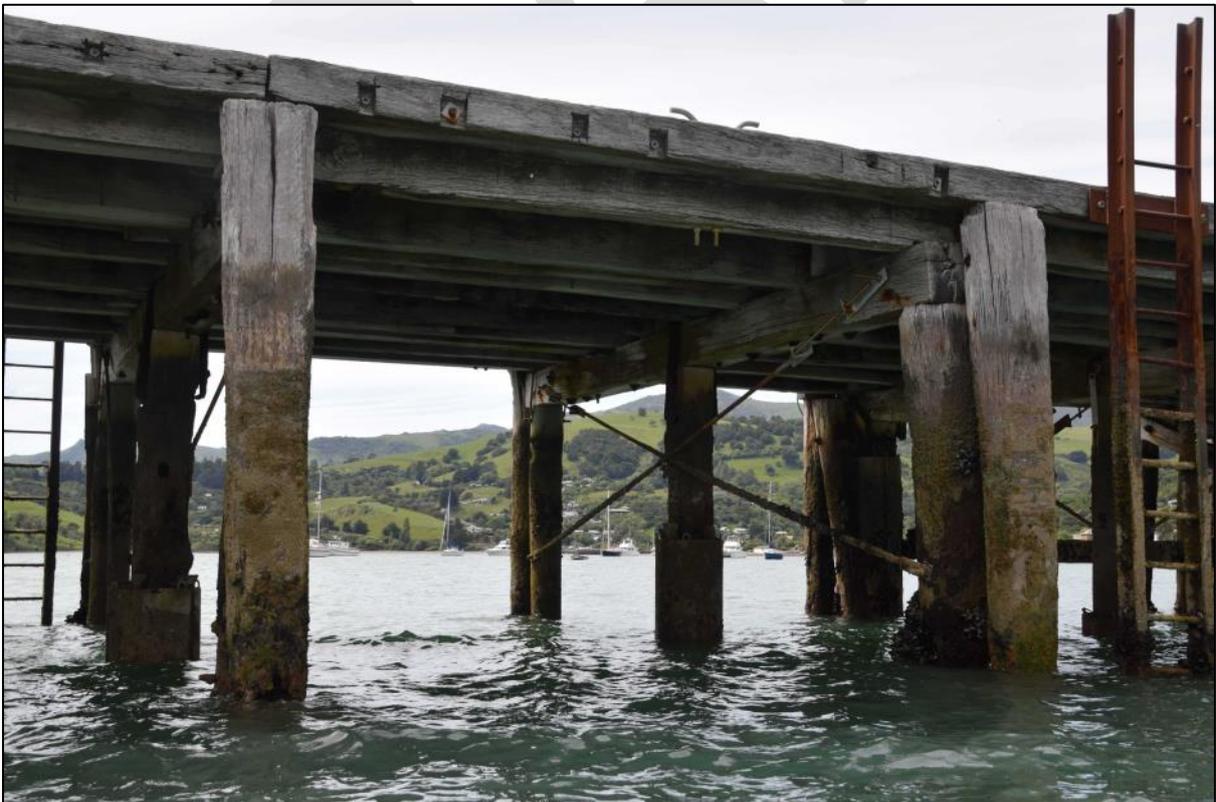
Photo 13 Here the original timber cross-braces to the bents have been replaced with modern steel bracing rods and a number of the piles have had repair 'jackets' encased around their lower sections.

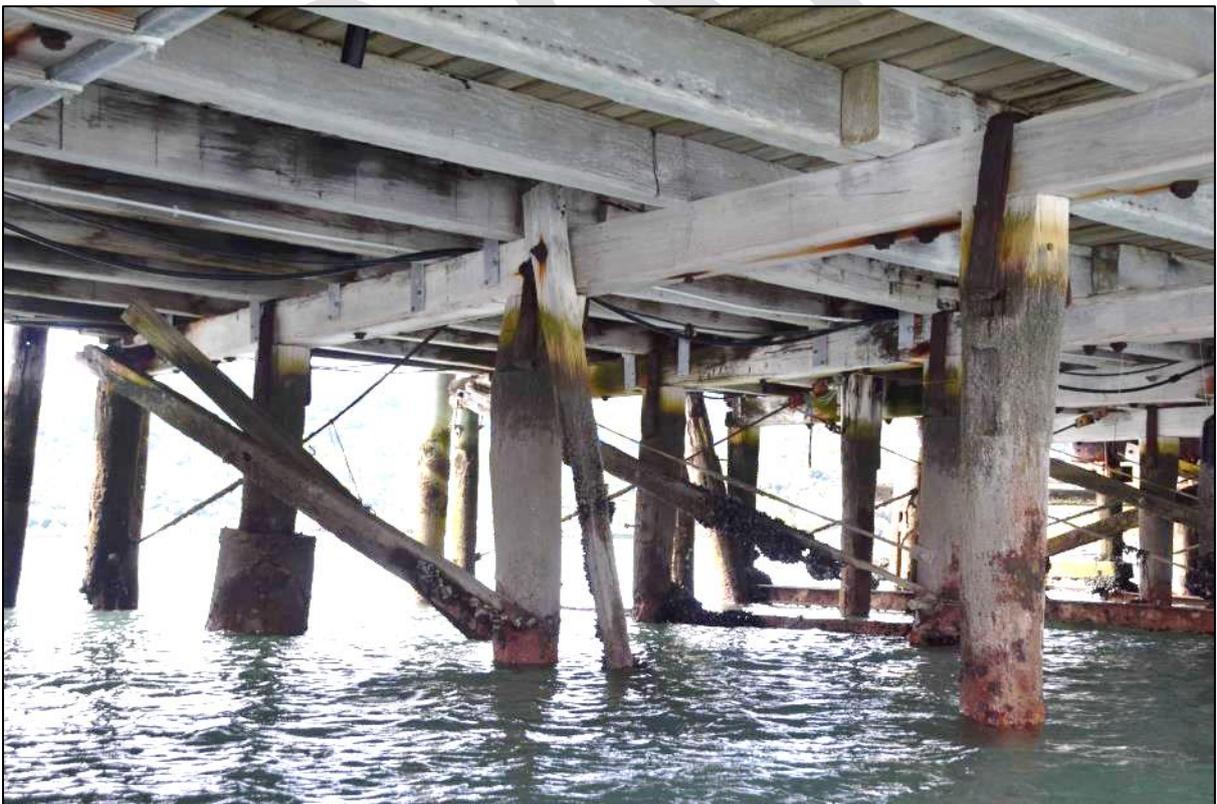
Photo 17 An image 2 bays closer to the shoreline than 16 showing the original widened structure under the original shed –with continuous pile cap spanning over the additional piles and wrought iron straps to the heads of the piles now delaminating and, in places, no longer connected to the piles. The bent in the foreground is missing bracing and one of the piles has a 'jacket' repair.

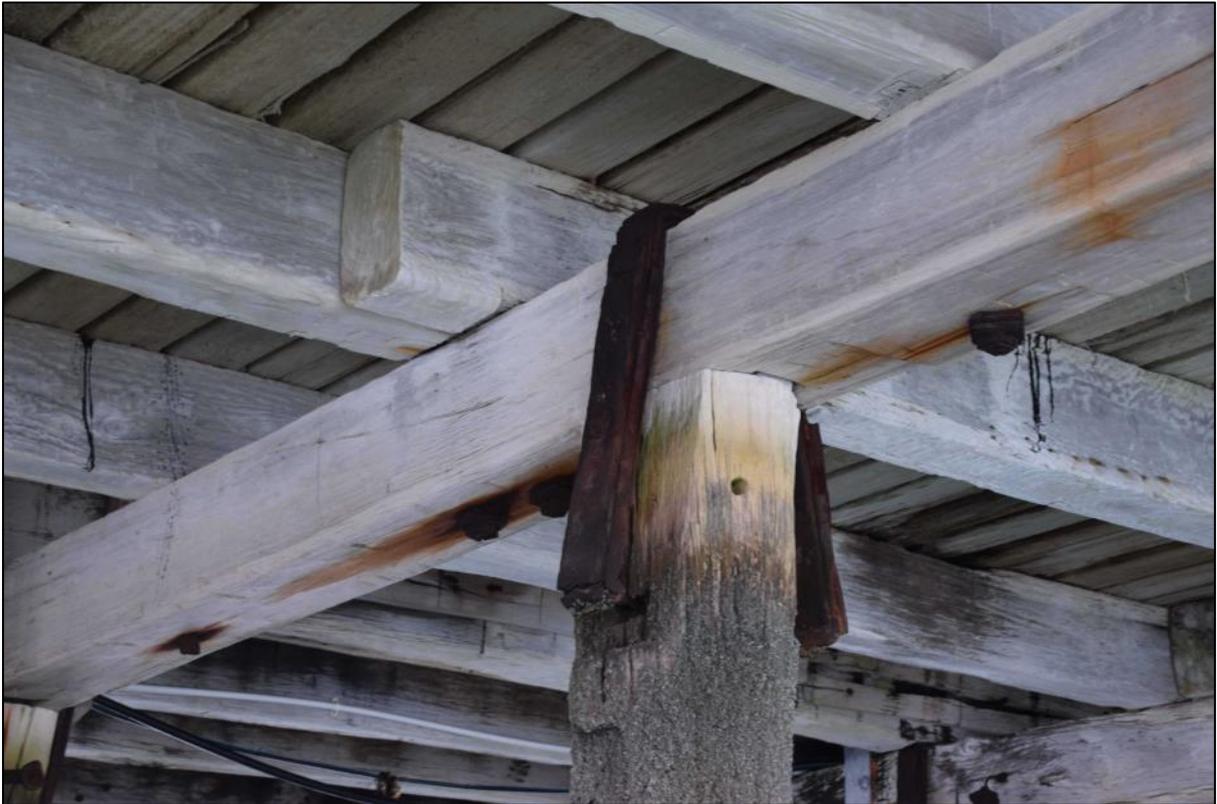
Photo 18 Close-up of the pile head on the right of Photo 17 showing the original wrought iron strap connection with the pile cap beam – now corroding/delaminating and separated from the pile head.

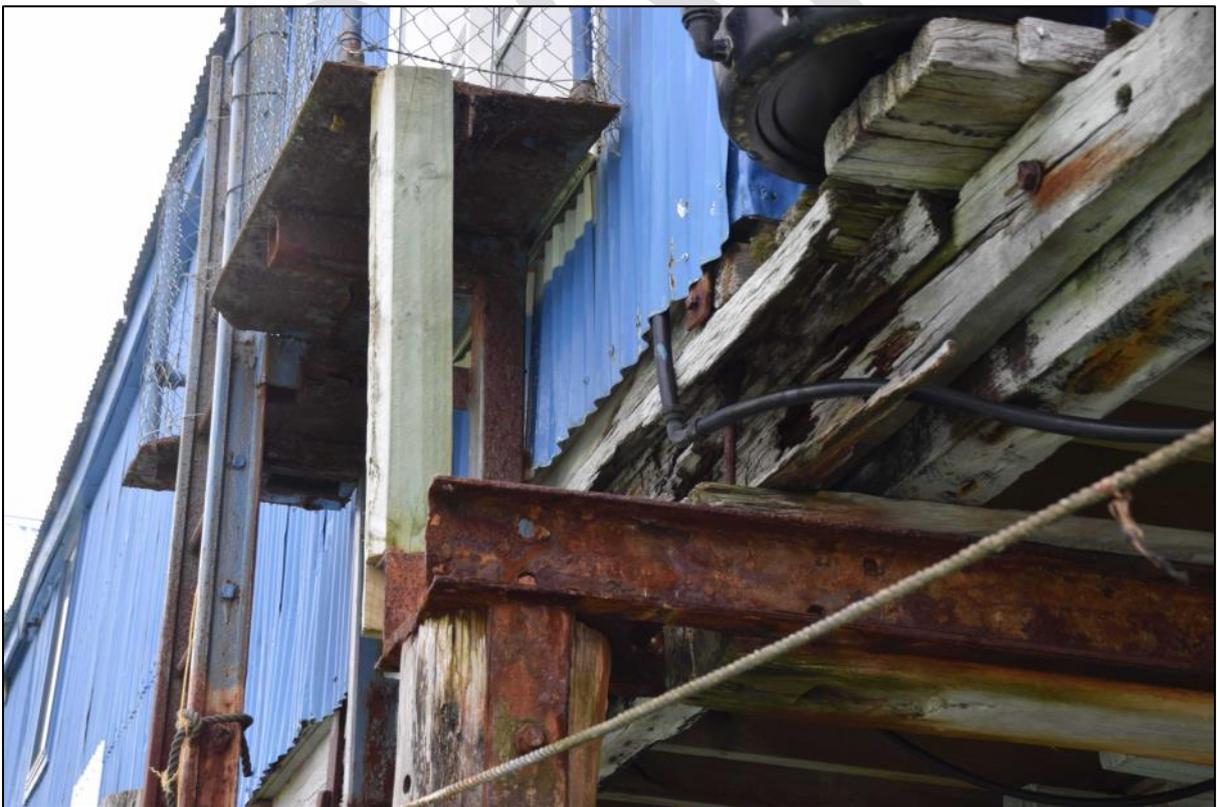
Photo 19 Timber decay and corrosion at the junction of two of the modern sheds (south side approx. 16th bent from the abutment).

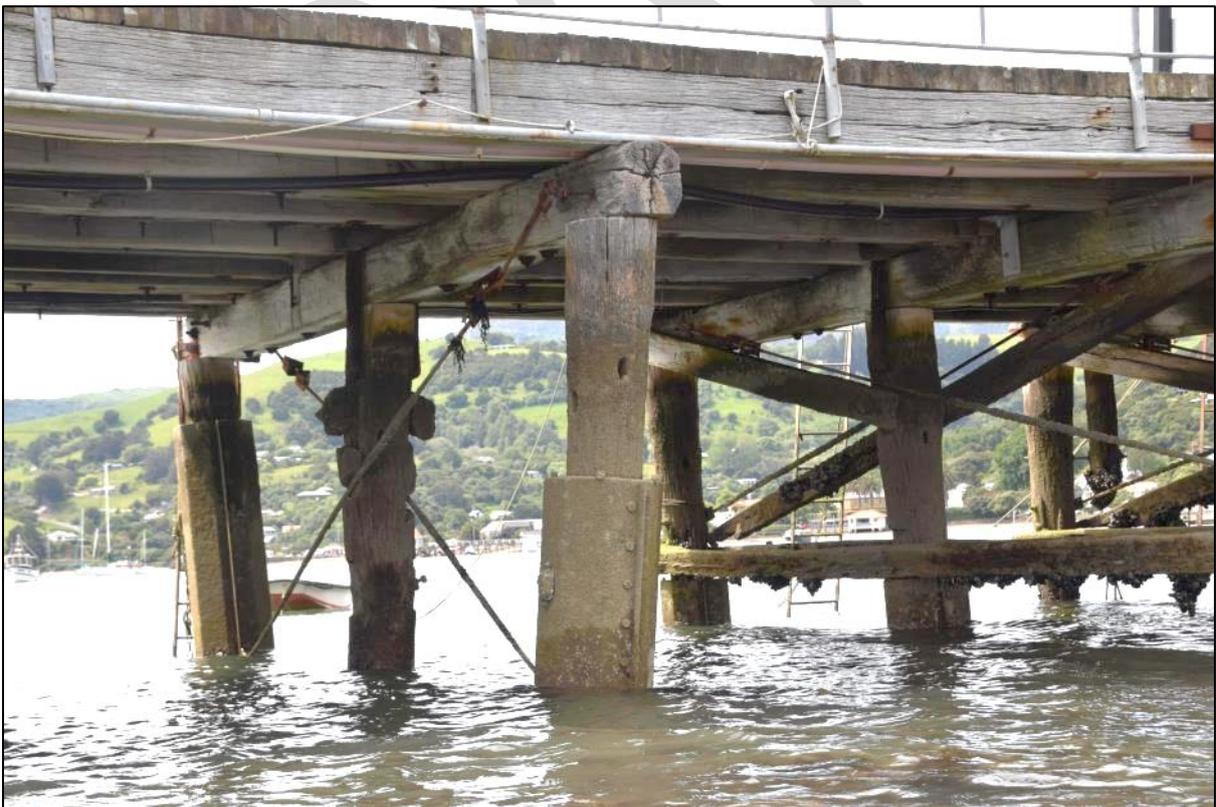
Photo 25 The same bent as in Photo 6, but from the south side. Both outer piles have 'jacket' repairs and the bent is missing its original horizontal brace. The diagonal timber braces have been cut off and replaced by steel rods.

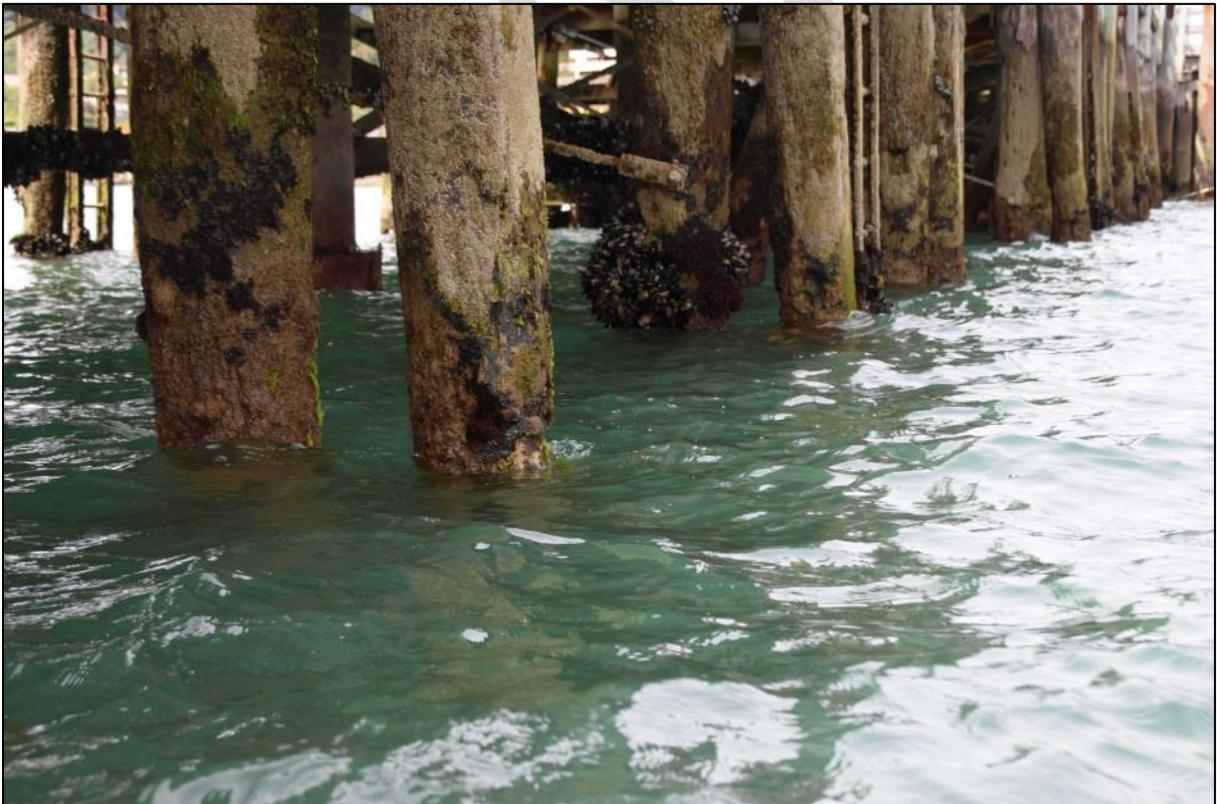
Photo 27 Severe decay at the water line to a fender pile on the south side of the wharf towards the western end. The photograph shows rows of piles and adjacent fender piles, many of which are thought to be original and of Ironbark timber.

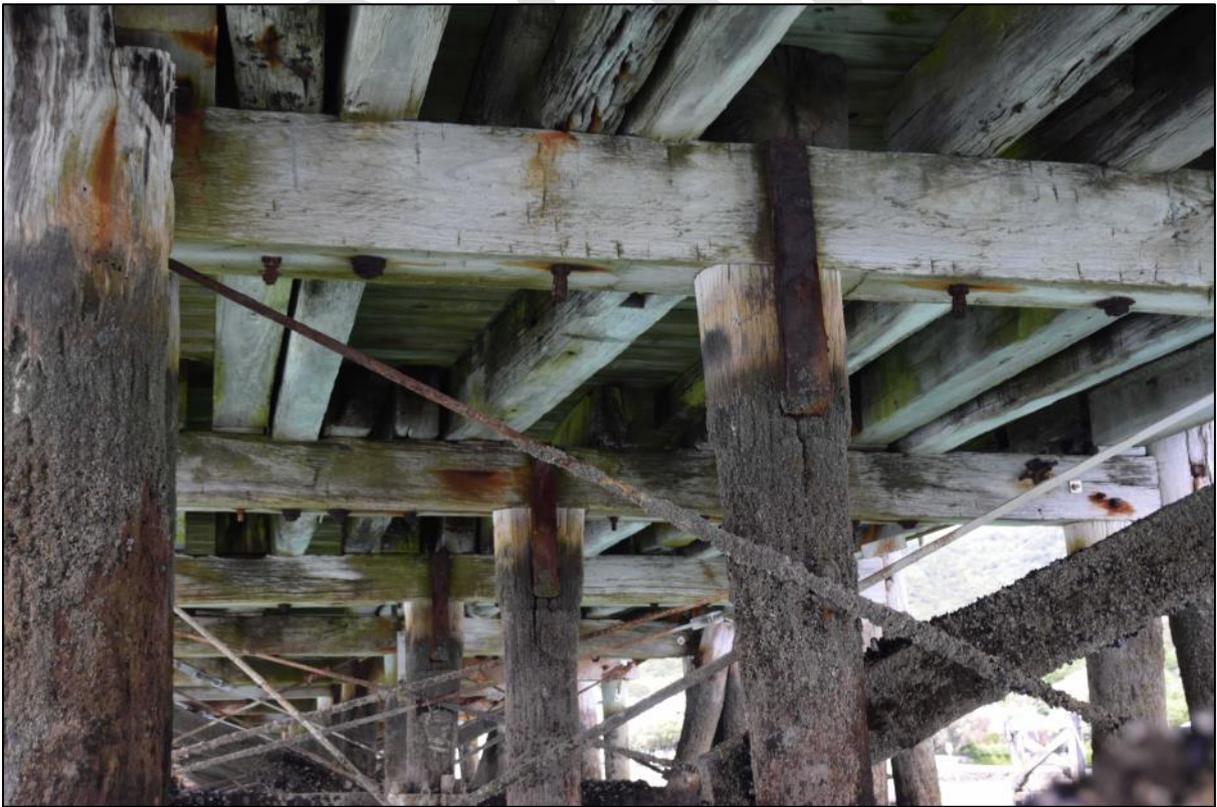
Photo 29 original wrought iron strap connections between the central piles and their pile cap. The joints also have a mortice and tenon.

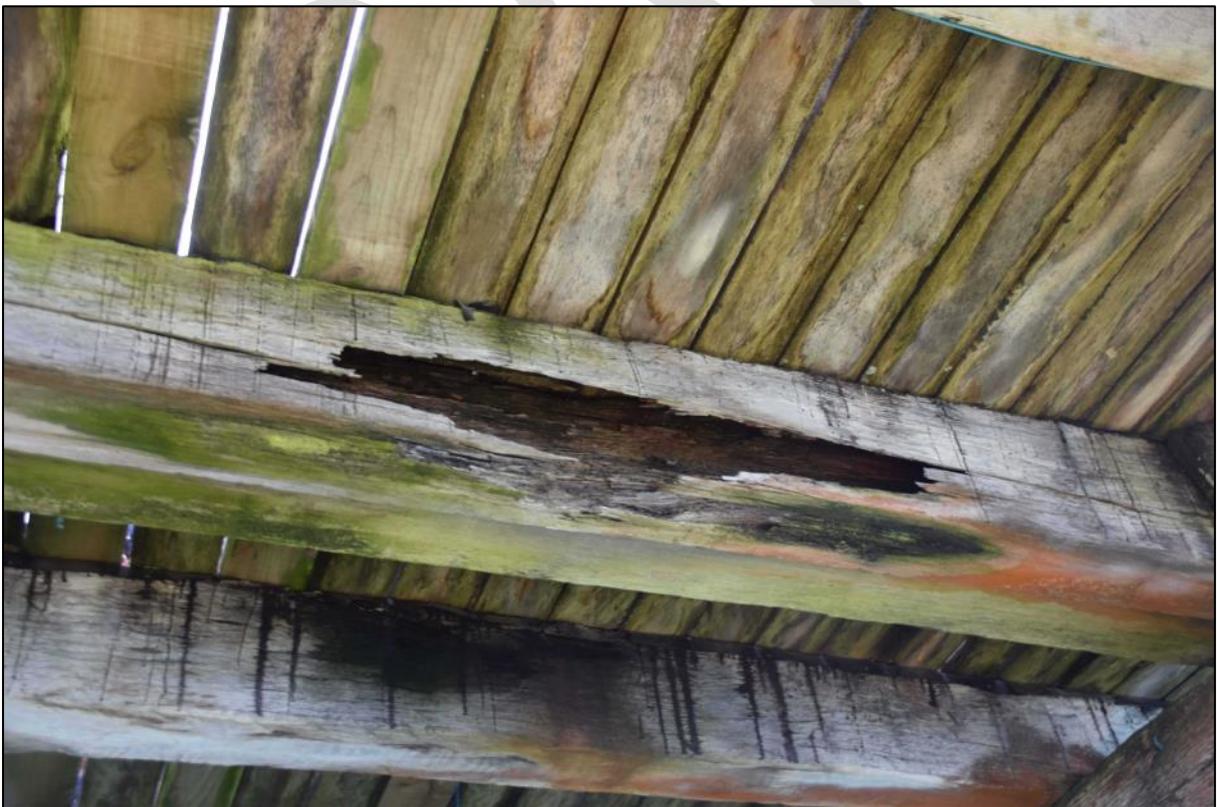
Photo 31 A large area of decay in one of the stringers close to the modern steps toward the western end of the wharf.

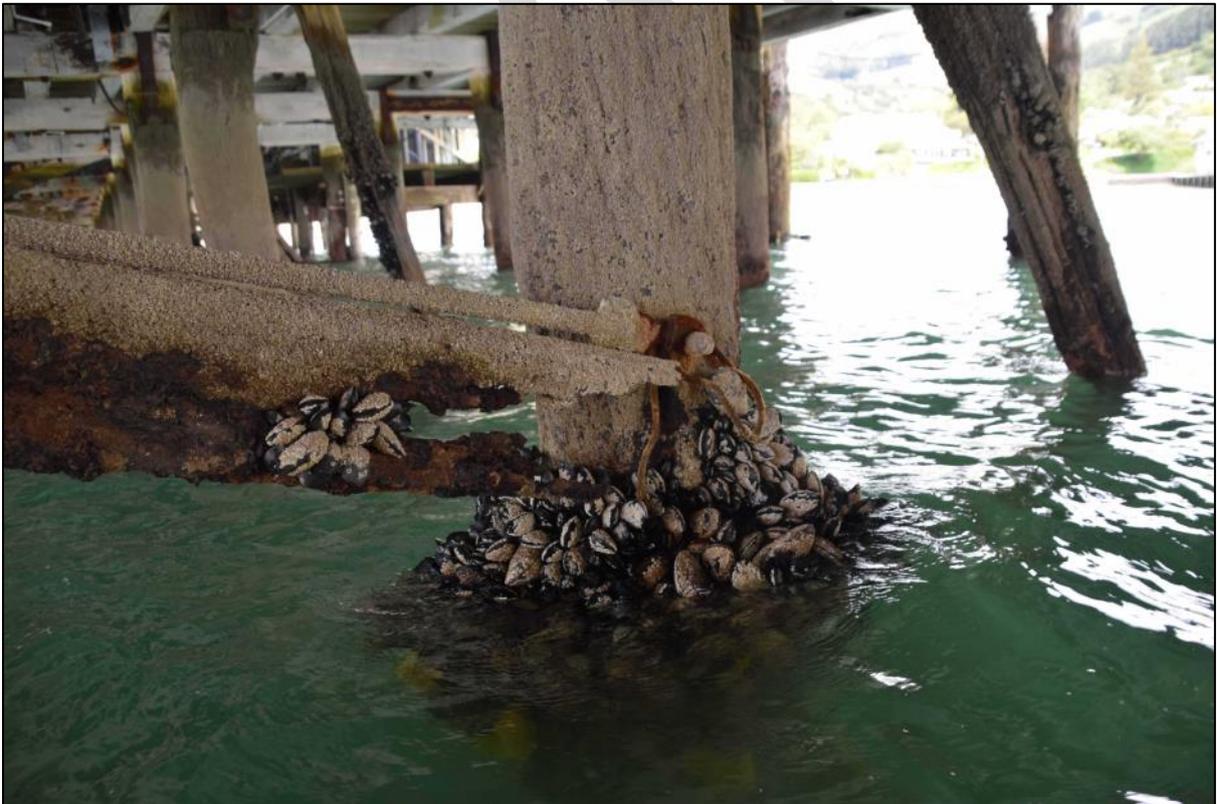
Photo 35 Broken/corroded steel brace.
