# AKAROA MAIN WHARF, AKAROA

Conservation Plan  
December 2021 - DRAFT

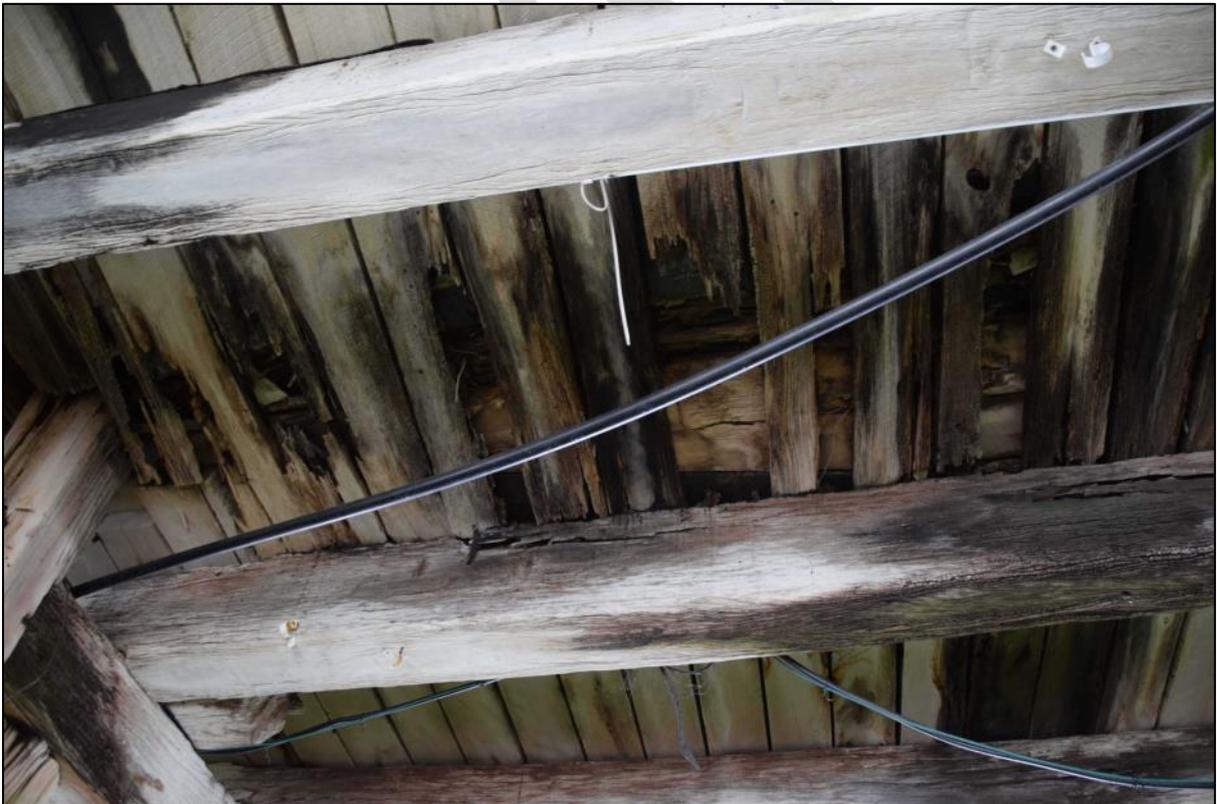
Photo 37 Further decay in decking boards beneath the existing deck finish.

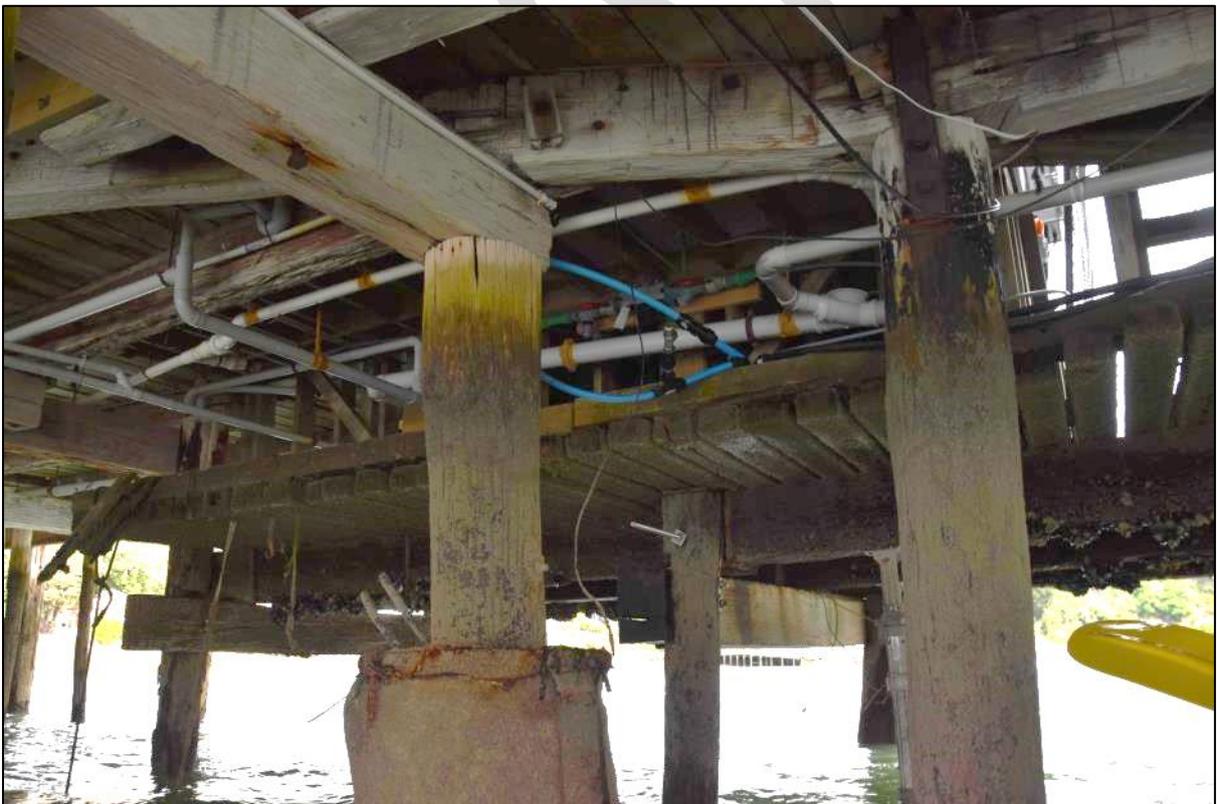
Photo 39 Tanks and modern piping on the lower deck area on the south side of the wharf (refer to Photos 21 & 22).

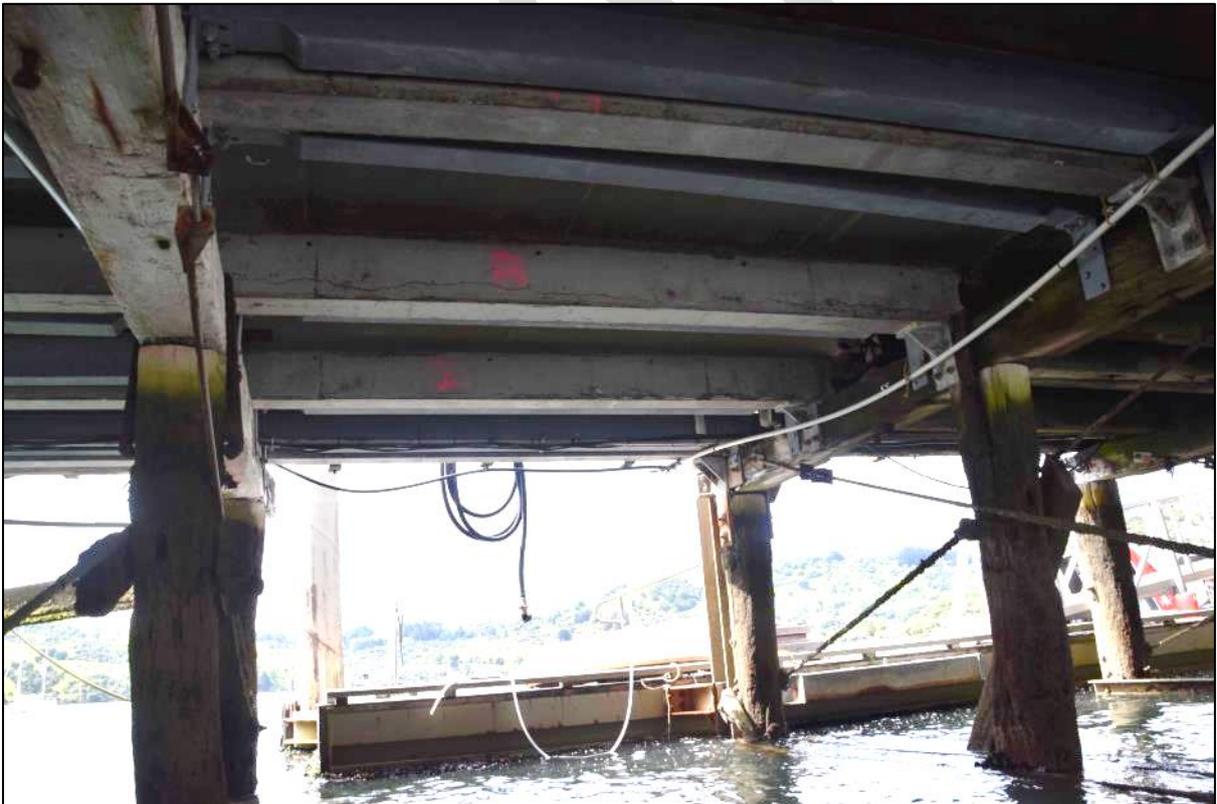
Photo 41 A close-up of inserted concrete and steel beams (Photo 40) – some of the concrete beam are cracked. Poorly restrained and concealed modern conduits.
