Appendix O

Subject: 265 Riccarton Road – Antonio Hall building – Post-fire structural inspection Project Number: 210611

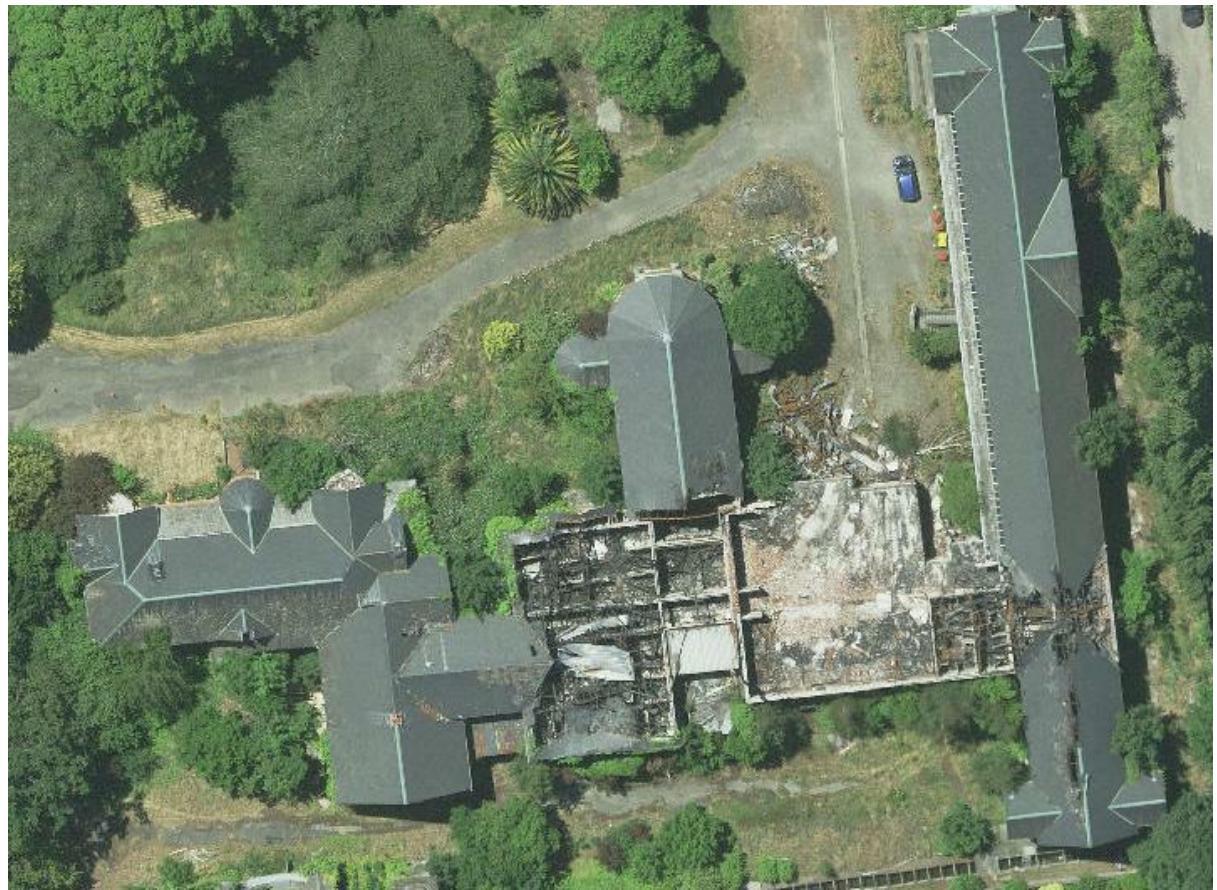
Figure 2- Aerial photo at 265 Riccarton Rd

Miyamoto understands that there was damage in an earlier fire back in 2019 which affected the

middle section with a wedding chapel and part of the east wing (see Figure 2).
