DETAILED ENGINEERING EVALUATION OF AN EARTHQUAKE AFFECTED BUILDING

VICTORIA JUBILEE CLOCK TOWER

CORNER MONTREAL AND VICTORIA STREETS CHRISTCHURCH

September 29th 2011

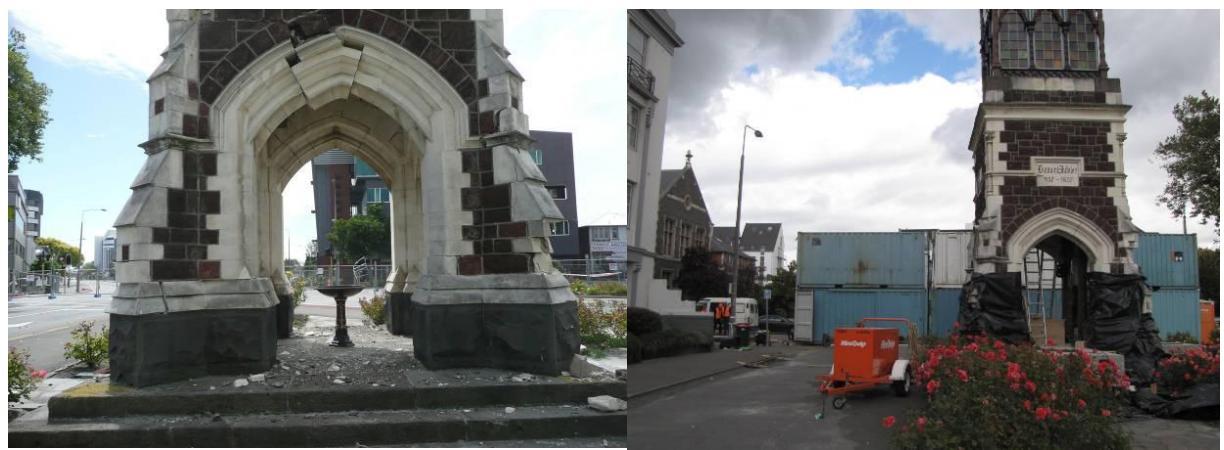
View of the south arch shortly after the February earthquake showing the dislodged arch keystone and damaged columns

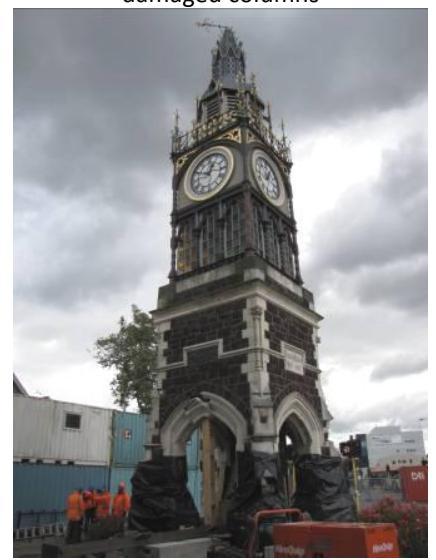
Elevation of the entire tower from the south, finial bent at top

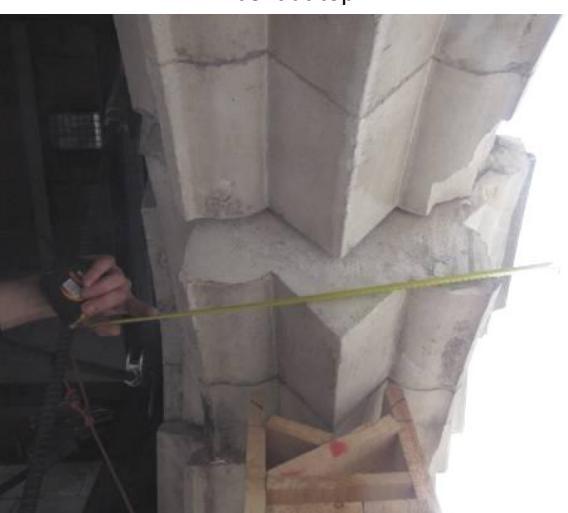
View of the dislocated southern arch keystone

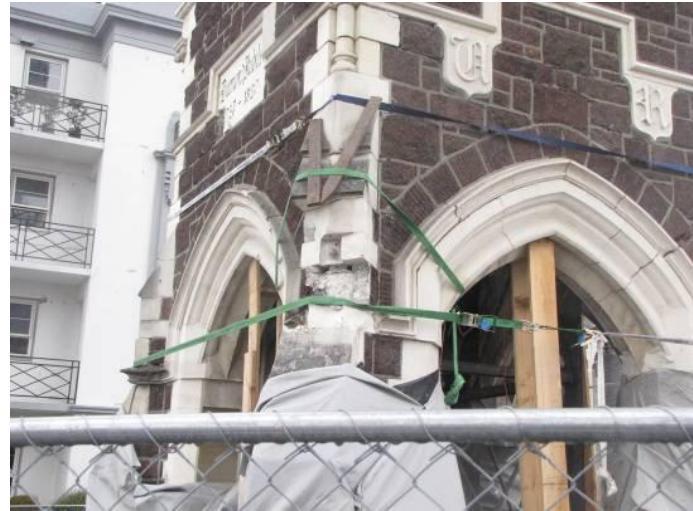
The failure mechanism observed was frame action of the buttress columns and arches at the tower base resulting in tension failure of the retrofitted stainless bars and gross movement of the stones in the buttress columns and arches.

View from the north after stabilisation showing damage to the columns including the failed internal stainless rods
