CHRISTCHURCH CITY COUNCIL BU 0822-014 EQ2 Linwood Resource Centre 322 Linwood Avenue, Linwood

QUANTITATIVE ASSESSMENT REPORT FINAL

- Rev C
- 01 July 2013

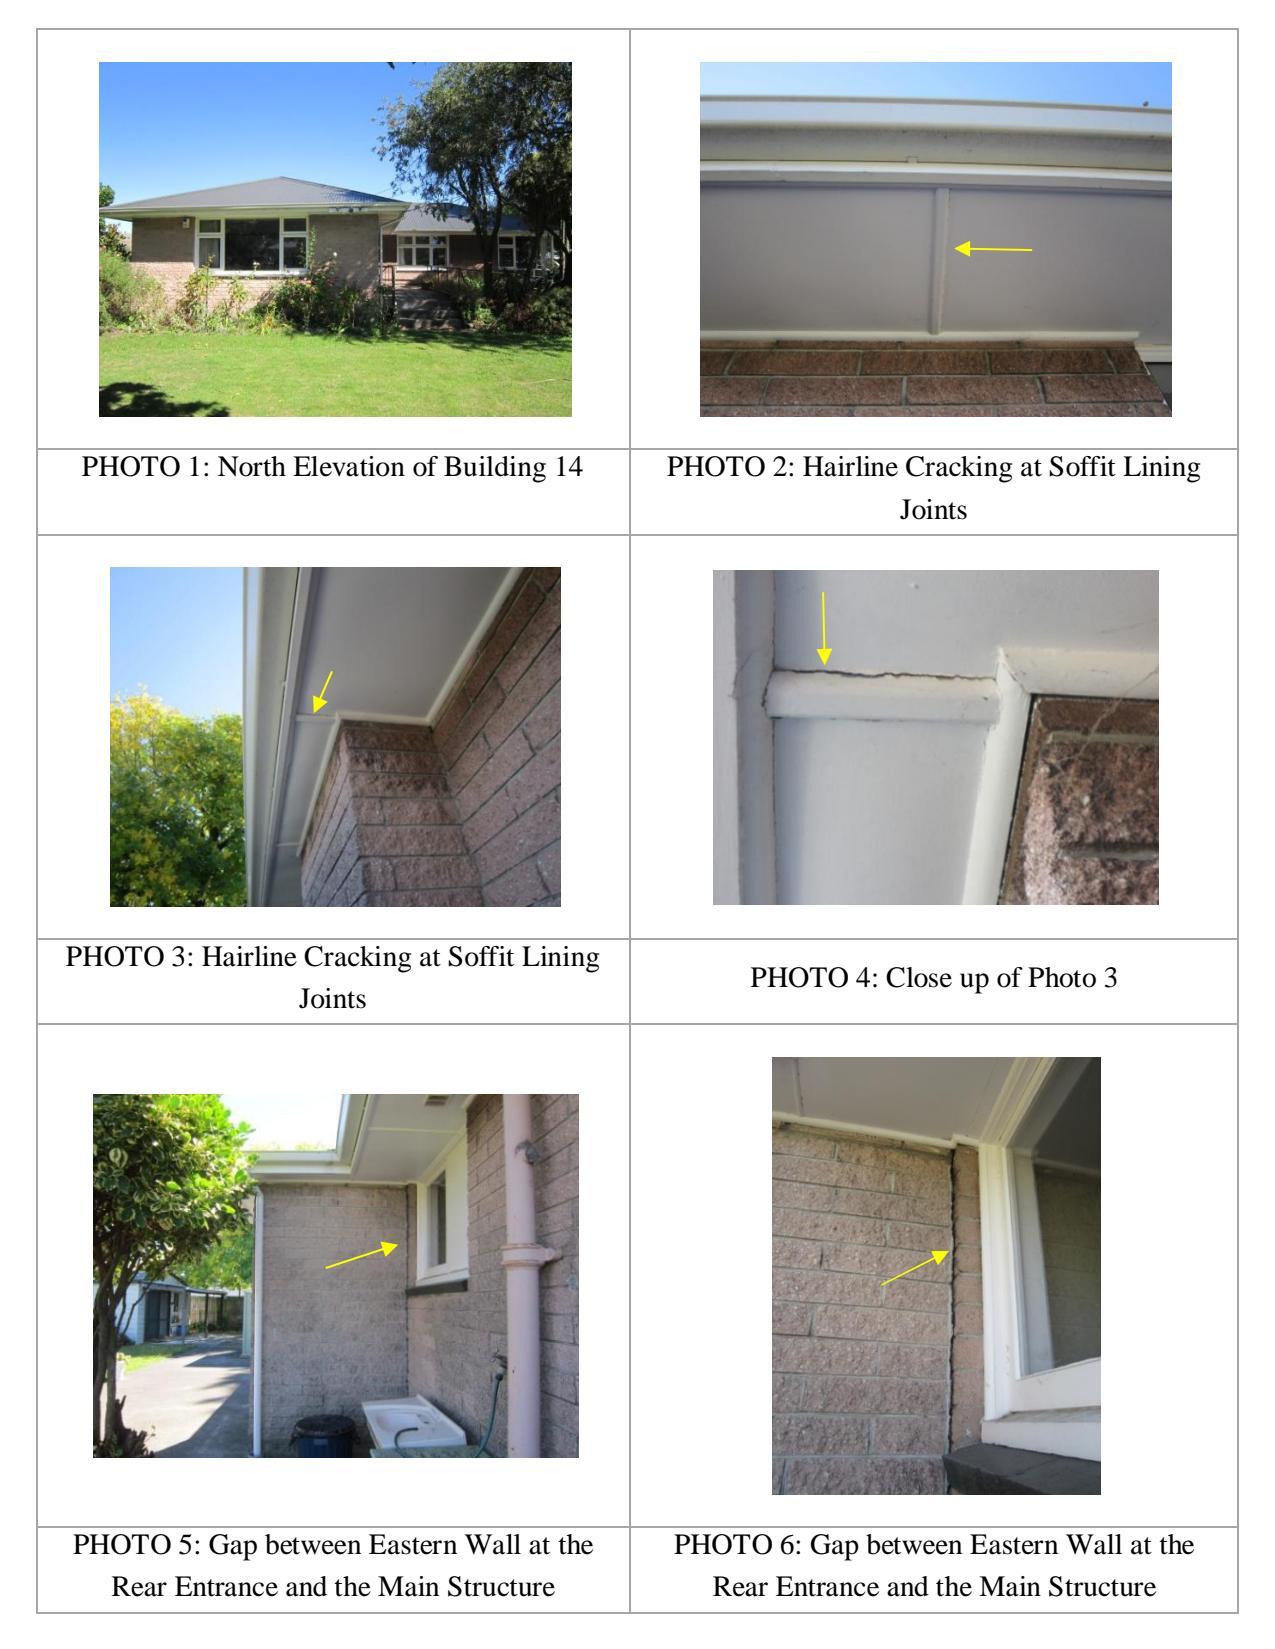
- 1) Hairline cracking present along the joints in the soffit linings (typical) (PHOTO 2, 3 & 4).
- 2) The eastern summerhill stone wall at the rear entrance has pulled away from the main structure (PHOTO 5 & 6).

- 1) Northern Meeting Room
 - Vertical hairline cracking present at the wall lining joints above the door and northern window (PHOTO 8, 9 & 10).
 - Hairline cracking present between the ceiling lining and wall lining joint in the SW corner.

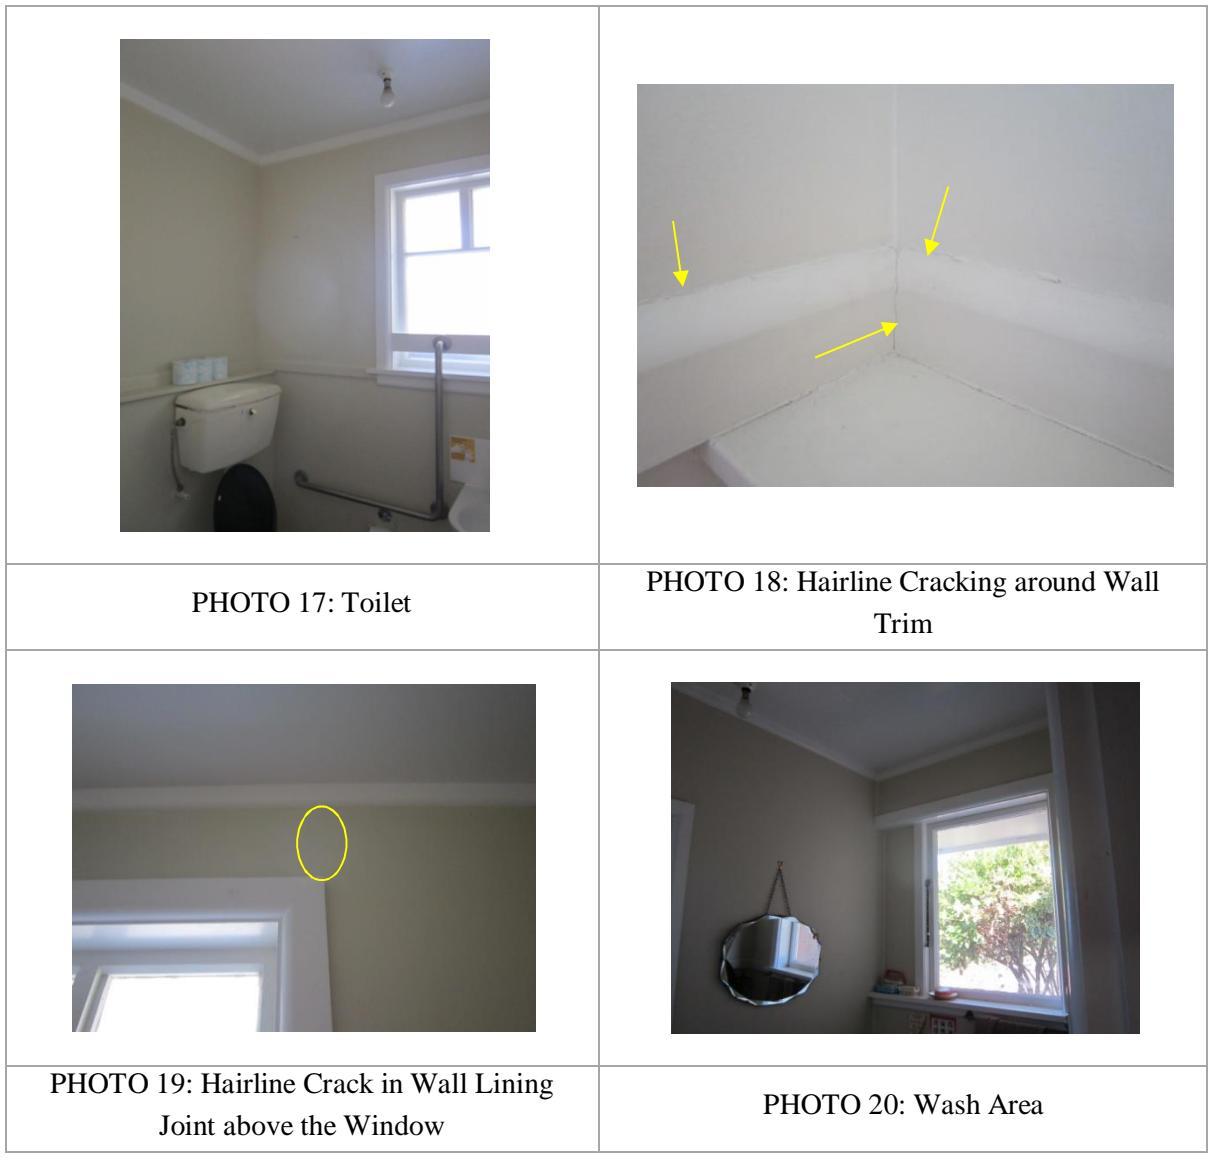
- 5) Toilet
 - Hairline cracking present between the wall lining and window architrave joint.
 - Hairline cracking present between the wall lining and wall timber trim located at mid height of the wall (PHOTO 18).

- Vertical hairline cracking present above the eastern window (PHOTO 19).
- 6) Wash Area
 - Vertical hairline cracking present at wall lining joint above the window (PHOTO 21).

- Hairline cracking present along the timber scotia and ceiling lining joint (PHOTO 21).

- Hairline cracking present along the timber wall trim and wall lining joint (PHOTO 22).
- 7) Kitchen
 - Hairline cracks present in the wall lining joints above the door (PHOTO 24).

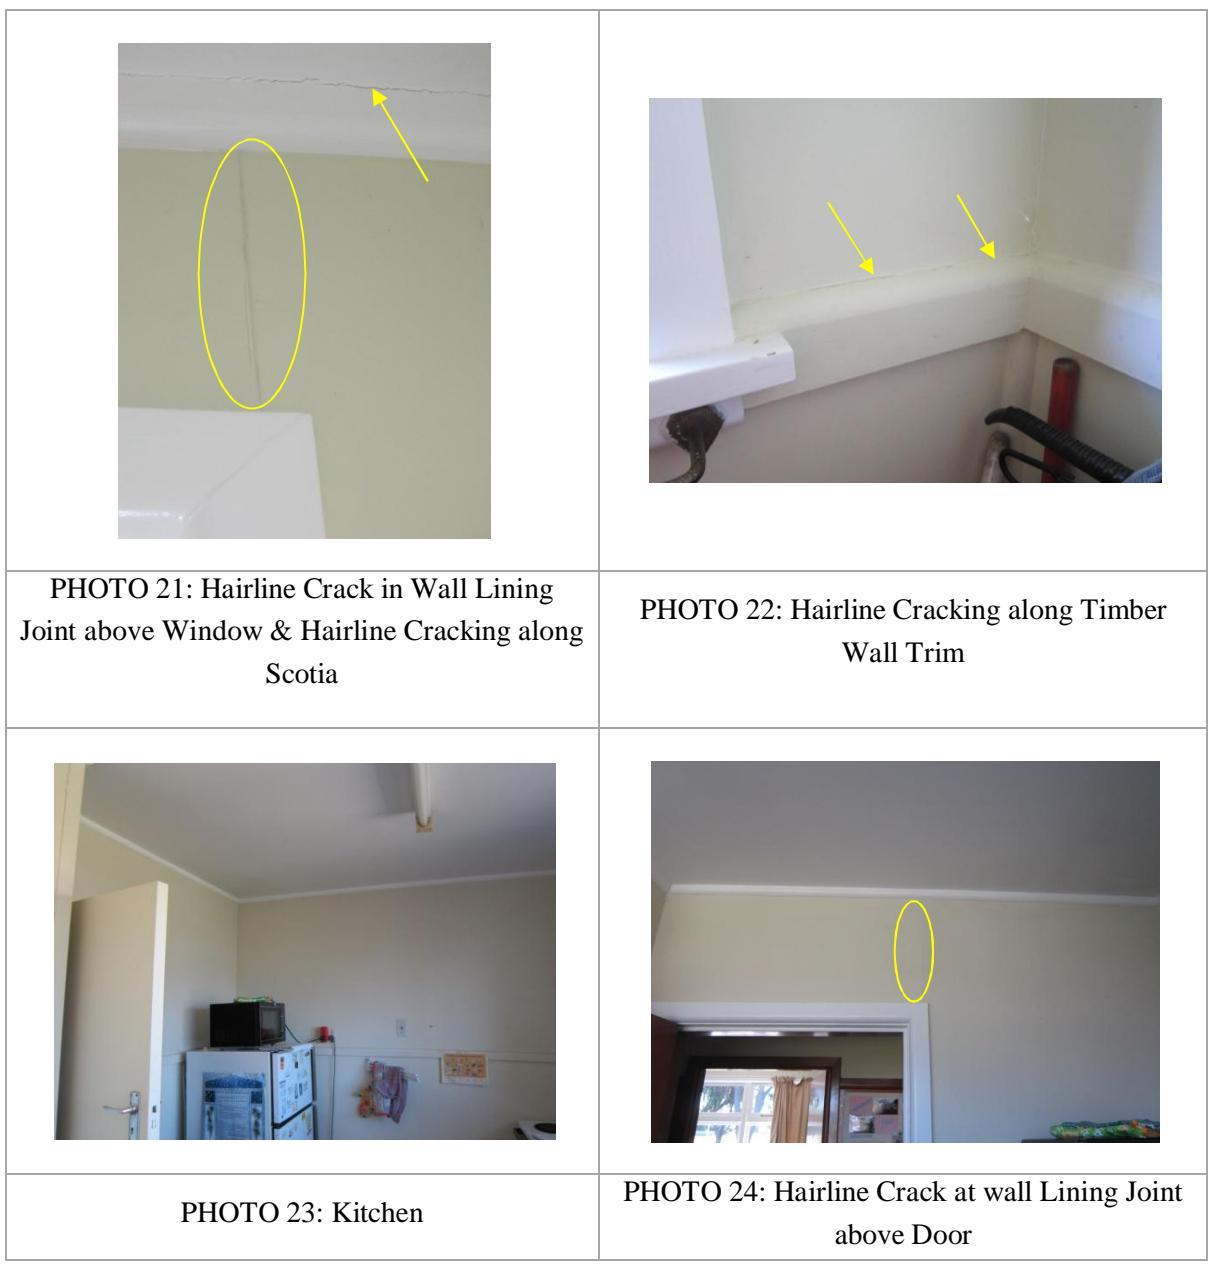
- Hairline cracking present along the scotia and ceiling lining joint (PHOTO 25).
 - Hairline cracking present along the timber wall trim and wall lining joint (PHOTO 26).

- Hairline cracking at timber wall trim joints (PHOTO 27).
- 8) South-West Lounge (2)
 - Hairline cracking present at ceiling lining joints (PHOTO 29).
- 9) North-West Office

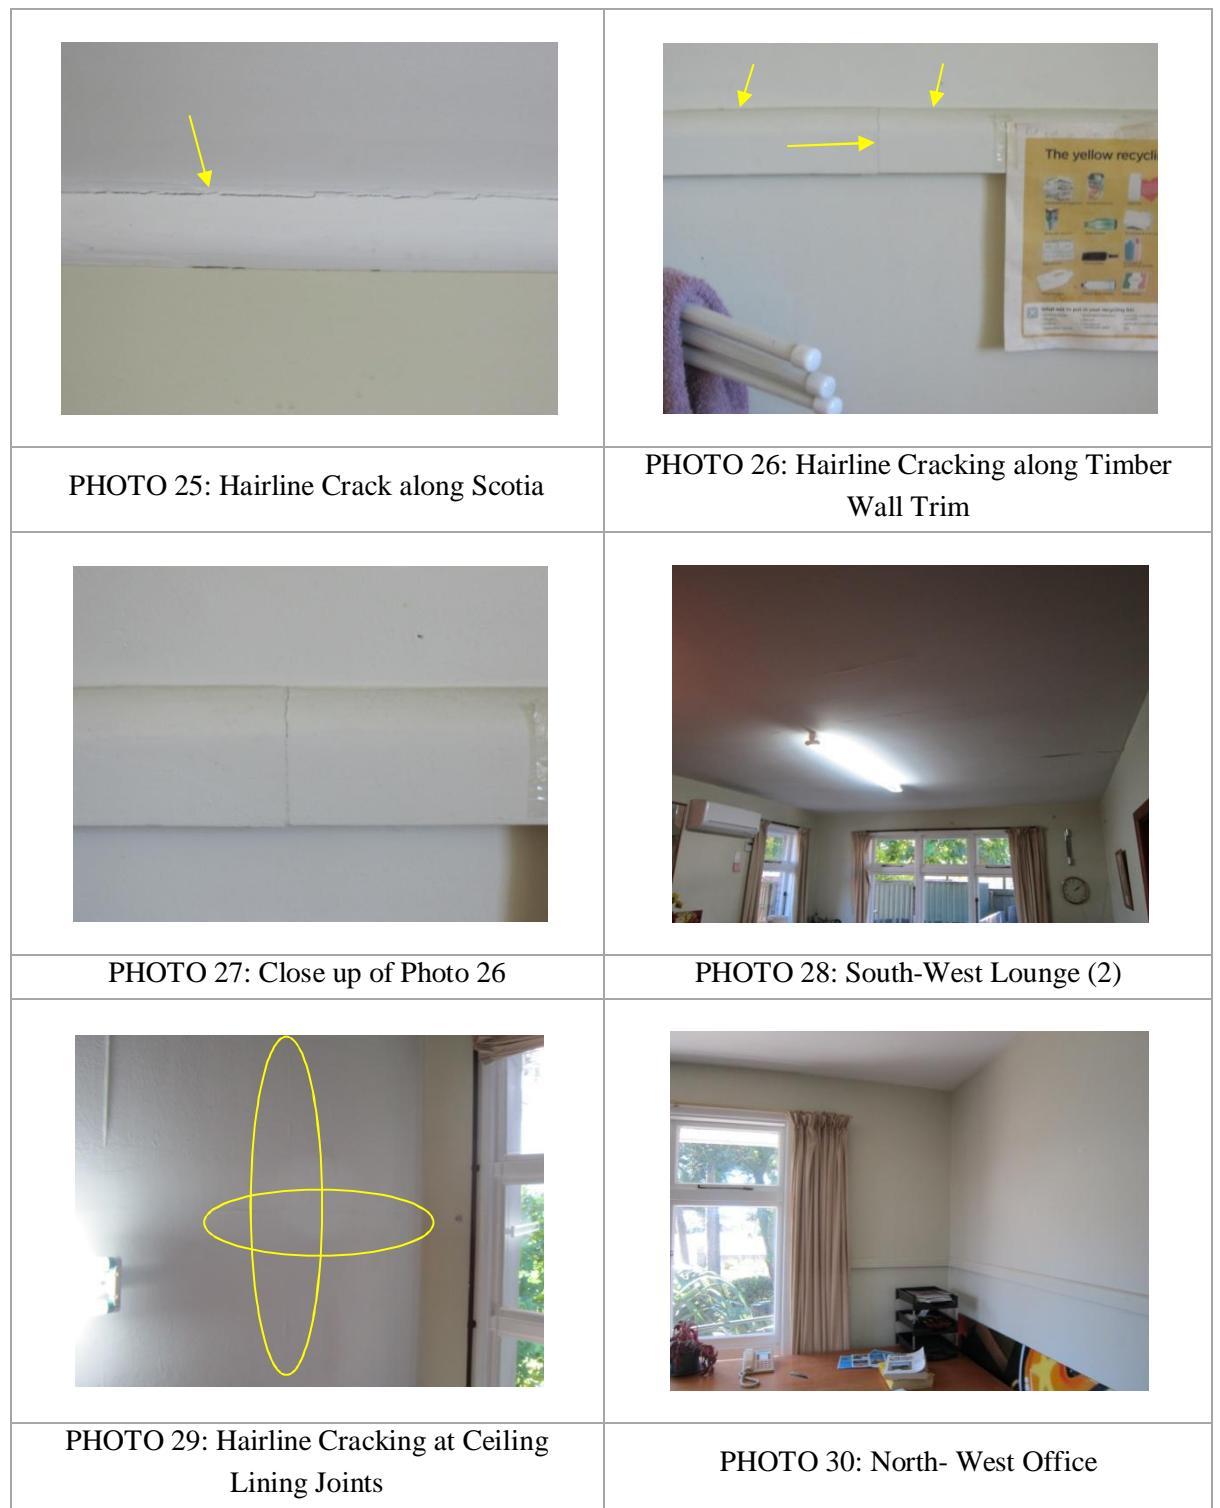
- Hairline cracking present along the timber wall trim and wall lining joint (PHOTO 31 &32).
 - Hairline cracking present along the wall lining joint in the NE corner (PHOTO 33).

- 10) North-West Office (3)
 - Hairline cracking present in wall lining joint above the window on the western side (PHOTO 35).
- 11) Front Entrance / Hallway

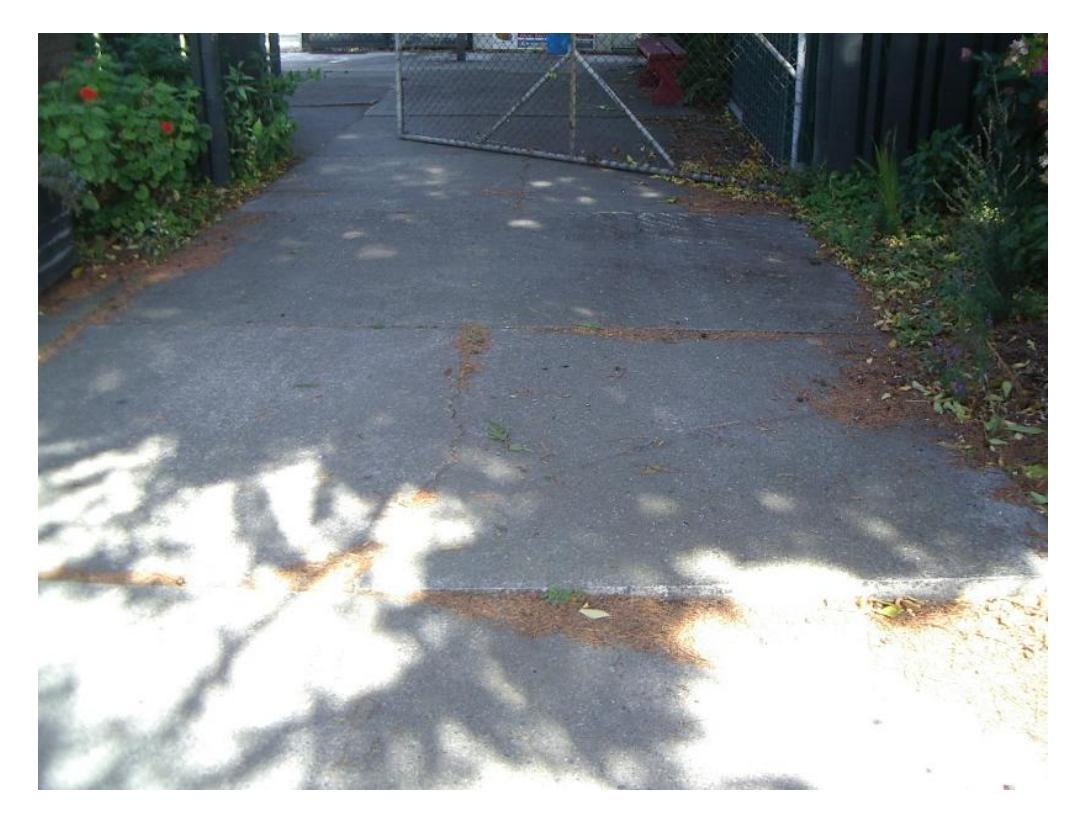
Residents report that the only damage occurred to the footpaths, with paving slabs being displaced, (Figure 8) and that no liquefaction occurred on the site.

Figure 8 Damaged paving slabs at Linwood Resource Centre
