DETAILED ENGINEERING EVALUATION – QUALITATIVE AND QUANTITATIVE REPORT

NEW BRIGHTON CLOCK TOWER

September 2012

NEW BRIGHTON CLOCK TOWER (213 Marine Parade, New Brighton)

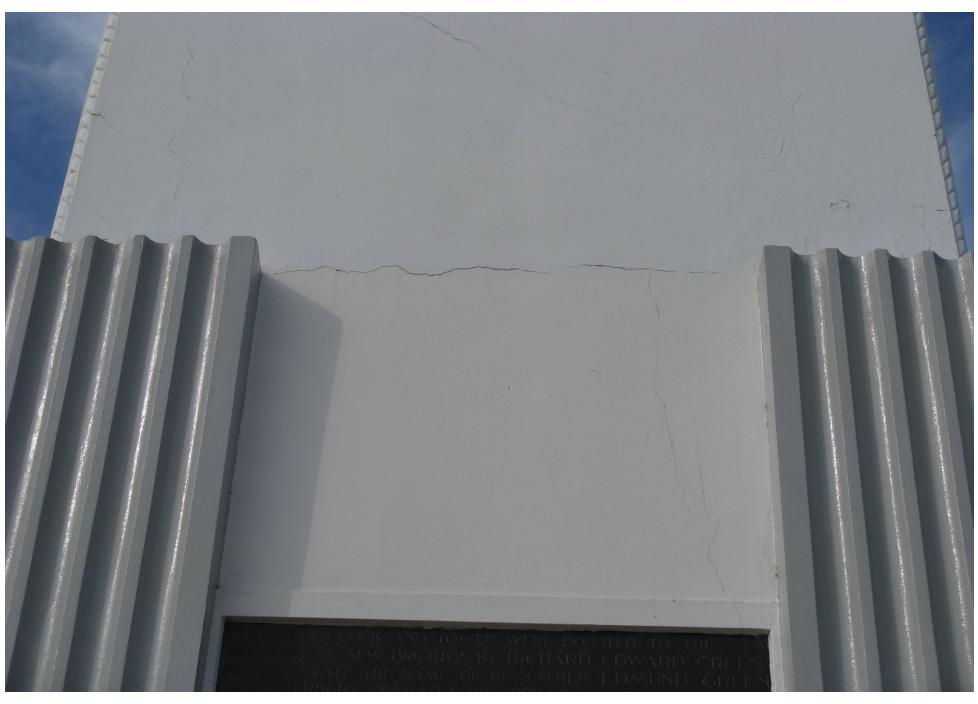
- The tower appears to be vertical.
- From ground level there appears to be a horizontal and vertical cracks (and some diagonal cracks) on the upper western face (Figure 7a). These cracks were noted in a two reports dated in February 1993 and October 2009 and so are therefore pre-earthquake (but may have worsened since). The horizontal crack corresponds to a poor quality of concrete in a construction joint (two stages of concrete pouring while construction). A closer inspection of the crack with did not show signal of propagation from East to West (note the crack was not visible on the internal face). The width of the crack was measured to be 0.4mm. note that from ground level the

crack appear wose (thicker) due to a build-up of dirt and mold behid the paint at the crack locations.

Figure 7a – Horizontal crack on the west face

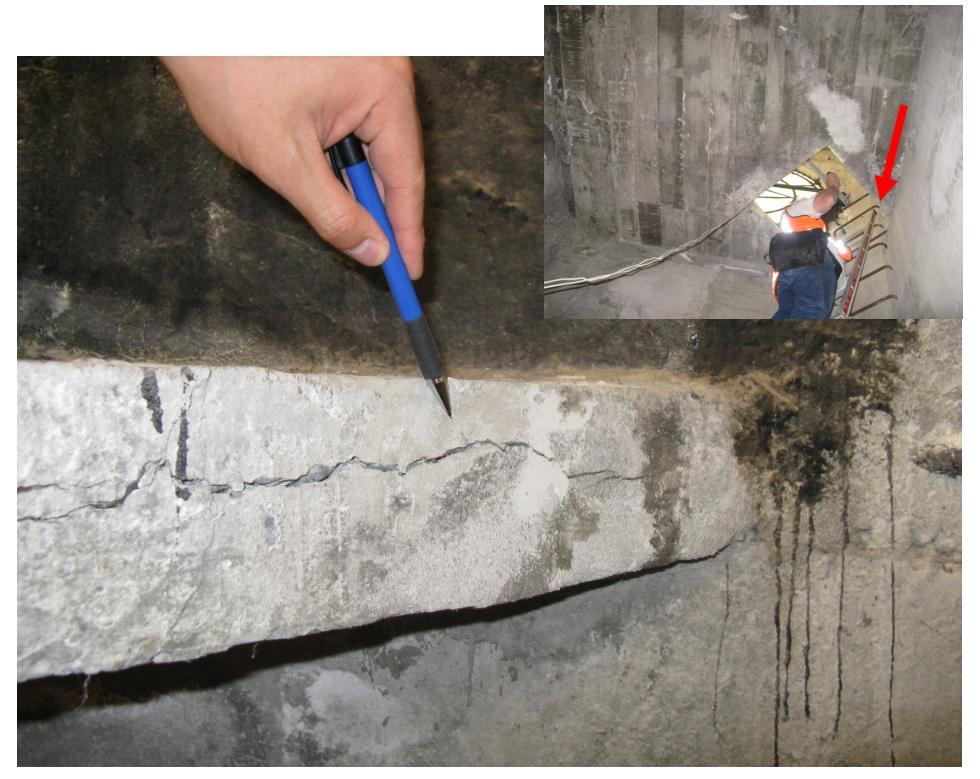
• A horizontal crack was observed in the side of the penetration through the level 2 floor slab (Figure 7b)

Figure 7b – Interior of the north and East faces showing the vertical cracks and moisture inside the clock tower

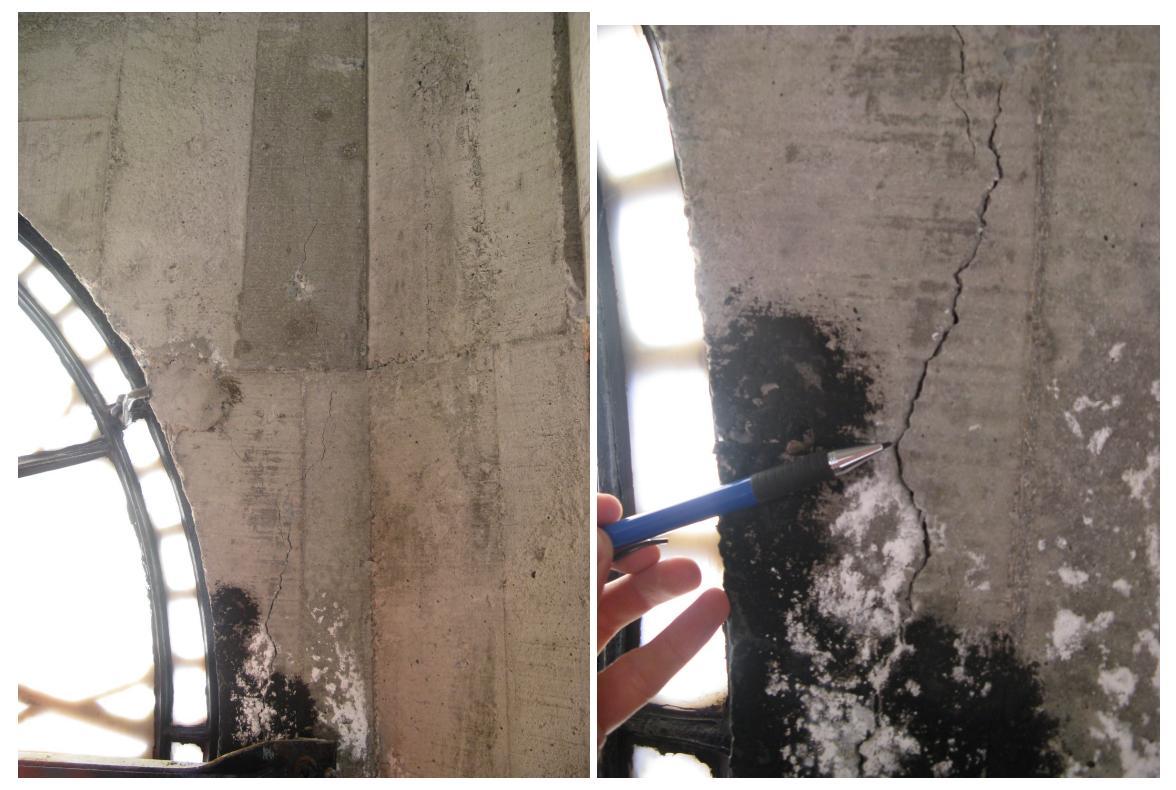
• Beside one of the clock faces there is a vertical crack (figure 7c).

Figure 7c – Vertical crack found on the side of one of the clock faces: location (left). Close up (right)

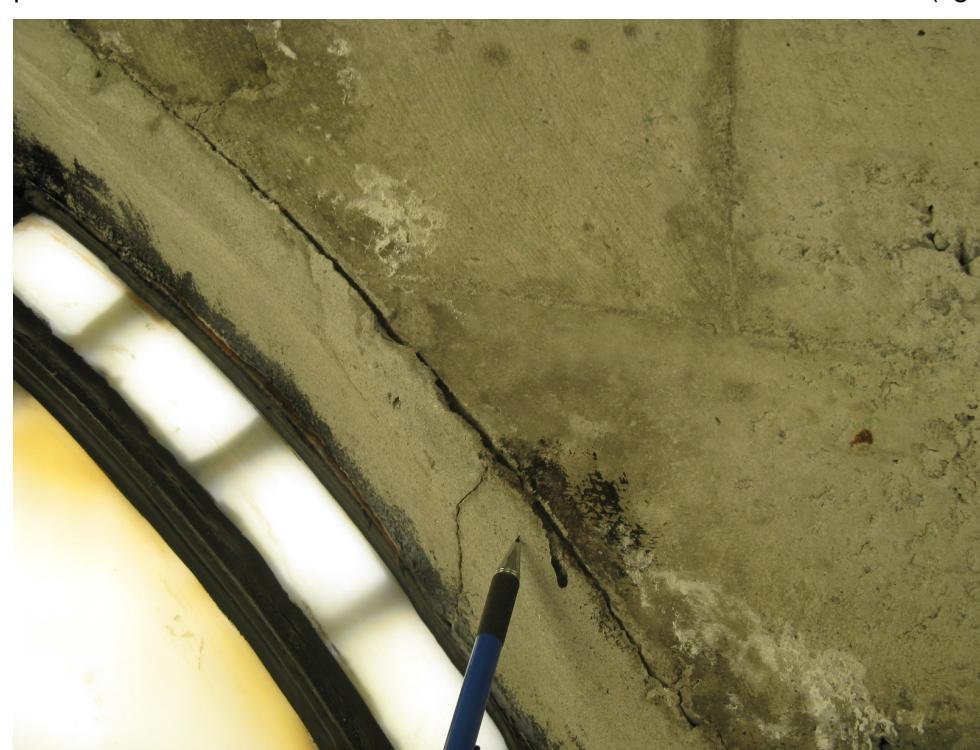
• Separation between the mortar and concrete on a few of the clock faces. (figure 7d)

Figure 7d Separation between mortar and concrete

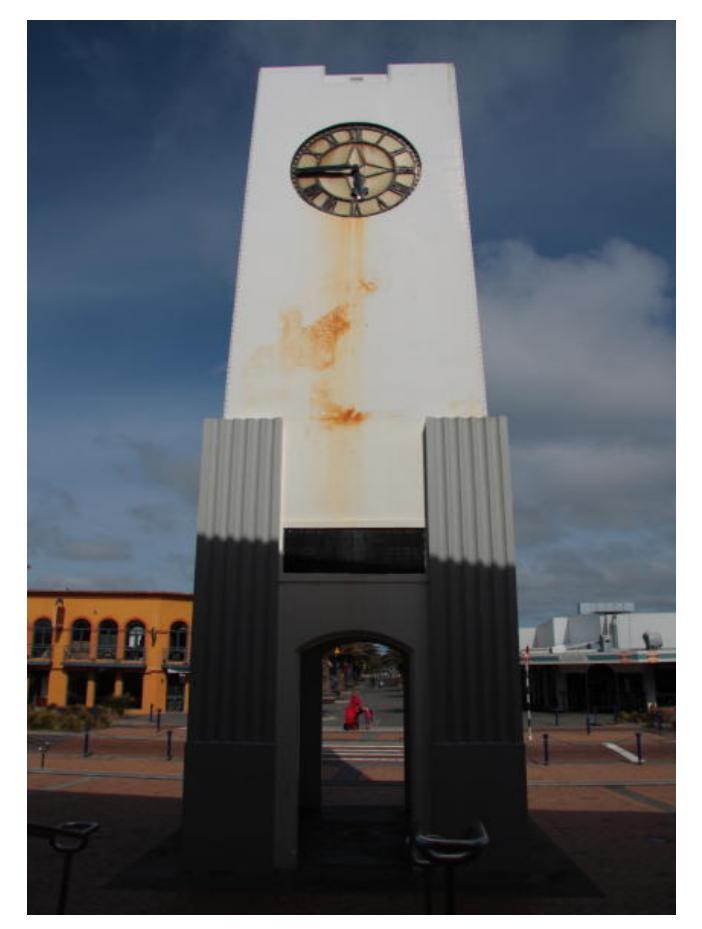
• Corrosion coming from the clock framing in the East face (Figure 7e)

Figure 7e Rusting stain on East face

- The structure requires maintenance to reduce the corrosion of the bars and spalling of the concrete in some parts of the structure.
- To upgrade the structure to a higher level of the new building standard, strengthening of the foundations by using screw piles or additional concrete foundations in combination of strengthening the walls using FRP or similar products would be an option. This will require geotechnical investigations and model complex computer analysis of the structure.
- Repair the cracks by using a suitable crack injection such a SIKA InjectoKit TH. Interior cracks should also be addressed with the crack injection method. A full survey and methodology should be undertaken to address the concrete crack repair method required.
