Our Ref: 1584

30 June 2011

Re: Opawa Library – POST-EARTHQUAKE INSPECTION

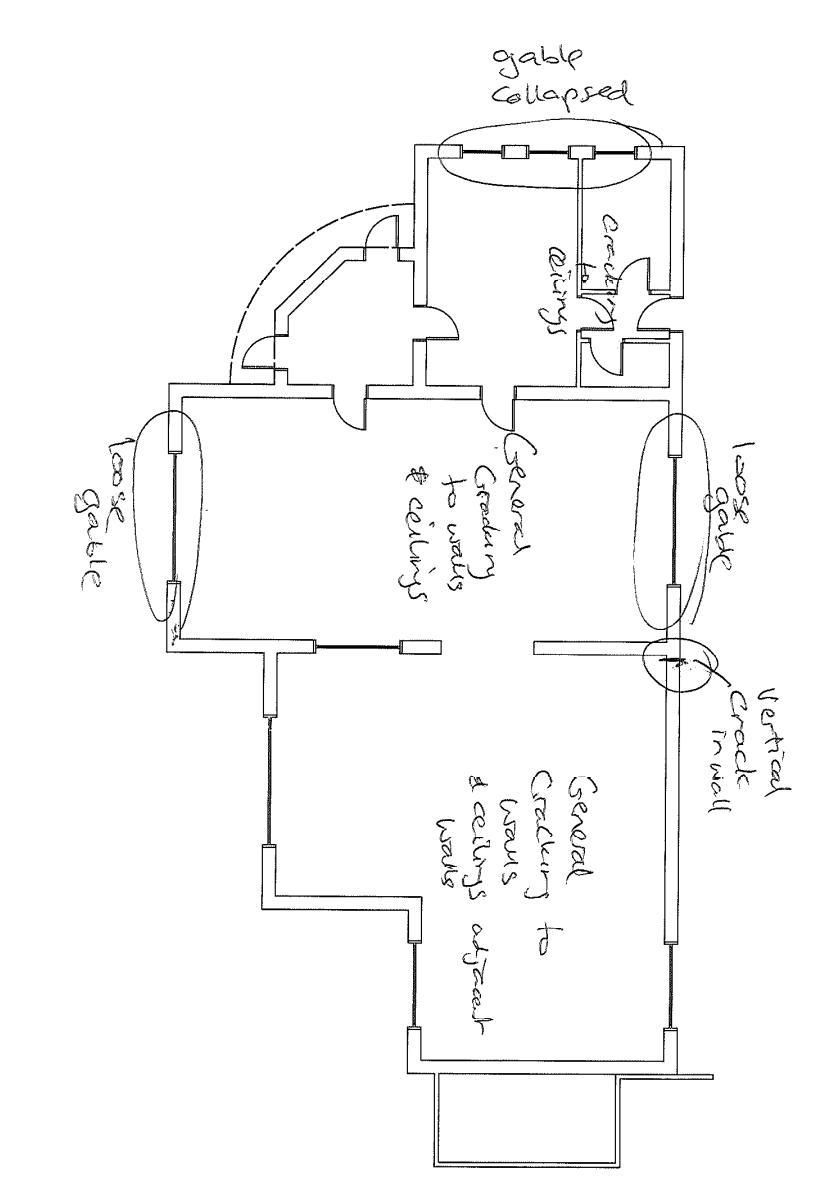
APPENDIX B. MARKED-UP DRAWING INDICATING DAMAGED LOCATIONS

Damage caused by the February earthquake to the Opawa Library is described below. Damage described is additional to earlier earthquake damage. Refer to Appendix B for marked-up drawings indicating damaged locations.

The Front Gable has collapsed. The remaining two side gables on the original building are cracked at their support and leaning.

iii. Damage to Join between Original and Extension: A large vertical crack has opened up between the original construction and extension.
