Appendix 1

Implementation Examples

Following are some examples of conservation issues at Addington Cemetery. They include typical examples of common grave types, with recommended conservation interventions.

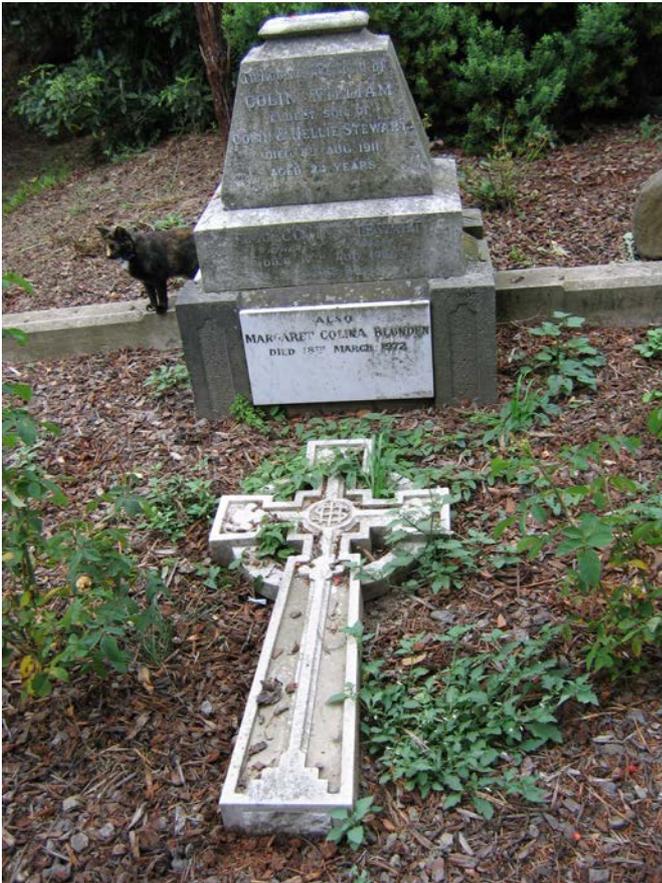
Photograph 1
Broken Headstone

Example – top part of headstone broken off

Issue – the stone surface lying against the earth can accelerate deterioration of the stone

Recommendation – insert pins and reinstate to upright position on base

Priority - Necessary

Who to Undertake – Stonemason

- Rejoining should only be carried out by suitably qualified professionals.
- Broken headstone pieces may be rejoined using bronze or other non-ferrous dowels and appropriate adhesives such as acrylic or epoxy resins.
- Do not use Portland cement or Plaster of Paris.
- Do not use iron as it is potentially corrosive.
- Wash from lime mortar causes problems especially with sandstone or polished black granite.

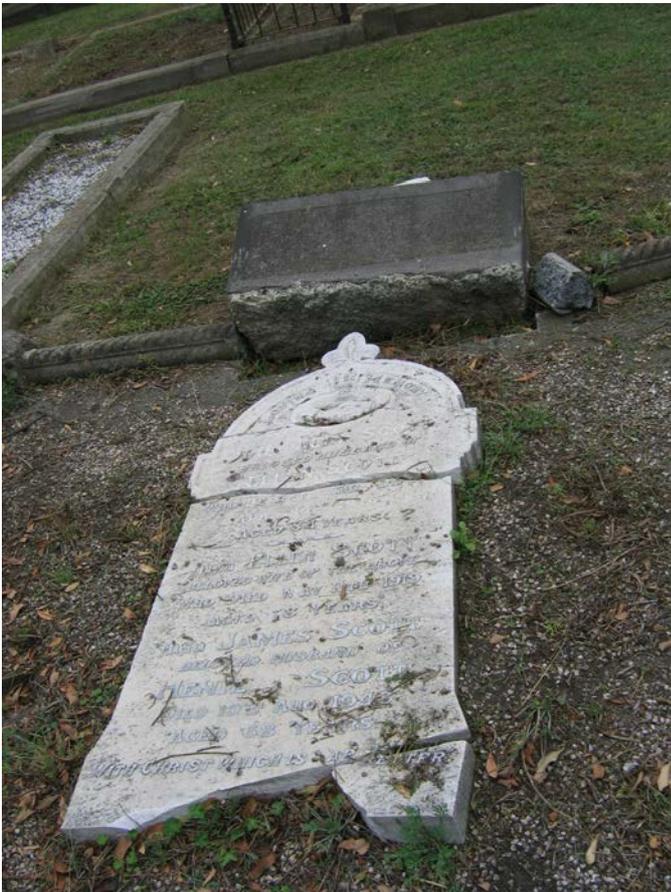
Photograph 2
Broken Headstone

Example – headstone broken off and shattered in a number of places

Issue – the stone surfaces lying against the earth can accelerate deterioration of the stone, and the broken pieces could become separated and disassociated from the grave

Recommendation – Seek advice to have the broken pieces glued back together. If possible and practical, the headstone can also be pinned and returned to an upright position as with the recommendations with Photograph 1 above

Priority – Necessary

Who to Undertake - Stonemason

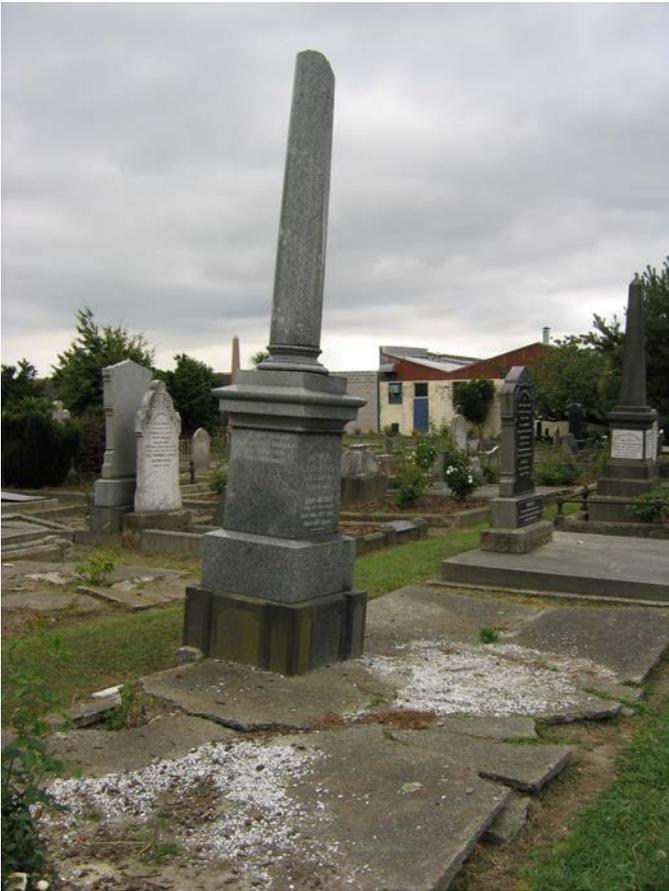
Photograph 3
Unstable Memorial

Example – unstable leaning monument (and broken and uneven concrete grave)

Issue – monument likely to topple and break, possibly damaging other graves or people in the process

Recommendation – Stabilise and reconstruct concrete slab, with sufficient reinforcing to secure the monument

Priority – Urgent to Necessary

Who to Undertake – Depending on the structure: Architectural Conservator, Engineer, Stonemason

Additional comments: A slight lean in a headstone is not in itself an issue and can add to the character of the historic cemetery. The issue is when it may collapse. There are a number of headstones/memorials at Addington Cemetery that are on a slight lean now and currently no intervention is required. They should be monitored however, and stabilised if the leans threaten their stability.

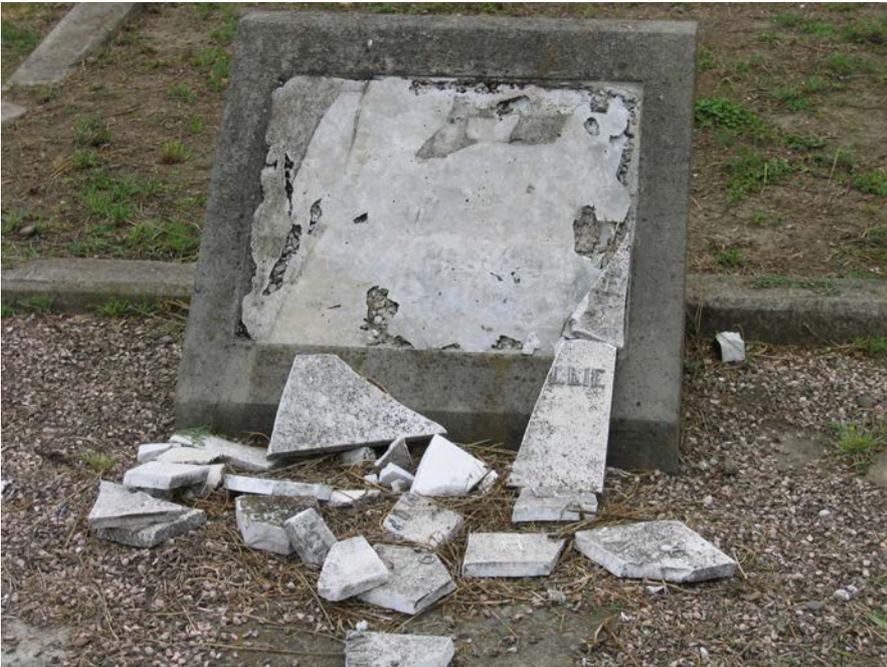
Photograph 4
Multiple Breaks

Example – Multiple breaks in relatively thin slabs

Issue – In many cases this is due to vandalism, and there is the risk that the broken pieces are removed and become disassociated from the grave.

Recommendation – glue pieces together and reinstate if possible. If not possible to reinstate, seek advice on resetting in a new concrete slab/desk.

Priority – Urgent/Necessary

Who to Undertake – Conservator/Stonemason

Additional Comments: Fragments of headstone could be set in concrete or some other way to present the fragments being removed. However, it is critical to ensure that if the fragments are set in concrete, they definitely belong to that burial/grave site.

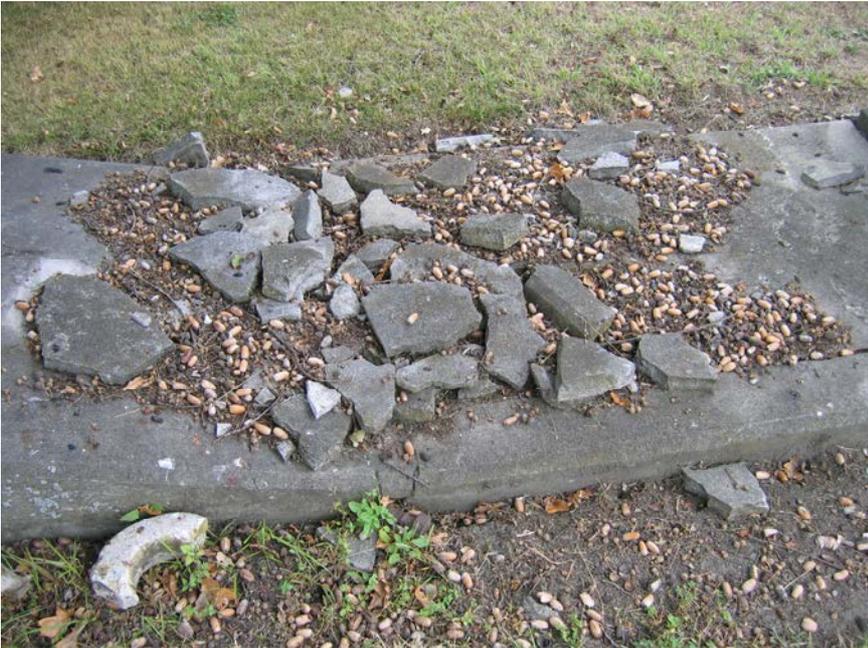
Photograph 5 Collapse

Example - concrete slab/vault distortion or collapse, generally due to compaction of grave fill (sometimes due to vandalism)

Issue - potentially unstable (and can make the headstones/monuments unstable), and it can appear unsightly

Recommendation -One option is to cover the cracked concrete area with gravel. This is an affordable, minimum labour option which has been endorsed by the Historic Cemeteries Conservation Trust of New Zealand. It has the advantage of retaining the original concrete below the gravel. In some cases, under professional guidance, it may be best to record then remove the broken stone, correct ground level and reset concrete

Priority - Immediate/Urgent where the stability of other elements of the grave (and safety of people) is being compromised. Generally the priority ranges from Necessary to Desirable.

Who to Undertake - Stonemason/conservator for correcting ground level and replacing concrete, but for infilling with gravel, Council staff may undertake.

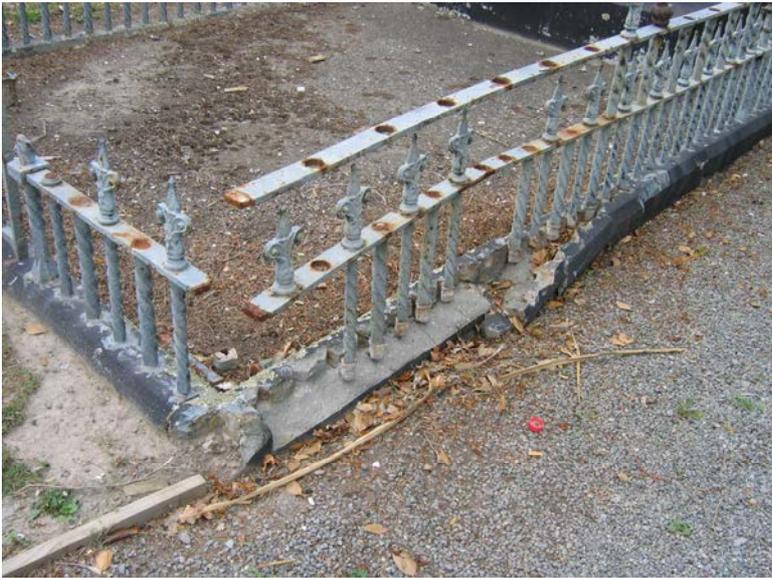
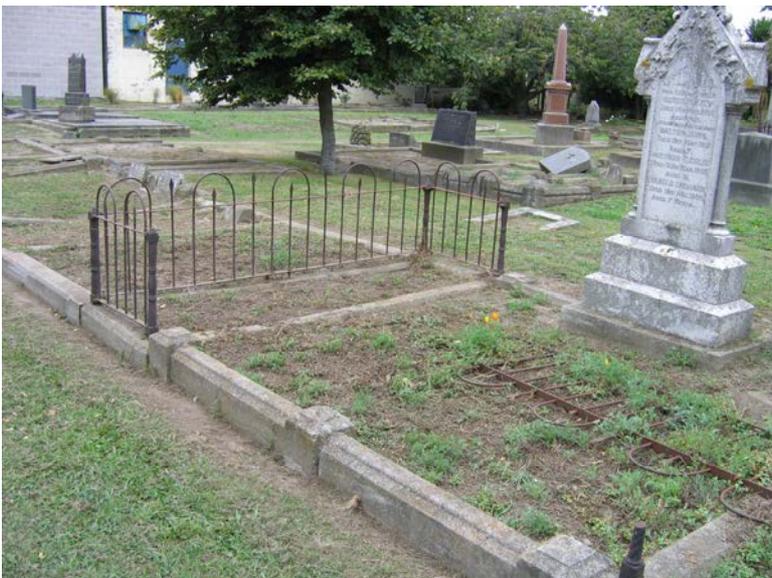
Photographs 6 Railings

Example – bent wrought iron railing with some parts missing, rusting, broken

Issue – looks untidy, iron corroding, parts could become disassociated with the grave

Recommendation – For rusting iron, thoroughly hand clean to get loose rust off, then apply fisholene or if going to paint afterwards, apply anti-rusting guard and then paint with oil based paint. For broken, bent iron, parts of the concrete plinth of the rails could be reconstructed and rejoined. Where parts of the railing have been removed, they could be reinstated where original location is known.

Priority – Necessary to Desirable

Who to Undertake – Historic iron specialist

Additional Comments: Only paint where there is an indication of the original paint colour (often it was black). For the most part, rust on wrought and cast iron is not causing major problems at Addington Cemetery. The area where the iron joins the concrete plinth or the earth is where most corrosion is occurring and this is the main reason to apply fisholene or paint.

Note: Cast and wrought iron should be riveted, not welded.

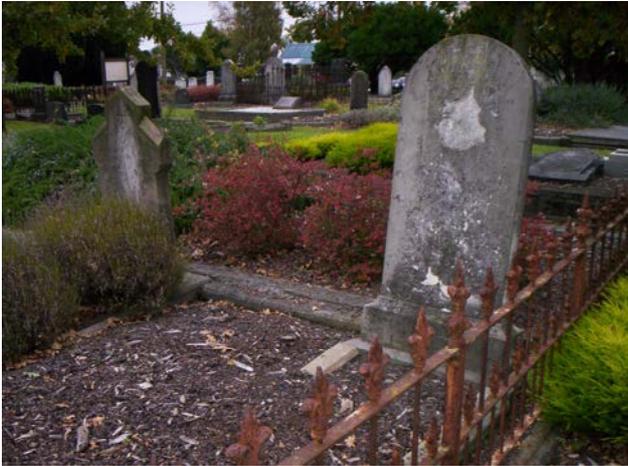
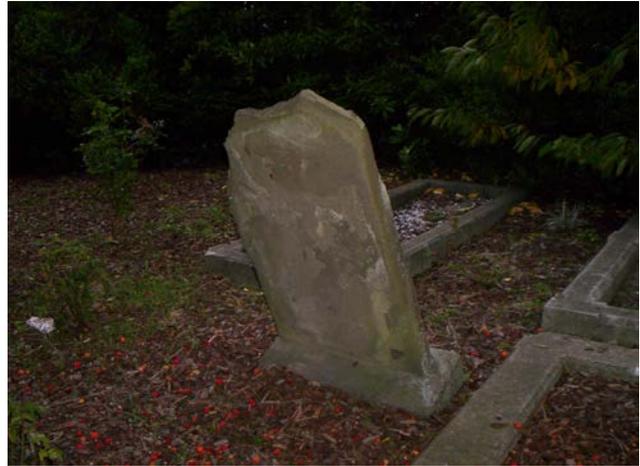
Photographs 7

Example – Delamination of stone

Issue – Parts of original stone is falling away and historic inscriptions are disappearing

Recommendation – Have assessed on a case by case basis. A possible solution is to clean off all moss/lichen/dirt, record the information inscribed, then apply a poultice over the entire stone to rid it of salts, then micro grout it solidify the loose bits. For some stone, such as the slate one in the above photo on the right, the delamination is exacerbated by frosts. One solution could be to put a breathable cover (such as straw) over the stone during heavy winter frosts.

Priority – Desirable, dependent on further information. For the most part addressing delamination is difficult.

Who to Undertake – Stone Conservator

Additional Comments: Delamination is where a hard outer crust forms on the stone and causes it to come away and fall off. In many cases, there is very little that can be done to address it. While a poultice may be a solution to get rid of the salts causing the hard outer crust, it would need to be done every 5-10 years since salts will continue to enter the stone through the ground. Micro grouting is a technique developed by the International Centre for the Study of the Preservation and Restoration of Cultural Property (ICCROM) for reattaching or consolidating heritage fabric such as fresco and stonework. Micro grouting involves drilling tiny holes in the stonework, flushing the holes with alcohol to clean them and then very gently injecting lime fly ash grout.

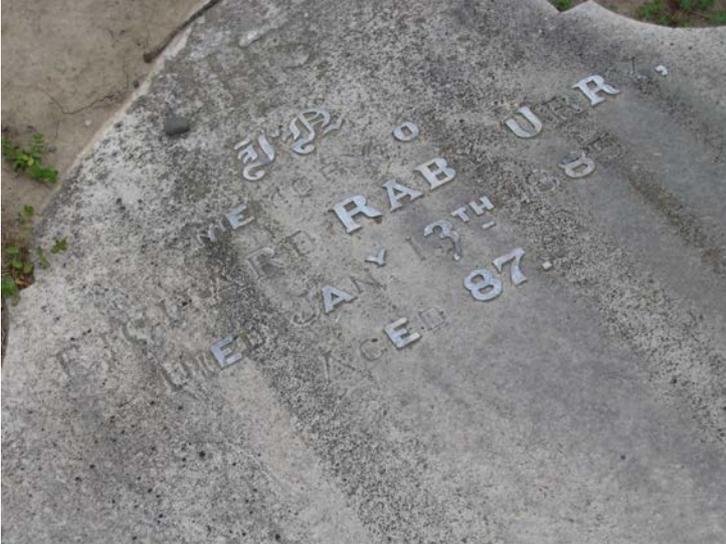
Photograph 8
Lead Lettering

Example - Lead lettering falling off

Issue – Heritage fabric is broken or lost and inscriptions become hard or impossible to read

Recommendation – Lettering can be re-leaded, although this may require extensive work. An alternative would be to record as much of the inscription as possible and photograph with the sun slanting across the face of the stone.

Priority – Medium

Who to Undertake – Re-leading only to be carried out by experienced professionals. Systematic recording can be carried out by Council staff or volunteers.

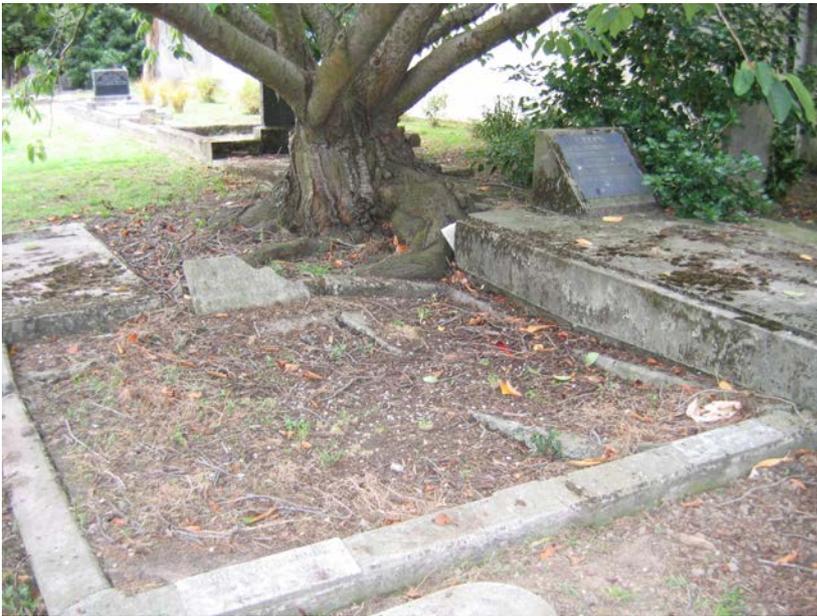
Photograph 9
Tree Roots

Example – tree growth adjacent to graves

Issue – roots are damaging graves and shade encouraging moss growth

Recommendation – Seek advice from arboriculturalist. Where the tree does not have historic value, carefully remove at just above the ground level, taking care to protect graves. This may involve removing limbs and then poisoning the stump and roots. Stabilisation or repair of the grave can then be carried out.

Priority – Urgent to Necessary, on a case by case basis

Who to Undertake – Council staff under the guidance of arboriculturalist.

Additional Comments: Trees that have high heritage value for the cemetery need to be treated differently. Some yew trees are likely to be well over 100 years old and are themselves part of the grave/memorial. Under the guidance of an arboriculturalist, identified limbs of trees could be removed or pruned to lessen the impact on the graves. In some cases, it may be necessary to remove historic trees, but this should only be done weighing up all the considerations. It may be possible to take cuttings of some trees to replant where their lineage is important. (See also Photograph 10 example).

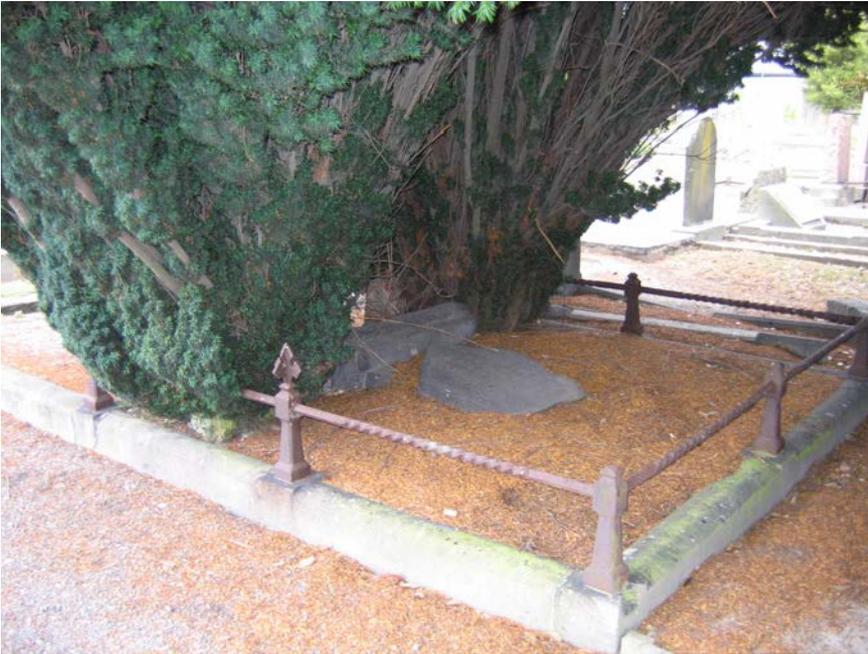
Photograph 10
Historic Trees within/adjacent to Grave Sites

Example – historic trees within grave sites

Issue – the trees themselves are part of the memorial and have heritage value, but as they grow, the trees over time are damaging other historic features such as railings, headstones, vaults.

Recommendation – seek the advice of an arboriculturalist. One solution may be to take out the inner limbs of the trees but retain the height and form of the tree. Consider taking cuttings of historic trees should replacement be deemed necessary in the future.

Priority - Necessary

Who to Undertake – Seek advice from arboriculturalist.

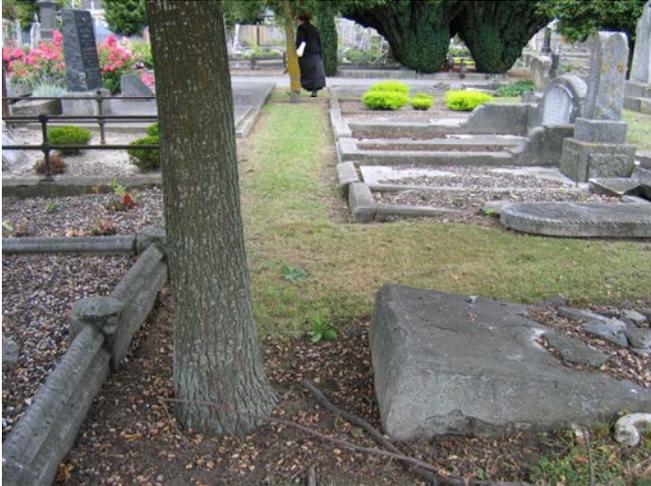
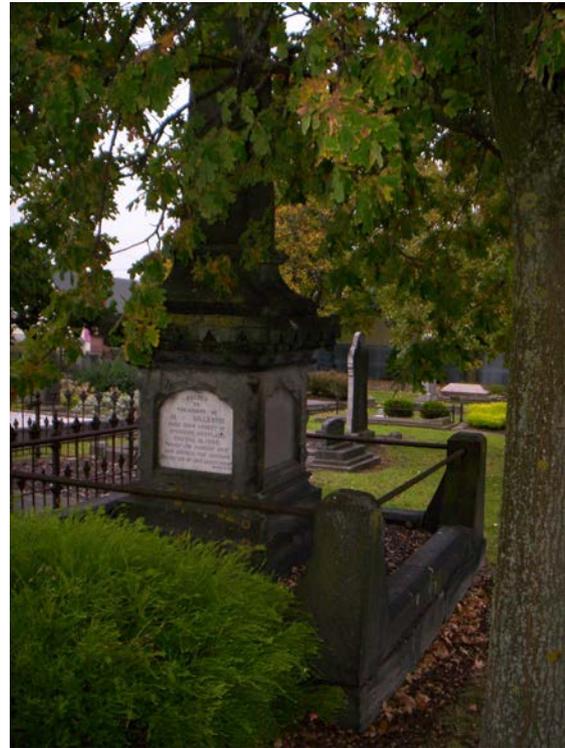
Photographs 11
New Oaks

Example – oaks planted in line in pathways between graves

Issue – while these trees are pleasant to look at presently, if left, they will grow to a substantial size and their roots will impact on the adjacent graves. In addition, the trees drop acorns (and will continue to do so), which may result in wilding oak seedlings. Finally, the shade created by the oaks is causing damp (and associated moss) on some headstones.

Recommendation – remove the line of young oaks, taking care not to damage the graves in the process.

Priority – Urgent/Necessary

Who to Undertake – arboriculturalist

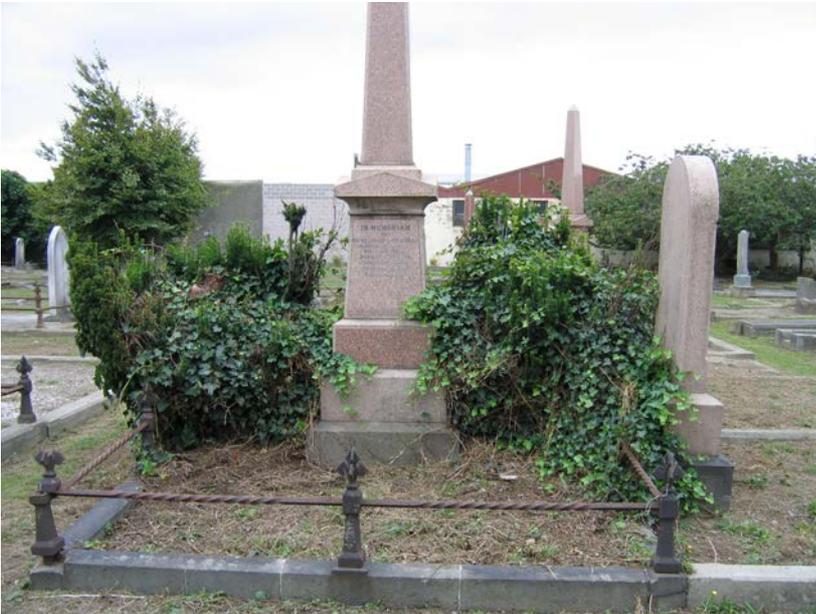
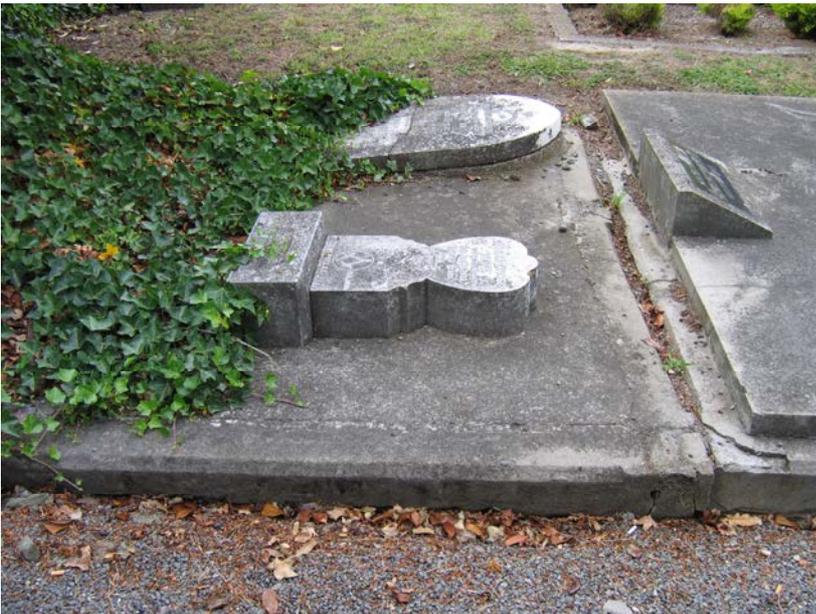
Photographs 12
New Plantings

Example – invasive plantings/weeds (eg ivy in photographs above)

Issue – damages stone, ironwork, obscures inscriptions, invasive

Recommendation – eradicate (eg by cutting at stem and leaving to die)

Priority – Necessary

Who to Undertake – Council staff

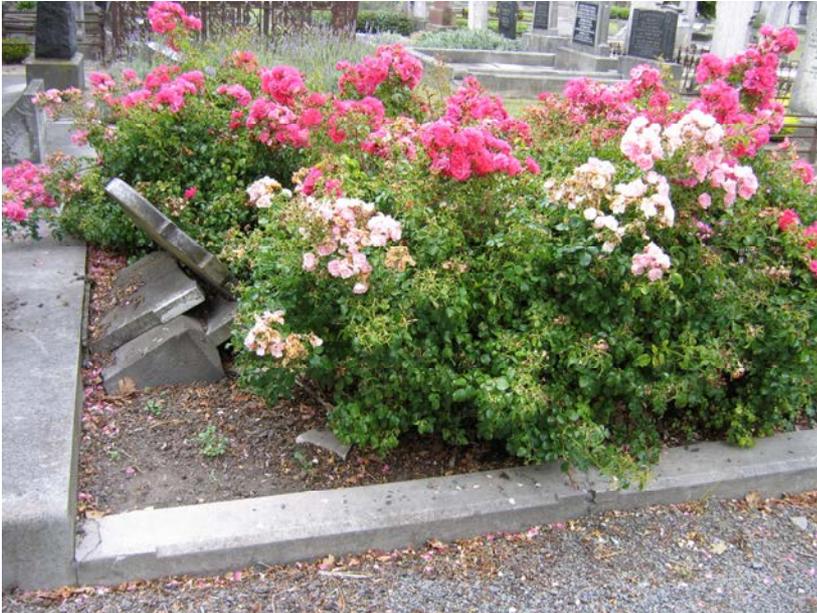
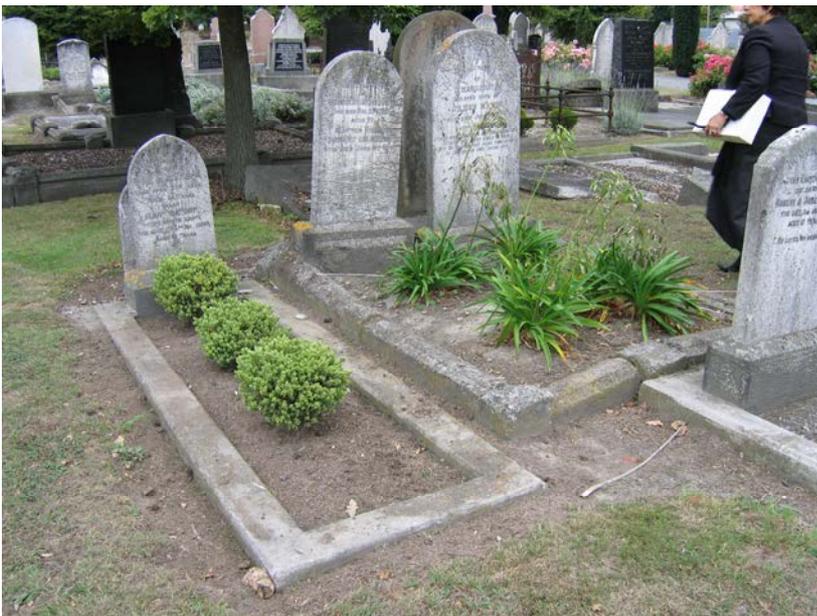
Photographs 13
Plantings on Graves

Example – Recent plantings on graves

Issue – If not carefully maintained, will obscure headstones and potentially damage stone and ironwork over time.

Recommendation – Carefully maintain recent plantings. For example, the roses should be trimmed hard with hedge cutter (post-flowering) and agapanthus, hebes etc should be pruned and thinned regularly.

Priority – Necessary

Who to Undertake – Council staff

Additional Comments: Avoid new plantings on graves.

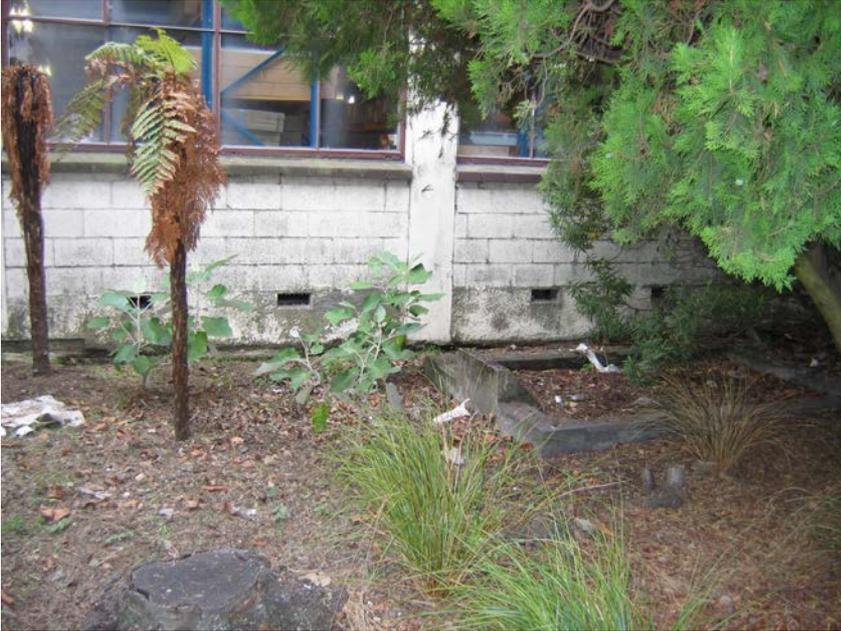
Photograph 14
Recent Plantings on Burial Sites

Example – Recent tree plantings in areas of known and likely burials

Issue – While recent plantings, such as in the photograph above, are not necessarily a fault or issue, they have the potential to become so if they damage graves.

Recommendation – Avoid the use of woody trunked species, such as the native Rangiora shown in the photograph above (whereas the tussocks and ponga are smaller and less likely to cause damage). Consider relocating the recently planted species such as Rangiora to the proposed walkway area to the east of the cemetery. If ground penetrating radar shows no burials near the area of the foundations of the Sexton’s shed, this may be another suitable alternative for the young native trees.

Priority – Necessary/Desirable

Who to Undertake – Council staff/Addington Bush Society

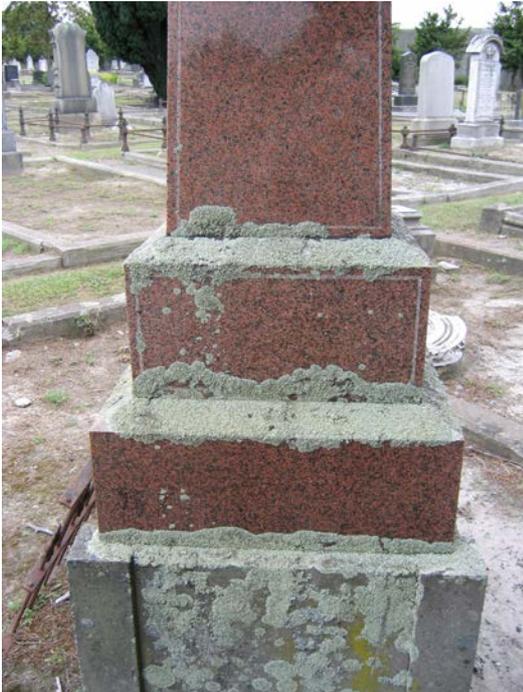
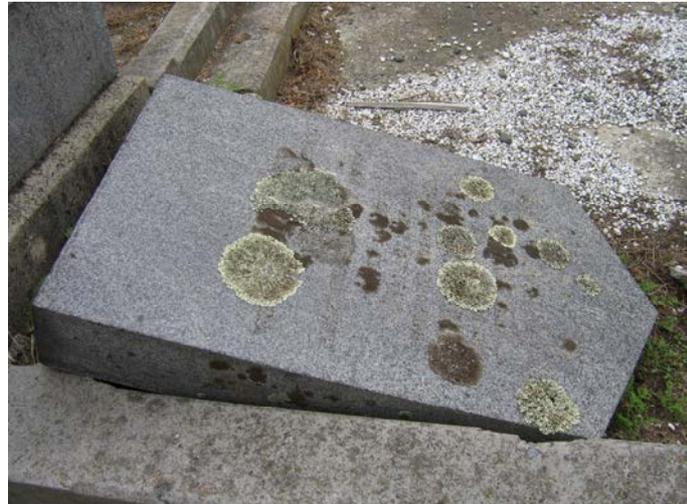
Photographs 15 Lichens and Mosses

Example – Biological Growth, notably mosses and lichens

Issue – Some growths are eating into stone, including obscuring inscriptions

Recommendation – Seek advice on a case by case basis as not all growth is causing damage. If removing biological growth, ensure this is done very carefully. In some cases, as with the photograph above, the main parts of the lichen can be scraped off carefully with a scalpel, then loose material gently brushed off the surface of the stone. In some cases it may be appropriate to use a biocide (see additional comments below).

Priority – Necessary/Desirable

Who to Undertake – Ideally a stone conservator, or an expert with experience in removing mosses/lichens on historic structures

Additional Comments: There is considerable discussion about the best way to deal with biological growth. English Heritage advises that most lichens, mosses and some wildflowers can be left on monuments so long as they do not obscure carved details, and do not recommend the use of chemicals. The National Trust of Australia's guide to conserving cemeteries cautions against removing biological growth and recommends expert advice if anything other than gentle brushing off is required. The HCCTNZ similarly cautions, but states that if it is necessary to remove biological growth, then use only preparations based on quarternary ammonium compounds eg benzylkonium chloride. For lichens, algae, fungi and moulds, the HCCTNZ recommends Kemsol "Mosskill".

For Addington Cemetery, the lichens and mosses are causing damage to the stone, including the inscriptions and in general should be removed. If a biocide is to be used, it is essential that it doesn't have soluble salts in it.

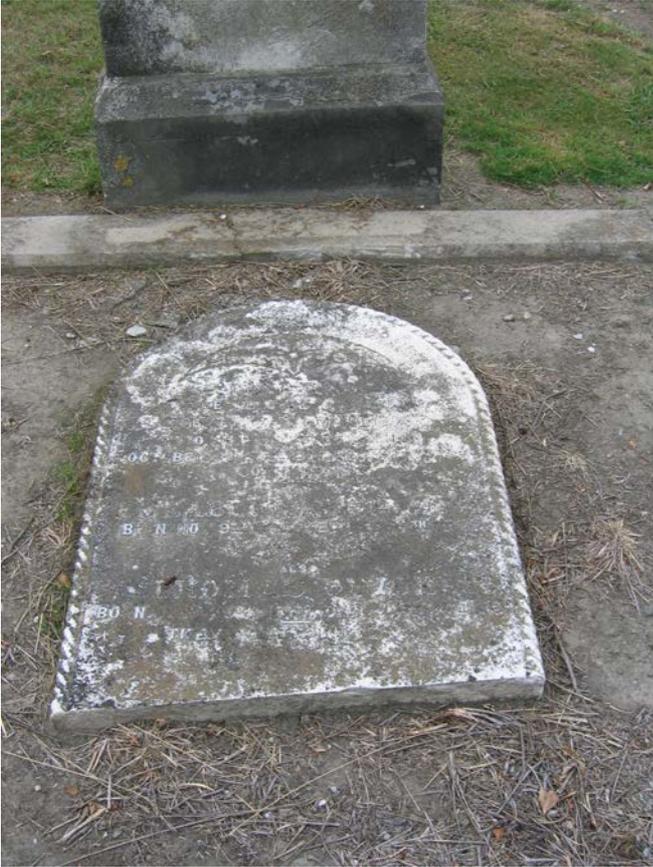
Photograph 16
Dirty Headstone

Example – Dirty headstone

Issue – Obscures historical inscriptions and can cause damage

Recommendation – *In general, do not clean* unless not cleaning will result in information loss (text/pictorial inscriptions) or dirt is hiding faults that need to be assessed/addressed

Priority – Potentially desirable, although non-intervention may be most appropriate in most cases

Who to Undertake – Stone conservator/stone mason or Council staff with appropriate training

Additional Comments: Do not clean headstones often, and do not clean unstable stones. Avoid acidic cleaners on marble or limestone. An effective gentle way to wash light soiling is washing with small quantities of water and natural fibre brushes. Never use wire brushes. Don't clean with water at a time when there is a risk of freezing temperatures before the stone dries out. Never sandblast or use high-pressure sprays on monuments.
