**Canterbury Earthquakes 2010/11 Port Hills Slope
Stability: Risk assessment for Deans Head**

**GNS Science Consultancy Report 2014/77
August 2014 FINAL**

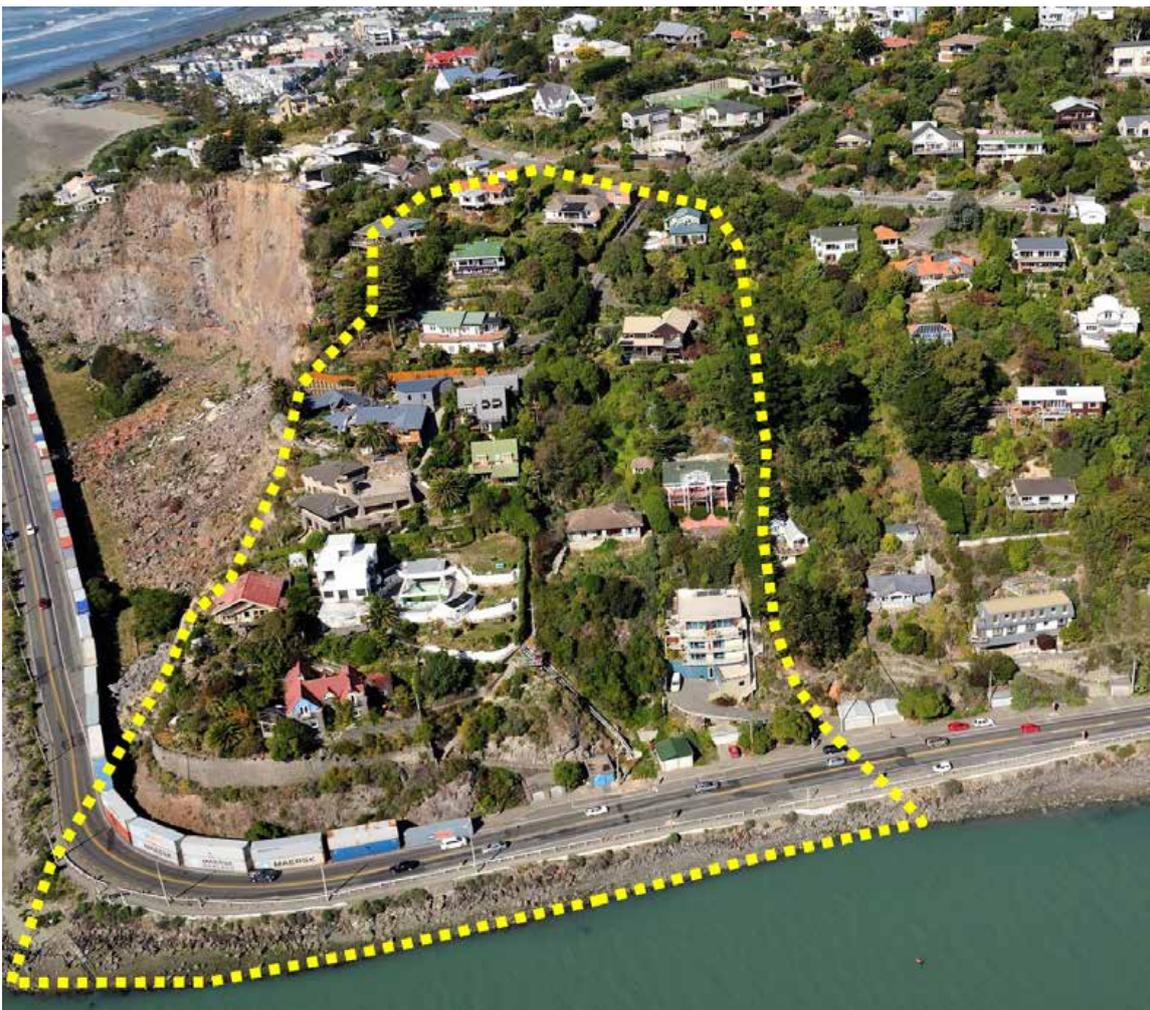
Figure 3 Aerial view of the Deans Head mass movement is within the yellow dashed lines (approximate extent only – refer to Figure 2 for the mapped extent).
