ŌPĀWAHO / HEATHCOTE RIVER CATCHMENT

TAUĀKĪ WAI PĀTAUA / VISION AND VALUES

Date: 21 DECEMBER 2016

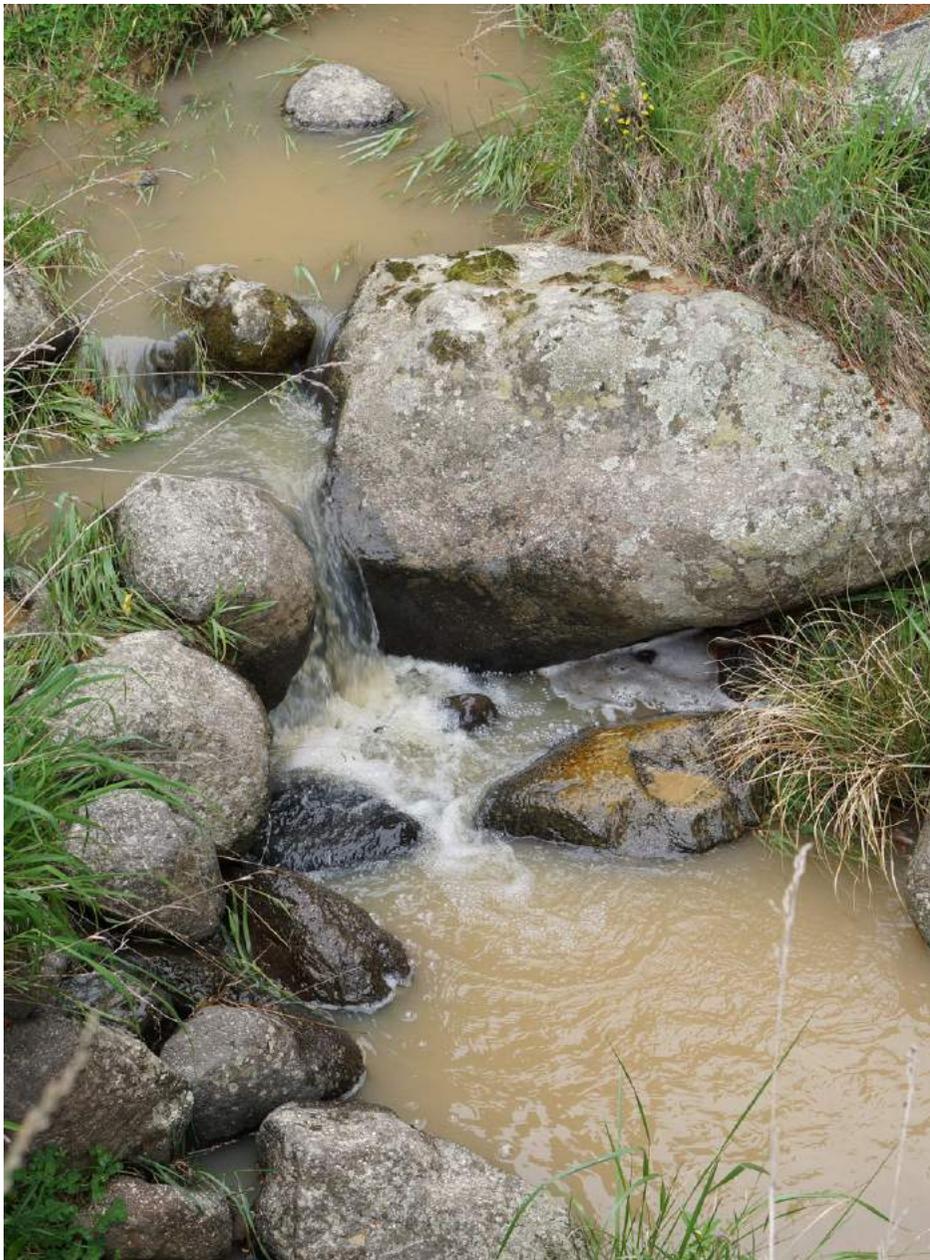
Port Hills stream with high sediment load after a heavy rainfall event

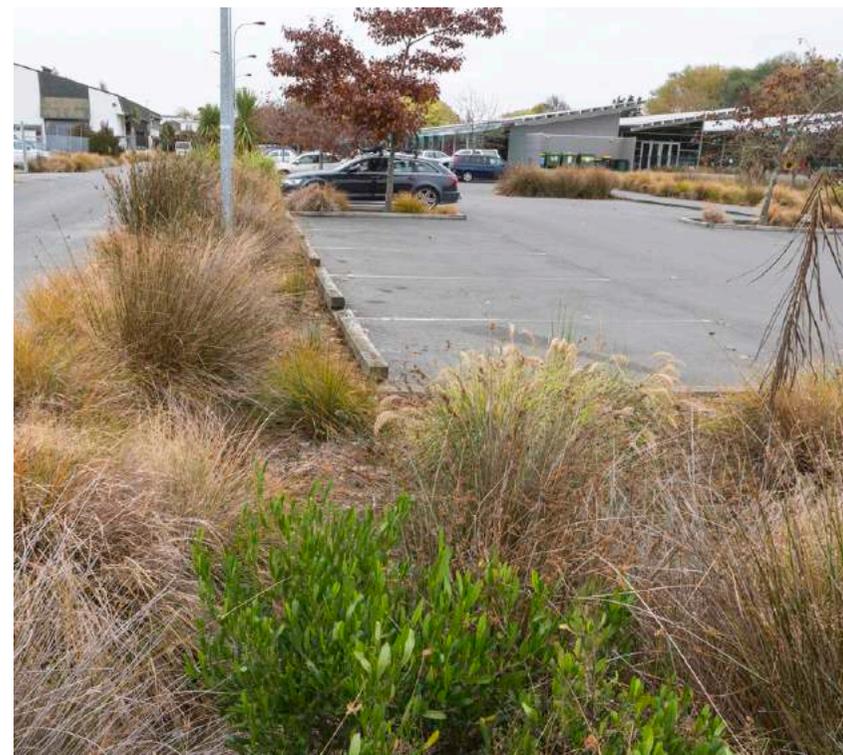
South Library rain gardens, Beckenham

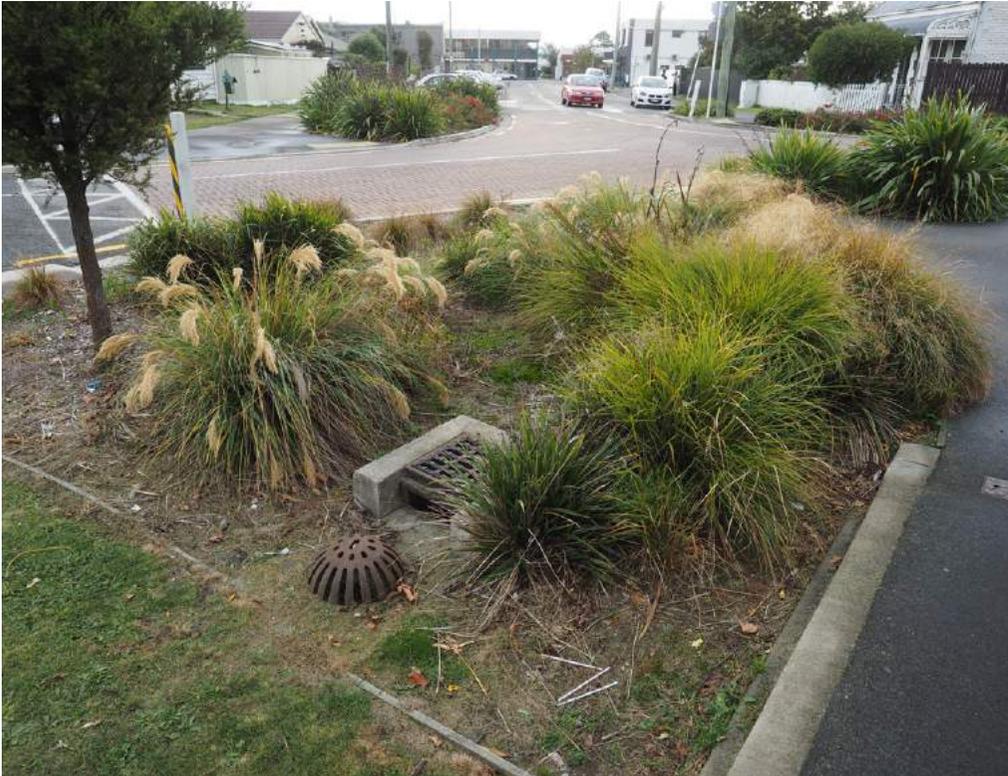
Rain garden on Meredith Street, Addington

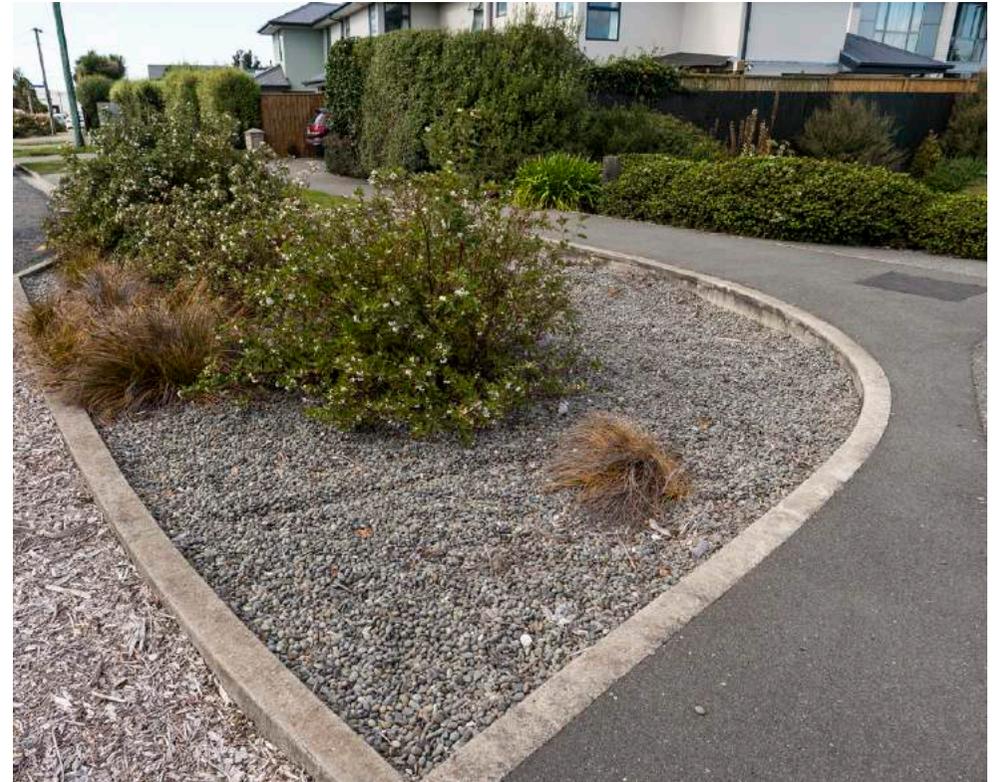
Rain garden on Fairfield Avenue, Addington

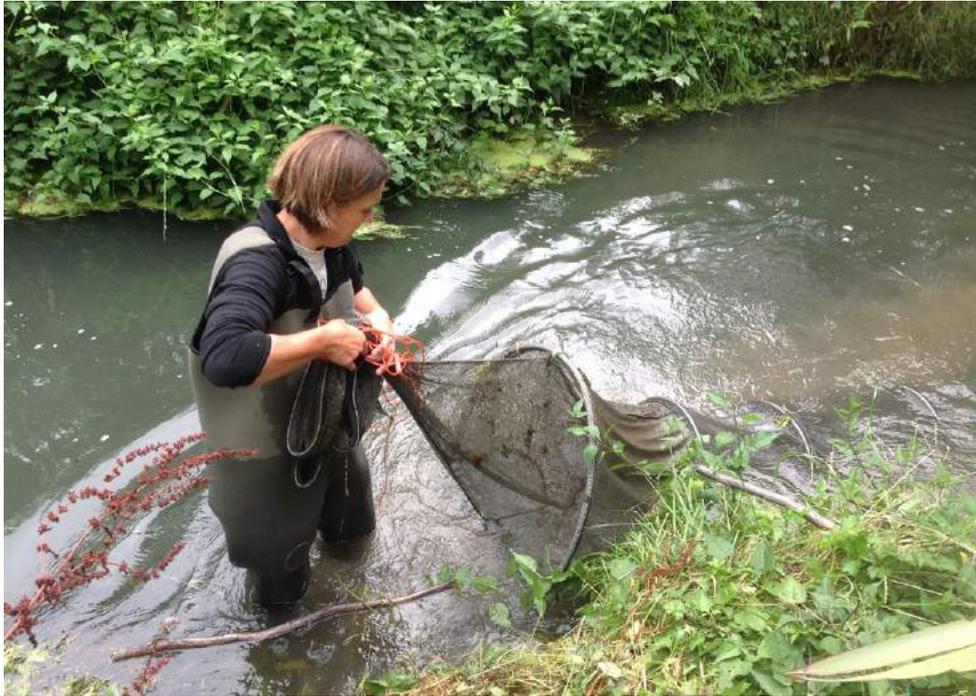
Fish sampling with a Fyke Net (Care of Boffa Miskell)

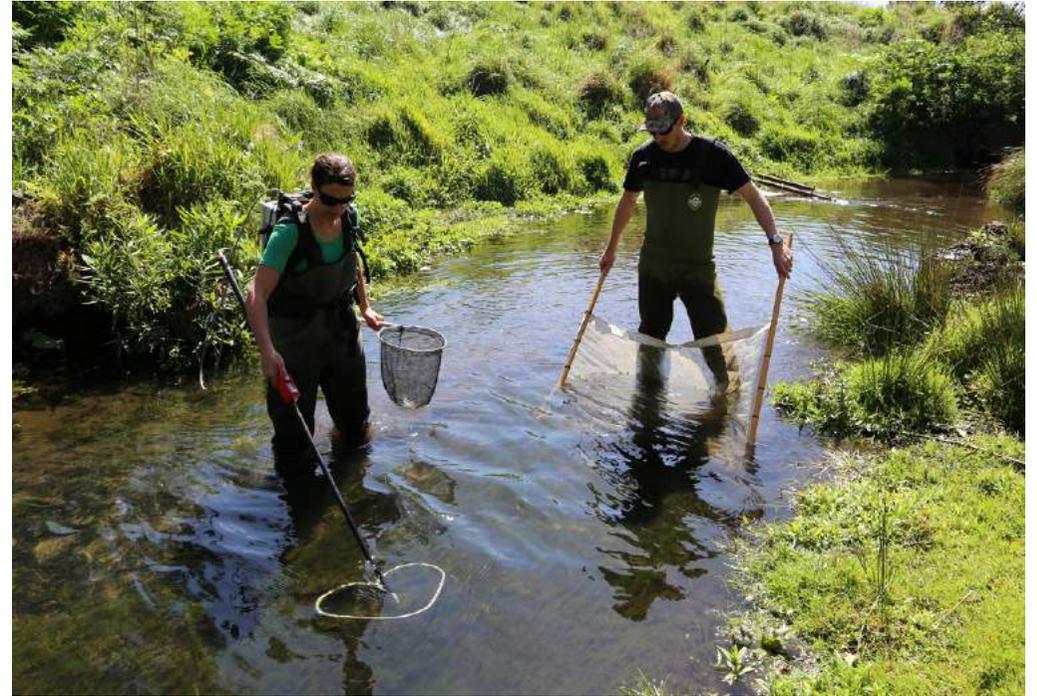
Electirc fishing (Care of Boffa Miskell)

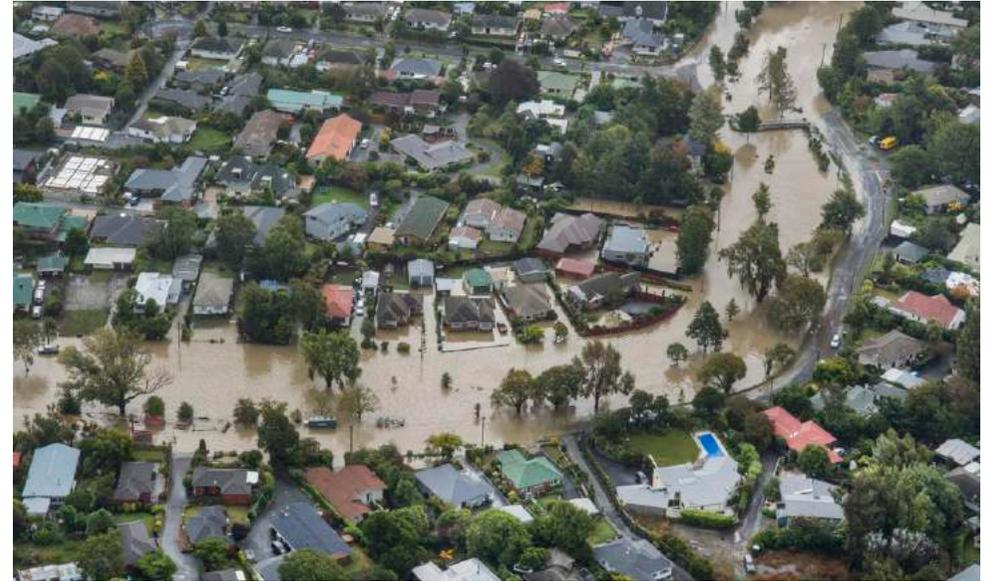
Flooding in the lower Ōpāwaho / Heathcote River March 2014 showing the typical flood water coloured by sediment from the Port Hills

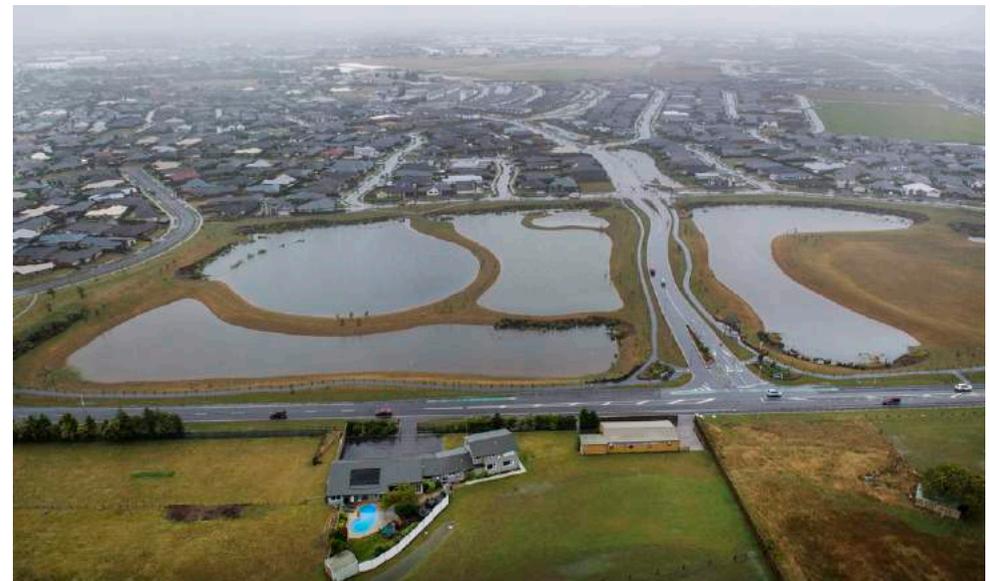
Awatea Basin flood Detention facilities. This services the new Wigram Skies subdivision and retrofits parts of Hornby March 2014
