Christchurch Aquatic Ecology Monitoring 2021

July 2021

Prepared for:
Christchurch City Council

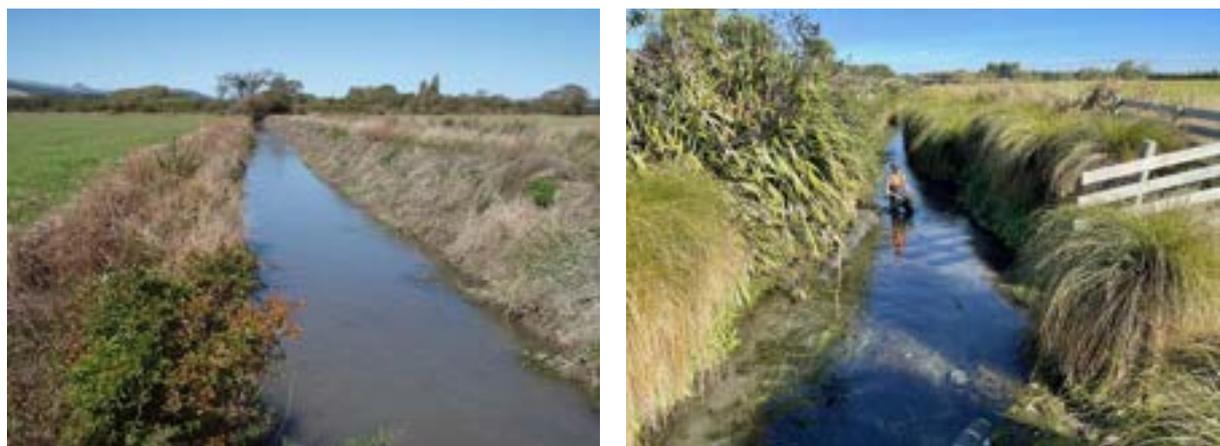
Figure 7: Cases Drain (Site HA09) in 2011 (left) and 2021 (right), showing improved native riparian cover.

As noted in Section 3.2 above, recent plantings along Cases Drain have improved riparian buffering, fish cover, and channel shading. Additional planting with taller-growing shrubs and

trees is recommended at this location, as the low-stature native grasses and shrubs do not shade the waterway sufficiently to prevent nuisance plant growths.

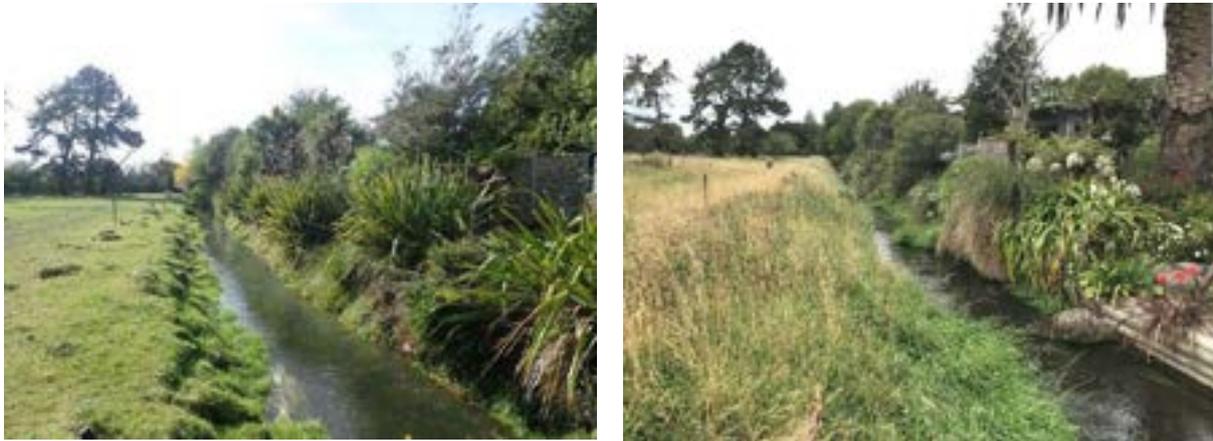
Figure 8: Cashmere Stream at Site HE27, photographed in 2020 (left) and 2021 (right). The 2020 image was taken shortly after waterway bank maintenance contractors had trimmed the banks, whereas the maintenance crew had not yet visited the site prior to the 2021 survey.

Longer riparian grass and shrubs resulted in more overhanging vegetation and improved fish cover in 2021 than in 2016 at Site HA06 on the Halswell River. Longer riparian grass and more overhanging vegetation was observed in 2021 than in 2020 at Sites HE27 and HE28 on Cashmere Stream (Figure 8). Care was taken to sample all sites prior to maintenance crews visiting the sites in 2021, whereas 2016 and 2020 sampling occurred soon after water

maintenance activities. Thus, improved habitat conditions at these sites in 2021 was primarily because there had been a longer time since the last round of waterway maintenance had been done. Presumably riparian habitat conditions declined again following the next round of waterway maintenance.

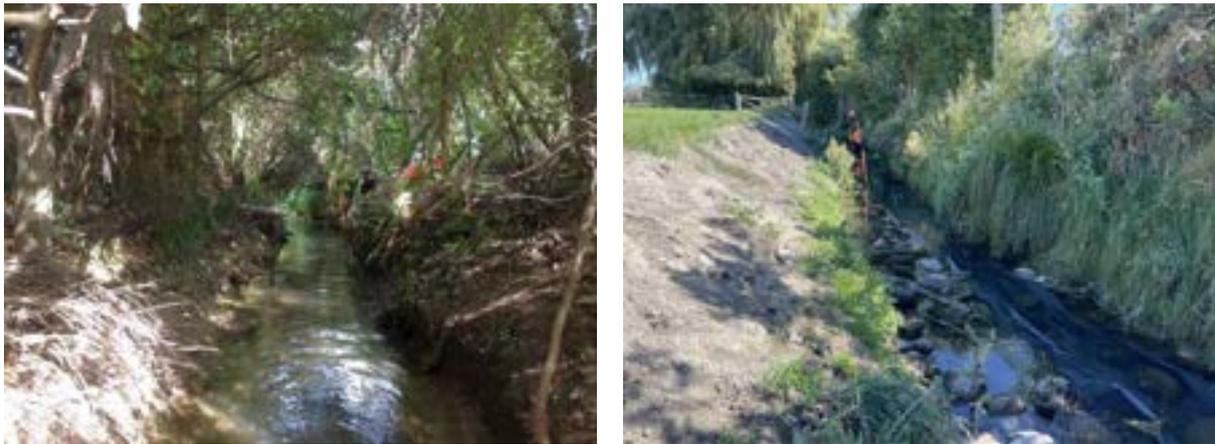
Figure 9: Contrasting riparian and instream habitat conditions at Creamery Stream (Site HA08) between 2016 (left) and 2021 (right). Note black polythene lining the bed in the 2021 image.

- **Investigate recent works in Creamery Stream.** Recent removal of bank vegetation, bank regrading, and polythene on the bed of the stream all degraded habitat within Creamery Stream. This is worth following-up by council, given At Risk wai kōura and threatened lamprey are present in Creamery Stream.

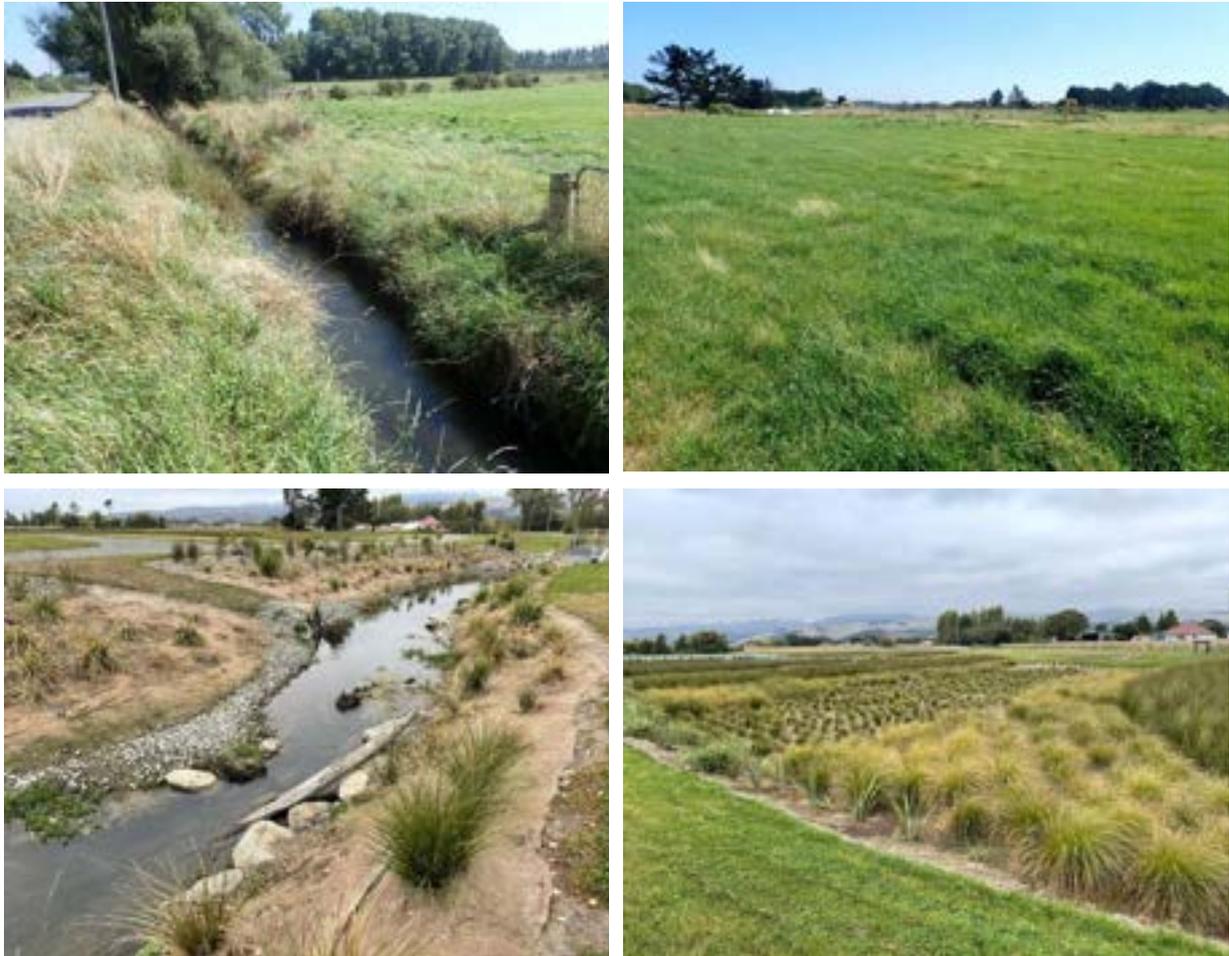
Figure 39: Images of Quaiques Road drain and wetland taken in 2019 (upper) and 2021 (lower).

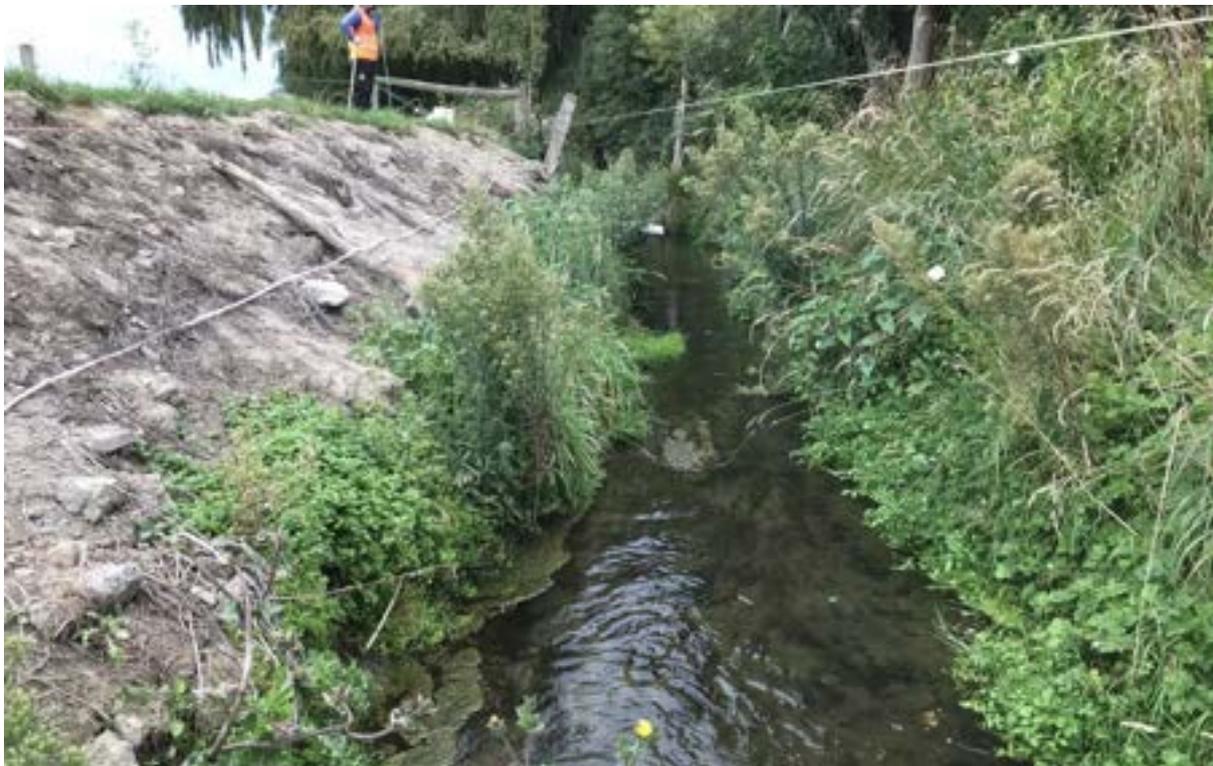
Figure 4: Site HA08 (Creamery Stream downstream of Sabys Rd) – upstream looking downstream. Note that this photograph was taken at the time of the habitat survey, prior to polythene sheeting being placed in the waterway.
