# Avon River Precinct

Baseline Conditions of the Avon River  
Prepared for the Christchurch City Council

9 May 2014

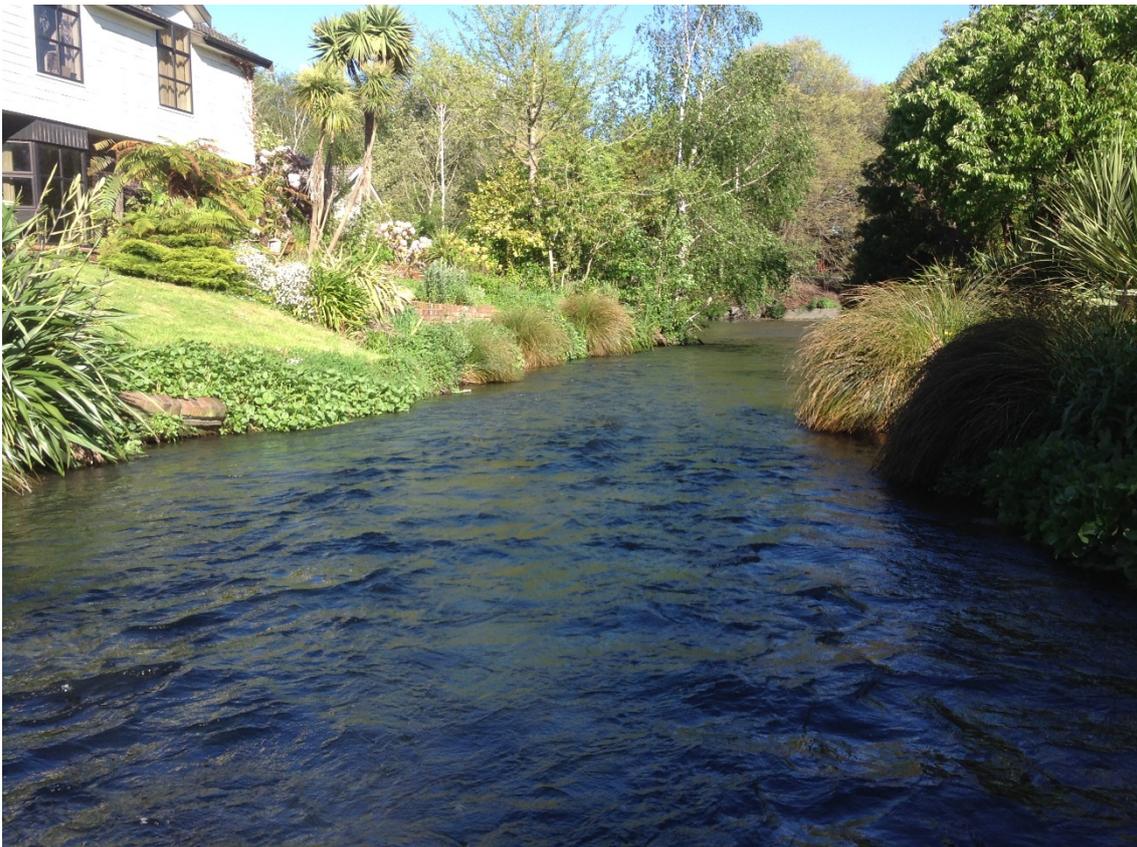
The upper most reference site was located in the Avon River downstream of the Mona Vale weir. Here the river was approximately 8.8 m wide and on average 33 cm deep. The velocity on the day of sampling was 0.43 m / s. The true right (TR) bank was well vegetated with *Carex secta*, flaxes and other native plantings in the Girls' High School grounds; however, these appeared to have slumped into the waterway as a result of the Canterbury earthquakes. The macrophyte *Erythranthe guttata* was abundant, albeit in patches, along the margins of the site. The true left (TL) bank was within residential housing and gardens, including mown grasses and shrubs to the water's edge, with scattered *Carex secta* and flaxes. The retaining wall along the TL had slumped greatly due to the Canterbury earthquakes. The river bed had a moderate Substrate Index (2.6), indicating substrates were dominated by pebbles and larger cobbles. The substrates were slightly embedded (average embeddedness score of 2.3) and moderately-tightly packed (average compactness score of 3.8).

Reference Site 1: Avon River downstream of Mona Vale weir, looking downstream.

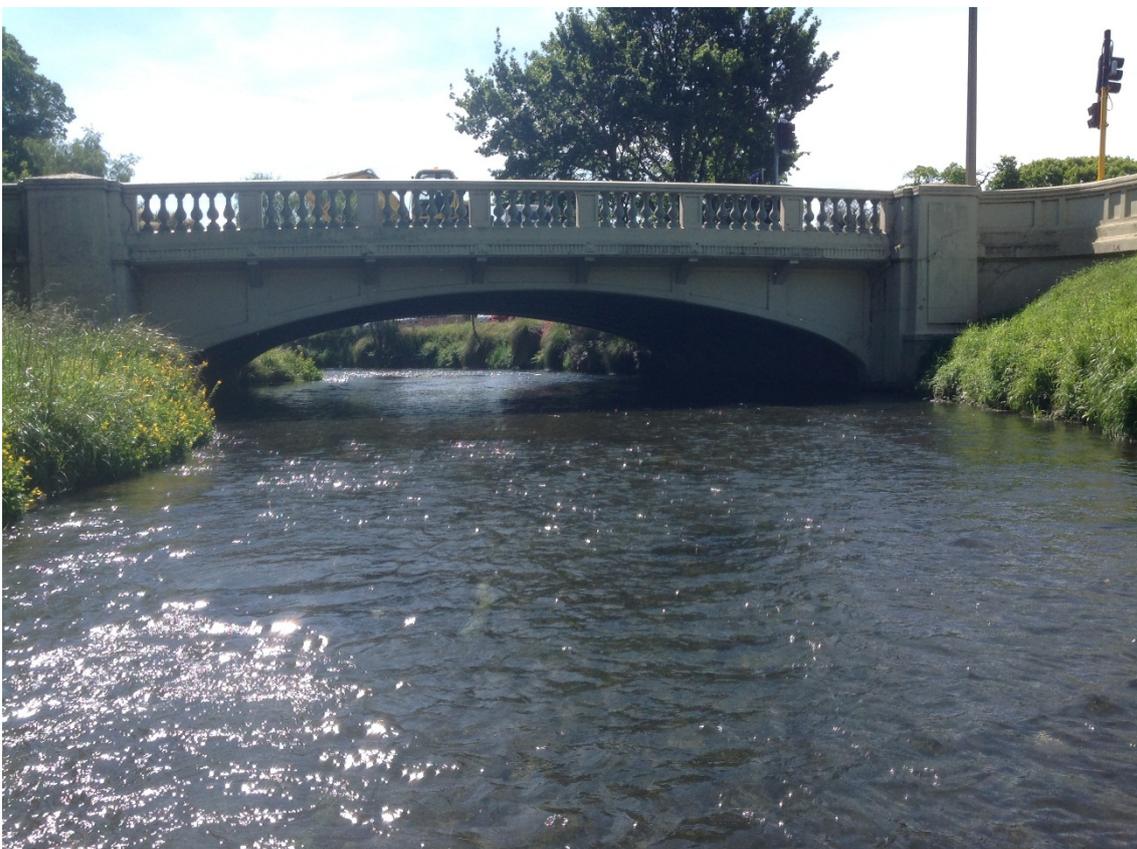
The second reference site was in the Avon River at the Carlton Mill Corner. Here the river was approximately 11 m wide with an average water depth of 49 cm and a velocity of 0.43 m / s on the day of sampling. Both banks were predominantly covered with long grass, with a few *Carex* secta plants along the TL side. *Erythranthe guttata* was present along much of the TR side and macrophyte beds (of approx. 50% cover in parts of the site) were dominated by *Elodea Canadensis* and *Potamogeton crispus*, with *Nitella hookeri* and filamentous green algae also present. The substrates were largely comprised of cobbles and pebbles, with a Substrate Index of 2.5. The substrates were slightly embedded (average embeddedness score of 1.9) and moderately packed (average compactness score of 3.3).

Reference Site 2: Avon River at Carlton Mill Corner, looking upstream.

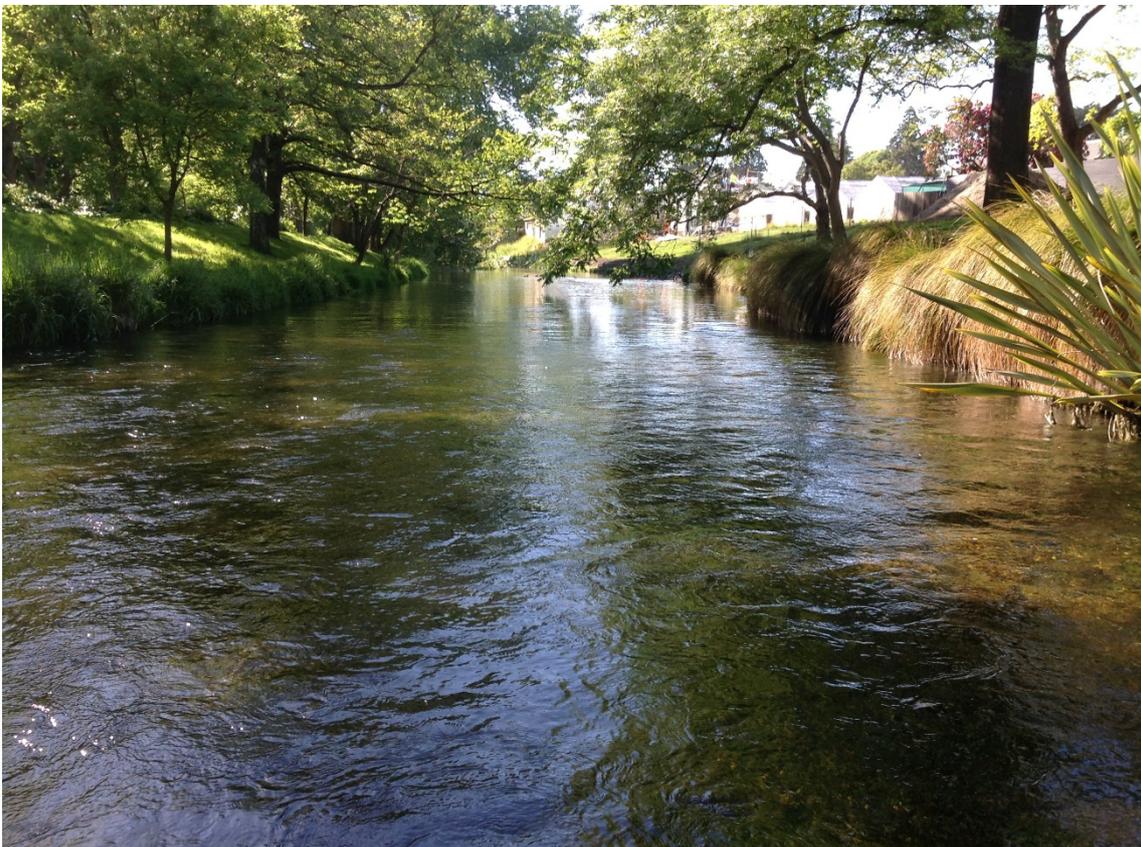
The final, downstream most reference site was in the Avon River within Hagley Park. Here the river was approximately 12 m wide with an average depth of 31 cm. The river was quite swift, with a velocity of 0.48 m / s on the day of sampling. The TL bank at this site was mostly grassed, with longer grasses along the stream margin, and well established trees providing a substantial amount of shading to the channel throughout the day. The TR bank was also grassed with established trees, but also had some *Carex secta* and flax plantings right on the water's edge, which provided abundant overhanging vegetation to the river in parts of the site. Macrophyte beds were abundant (sometimes covering almost all of the river channel, approx. 50-100% cover) and were dominated by *Myriophyllum propinquum*, *Potamogeton crispus*, *Nitella hookeri* and filamentous green algae. The substrates were dominated by pebble and cobbles, with a Substrate Index of 2.6. These substrates were slightly-firmly embedded (average embeddedness score of 2.9) and tightly packed (average compactness score of 4).

Reference Site 3: Avon River in Hagley Park, looking downstream.

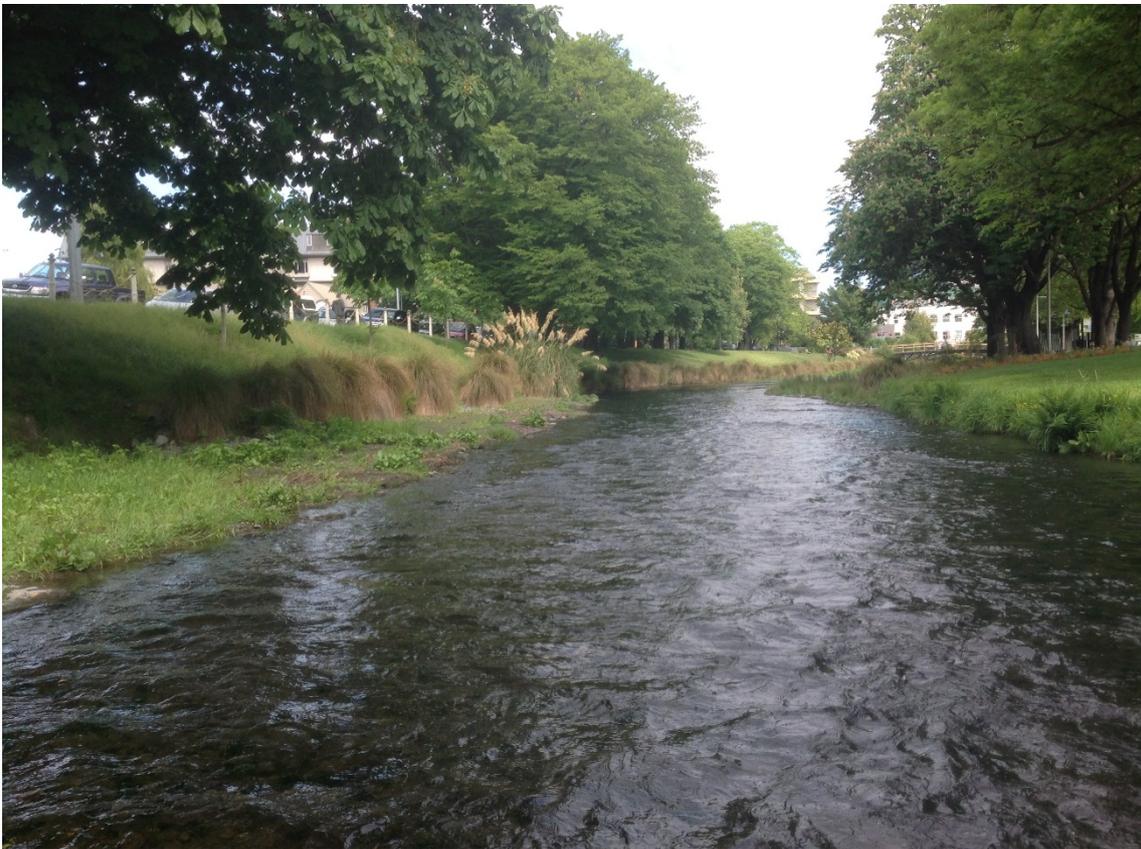
The upper most rehabilitation site<sup>6</sup> was within the Avon River near Durham Street, encompassing an area where in-stream physical remediation works were undertaken in 2013 and now often referred to as 'Watermark'. The river at this site was approximately 9.8 m wide with an average water depth of 30 cm and a velocity of 0.28 m / s on the day of sampling. Both banks of the river at this site were grassed, with plantings of *Carex secta* along the margins, particularly on the TR bank. Macrophytes were not particularly common in the river at this site, but there was the occasional patch dominated by *Myriophyllum propinquum* and filamentous green algae. The Substrate Index of 3.4 indicated the bed was dominated by larger substrates, and there were aggregations of boulders and large cobbles throughout the site. The substrates were generally only slightly embedded (average embeddedness score of 1.6) and mostly loose (average compactness score, 1.5).

Rehabilitation Site 1: Avon River near Durham Street, looking upstream towards the Antigua Boatsheds.

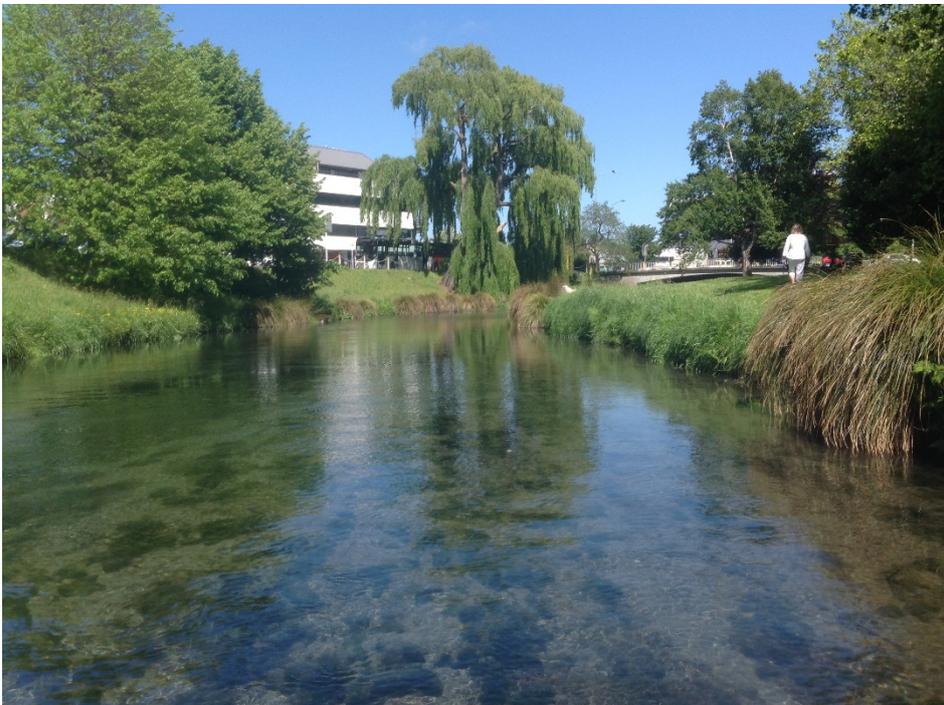
The second rehabilitation site was located downstream of Montreal Street and approximately 20 m upstream Rhododendron Island. Here the Avon River was approximately 15 m wide and on average 42 cm deep. The velocity on the day of sampling was 0.58 m / s. Both banks had scattered plantings of *Carex secta* and ferns, with relatively long, unmown grass to the water's edge. The banks of the river channel were concrete lined and channelised, limiting the amount of undercut banks in the survey section. The river bed was dominated by smaller substrates of sand and pebbles (Substrate Index of 1.5), but also with areas dominated by cobbles. The substrates were slightly embedded were (average embeddedness score 1.9) and tightly packed (average compactness score 4). Macrophyte beds dominated by *Elodea canadensis* and *Potamogeton crispus* were widespread in parts of the survey reach. Long filamentous green algae also dominated much of the sandy substrates.

Rehabilitation Site 2: Avon River at Rhododendron Island, looking upstream towards the Montreal Street Bridge.

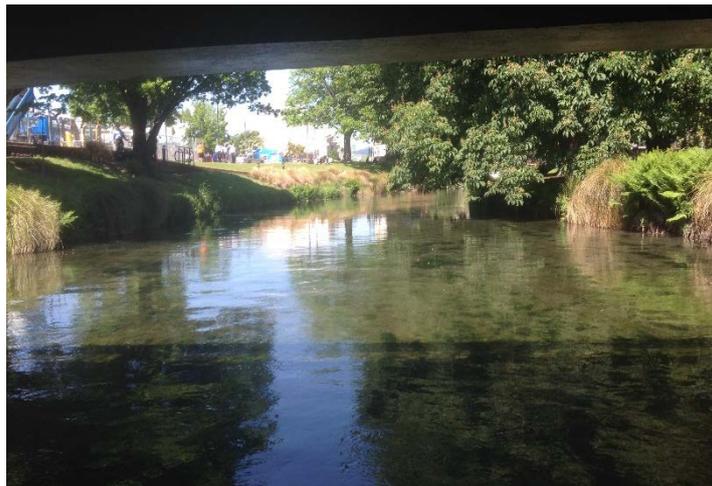
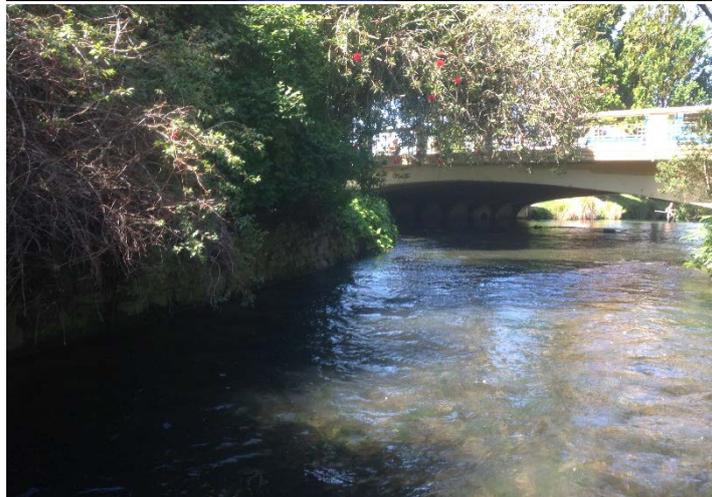
The third rehabilitation site was located in the Avon River at the Hereford Street Bridge crossing. The survey reach extended both upstream of the Hereford Street Bridge and downstream along both sides of 'Mill Island'. Upstream of the bridge the river was approximately 15 m wide, however, the wetted width was around half this width either side of the island. The water depth was on average 36 cm, with a velocity of 0.42 m / s on the day of sampling. Both banks of the river upstream of the bridge were generally grassed with a few scattered *Carex secta*, ferns and large trees overhanging the water. Downstream of the bridge the riparian vegetation of Mill Island added a great deal of shading to the stream. However, the river banks were lined along the entire survey reach, again limiting the amount undercut banks at this site. The substrates varied upstream and downstream of Hereford Street Bridge. Upstream of the bridge the river bed was dominated by finer, sand substrates much of which were covered with long filamentous green algae. Large cobbles and boulders were present downstream at Mill Island, with submerged macrophytes including *Elodea canadensis* and long filamentous green algae. The average Substrate Index for the site was 3.2, indicating coarser substrates dominated the river bed. The substrates were slightly-firmly embedded (average embeddedness score 2.5) and moderately packed (average compactness score 3.7).

Rehabilitation Site 3: Avon River at Hereford Street, looking upstream through the Hereford Street Bridge (top photo) and upstream from Mill Island towards the Hereford Street Bridge (bottom photo).

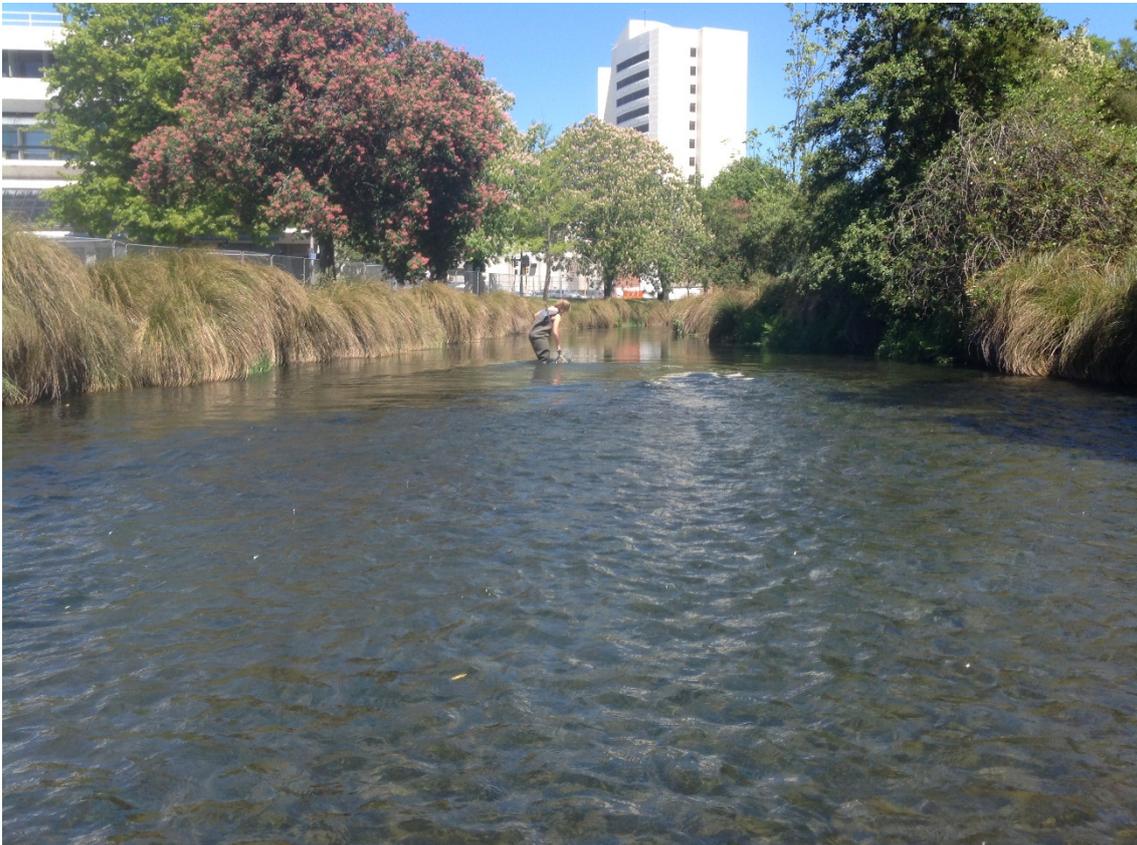
Rehabilitation Site 4 was in the Avon River at Victoria Square, upstream of the Armagh Street Bridge. Here the river was approximately 12 m wide with an average depth of 38 cm and a velocity of 0.49 m / s on the day of sampling. The TR banks of the Avon at this site were tightly planted with *Carex secta* overhanging the river. Otherwise, grass and exotic ornamental trees covered the river bank (TR) for approx. 5 m from the water's edge, then roads and commercial buildings dominated the wider riparian zone. There was a narrow (approx. 3 m), but well vegetated area on the TL bank between the river and the Provincial Court buildings and Durham Street. The river bed was dominated by larger substrates, including large cobbles and some boulders (Substrate Index, 3.0). In the shallower areas, macrophyte beds were growing on finer substrates of sand, gravel and pebbles. The dominant macrophyte at this site was *Potamogeton crispus* with long filamentous green algae. The substrates were slightly embedded (average embeddedness score 1.8) and moderately packed (average compactness score 3.7).

Rehabilitation Site 4: Avon River at Victoria Square, located upstream of the Armagh Street bridge (facing upstream).

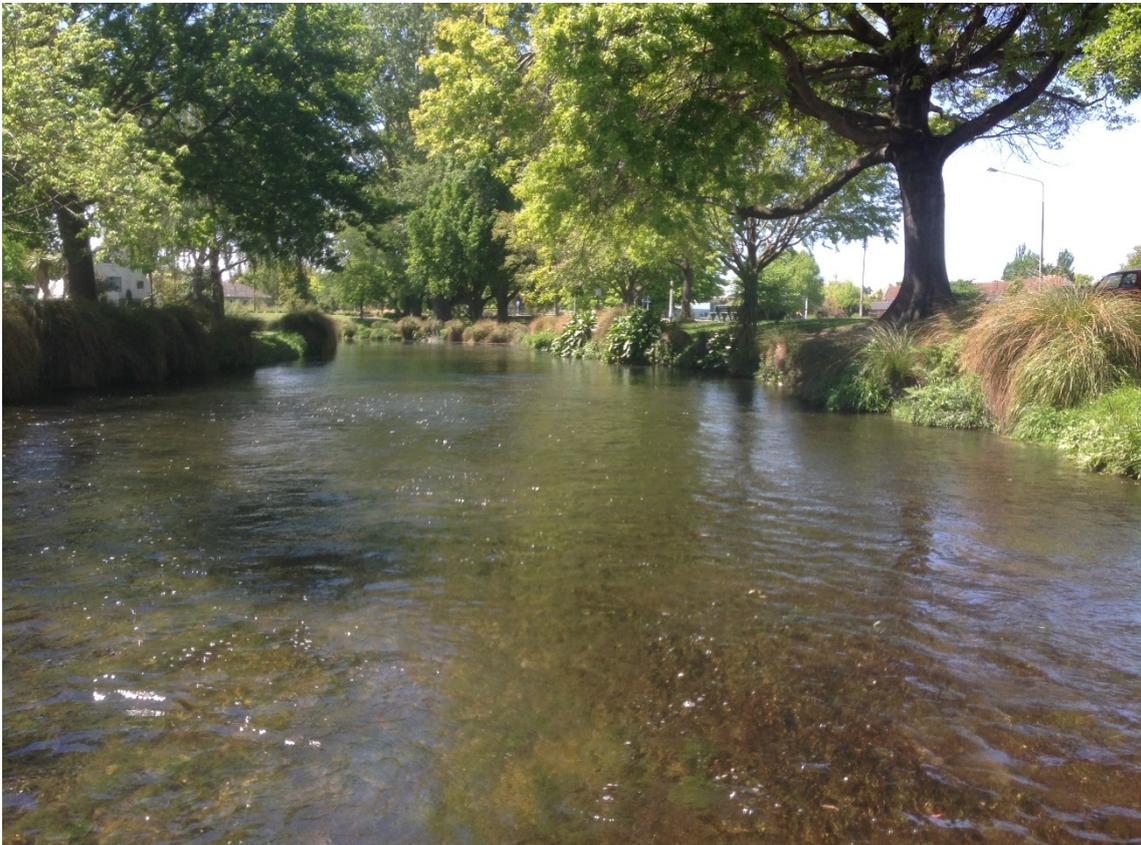
The final rehabilitation site on the Avon River was located near Kilmore Street; this was the downstream most sampling site in this study. At this site, the river was approximately 15 m wide with an average water depth of 31 cm and a velocity of 0.63 m / s on the day of sampling. The TL bank had *Carex secta* planted along the edge of the river, while grass and scattered trees were within 5-8 m of the water's edge, and a road and residential apartments were within 20-50 m of the river. Macrophyte beds dominated the river bed, almost entirely covering the bed in parts of the site. These were dominated by *Potamogeton crispus*, *Elodea canadensis* and filamentous green algae. *Erythranthe guttata* was present along the TR banks in between *Carex secta* overhanging the river channel. However, the macrophyte beds and marginal *Erythranthe guttata* were mechanically removed by City Care immediately after the macroinvertebrate and habitat sampling. The substrates were dominated by smaller cobbles, pebbles and sand (Substrate Index, 1.4), slightly embedded (average embeddedness score 1.9) and moderately packed (average compactness score 3.5).

Rehabilitation Site 5: Avon River near Kilmore Street, looking downstream
