Kā Pūtahi Creek Ecology

Five years after the realignment works
Prepared for Christchurch City Council

19 July 2021

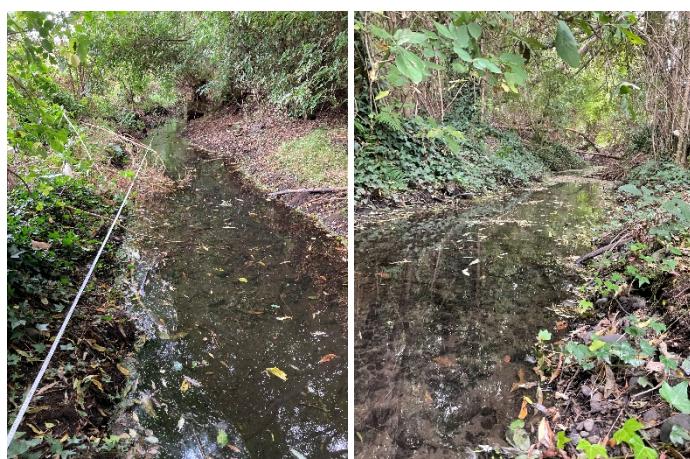
Photo 1. Site C1 view looking upstream (left) and downstream (right).

C1 (Photo 1) is located within an area of mature exotic trees and alongside the new CNC. Here, the creek is an average of 1.3 m wide, shallow (average of 15.4 cm) and is dominated by run and pool habitat. There is a small section of riffle (about 3 m long), which was the only riffle seen at any of the survey sites. The water velocity was faster than at other survey sites, however, was still slow at 0.02 m / s. Riparian vegetation on both banks is dominated by exotic trees and shrubs, including elder and crack willow. The riparian buffer extends for approximately 60 m on the true left (TL) bank and 8 m on the true right (TR) bank, providing near-complete shading for the creek along the surveyed reach. Wandering willy provides groundcover in some places along the 50 m reach, however, the banks are typically bare earth. In some places, the banks are eroding into the waterway.

There were no macrophytes along the survey reach at C1 in the 2021 survey, compared to cover recorded in the 'Year One' survey (10.8%) and a very small amount of cover in the baseline survey (0.6%). No algae was recorded along the reach, nor any log jams or large boulders. There was less woody debris and leaf packs (average of 1.2 cm and 2.8 cm respectively, across an average width of 1.34 m) present in 2021 than observed in the 'Year One' survey (22.5 cm woody debris and 5 cm leaf pack across an average width of 1.8 m).

The stream bed substrates were dominated by silt and clay, with occasional patches of cobbles. The substrates had an average compactness score of 2.3, where although dominated by finer substrates, the riverbed substrates were mostly loose, with little compaction. Substrate was moderately embedded with an average score of 2.7. Fine sediment cover was slightly lower in the 2021 survey than previously, with 83.5% average cover, compared to 95% and 93% recorded in the baseline and 'Year One' surveys respectively. Soft sediment was 10.75 cm deep on average in this survey.

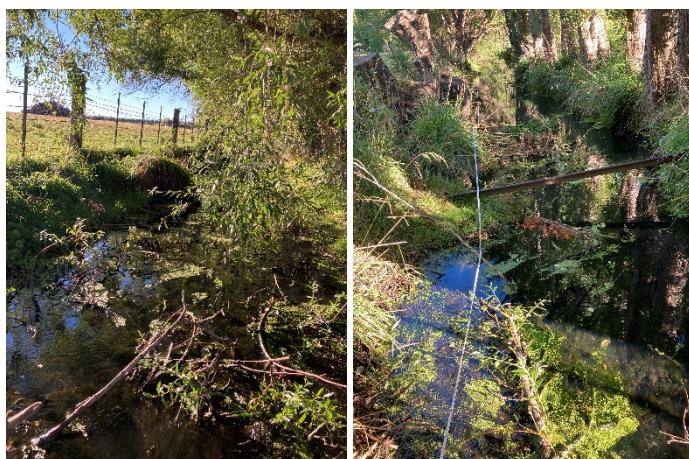
Photo 2. Site C2 view looking upstream (left) and downstream (right).

Site C2 (Photo 2) is located downstream of the realigned reach of the Kā Pūtahi Creek and runs through farm paddocks. Here, the waterway is entirely run habitat that is on average 2.9 m wide and 22.1 cm deep. On the day of surveying, water flowed slowly with an average velocity of 0.02 m/s.

Macrophyte and algae cover was higher than that seen in previous surveys, with filamentous algae covering approximately 20% of the bed (determined from an average measure across the transects). Woody debris was prevalent along the reach and covered more of the reach than observed in the baseline and 'Year One' surveys.

The substrate at C2 was almost entirely silt / sand and had a compactness score of 4 indicating very compact substrate. Soft sediment cover and depth measurements reflected this, with an average sediment depth of 36.5 cm and cover of 100%. Soft sediment at C2 was the deepest of any site and was similar to that seen in previous surveys.

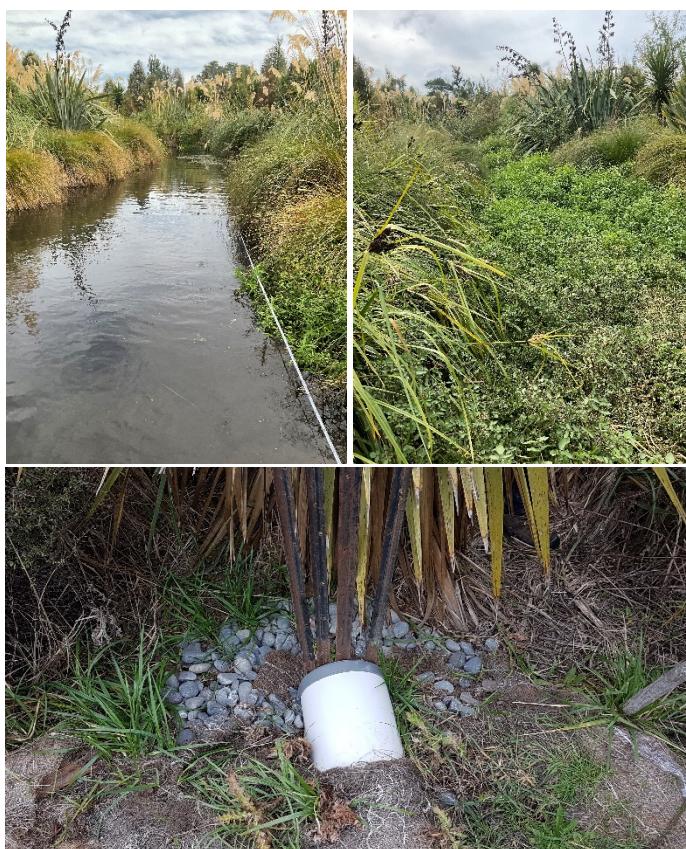
Photo 3. Site R1 view looking upstream (top left) and downstream (top right); construction-phase stormwater discharge pipe (bottom).

A construction phase stormwater discharge pipe from the adjacent subdivision has been installed since the 1-year post-realignment survey. While we did not observe this in our survey, Belinda Margetts (Principal Waterways Ecologist visited the site on 16 July 2021 and noted that there were no obvious effects from the discharge. The pipe discharges to ground (on the bank) rather than into the waterway directly (Photo 3).

The substrate at this site is predominantly cobbles covered by a significant amount of sediment. 100% of the reach was covered by sediment, compared to 52% at the 'Year One' survey. Sediment was an average depth of 4.6 cm, compared to 0.5 cm in the 'Year One' survey. Here, fine sediment was not overly compact over and around the cobbles and the substrate was slightly embedded, with an average score of 2.3. Sediment and cobbles were moderately compact with an average compactness score of 2.7.

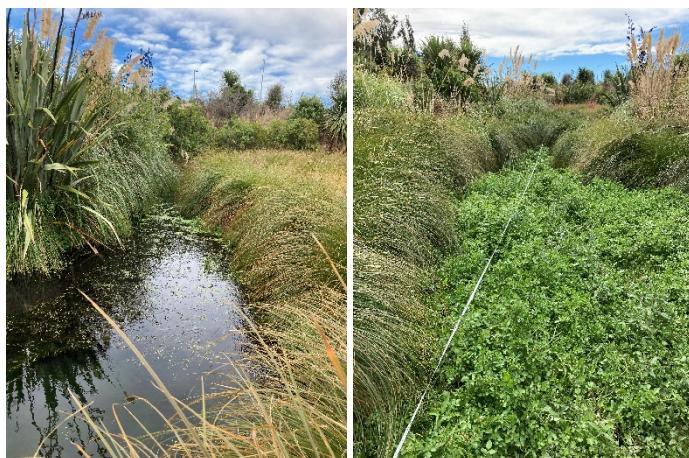
Photo 4. Site R2 view looking upstream (left) and downstream (right).

Site R2 (Photo 4) is in the middle of the realigned reach of the Kā Pūtahi Creek. The survey reach largely follows a bend which is relatively narrow at the downstream end, widening at the upstream end. The waterway has an average width of 3 m and average depth of 25.8 cm.

Habitat conditions at R2 are very similar to those at R1. The upper portion of the survey reach was smothered by dense macrophytes (watercress) and velocity data was not able to be collected. Downstream of the macrophytes, velocity was negligible. While the water is moving very slowly, the habitat is almost entirely pool habitat (84%), with about 8 m of run habitat present within the 50 m survey reach.

The riparian vegetation at R2 is in very good condition, with sedges, flaxes and toetoe having grown to overhang the waterway providing good habitat for aquatic fauna. While again, there is limited shading provided by taller vegetation over the channel, some shading is provided by these trees and shrubs at times. The banks are well stabilised by the riparian vegetation. Where the waterway widens in the upper part of the survey reach, watercress is prevalent, restricting water flow. Macrophytes were present, on average, across 20.6% of transects, and algae over 8.2%.

The substrate at this site is, again, small cobbles covered by fine sediment. Sediment covered the entirety of the site in a thin layer that was no deeper than 1 cm at any point measured. The substrate is slightly embedded with an embeddedness score of 2 and is moderately loose with an average compactness score of 2.2.

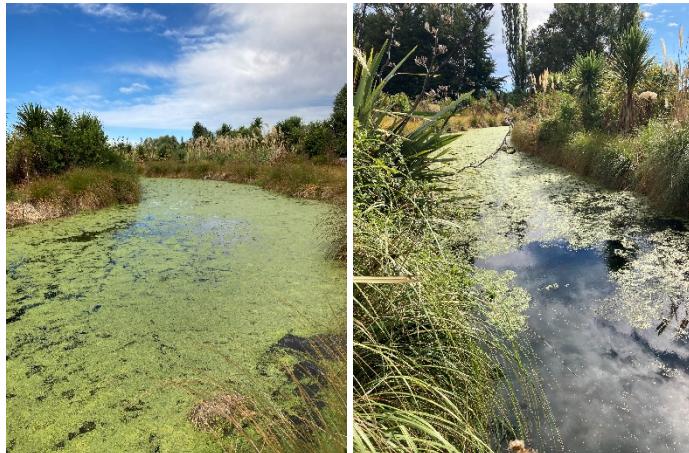
Photo 5. Site R3 view looking upstream (left) and downstream (right).

Site R3 (Photo 5) is located at the downstream end of the realigned section of Kā Pūtahi Creek. The waterway is very wide (average width 7.9 m), and there is little to no flow, meaning habitat is entirely pool or still habitat.

Most of the survey reach was covered by common duckweed (*Lemna disperma*), with dense curly-leaved pondweed (*Potamogeton crispus*) throughout the water column beneath.

The substrate at R3 is dominated by small cobbles. Sediment covers the entire site in a thin layer over cobbles, with an average depth of 1 cm. There was no fine sediment cover observed in the 'Year One' survey. The substrate is not embedded, with an average embeddedness score of 1.3. The substrate is mostly loose and easily moved, with an average compactness score of 1.8.
