Aquatic Ecology of sites within the Heathcote, Estuary & Coastal, and Avon SMP catchments

Informing the Comprehensive Discharge Consent

Prepared for Christchurch City Council

25 August 2015

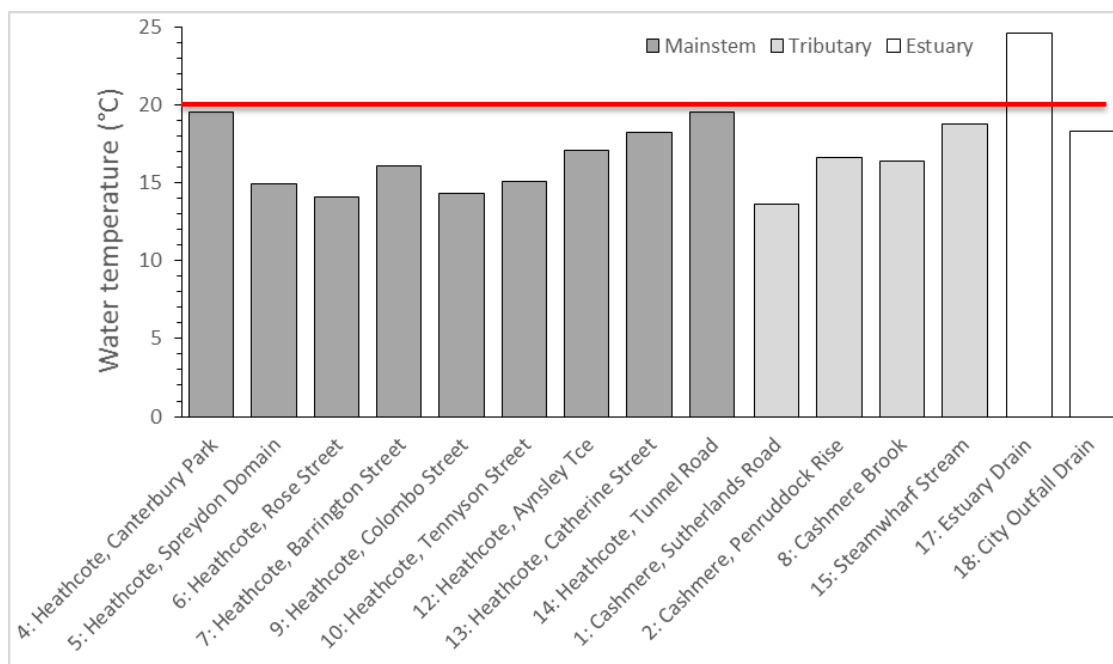
Water temperature was variable across all sites, with the highest temperature recorded in Estuary Drain (Site 17) (Figure 5). However, all sites, except Estuary Drain, were below the pLWRP guideline for Canterbury Rivers of 20°C. The coolest water temperatures were recorded at Sites 1 (Cashmere Stream upstream of Sutherlands Road), 5 (Heathcote River downstream of Spreydon Domain), 6 (Heathcote River Rose Street / Centennial Park), and 9 (Heathcote River downstream of Colombo Street). Water temperatures in the Heathcote, Estuary & Coastal, and Avon SMP catchments were generally greater than those recorded in the Avon SMP aquatic ecology survey during 2013 (Boffa Miskell 2014), however, the latter were recorded in late spring-early summer, compared to late summer for this study. It is important to note, however, that temperature was measured only once and during the daytime, and that temperature can vary diurnally and seasonally.

Figure 5. Water temperature measured, on one occasion, at the 15 sites surveyed within the Heathcote, Estuary & Coastal, and Avon SMP catchments in February and March 2015. The red line indicates the pLWRP guideline for temperature in Canterbury rivers.

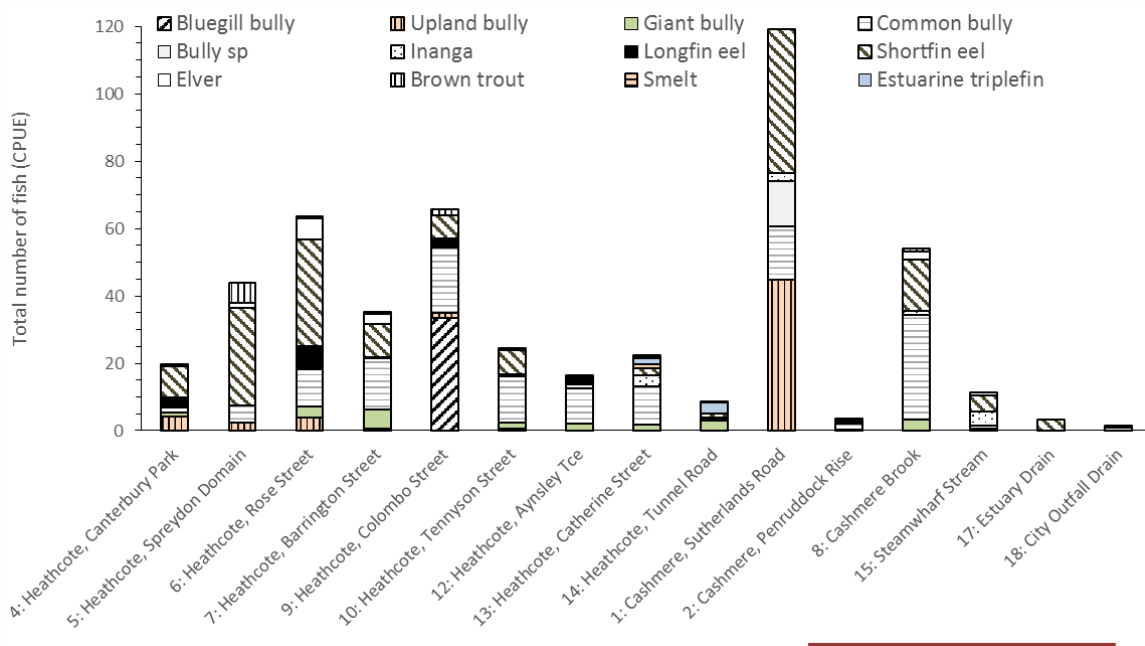
Figure 22. Total number of fish, separated by species, captured at each site surveyed in February and March 2015. Numbers are shown as catch per unit effort (CPUE): per 100 m² of area surveyed using electric fishing; or per net / night for trapping (Sites 2, 12-14, and 18). The dark red line indicates the sites where traps and nets were used to survey fish.

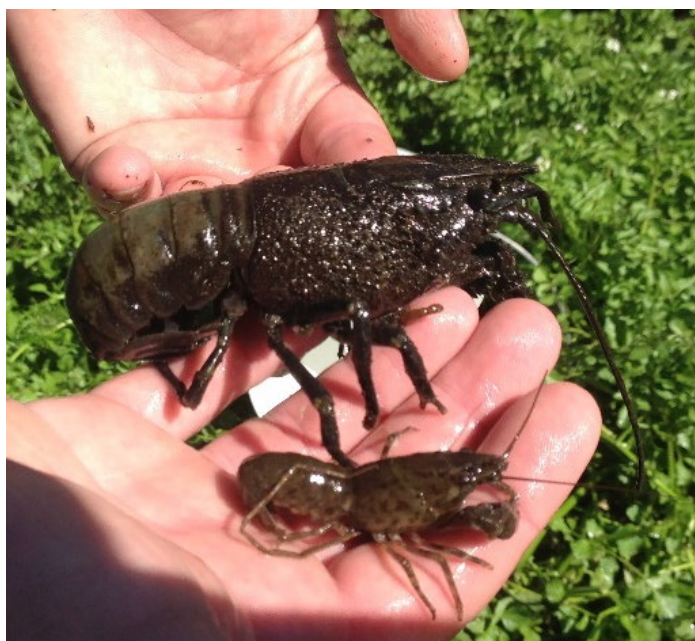
Photo 1. Kōura captured during electric fishing of the Heathcote River downstream of Barrington Street.

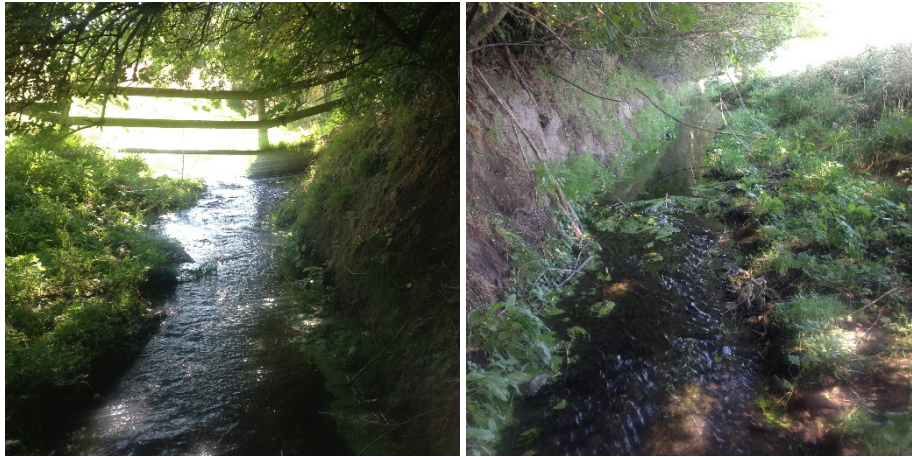
Site 1: Cashmere Stream upstream of Sutherlands Road

This site was located in the headwaters of Cashmere Stream, upstream of Sutherlands Road, in the rural outskirts of the city. Here the stream was approximately 1.5 m wide and shallow, with an average water depth of 5 cm. The velocity on the day of sampling was 0.33 m / s. Although the stream channel was natural (rather than lined), it was constrained by a shelter belt on the true right. This shelter belt provided a substantial amount of shade (50-75%) to the channel in the upper area of the site, but downstream towards Sutherlands Road was more open with much less stream shading (Photo 2). The stream bed was dominated by gravels and pebbles, with a Substrate index of 4. However, these coarser substrates were relatively embedded by fine substrates. Macrophyte cover was patchy within the site, with between 5% and 60% cover recorded across the three transects, including the macrophytes duckweed (*Lemna* sp.), floating sweetgrass (*Glyceria fluitans*) and the alga *Nitella hookeri*. Exotic species dominated the macrophyte community.

Photo 2. Cashmere Stream, upstream of Sutherlands Road (Site 1), looking downstream (left) and upstream (right).

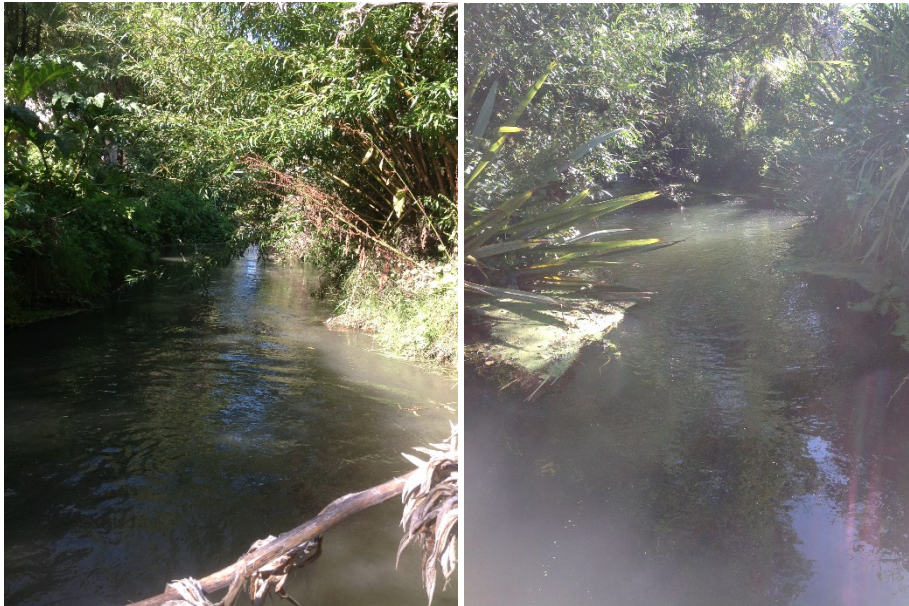
Site 2: Cashmere Stream at Penruddock Rise

Site 2 was also located on Cashmere Stream at Penruddock Rise, approximately 2.5 km downstream of site 1 and around 1 km upstream of the confluence with the Heathcote River. Here Cashmere Stream was wider (approximately 5 m) and deeper (60 cm) than upstream at site 1. Velocity on the day of sampling was 0.29 m / s. Cashmere Stream at site 2 was within a residential area, but the immediate riparian margin was within Cashmere Stream Esplanade Reserve with substantial riparian vegetation cover (both native and exotic species) (Photo 3). However, the wider nature of the channel here meant that canopy cover (and shading) was patchy, ranging from 0% to 80% cover. The stream bed had a moderate substrate index (3.08), indicating the substrates were dominated by finer silt and sands with some cobbles and pebbles. Some large cobbles and artificial substrates (e.g. bricks and concrete pieces) were observed but were not recorded within the quadrats surveyed. Macrophyte cover, including species such as Canadian pondweed (*Elodea canadensis*), curly pondweed (*Potamogeton crispus*), and the alga *Nitella hookeri*, was high across much of the stream bed surveyed, with recordings of up to 80-100% in some quadrats. Exotic species dominated the macrophyte community. Organic material, such as leaves, sticks, and large woody debris, was relatively abundant at the site.

Photo 3. Cashmere Stream, at Penruddock Rise (Site 2), looking downstream (left) and upstream (right).

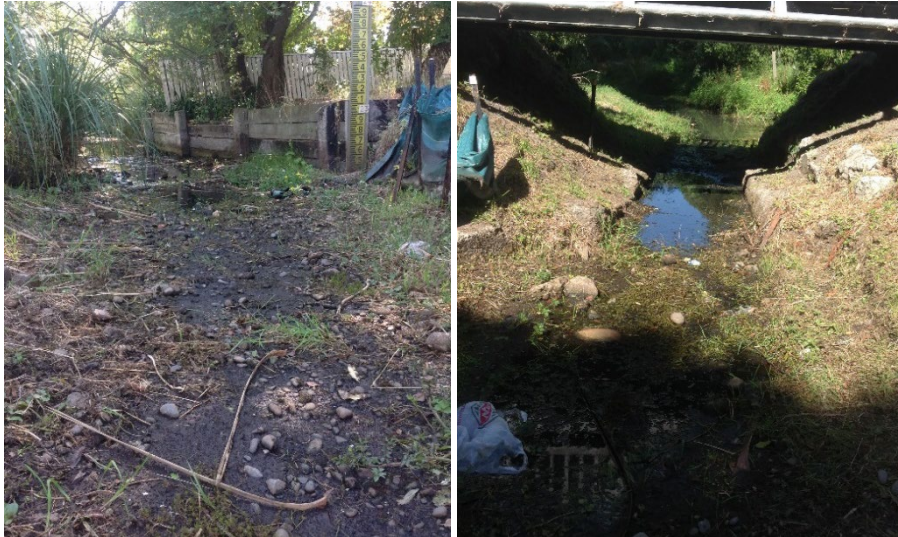
Photo 4. Heathcote River at Templetons Road (Site 3), looking downstream (left) and upstream (right). This site was dry with only a few isolated pools immediately up- and downstream of the proposed survey reach, so was not surveyed during this 2015 study.

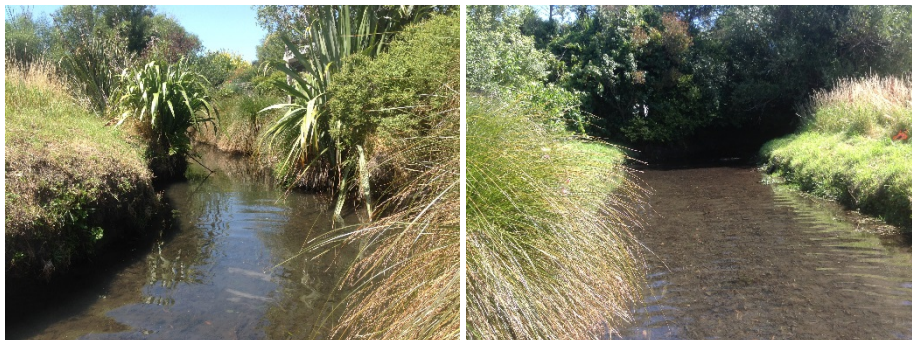
Site 4: Heathcote River within Canterbury Park / Showgrounds

Site 4 was located in the Heathcote River, approximately 1.4 km downstream of site 3, where it flows through the Canterbury Park / Showgrounds (true left) (Photo 5). Here the river was approximately 4.5 m wide, with an average water depth of 15 cm. The velocity on the day of sampling was 0.09 m / s. The banks of the river were partially lined with timber (both banks) and concrete / brick (true right bank). The riparian vegetation consisted of grasses, flaxes, and scattered trees and shrubs, all of which provided some shading (at times) to the channel margins. However, much of the in-stream habitat was without shade at the time of surveying. Macrophytes were patchy throughout the survey reach, with some curly pondweed, sweetgrass, and duckweed present. Exotic species dominated the macrophyte community. City Care's stream maintenance team had recently conducted the macrophyte maintenance / removal at this site (Ben Lay, Waterways Supervisor, City Care, pers. comm). The stream bed was dominated by gravels and pebbles, with a Substrate index of 4. However, these coarser substrates were relatively embedded by fine substrates.

Photo 5. Heathcote River within Canterbury Park / Showgrounds (Site 4), looking downstream (left) and upstream (right).

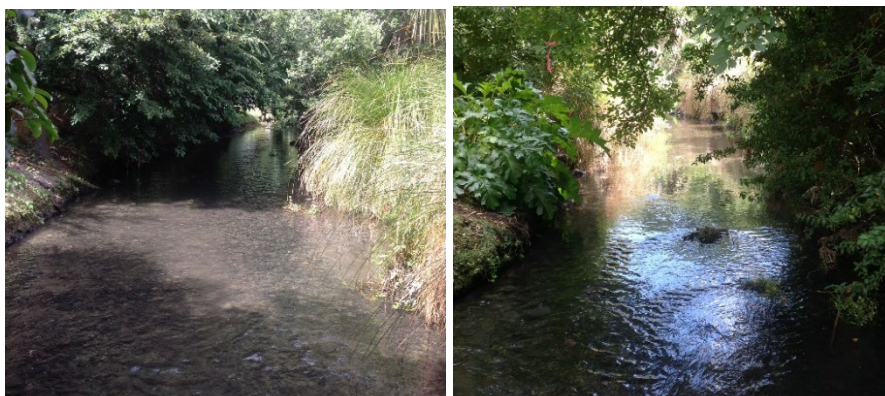
Site 5: Heathcote River downstream of Spreydon Domain

The Heathcote River downstream of Spreydon Domain (Site 5) was approximately 4 m wide, with an average water depth of 15 cm. On the day of sampling, velocity was 0.28 m / s. The river was within a residential area, but downstream of Spreydon Domain. This site was approximately 1.8 km downstream of site 4. The true left bank was earth, whereas the true right had some rock to stabilise it. There was quite a lot of *Carex* grasses overhanging the channel, some trees providing in-stream shading, and exotic species such as bear's breeches (*Acanthus* sp.) (Photo 6). The stream bed was dominated by gravels, pebbles, and cobbles, with a Substrate index of 4.1. These coarser substrates were embedded by fine sediments. There were few macrophytes present at the time of sampling.

Photo 6. Heathcote River downstream of Spreydon Domain (Site 5), looking downstream (left) and upstream (right).

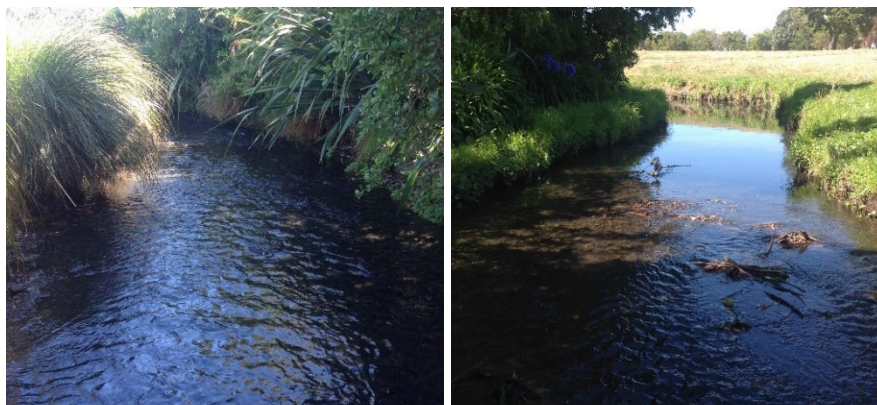
Site 6: Heathcote River at Rose Street / Centennial Park

Site 6 was located on the Heathcote River where it flows through Centennial Park, approximately 1.7 km downstream of site 5. The site included a small riffle immediately upstream of Rose Street (Photo 7). The river was 3.5 m wide with an average depth of 17 cm. The velocity was 0.31 m / s. The river was within residential area (true right) and parkland (true left). On the right bank, the riparian vegetation was predominantly trees and shrubs, while the left bank was generally mown grasses of Centennial Park with some plantings of *Carex* grasses downstream towards Rose Street. The Substrate index at site 6 was moderate (4.7), indicating the substrate was dominated by gravels and pebbles. Macrophytes were present, with an average cover of 37%, including the common species curly pondweed and sweetgrass. Exotic species dominated the macrophyte community.

Photo 7. Heathcote River at Rose Street / Centennial Park (Site 6), looking downstream (left) and upstream (right).

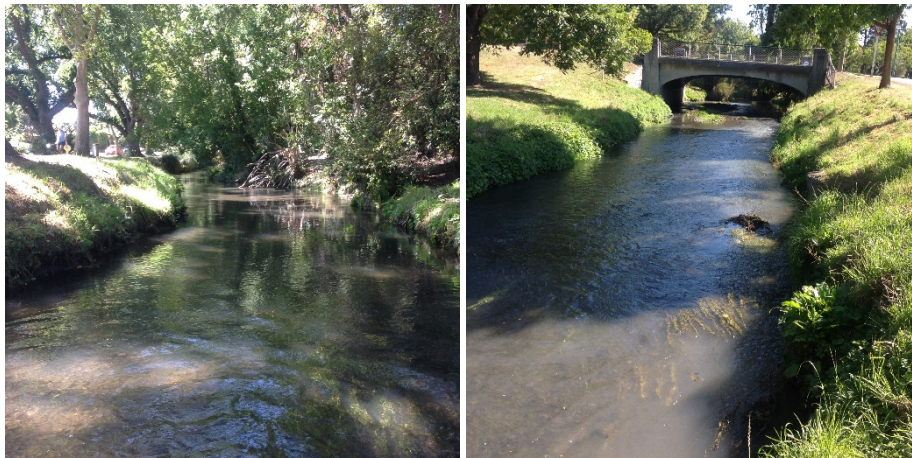
There was a discharge (Photo 8, right hand image), presumed to be sediment from construction works upstream of the site, which began after the sampling was completed.

Photo 8. Heathcote River downstream of Barrington Street (Site 7), looking downstream (left) and upstream (right).

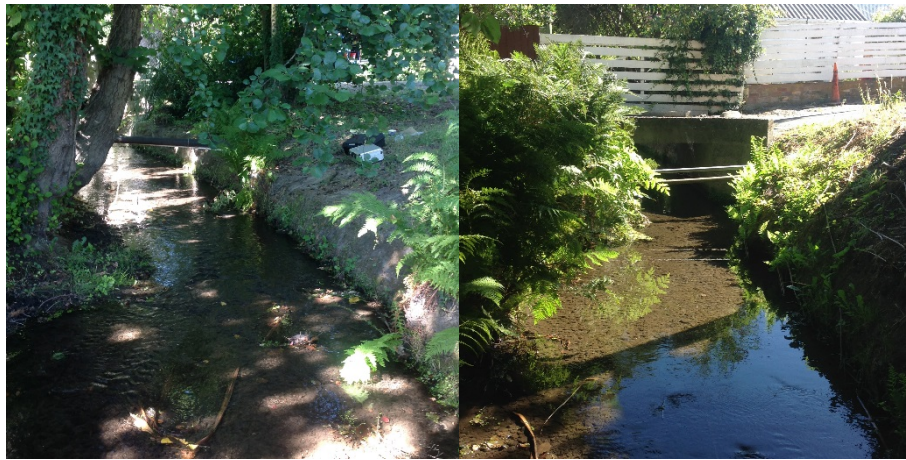
Site 8: Cashmere Brook at Ashgrove Terrace

Site 8 was within Cashmere Brook along Ashgrove Terrace. Cashmere Brook converges with the Heathcote River, just downstream of where site 7 was located. This tributary of the Heathcote River was approximately 2.5 m wide and 5 cm deep within the survey site. The survey site encompassed a small riffle section immediately upstream of the Ashgrove Terrace culvert. The velocity on the day of sampling was 0.20 m / s. The canopy cover and stream shading was variable within the site, with some areas with nearly 100% shade, while other areas were in full sun (Photo 9). The Substrate index of 4.15 indicated substrates dominated by gravels and pebbles, however, many of these coarser substrates were highly embedded by fine silts (especially at the upstream end of site 8). Macrophytes were generally absent, with only a small patch of the floating macrophyte, duckweed, observed when surveying.

Photo 9. Cashmere Brook at Ashgrove Terrace (Site 8), looking downstream (left) and upstream (right).

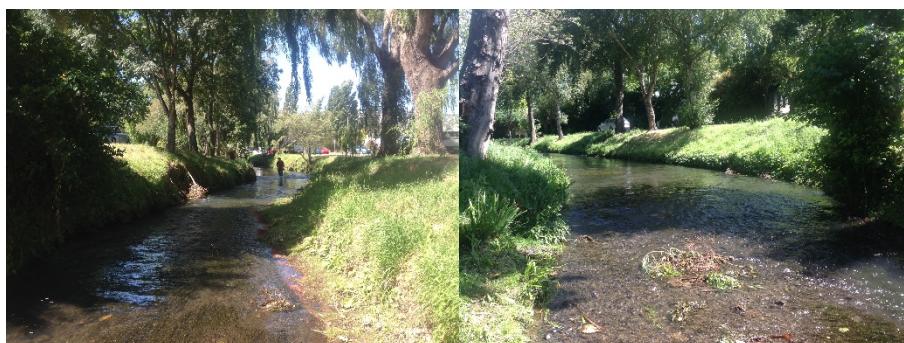
Site 9: Heathcote River downstream of Colombo Street

The Heathcote River downstream of Colombo Street (Site 9) ranged in width from 2.7-4.8 m (average 3.8 m), with an average water depth of 30 cm. This site was approximately 1 km downstream of site 7. A fast riffle was included in the survey site, and the average velocity on the day of sampling was 0.72 m / s. The riparian vegetation was dominated by grass, with some willow trees and shrubs providing some shade to the river (Photo 10). Curly pondweed (an exotic species) was abundant in places, but overall macrophyte cover was low. The substrate was dominated by gravels and pebbles, with a Substrate index of 4.7. Embeddedness was relatively low, compared to the other sites surveyed.

Photo 10. Heathcote River downstream of Colombo Street (Site 9), looking downstream (left) and upstream (right).

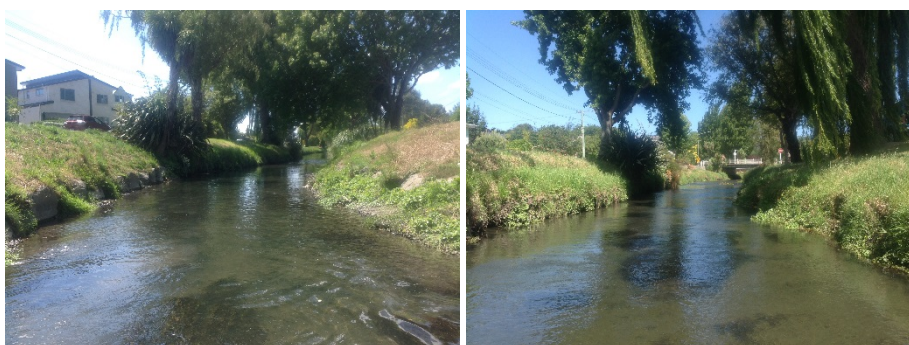
Site 10: Heathcote River downstream of Tennyson Street

Site 10 was located on the Heathcote River downstream of Tennyson Street, approximately 3 km downstream of site 9. The river was approximately 5.5 m wide and 35 cm deep here, with a velocity of 0.52 m / s on the day of sampling. Bank conditions were similar to that of Site 9 at Colombo Street, being dominated by grass with some willow trees and flaxes (Photo 11). Most of the survey site had limited canopy cover with little stream shading. Macrophytes were relatively common at site 10, with curly pondweed (an exotic species) covering about 25% of the channel. The substrate was dominated by silt / sand and small cobbles, with a Substrate index of 4.5.

Photo 11. Heathcote River downstream of Tennyson Street (Site 10), looking downstream (left) and upstream (right).

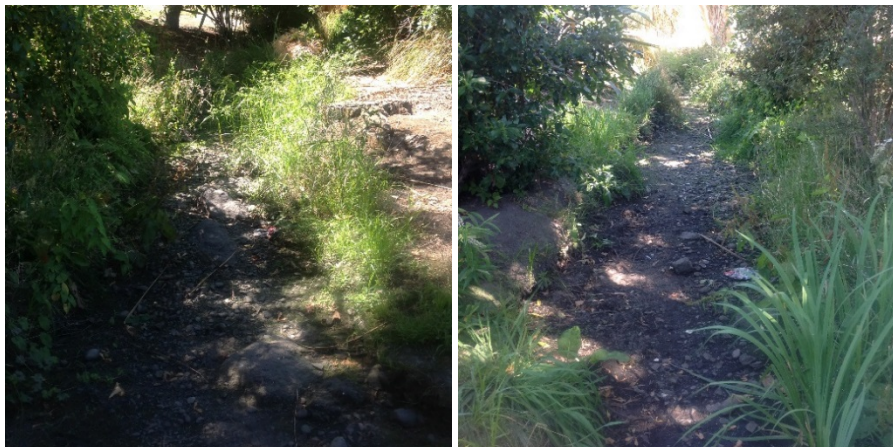
Photo 12. Jacksons Creek within Cameron Reserve (Site 11), looking downstream (left) and upstream (right). This site was dry, so was not surveyed during the 2015 study.

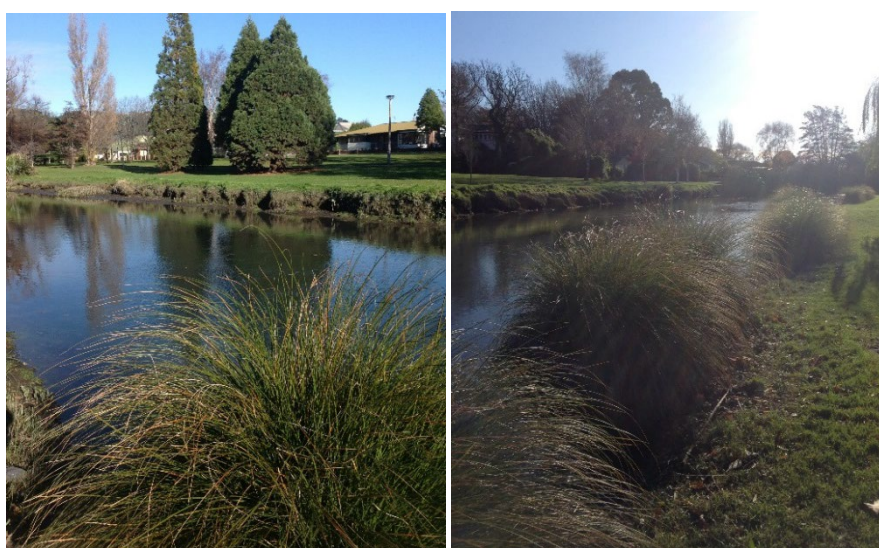
Photo 13. Heathcote River at Aynsley Terrace (Site 12), looking downstream (left) and upstream (right). Note, the original photos taken of this site were corrupted; these photos were taken in May 2015 and show newly trimmed riparian vegetation. The aquatic macrophytes had also been removed from much of the channel at the time this photo was taken.

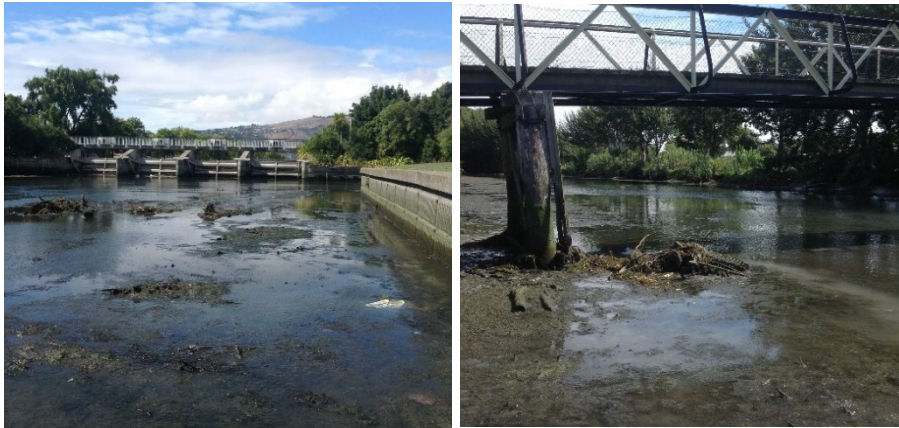
Site 13: Heathcote River at Catherine Street

The Heathcote River at Catherine Street (Site 13) was immediately upstream of the control gates of the Woolston Cut (Photo 14) and approximately 2.3 km downstream of site 12. This was a non-wadeable site, and when surveyed at low tide the mid-sections of the channel could not be fully surveyed. The site was approximately 30 m wide with an average depth of 38 cm (excluding the middle of the channel, which was much deeper). The velocity on the day of sampling was 0.08 m / s. The river bed was dominated by silt and sand, with a Substrate index of 3.1. Macrophytes was common in places, with curly pondweed, red pondweed and fennel-leaved pondweed (*P. pectinatus*), as well as *Nitella hookeri* (alga) and *Rivularia* (alga). Canadian pondweed was also present, but not common. Exotic species dominated the macrophyte community at this site.

Photo 14. Heathcote River at Catherine Street (Site 13), looking downstream (left) and upstream (right).

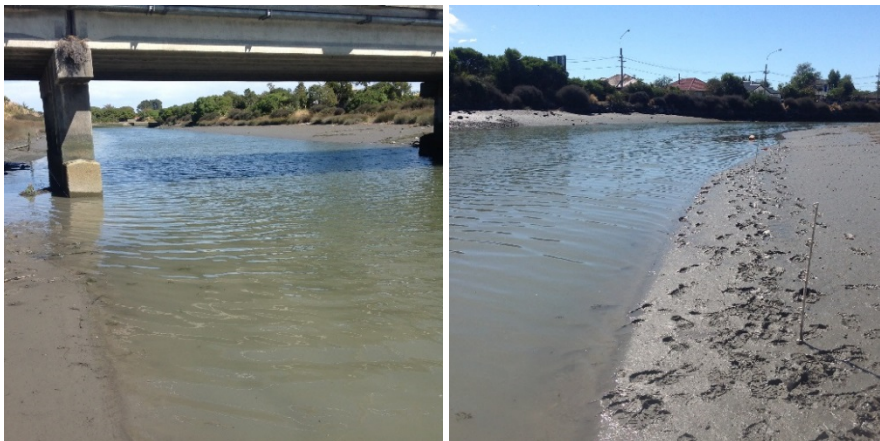
Site 14: Heathcote River at Tunnel Road

The downstream most site on the Heathcote River was located at Tunnel Road (Site 14). The river was very tidal here, with an average wetted width of approximately 15 m at low tide, but increasing to around 35 m at high tide (Photo 15). The river was, on average, 56 cm deep here (excluding the middle of the channel, which was much deeper) and velocity on the day of sampling was 0.28 m / s. The river banks were earth, with some rock reinforcing. The bed of the river was dominated by silt and sand as reflected by the Substrate index of 3 for this site. No macrophytes were observed at this site.

Photo 15. Heathcote River at Tunnel Road (Site 14), looking downstream (left) and upstream (right).

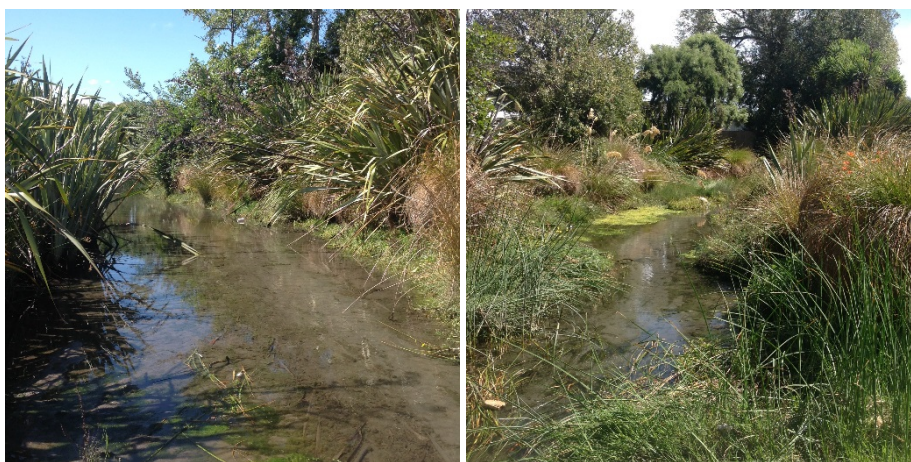
Site 15: Steamwharf Stream

Steamwharf Stream (Site 15) was upstream of Dyers Road and approximately 300 m upstream of its confluence with the Heathcote River. The stream flows through residential housing, with a small reserve (Steamwharf Stream Reserve) on the true left within the study site. The stream banks were earth, with high vegetation (dominated by native species) cover that provided some stream shading (Photo 16). The stream was approximately 4 m wide with an average depth of around 9 cm. On the day of sampling, the velocity was 0.17 m / s. The substrates consisted almost entirely of silt and sand with a Substrate index of 3. Macrophytes were sparse, with approximately 10% cover, dominated by bachelor's button (*Cotula coronopifolia*, native species). Long green filamentous algae was abundant at the site (total cover approximately 30%).

Photo 16. Steamwharf Stream (Site 15), looking downstream (left) and upstream (right).

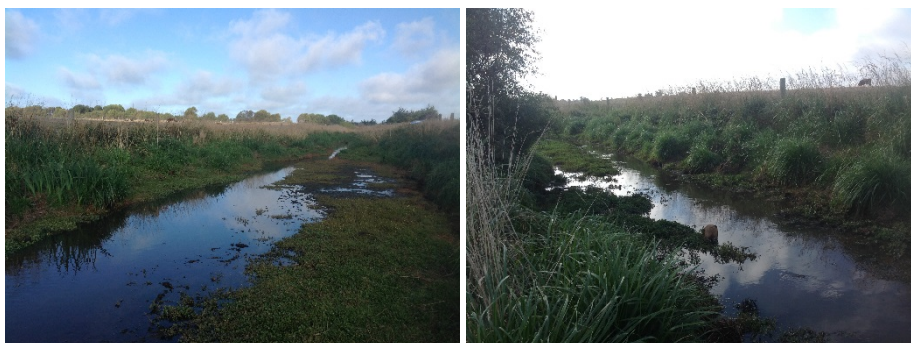
Site 17: Estuary Drain within Bexley Park

Site 17 was located within Estuary Drain within Bexley Park. This waterway was approximately 1 m and very shallow (average 5 cm water depth) at the time of sampling. There was very little flow on the day of sampling, with a recorded velocity of 0.18 m / s. The stream bed was covered with a thick layer of silt and sand (more than 1 m in depth, in places), with a Substrate index of 3. The riparian vegetation was largely long pasture grasses with some trees, which provided very little shade to the channel. Watercress (*Nasturtium officinale*, exotic species) and bachelor's button (native species) formed extensive macrophyte beds along the channel margins (Photo 17). Few macrophytes were present in the channel. Short filamentous algae was abundant, with some patches of long green filamentous algae also present.

Photo 17. Estuary Drain within Bexley Park (Site 17), looking downstream (left) and upstream (right).

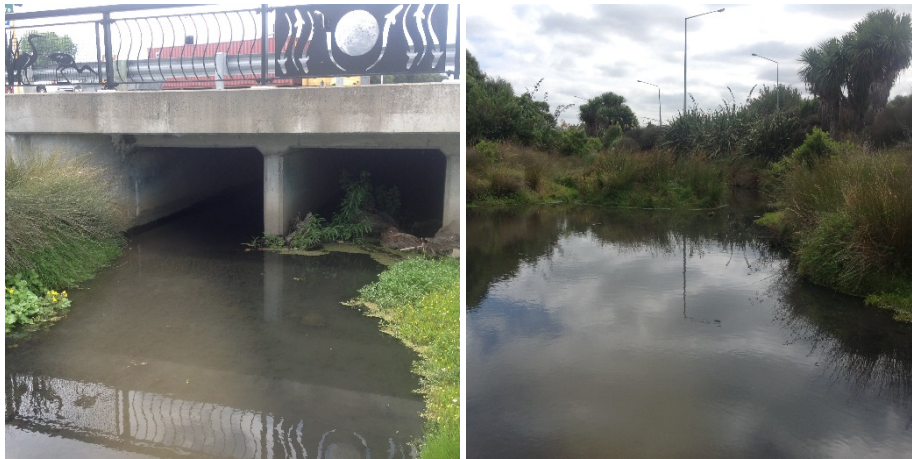
Site 18: City Outfall Drain / Linwood Canal

Site 18 was located in the City Outfall Drain, or Linwood Canal, which runs parallel to Linwood Road. This site was immediately upstream of Dyers Road and approximately 800 m upstream from its discharge point into the Avon-Heathcote Estuary. Wetted width and depth varied within the site, but on average was approximately 6 m wide and 21 cm deep. There was negligible flow (0.05 m / s) on the day of sampling (Photo 18). The City Outfall Drain, at the survey site, flowed through a residential area and a small area of roadside / streamside planting. This area was generally well planted with native species, with high riparian cover (dominated by native species) that provided some shade to the waterway, particularly along the margins. Macrophytes were relatively abundant, dominated by the exotic curly pondweed.

Photo 18. City Outfall Drain / Linwood Canal (Site 18), looking downstream (left) and upstream (right).
