23 June 2016

INFILTRATION TESTING RESULTS FOR AKAROA WASTEWATER DISPOSAL VIA IRRIGATION

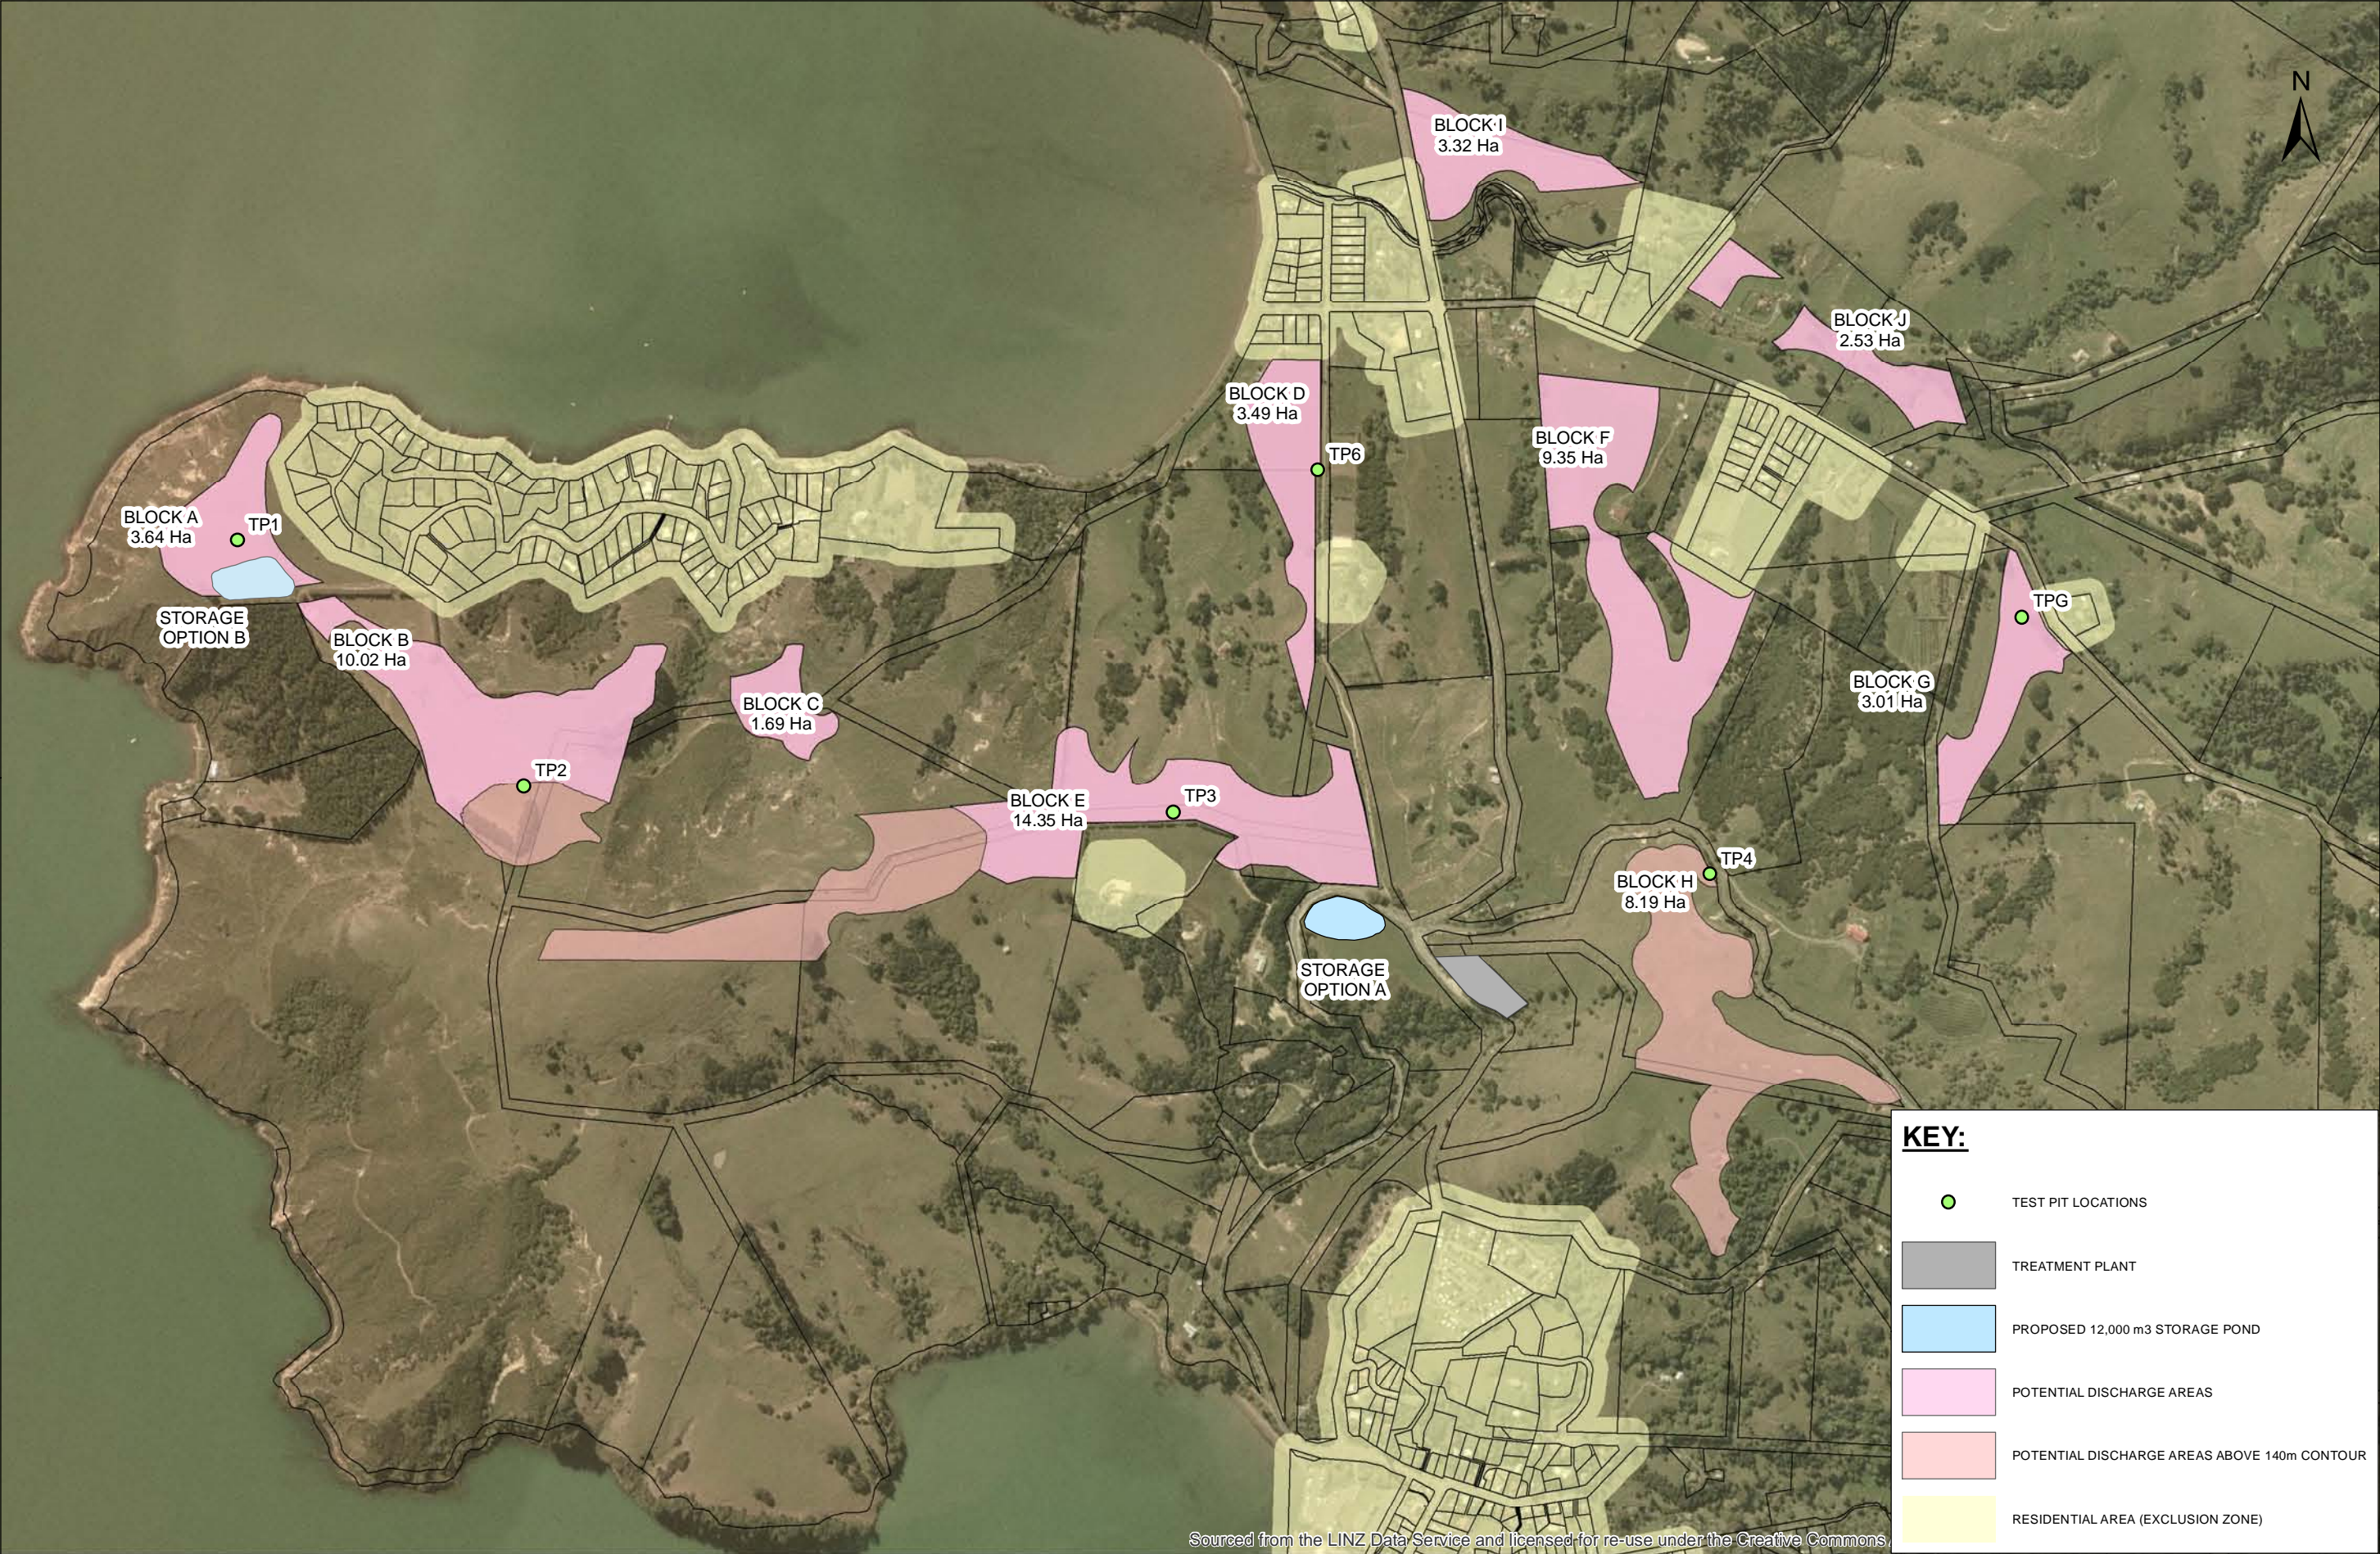
FIGURE 1: TEST PIT LOCATIONS

Test pits were excavated and infiltration tests were carried out at the locations shown in Figure 1, Appendix A. Eight infiltration tests were carried out using a double ring infiltrometer. These were carried out for a target minimum period of 90 minutes. Two infiltration tests, one in the surface soils and one in the less permeable subsoil, were carried out at four locations to determine a representative infiltration rate.

Table 2 summarises the data of the test pitting including location, depth and soil type. Figure 1, Appendix A shows the locations of the test pits carried out. Photographs of the test pits and materials are included in Figures 14 – 19, Appendix A.

Eight infiltration tests were carried out at the locations shown in Figure 1, Appendix A. To enable a comparative analysis of the sites, the tests were carried out on the high (loess), intermediate (loess colluvium) and low (alluvial) areas. These areas were defined by Beca and the map indicating these different zones is included in Figure 15, Appendix A. In the week prior to infiltration testing there was 81 mm of rain recorded at the Akaroa EWS station (36593) (Cliflo, 2016).

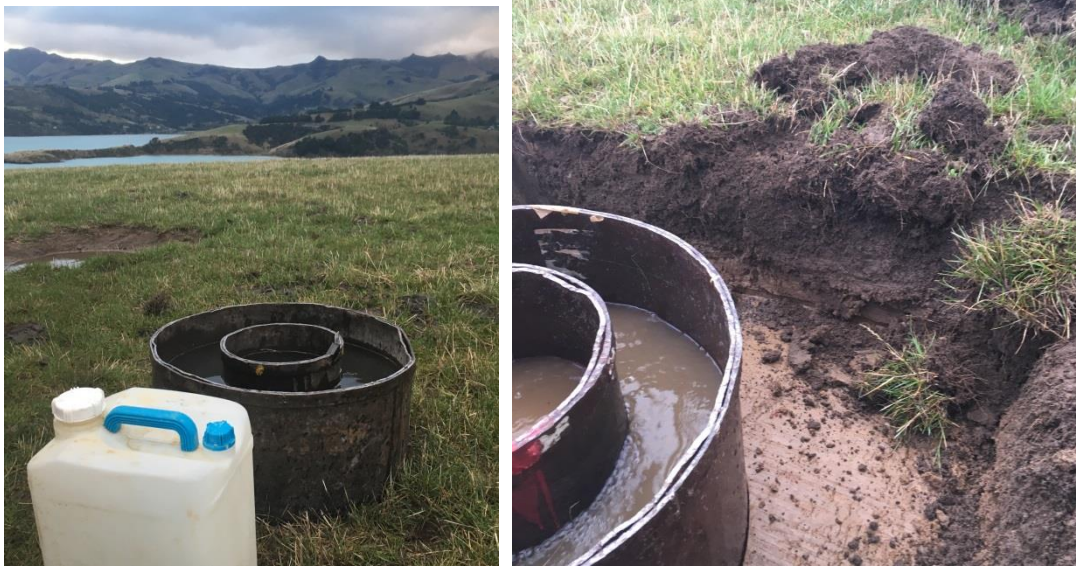
IT1 was carried out in the surface soils for a total of 2 hours 30 minutes, resulting in a stabilised infiltration rate of 22 mm/hr. A plot of the infiltration rate throughout the duration of the test is given in Figure 6, Appendix A.

IT1.5 was carried out to determine the limitations of irrigation of the low permeability layer beneath the topsoil. A small excavation was made, the depth of which was 0.28 m bgl. Topsoil was measured to a depth of 0.18 m bgl. The double ring infiltrometer was sunk in approximately 100 mm into the low permeability material. The test was carried out for 2 hours. The stabilised infiltration rate was measured to be 0 mm/hr. A plot of the infiltration rate throughout the duration of the test is given in Figure 7, Appendix A.

Figure 2: Infiltration Test IT1 (left) and subsurface Test IT1.5 (right) within Children's Bay land.

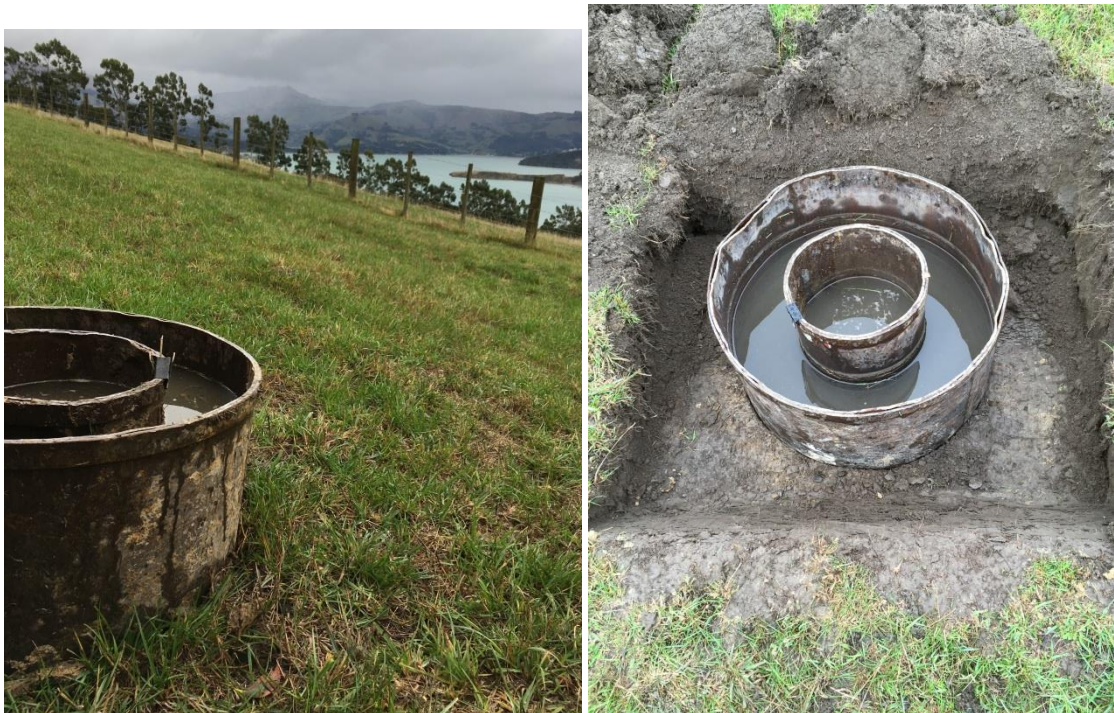
IT3 was carried out (in the surface soils) for 3 hours. The stabilised infiltration rate was measured to be 12 mm/hr. A plot of the infiltration rate over the course of Test 3 is given in Figure 8, Appendix A.

IT3.5 was also carried out approximately 100 mm into the low permeability strata, within a small excavation and at a depth of 0.28 m bgl. The test duration was 2 hours 30 minutes. The test was concluded after the infiltration rate stabilised at 12 mm/hr. A plot of the infiltration rate over the course of IT3.5 is given in Figure 9, Appendix A. Topsoil was measured to a depth of 0.22 m at this site. The subsoil infiltration rate measured was comparatively faster than the other subsoil infiltration rates. The double ring infiltrometer may not have been inserted as deep into the lower permeability layer relative to the other sites.

Figure 3: Infiltration Test IT3 (left) and subsurface Test IT3.5 (right) within CCC road corridor.

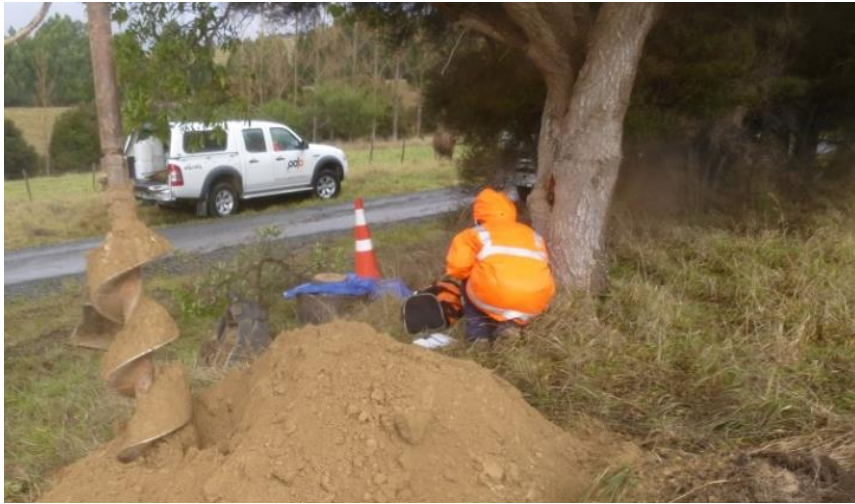
IT6 and IT6.5 were carried out in a road reserve. IT6 was carried out for 3 hours. The stabilised infiltration rate was measured to be 8 mm/hr. A plot of the infiltration rate over the course of IT6 is given in Figure 10, Appendix A.

Figure 4: Infiltration Test IT6 within CCC road corridor, subsurface test IT6.5 not shown.

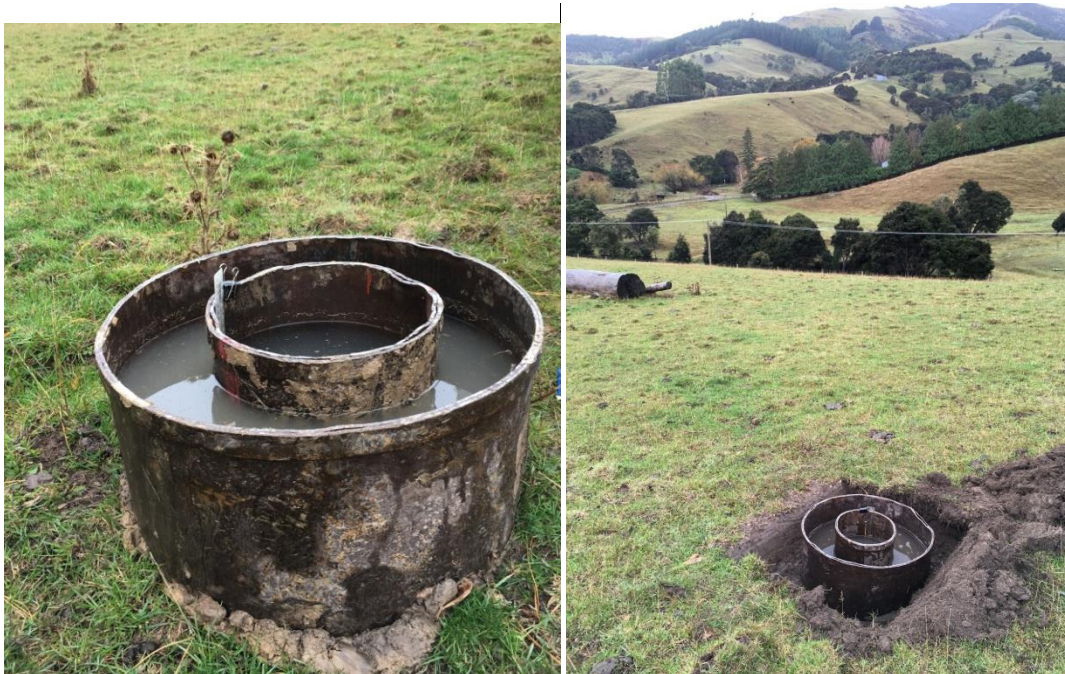
ITG was carried out for 1 hour 40 minutes, giving a stabilised rate of 30 mm/hr. A plot of the infiltration rate over the course of ITG is given in Figure 12, Appendix A.

For ITG.5 the double ring infiltrometer was sunk in approximately 100 mm into the low permeability strata, within a small excavation and at a depth of 0.20 m bgl. Topsoil was measured to 0.25 m bgl. The test was carried out for 1 hour 40 minutes, giving a stabilised rate of 24 mm/hr. A plot of the infiltration rate over the course of the test is given in Figure 13, Appendix A. It would be expected that the infiltration rate measured should have been slower. The infiltrometer may not have been inserted far enough into the low permeability layer, the depth of topsoil was greater than previous sites.

Figure 5: Infiltration Test ITG (left) and subsurface Test ITG.5 (right) within Paul le Lievre land.

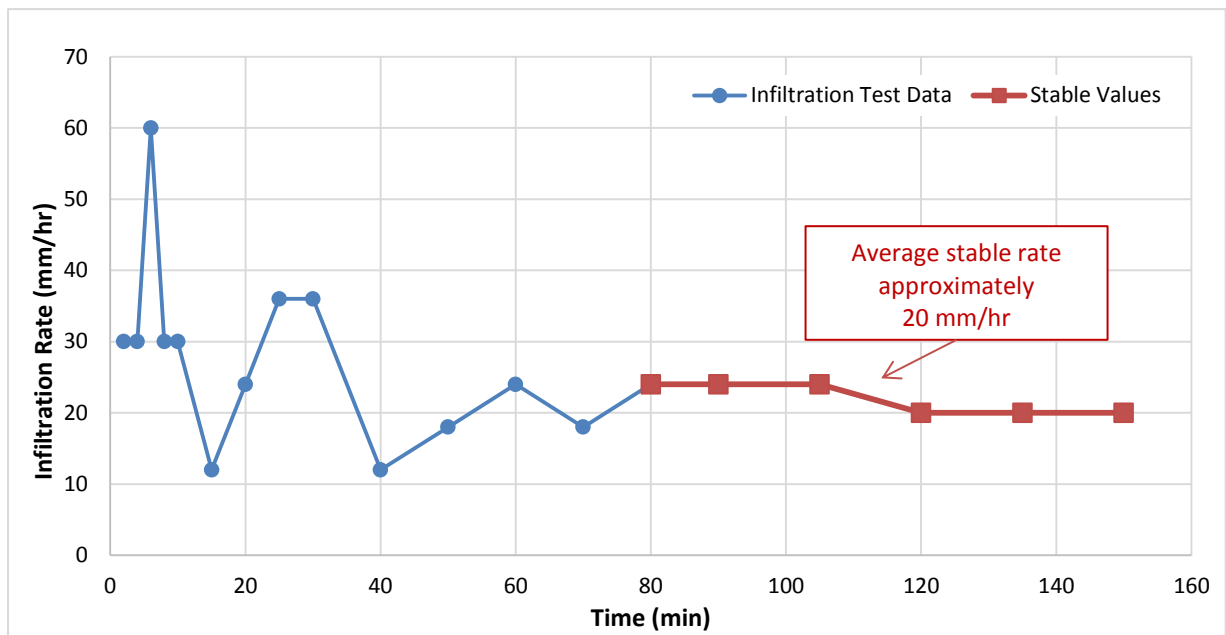
Figure 6: Infiltration Rate during Test IT1

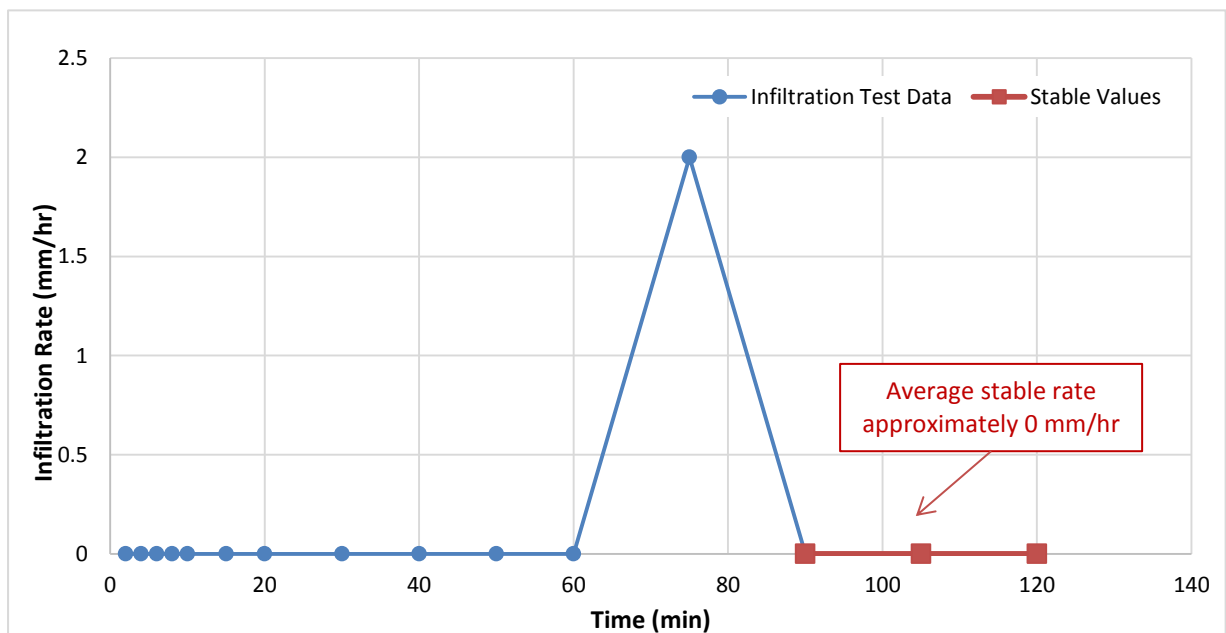
Figure 7: Infiltration Rate during Test IT1.5

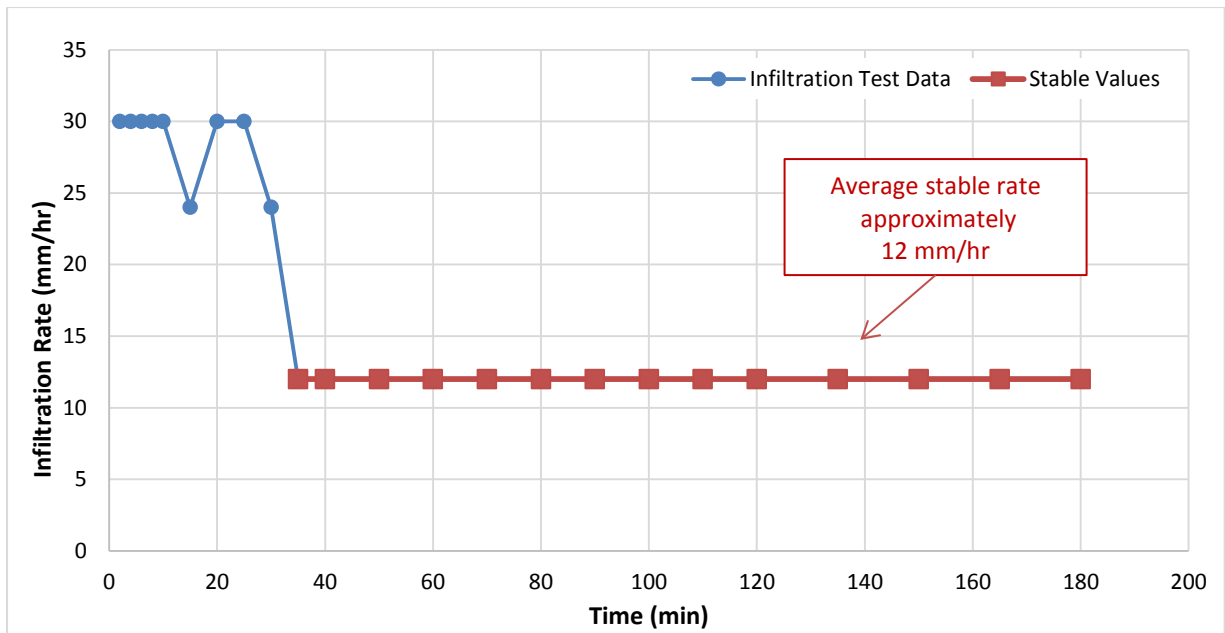
Figure 8: Infiltration Rate during Test IT3

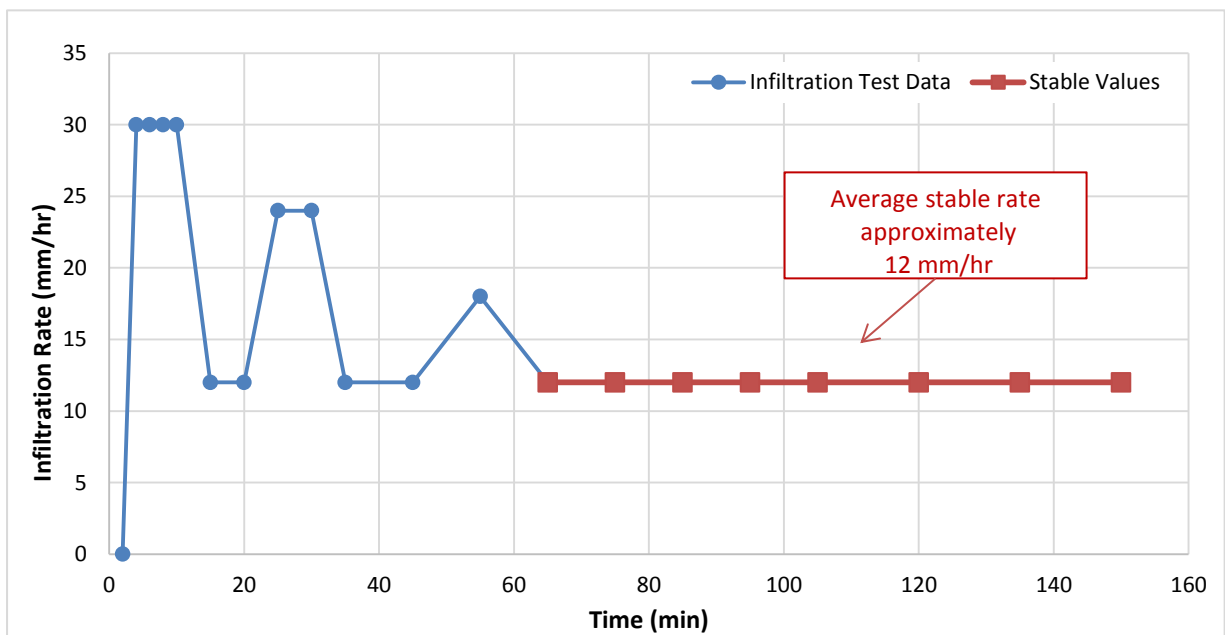
Figure 9: Infiltration Rate during Test IT3.5

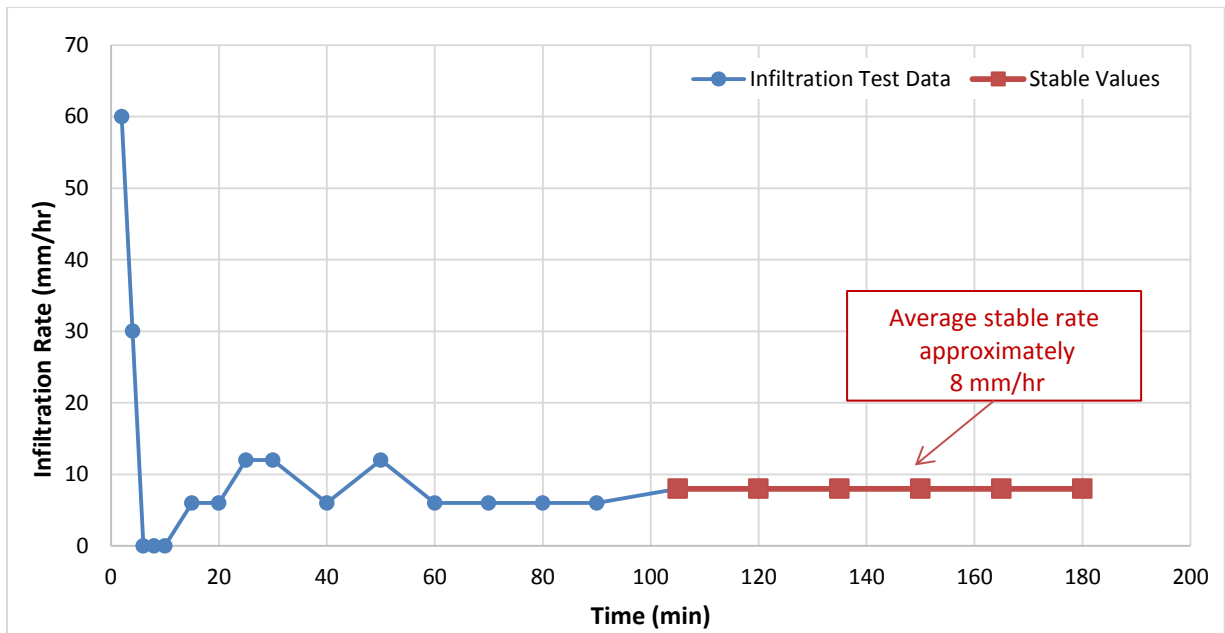
Figure 10: Infiltration Rate during Test IT6

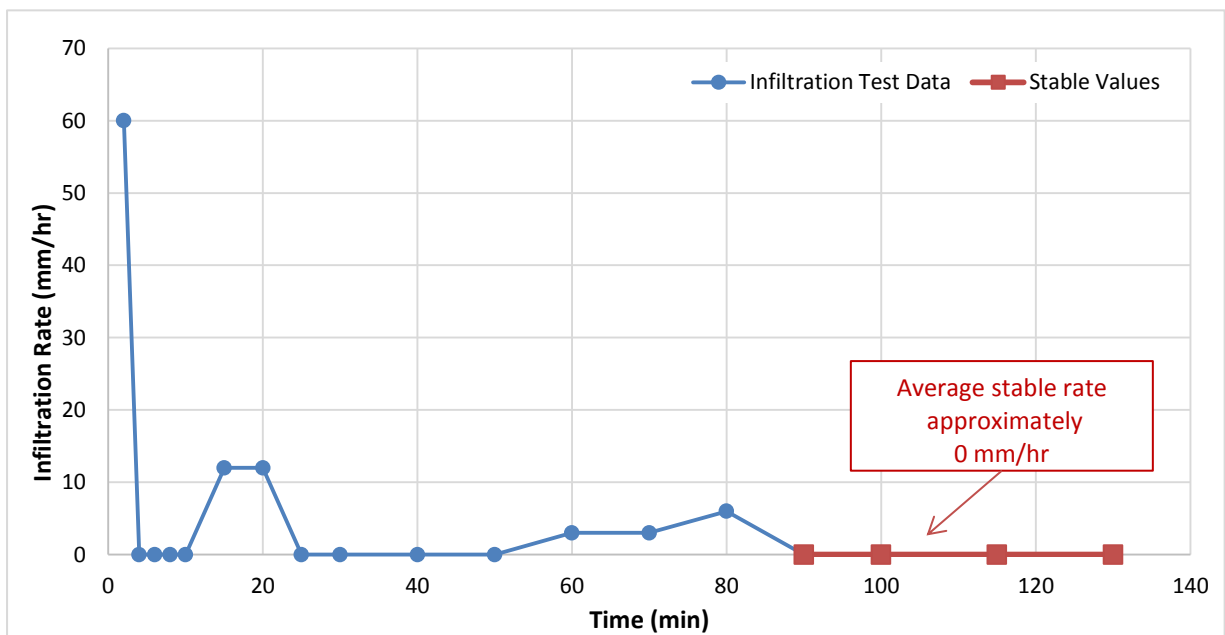
IT6.5 was carried out approximately 100 mm into the low permeability strata, at a depth of 0.30 m bgl. The test was carried out for 2 hours 10 minutes, resulting in a stabilised rate of 0 mm/hr. A plot of the infiltration rate over the course of IT6.5 is given in Figure 11, Appendix A.

Figure 11: Infiltration Rate during Test IT6.5

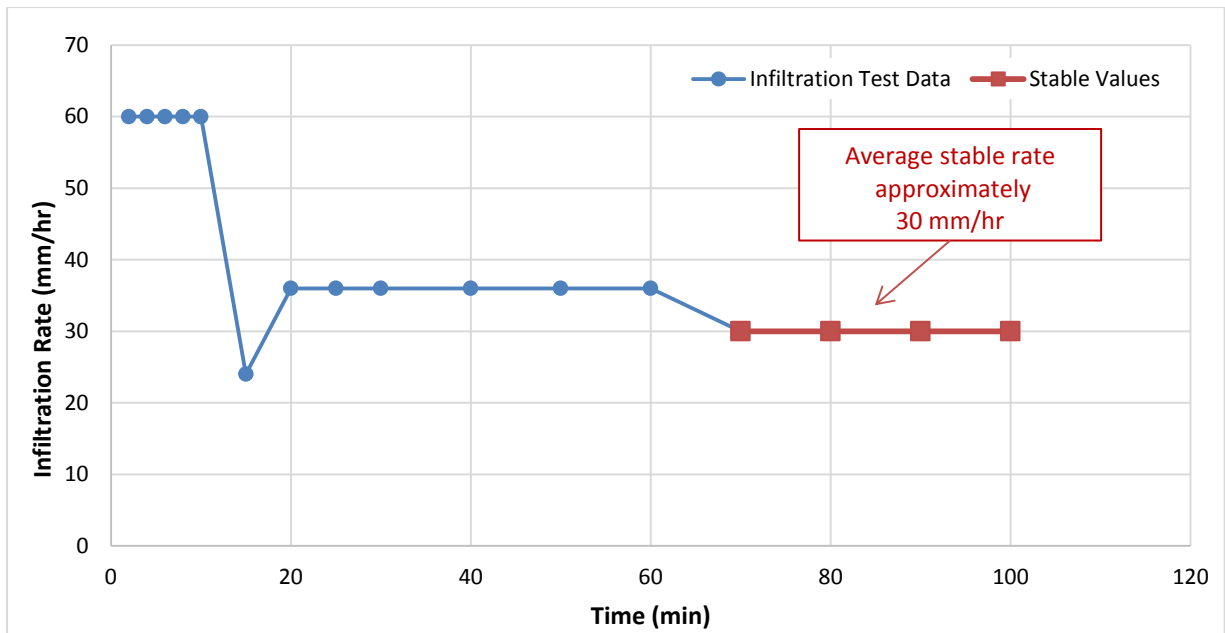
Figure 12: Infiltration Rate during Test ITG

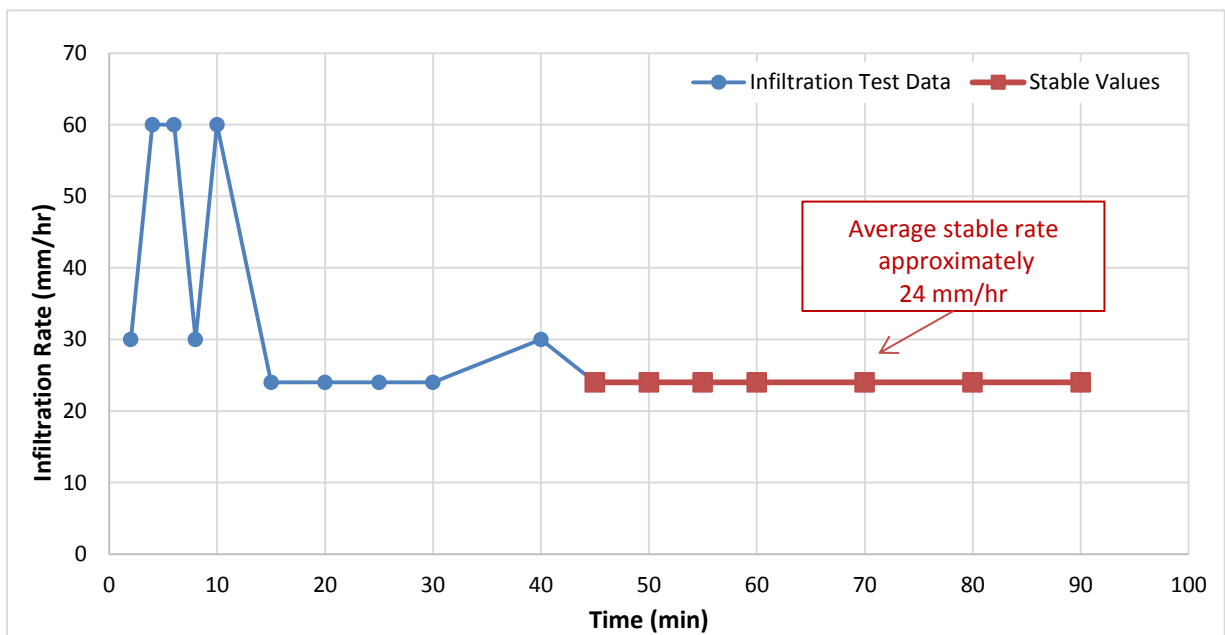
Figure 13: Infiltration Rate during Test ITG.5

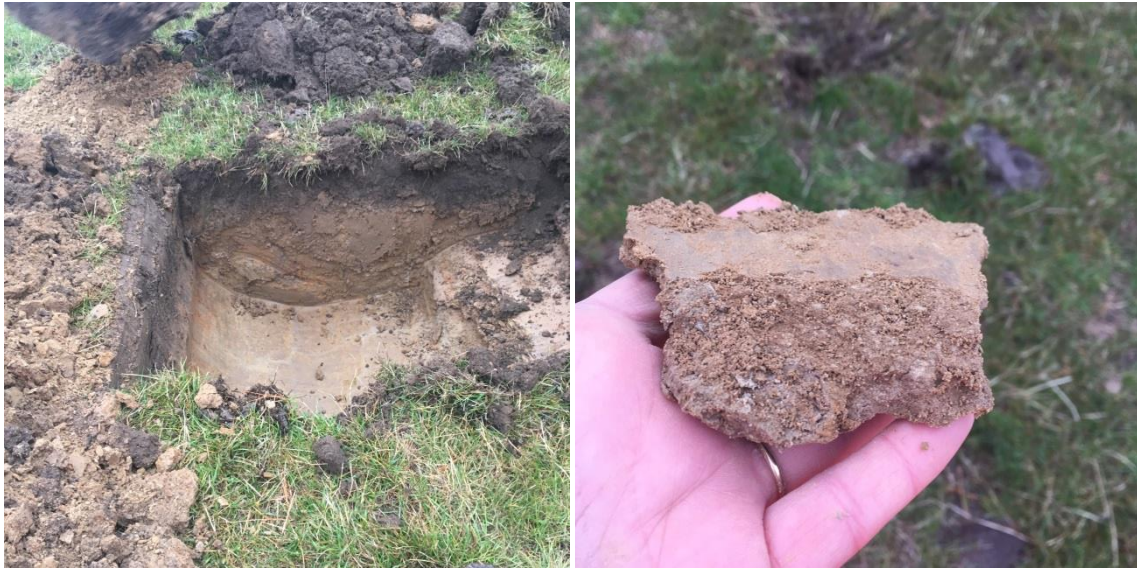
Site 1 is a flat section and the soils encountered in TP1 are consistent with the Takahe Soil description. There was a good depth of topsoil at this site and root penetration throughout the topsoil layer and with some continuation into the yellow mottled orange friable subsoil.

Figure 14: Test Pit 1 – test pit (left) and very firm layer at 1.3 m bgl (right).

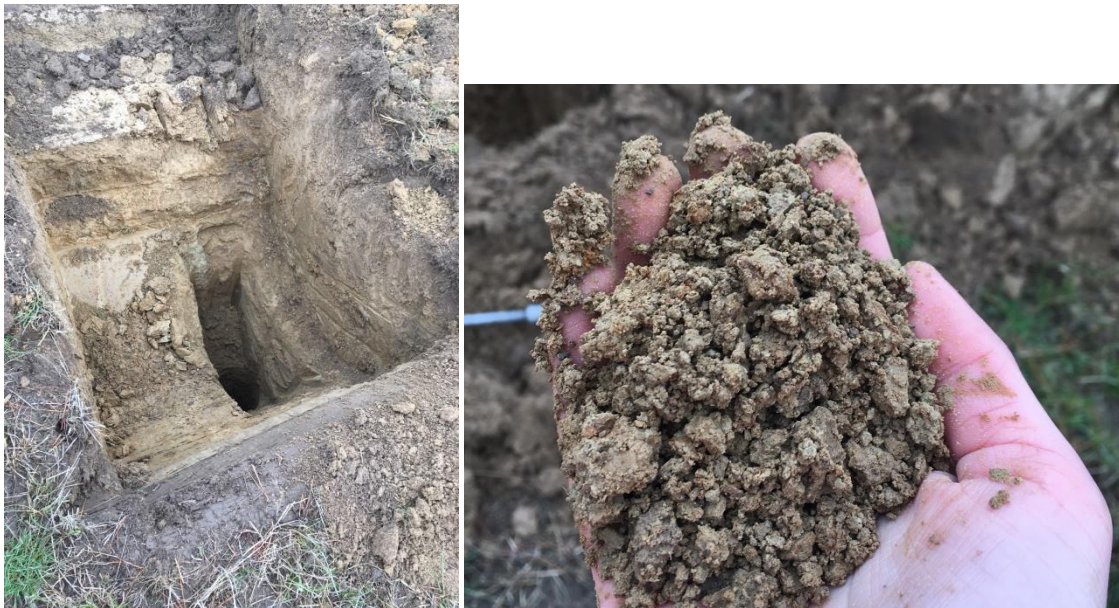
Site 2 was a reasonably steep slope, and further up the hill were scattered rocky outcrops. The soils encountered in TP2 were consistent with the Takahe Soil description. There was slightly less depth of topsoil and root penetration at TP2.

Figure 15: Test Pit 2 - test pit (left) and nutty/crumby silt material indicative of subsoil (right).

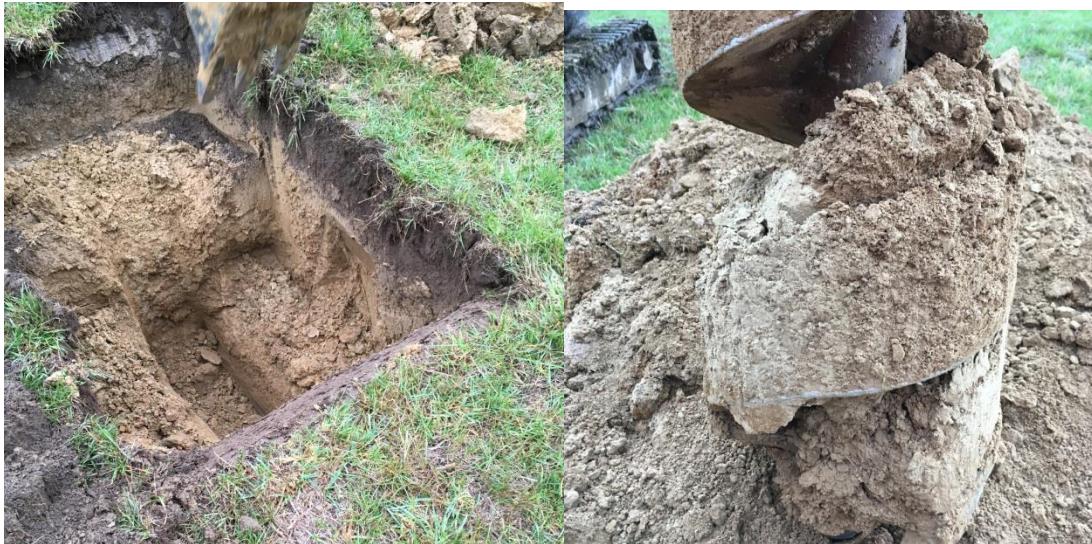
Site 3 was a reasonably flat to gentle slope. This site was in the road reserve and there was a good depth of topsoil, which may be a result of the land being worked. The materials encountered are consistent with the Takahe Soil description.

Figure 16: Test Pit 3 – test pit (left) and light grey material at 4.1 m bgl (right).

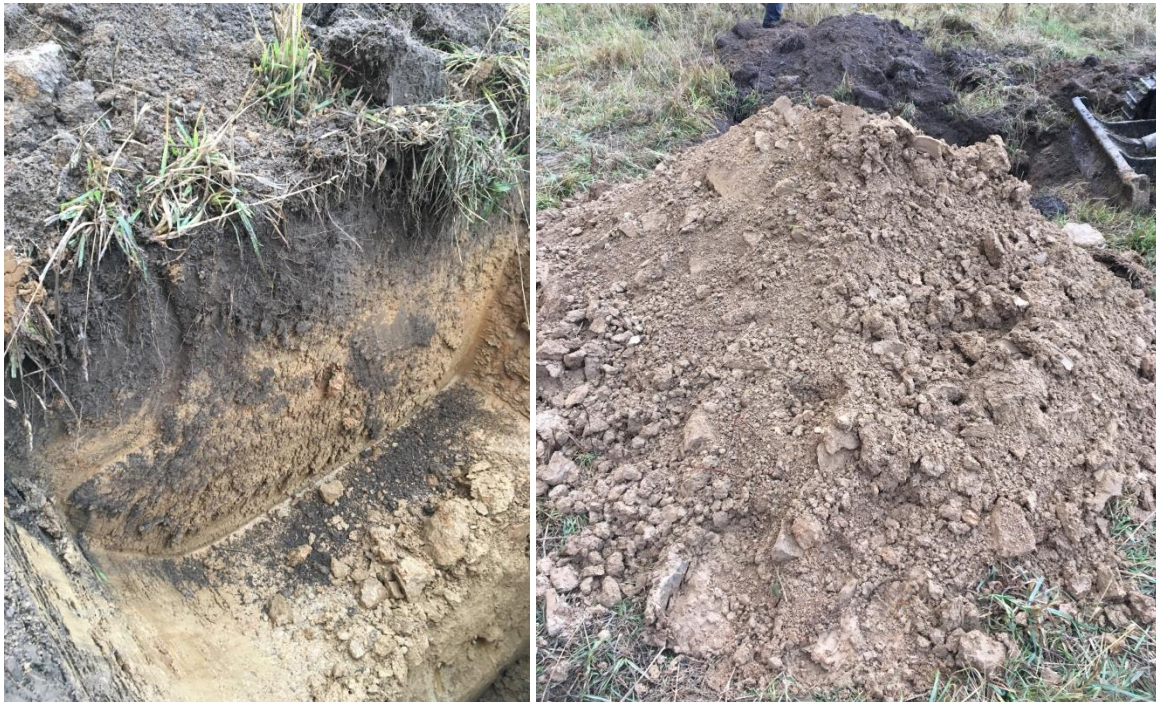
Site 4 was a flat section within a steep area. This site had the greatest depth of topsoil of all the sites investigated and was also at the greatest elevation. It appeared that the materials more closely matched Takahe Soils, rather than Pawson Hills soils.

Figure 17: Test Pit 4 - test pit (left) and nutty/crumby silt material indicative of subsoil (right).

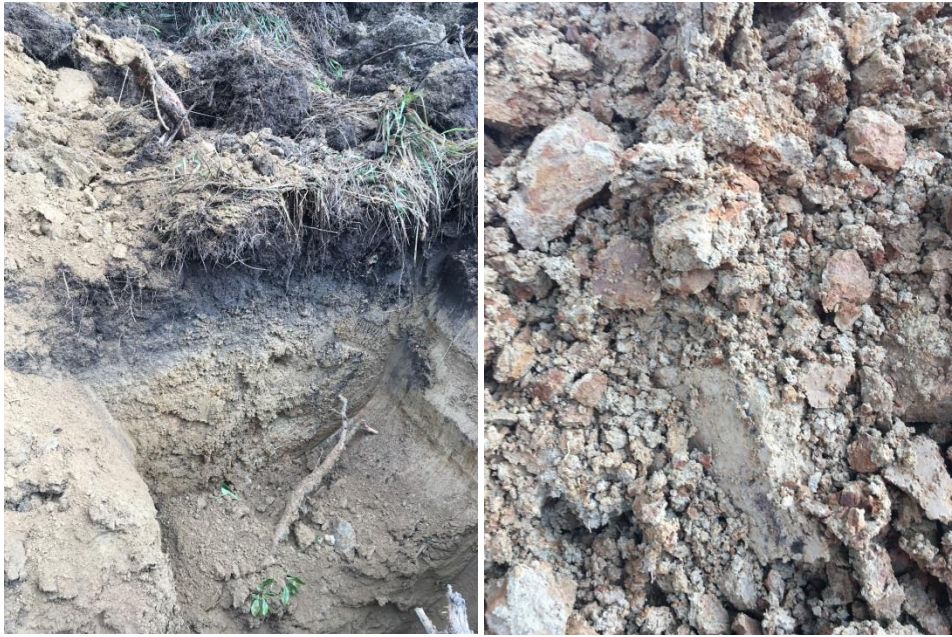
Site 6 was also carried out in the road corridor at the toe end of a line of trees. This was the only site with an obvious pale olive grey layer directly under the topsoil, indicative of Pawson Hills Soils.

Figure 18: Test Pit 6 - test pit (left) and nutty/crumby silt material indicative of subsoil (right).

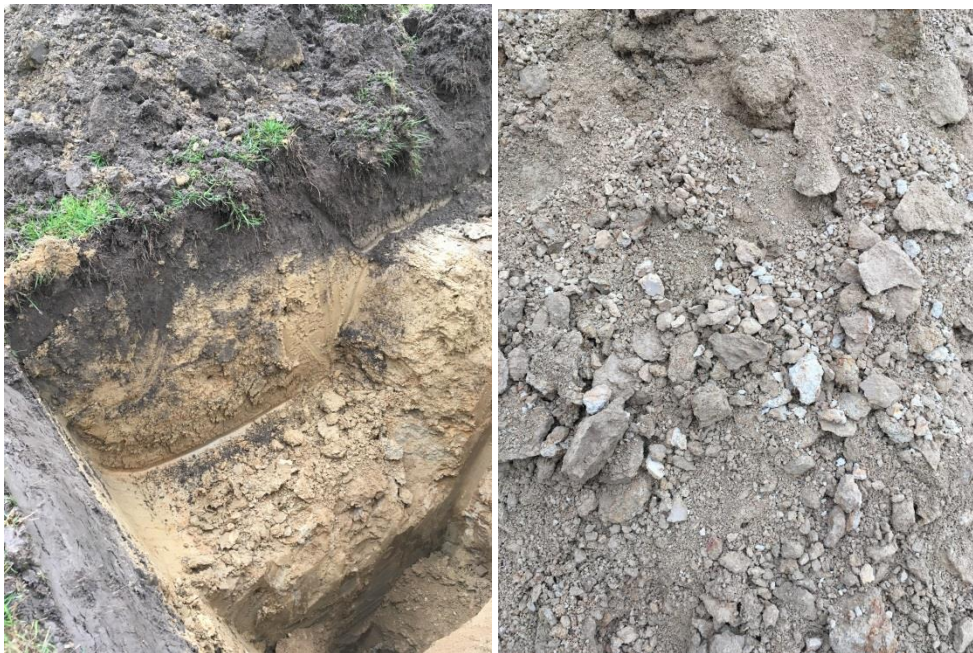
The test pit at Site G was carried out on a steep slope, there was a gully running through this property. It appeared that the materials most closely matched Takahe Soils.

Figure 19: Test Pit G - test pit (left) and material indicative of subsoil (right).
